From: Knoy.Jim@epamail.epa.gov
Sent: Friday, September 29, 2006 1:06 PM
To: Ferguson, Randall
Cc: bethann.williams@state.co.us; miller.johanna@epamail.epa.gov;
wolf.martha@epamail.epa.gov
Subject: Inspection of UPRR 41 Pan Am K#2 Tank Battery
Attachments: P9290001.JPG; P9290005.JPG; P9290006.JPG

Site location: Weld CR 15, approximately 1 mile north of road east from I-25 at the Mead exit, NE corner of first intersection and immediately north of the stream. SWSW Section 5, T3N, R67W COGCC Complaint # 200096598

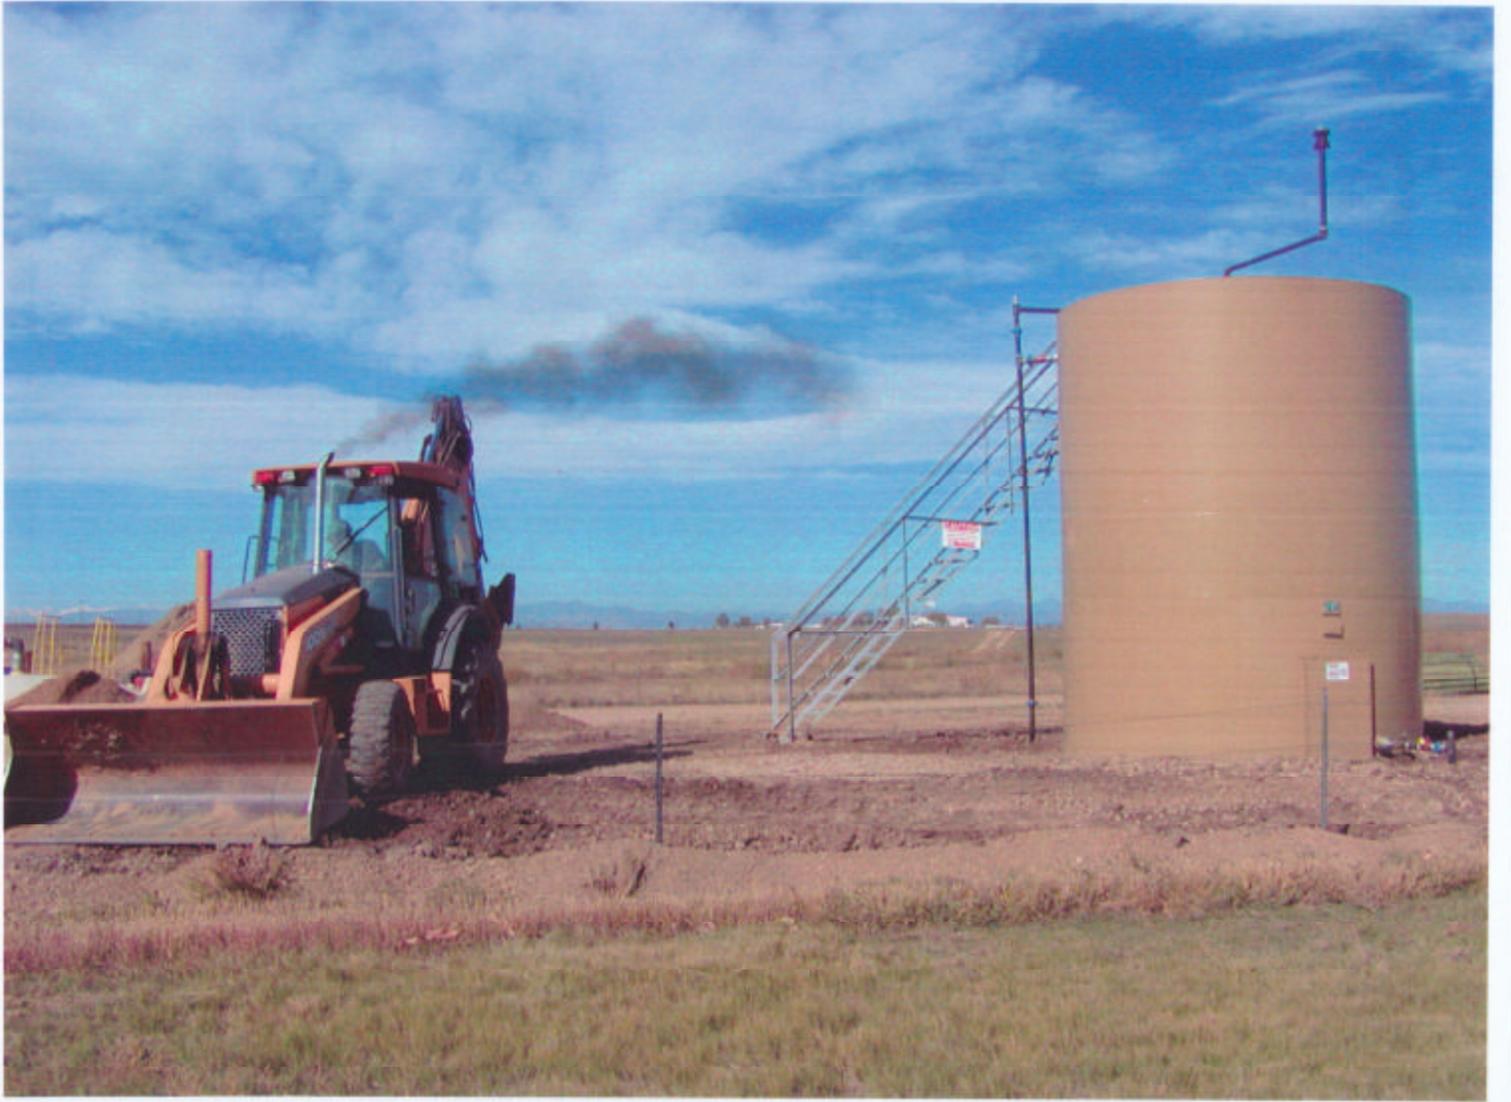
On September 29, 2006, I inspected the above mentioned Tank Battery in response to a call from the landowner, Mr. Mark Schell. I met Mr. Schell at his home and he accompanied me on the inspection. I observed two laborers using a backhoe to finish, what appeared to be, the backfilling of a hole where, according to Mr. Schell, the contaminated soil was first noted. I took pictures of this operation. I noted that there was essentially no secondary containment at this time, with the presumption that when the backfilling was completed, the secondary containment would be re-established. I did not meet with any company representatives during this inspection.

(See attached file: P9290001.JPG) (See attached file: P9290005.JPG) (See attached file: P9290006.JPG) Backfilling Spill area Stream water

I also recommend that Ms. Wolf's team follow-up on this facility, in coordination with the Colorado Oil and Gas Commission to ensure that secondary containment is restored adequately.

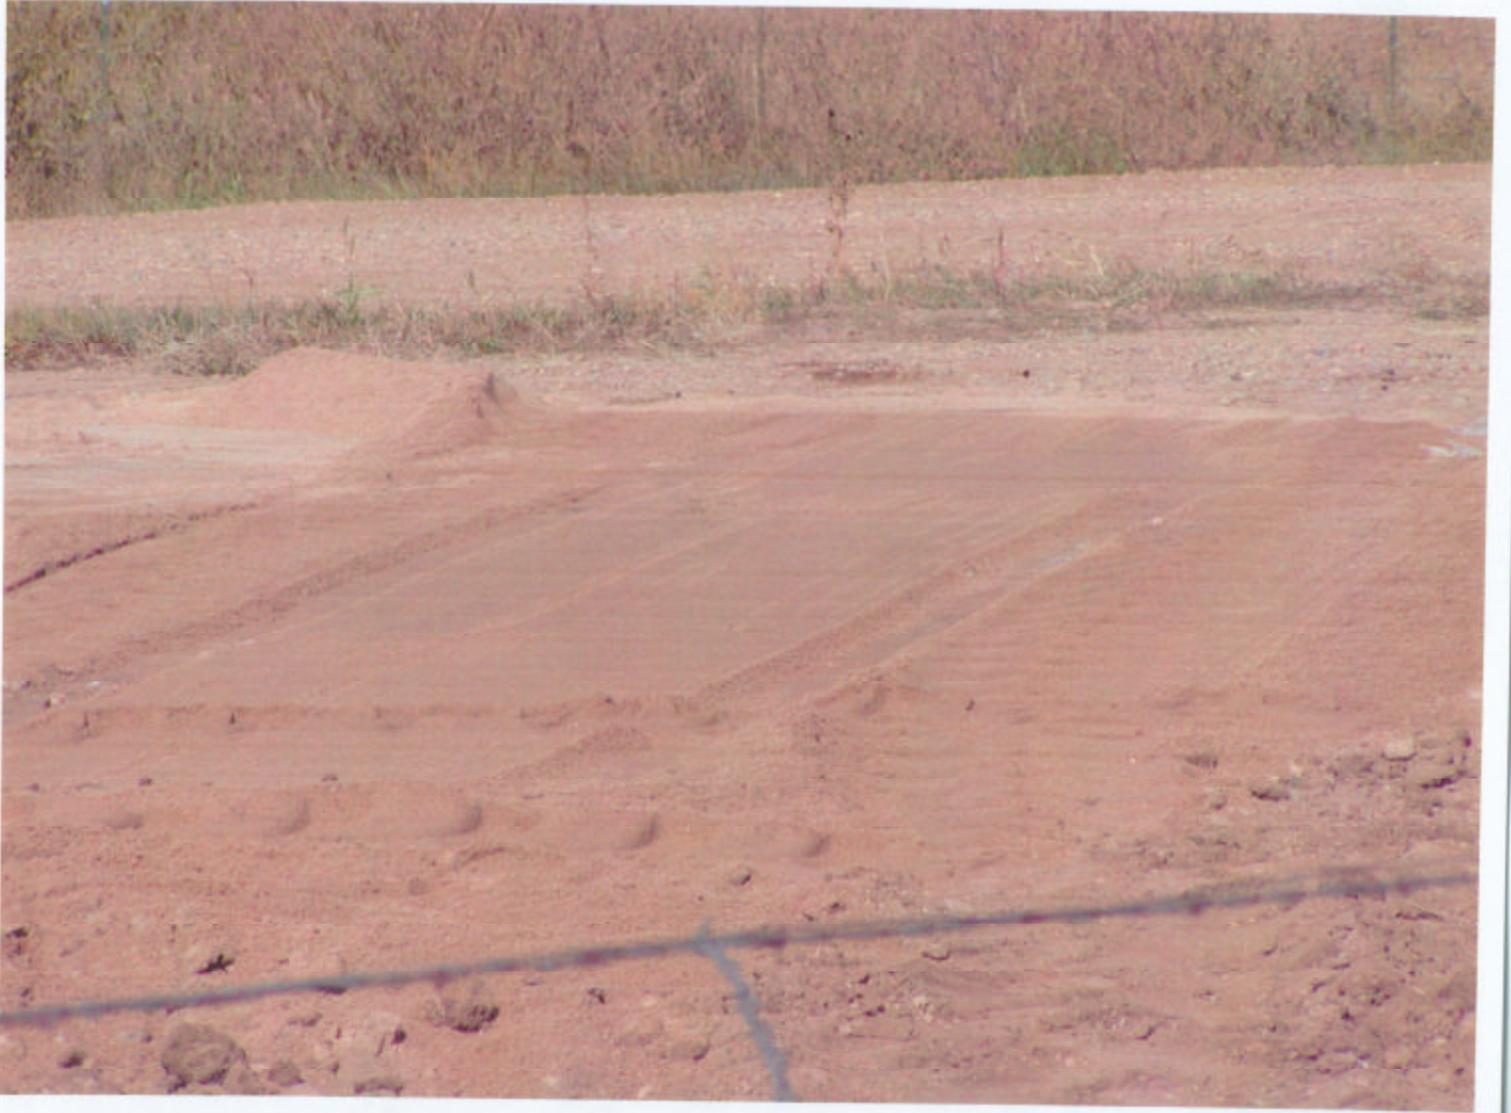
Apparently there is a dispute between the land owner and the facility operator/owner over how much oil was spilled on the soil. I could not make any determination in that regard. It does appear, however, that if there is a sizable quantity of contamination in the surficial aquifer, and that it is a very short trip, perhaps 40 feet, from the oil spill to the stream, and that violations of the Clean Water Act, as amended, would occur if not abated.

It is EPA's opinion that a determination of the existence and extent of a groundwater plume is needed soon so any needed cleanup/remediation can occur before heavy precipitation events occur which could increase the extend of contamination and costs to cleanup.

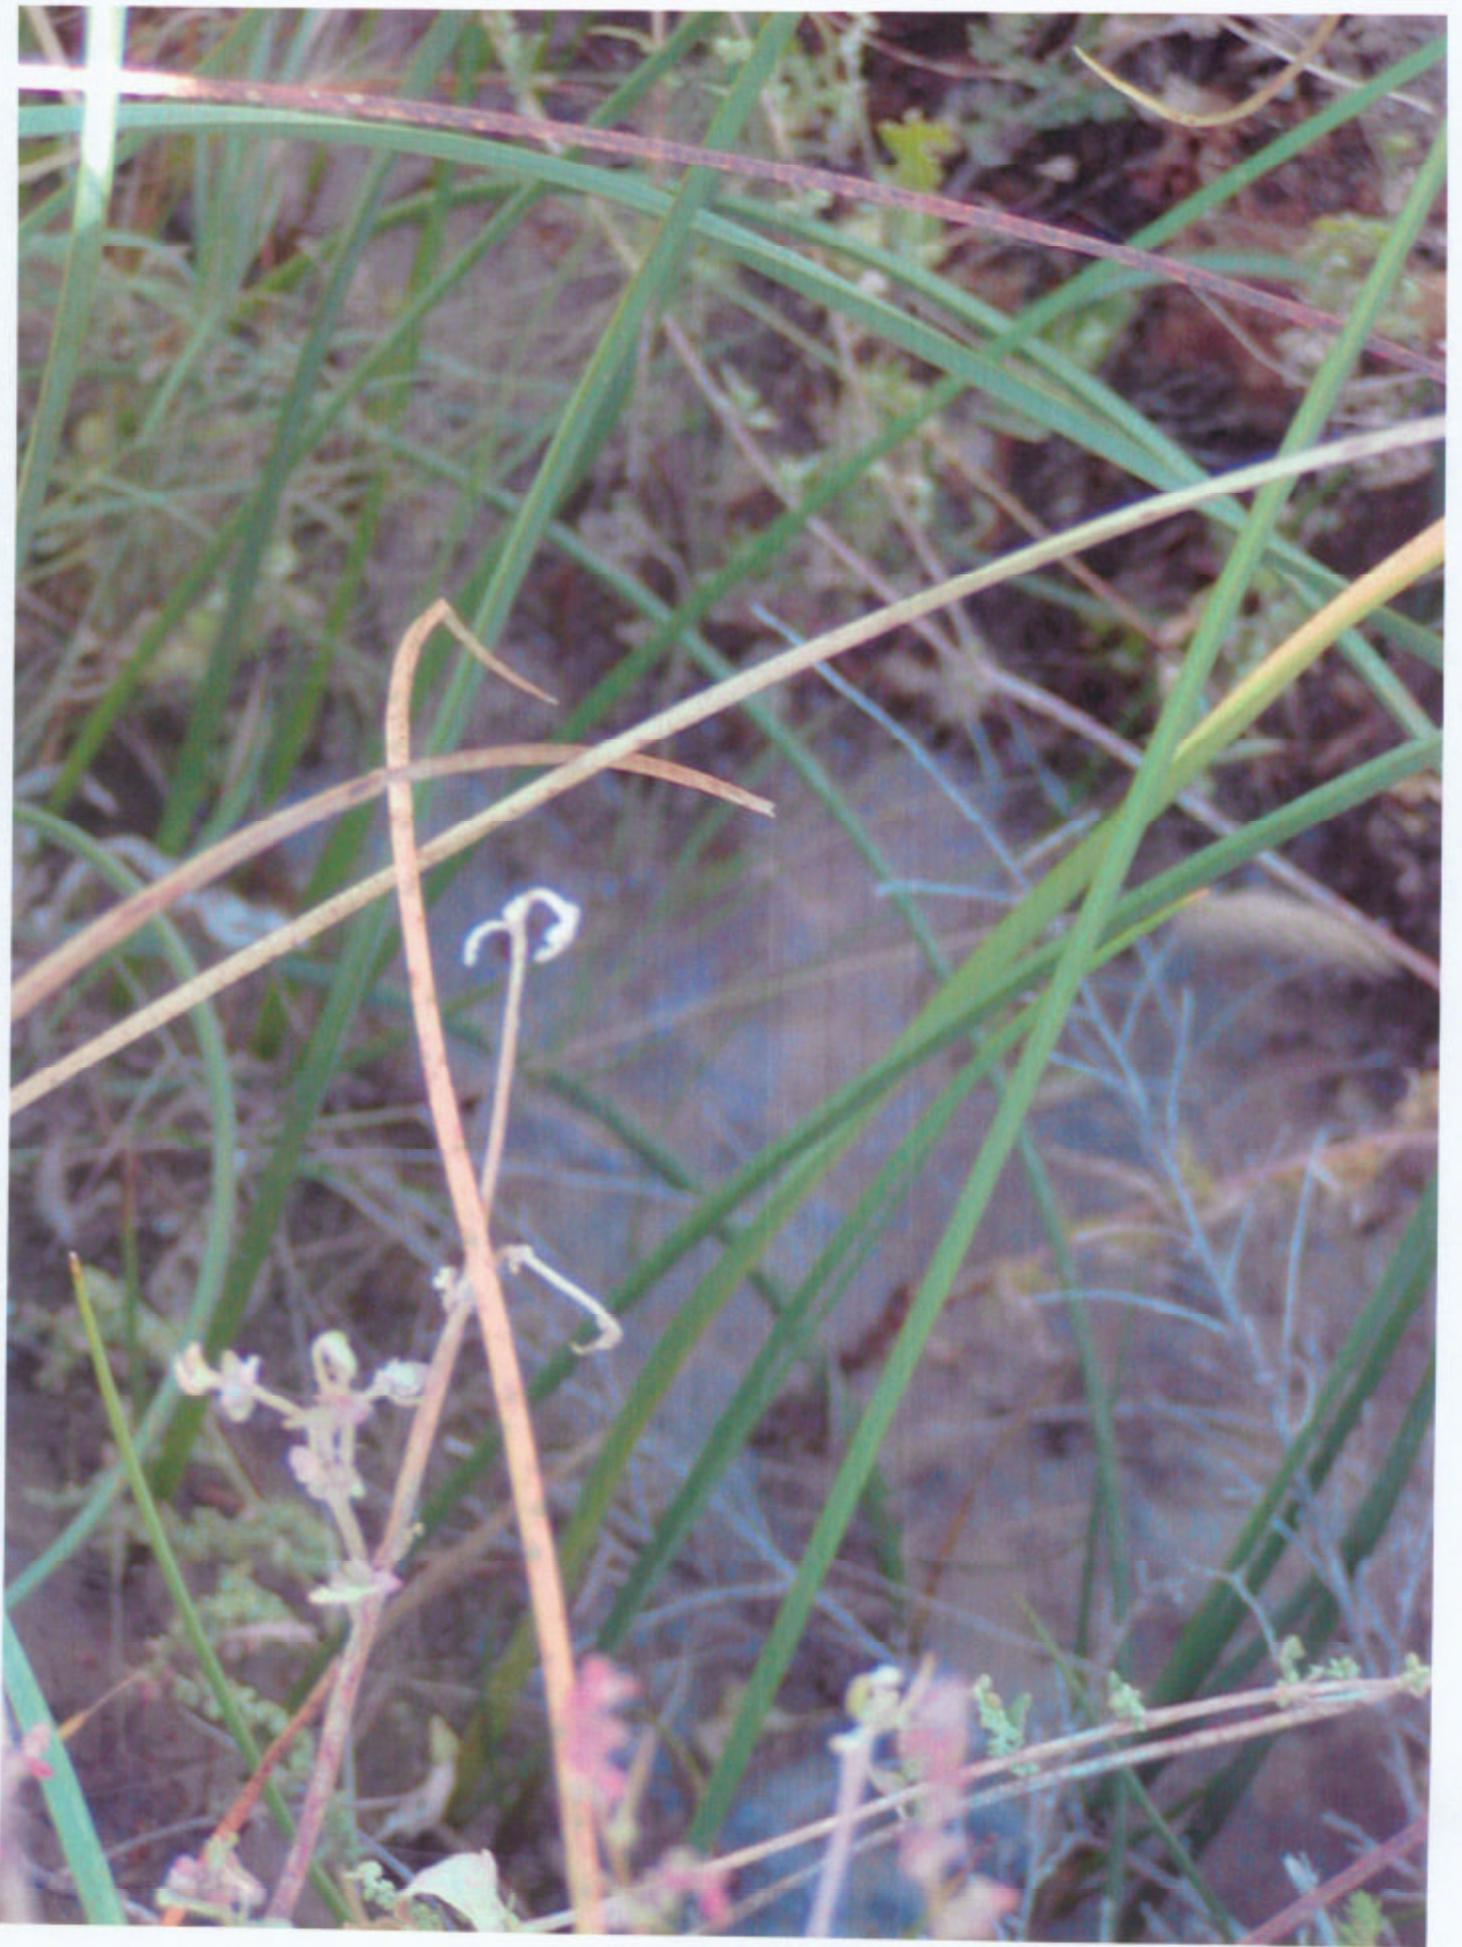
I looked at the stream immediately adjacent to the facility to the south and found surficial water. I took pictures of that water which are waters of the United States. I observed closely, but did not note any evidence of petroleum contamination at this time. I also took pictures of two ponds and the same stream, further downstream from the facility.
