Re: Water Well Sampling (May 9, 2007)
NESE 35 T32S, R68W
Las Animas County

Ross Water Well (permit 256909)
Project 1922
August 21, 2007

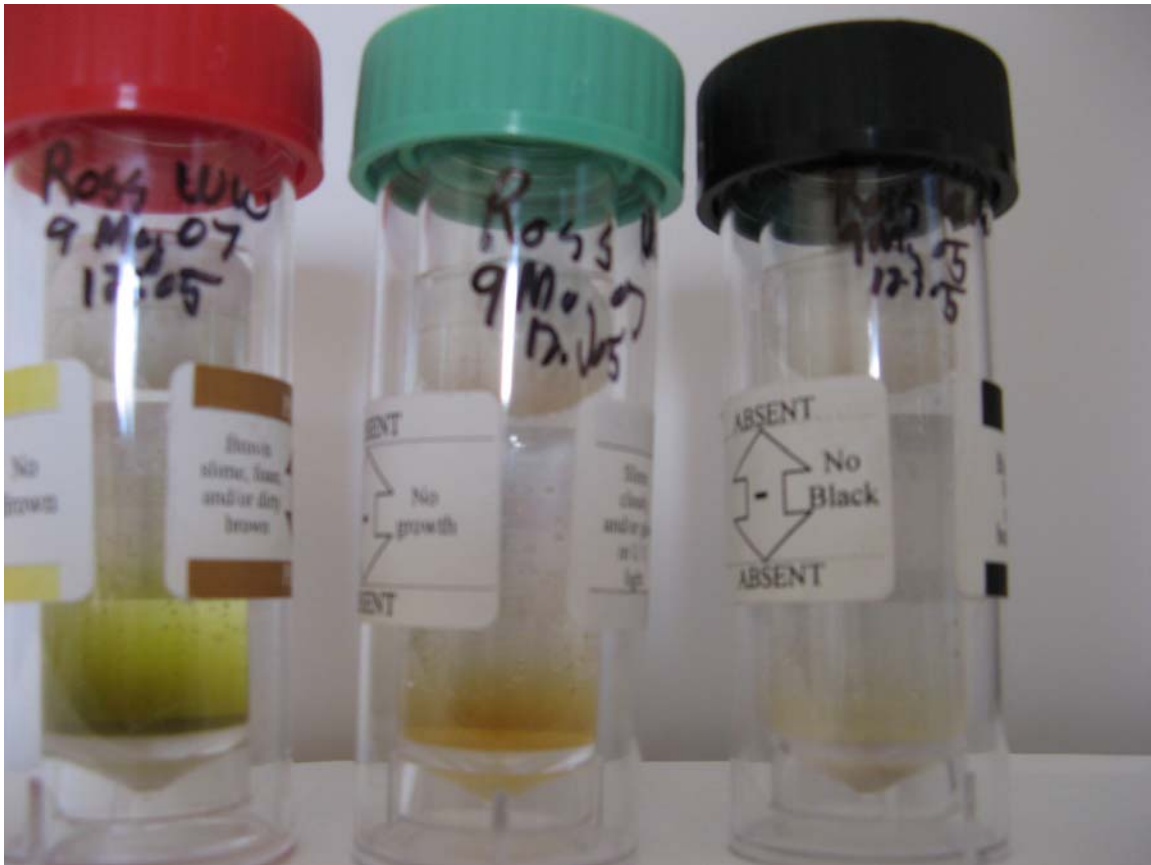
Photograph 1. BART Kits May 10, 2007

Moderately aggressive to very aggressive levels of IRB bacteria were detected in the water sample collected at this well. The green cloudy layer, at the bottom of the IRB tube (red cap) in Photograph 1, indicates the aggressive nature of the IRB population present in the water from your well.

Since iron bacteria were detected in the sample collected from this well you should consider treating the well and distribution system with disinfecting solutions on a regular basis. Once bacterial colonies are established they are difficult to eliminate; therefore, you may need to establish a schedule for periodic disinfection of your well system to help control the bacteria present in it. Pamphlets published by the CDPHE that provide more information concerning the treatment of iron and sulfur bacteria and shock chlorination treatment of bacteria are included as Attachment 1. You may also want to contact a licensed water well contractor for additional information or for help in disinfecting your well and distribution system. Additional information and assistance can be provided through the State of Colorado Health Department. Contact information for the agency is provided below.

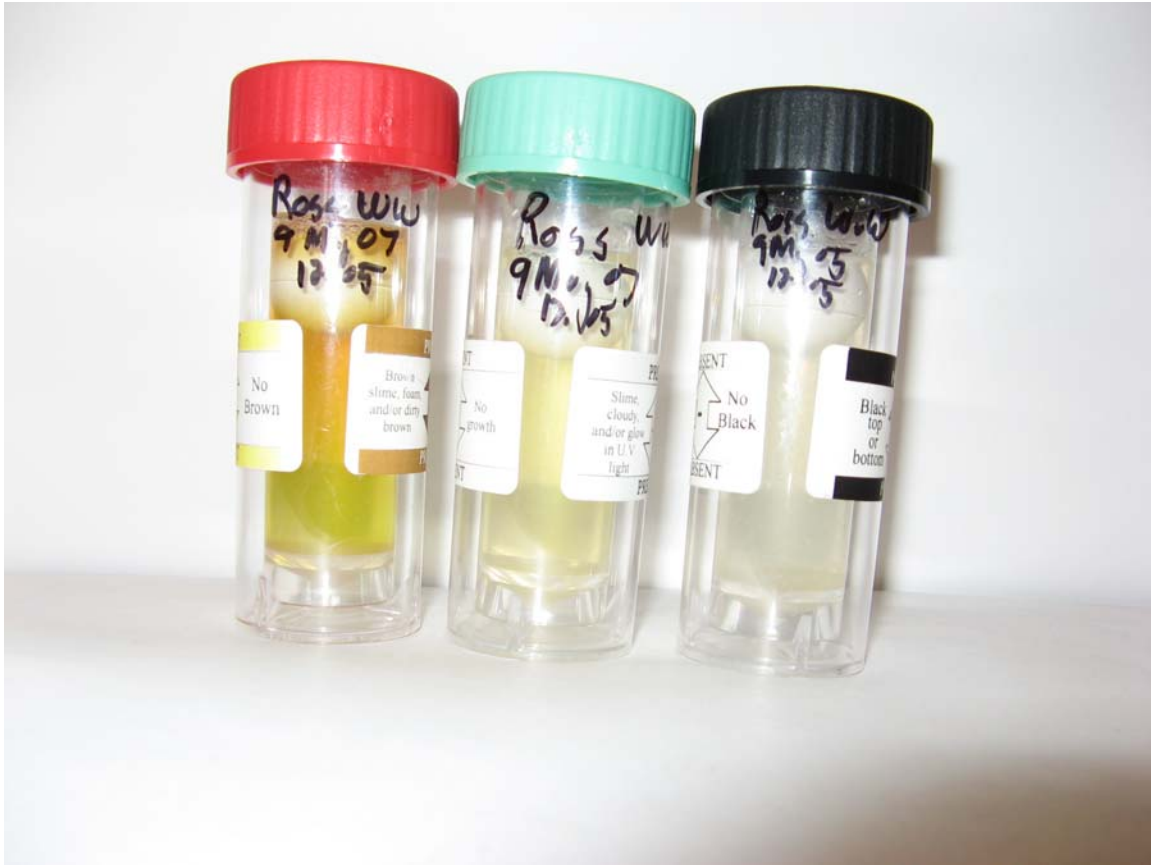
Photograph 2. BART Kits May 16, 2007

Levels of SLYM bacteria were not detected or possibly present at background levels in the water sample collected from this well as indicated by the slightly cloudy liquids seen the green capped vial in Photograph 2.

The test indicated that SRB were not detected in well water as shown by the clear liquids in the black capped vial in Photograph 2.
