Appendix A

Phase I Pit Status Evaluation Form

PIT STATUS EVALUATION FORM

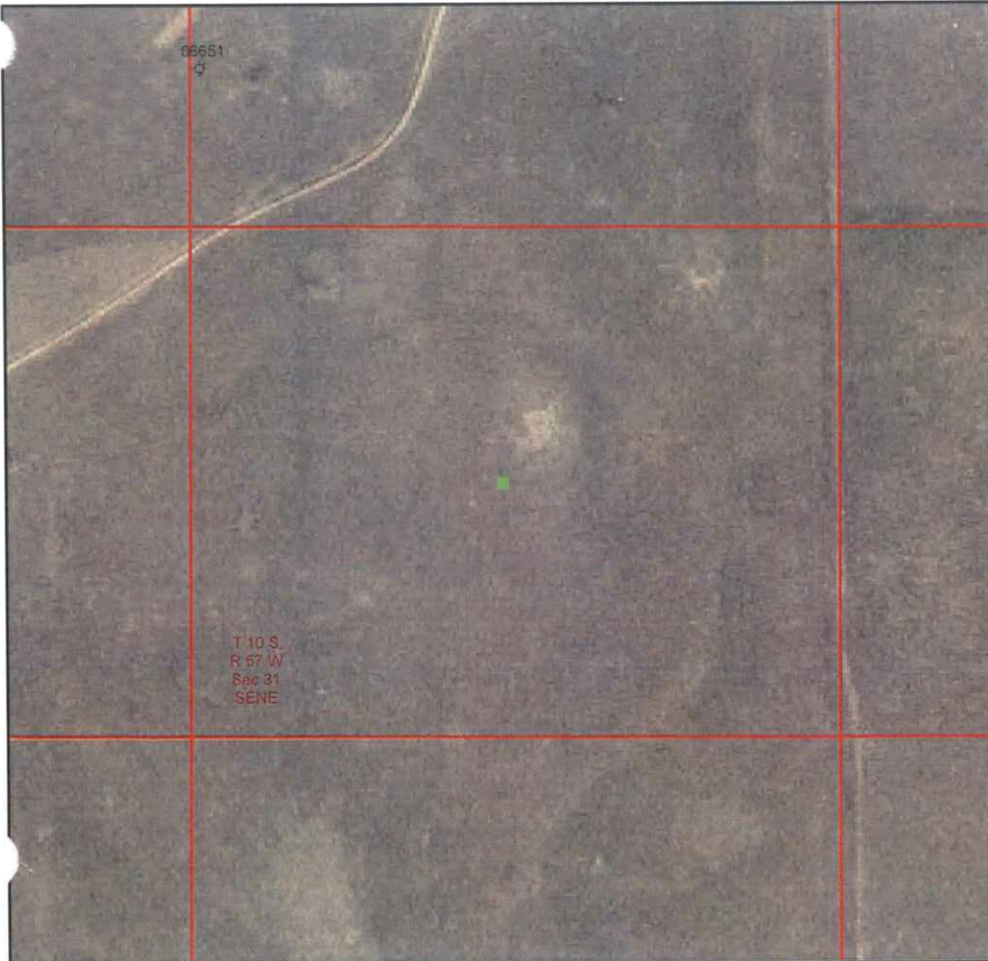
Facility ID: 100099

Notes: Sundry Notice indicates the site was never built

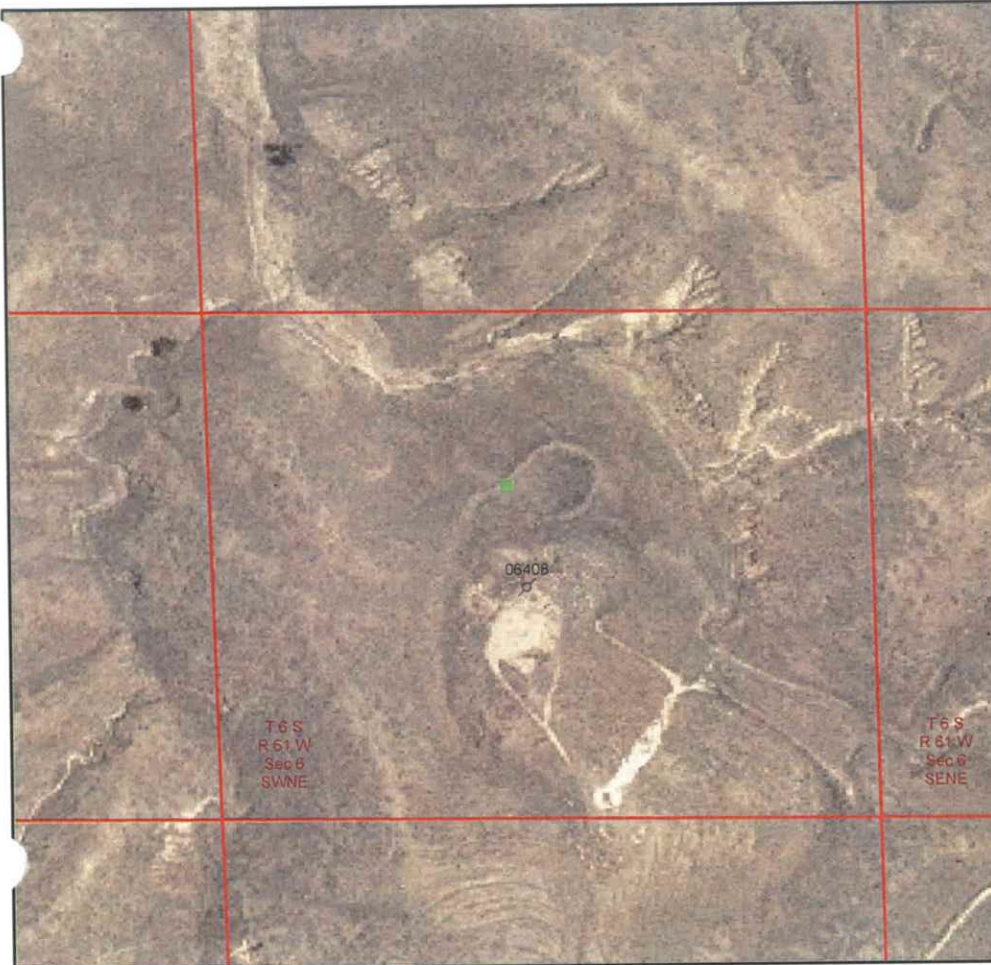
Facility ID: 111233

FIR satisfactory status

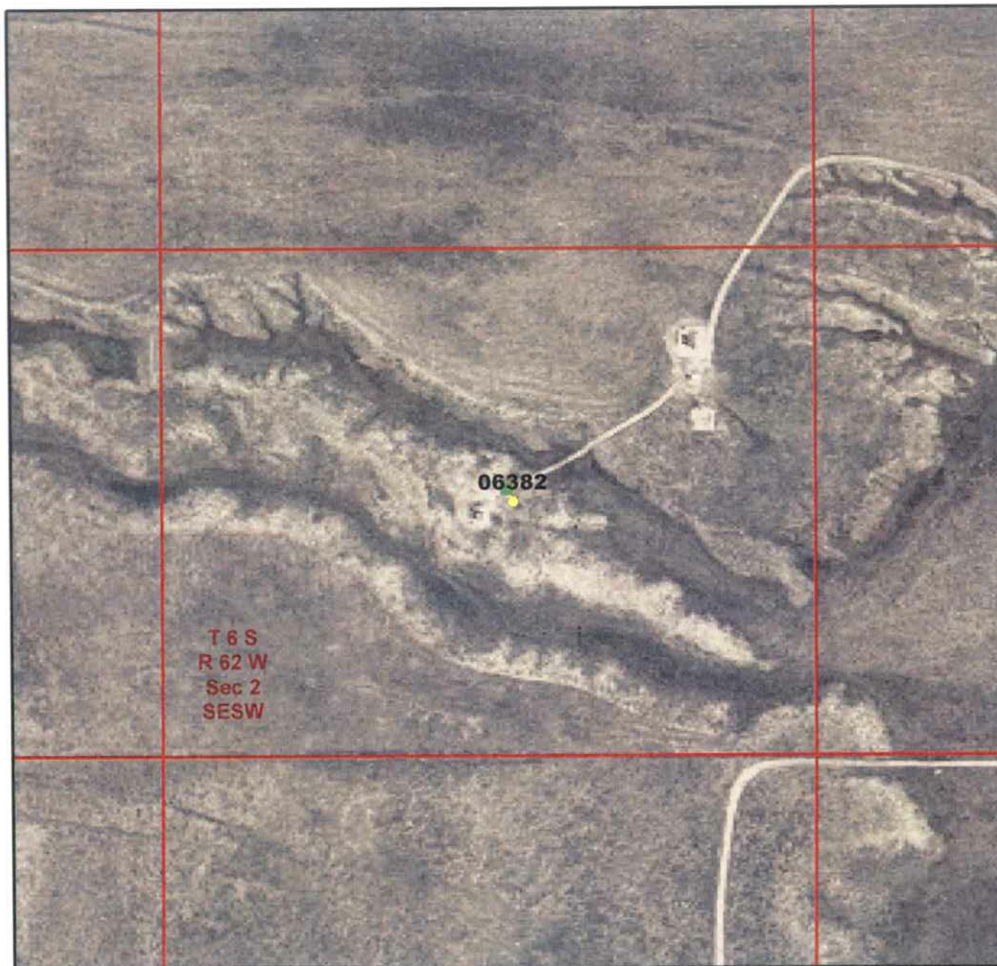
Facility ID: 111234

Notes: NOAV (2007) & subsequent correspondence regarding oil in pit but pit not in use.
Requested Form 27 by 2-24-08. Pit closed per Environmental Protection
Supervisor M. Ash (6-1-08)

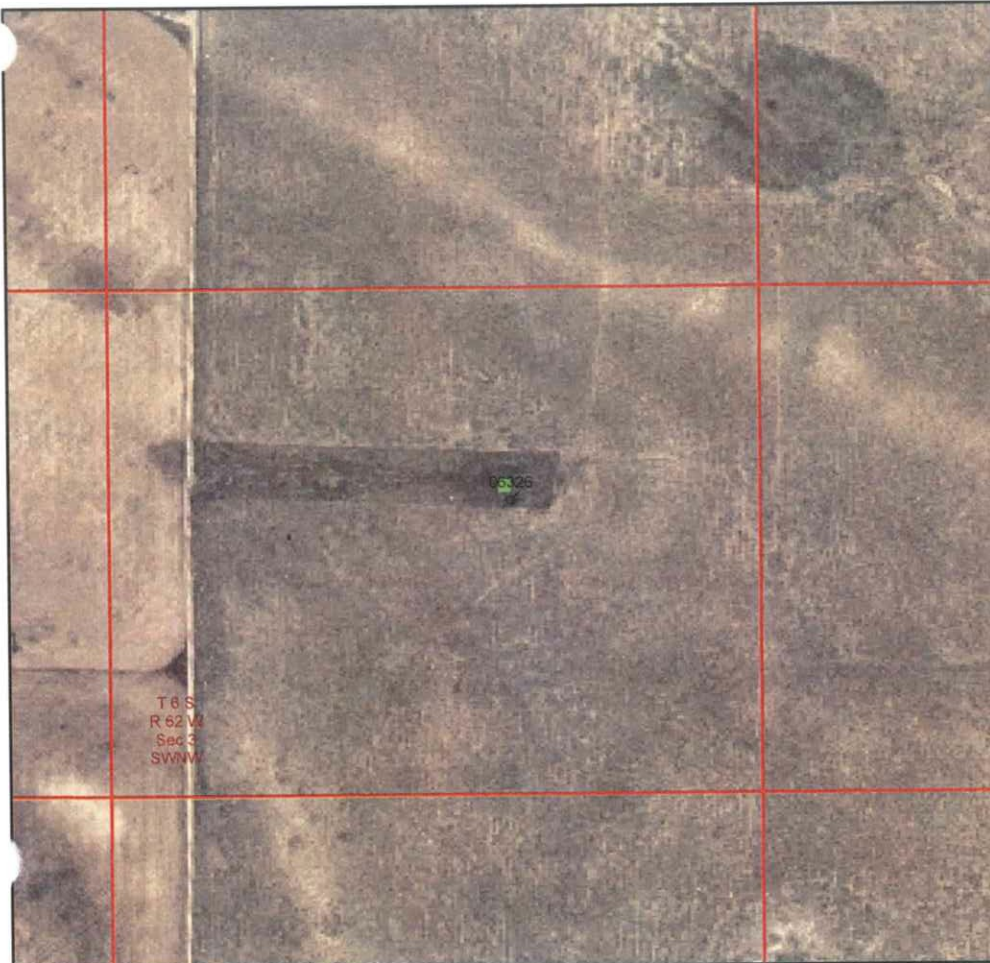
Facility ID: 111235

Notes: location photos & Sundry Notice indicate the area has been remediated.

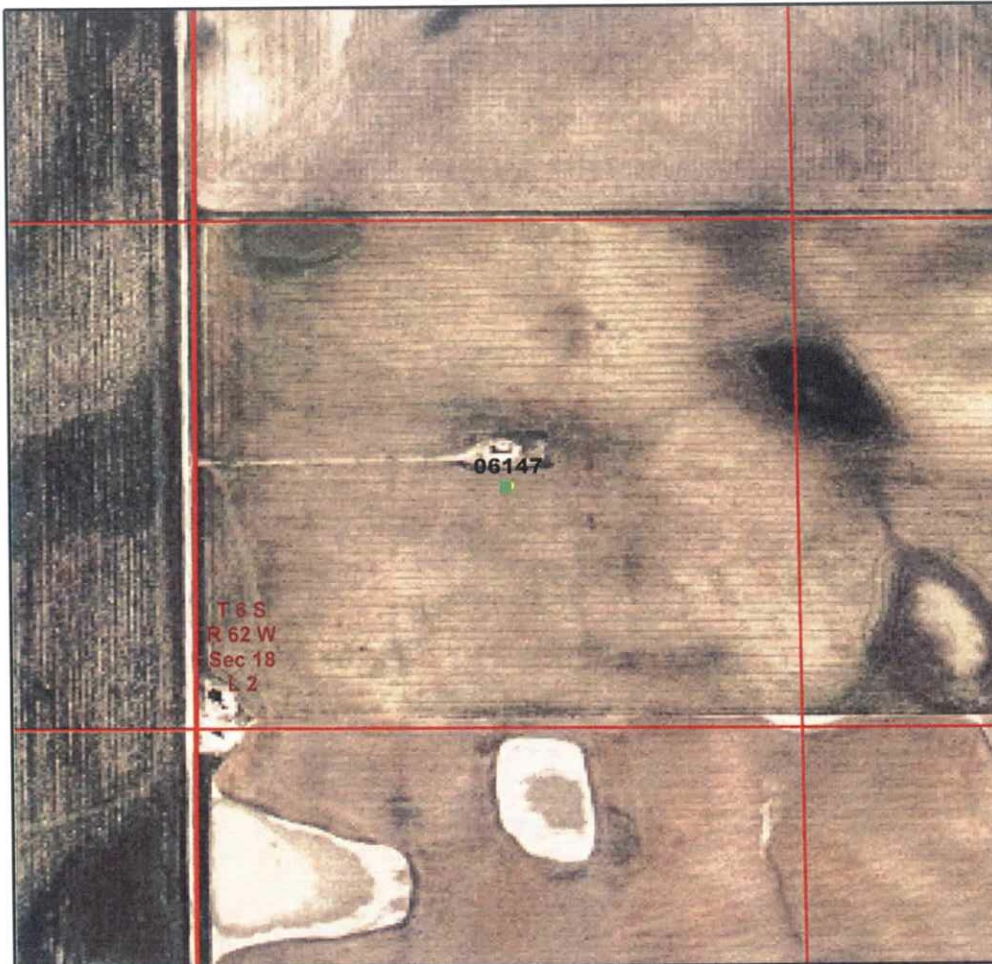
Facility ID: 111239

Notes: No Pit documents. FIR(2008) indicates covered concrete vault installed.

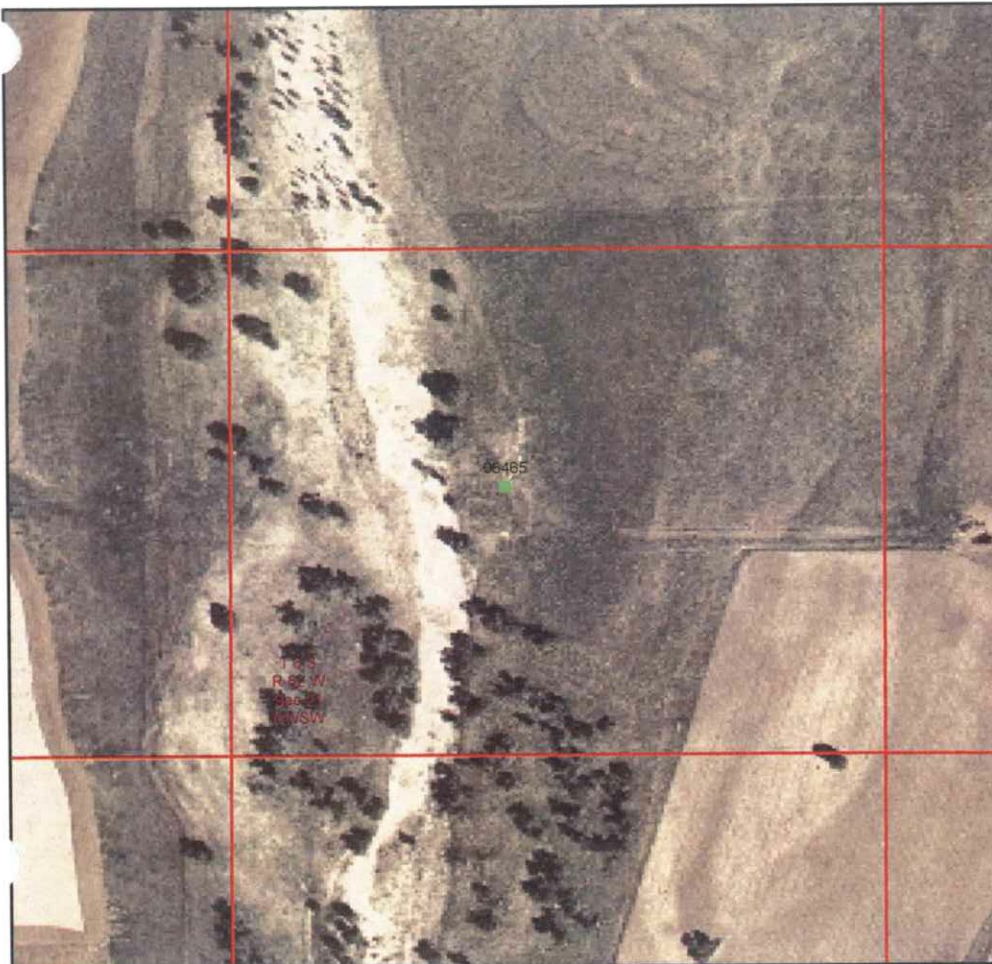
Facility ID: 111243

Notes: No Form 15. FIR location restored

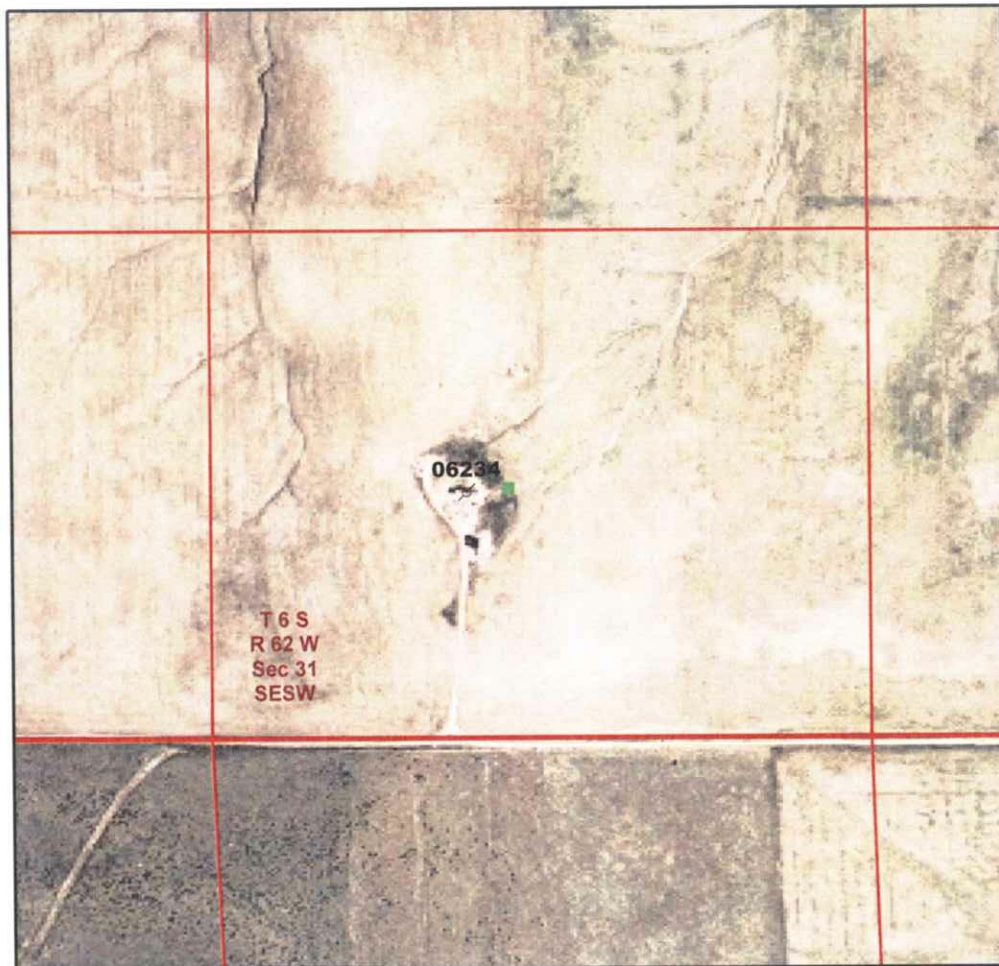
Facility ID: 111247

Notes: Well abandoned 2007. No documentation of closure online. FIR(7-6-2007)
cementing for Abandon. Site P&A Verified by Field Inspector, J. Precup
(6-3-2008)

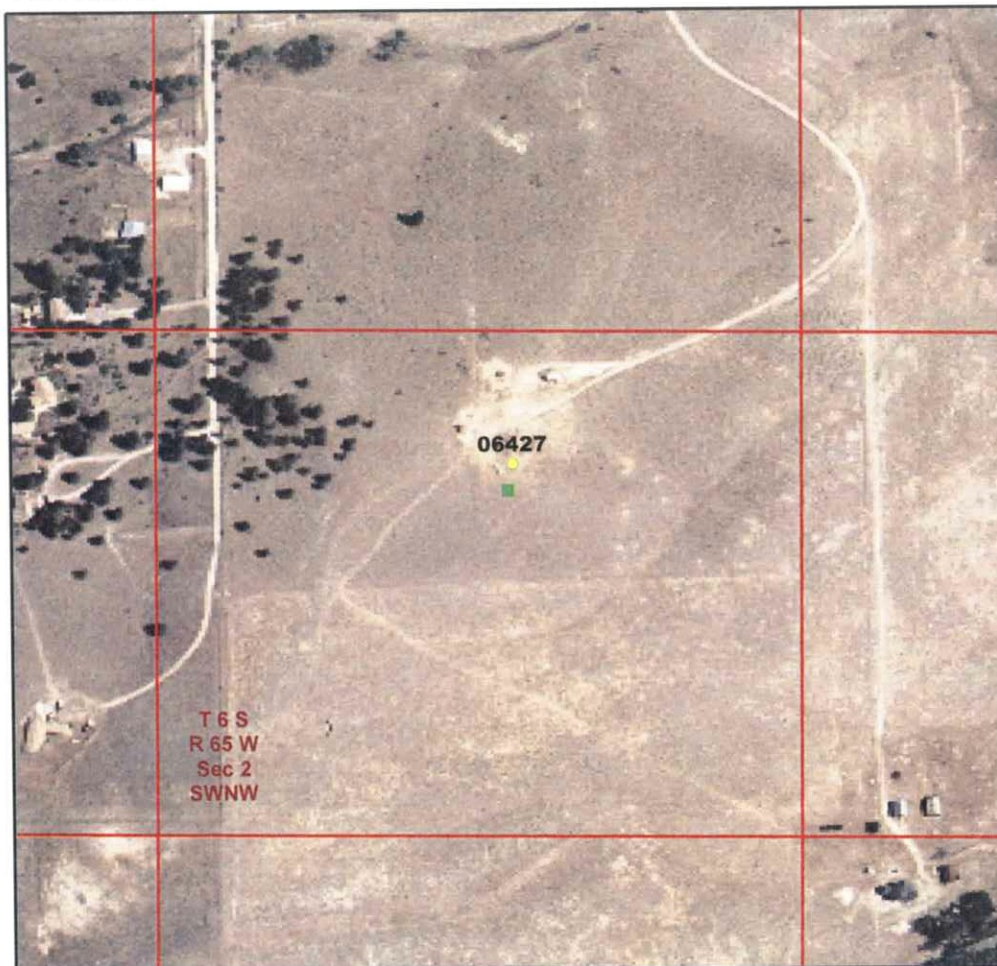
Facility ID: 111264

Notes: FIR (2008) Two 300 BBL tanks and fiberglass tank for water storage

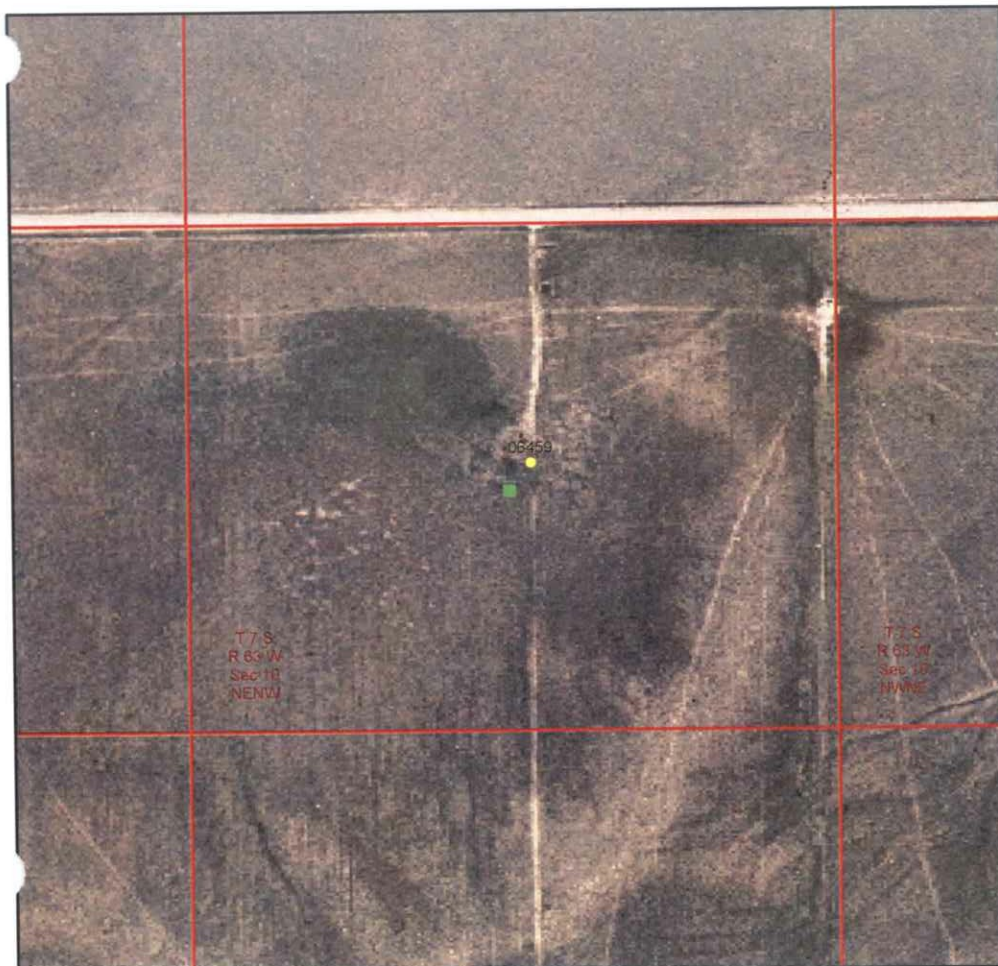
Facility ID: 111796

Notes: No pit documents. Well status TA until 4-20-2010
