# PIT STATUS EVALUATION FORM

S.S. PAPADOPOULOS & ASSOCIATES, INC.

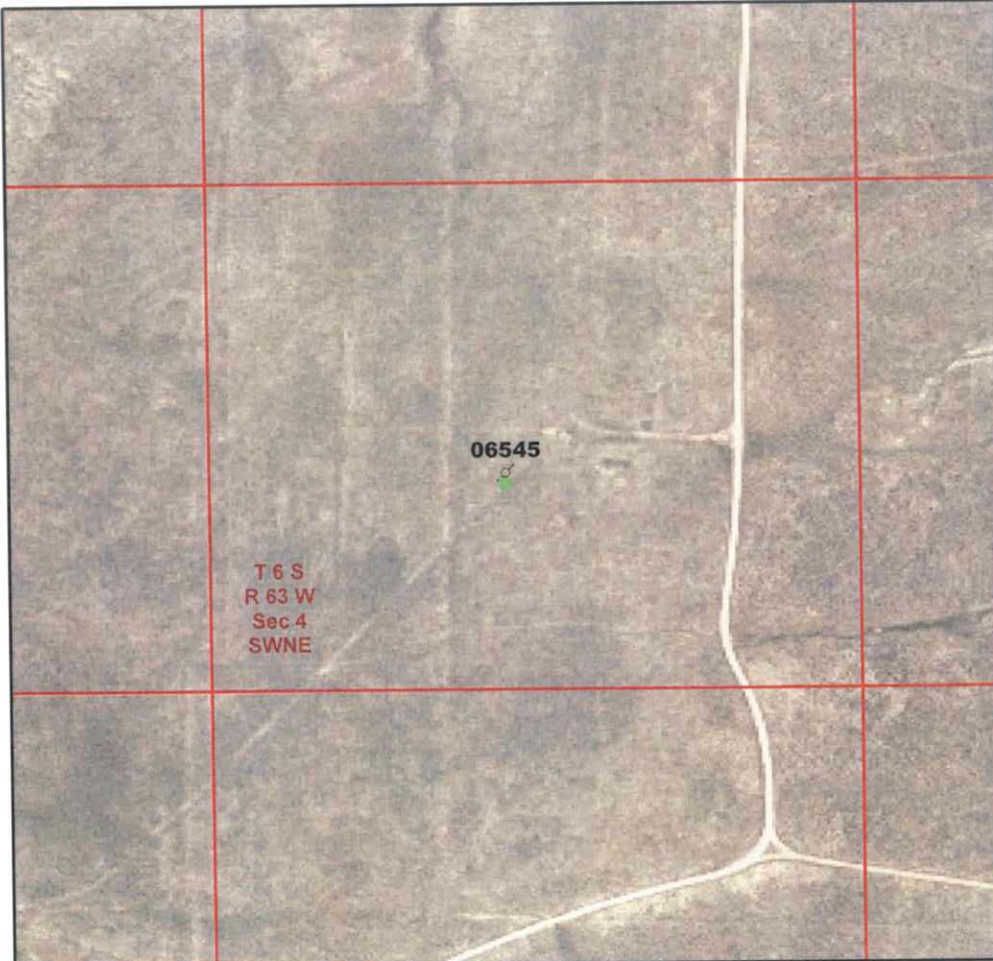
Pit Name: VETTER 1,2,3,4

Notes: LIF (1987) 1,400 BBL Fiberglass tank. WSIF (1988) 'pits backfilled & site  
clean' FIR (2003) 'Well plugged & site restored'

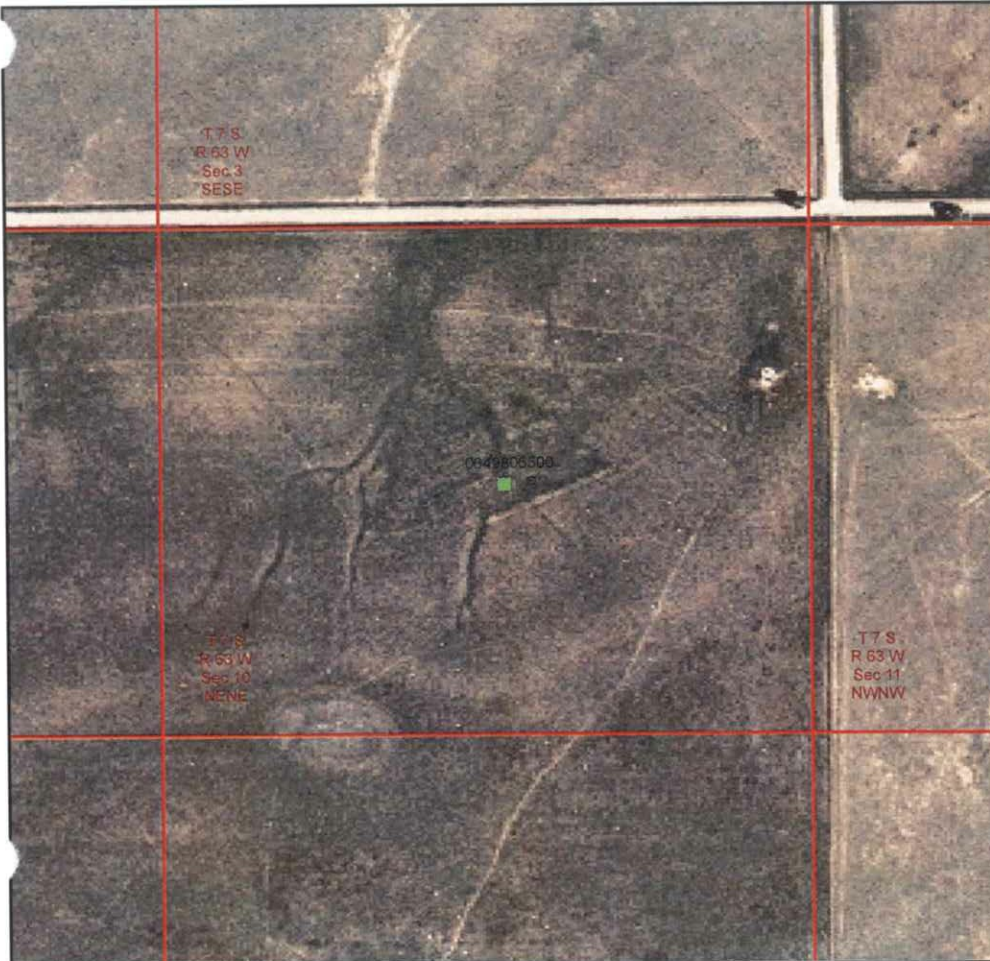
Pit Name: MAPLE UPRR 3X

Notes: No Form 15. WSIF (1987) pit backfilled & site clean.

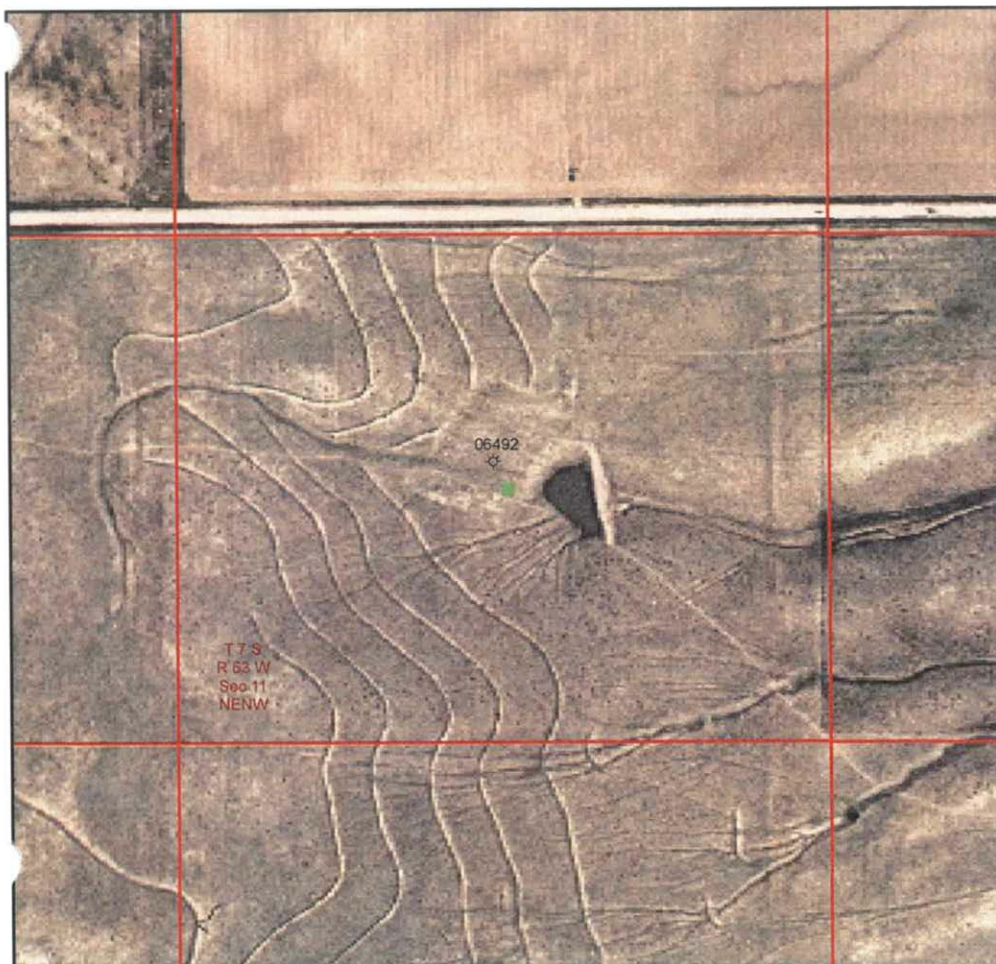
Pit Name: MAPLE UPRR 2

Notes: No Form 15. LIF(1985) open & wet pits, LIF(1986) "good surface rehab; earthen dam & East for watering pond for cattle"

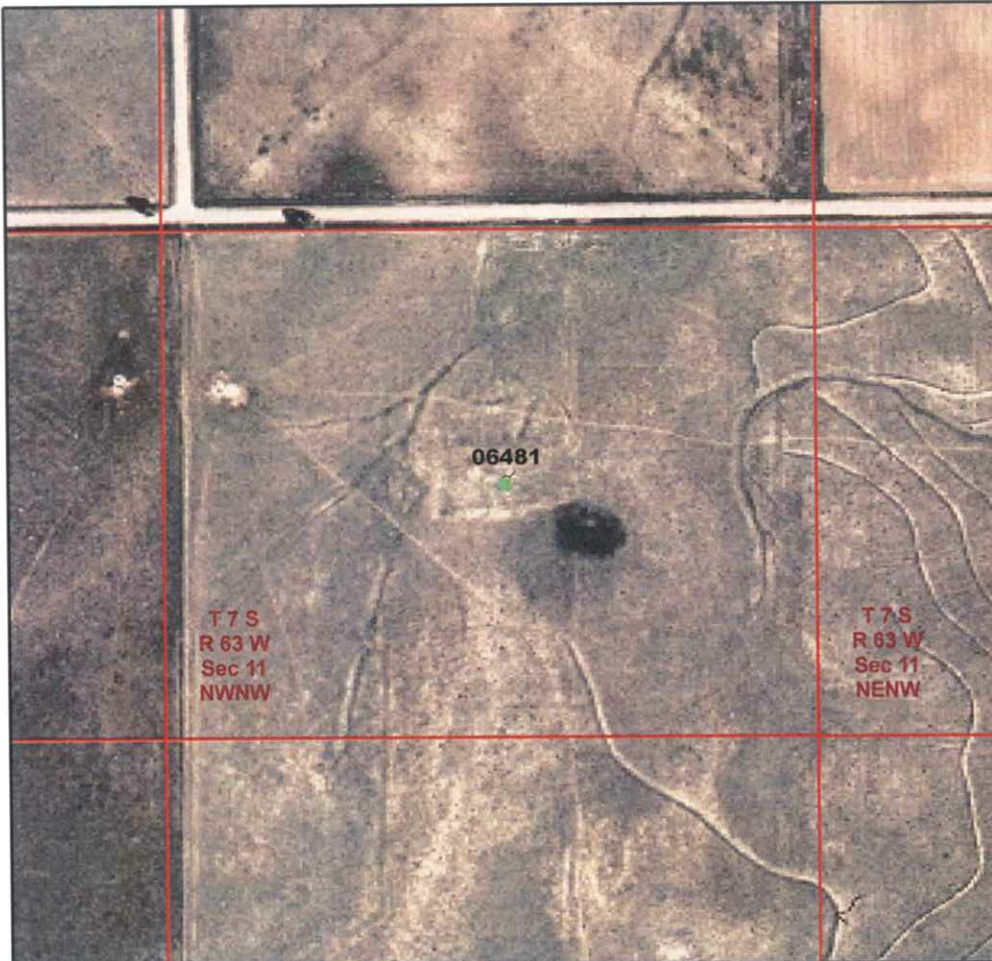
Pit Name: MAPLE UPRR 302-1

Notes: FIR (2000) no mention of pits. "Well plugged although site restoration not completed."

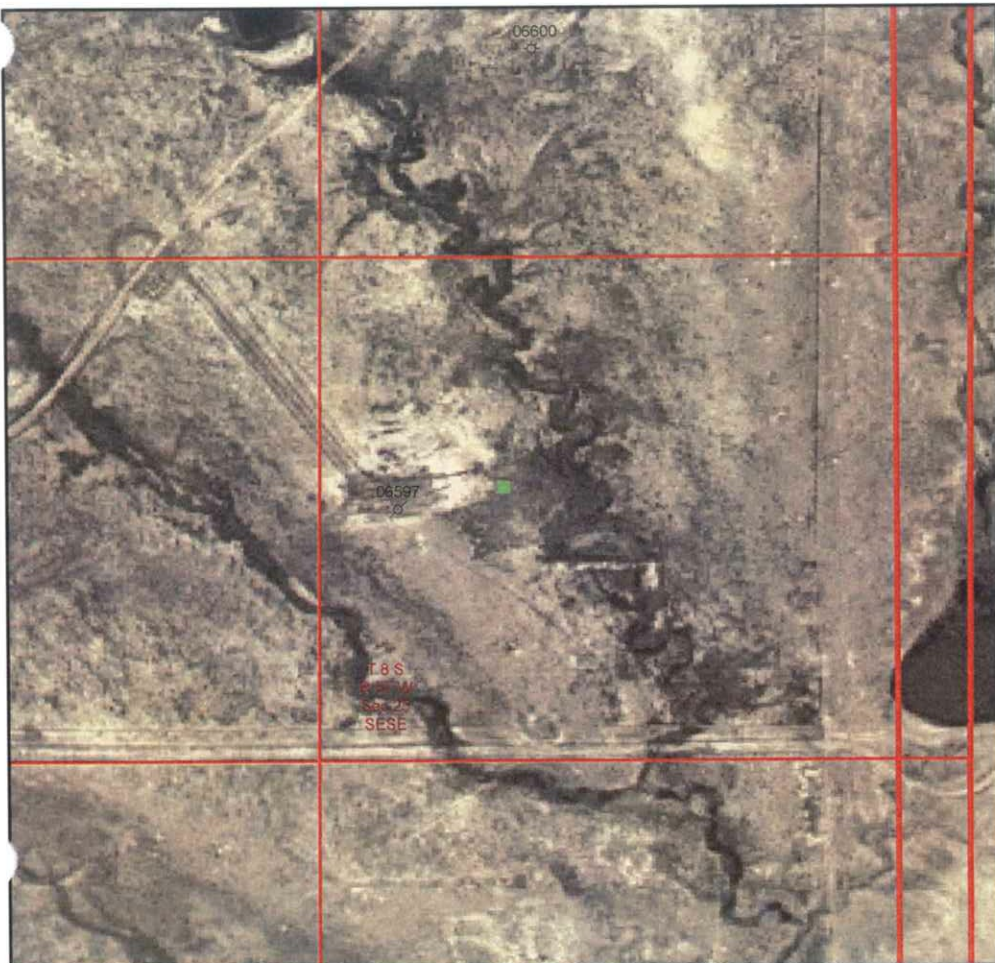
Pit Name: UPRC 1

Notes: No Form 15. FIR(1993) disposal pit backfilled

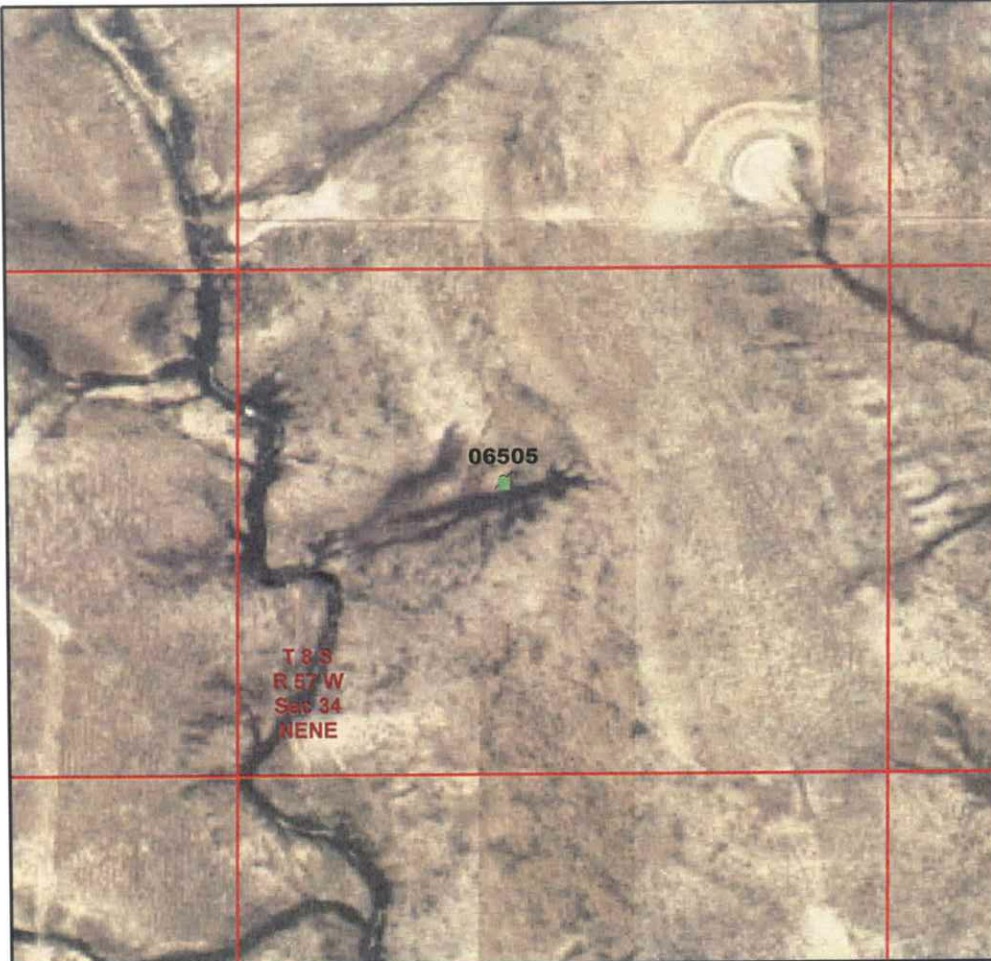
Pit Name: GAEDE 1-34

Notes: WSIF (1985) pits backfilled & site clean

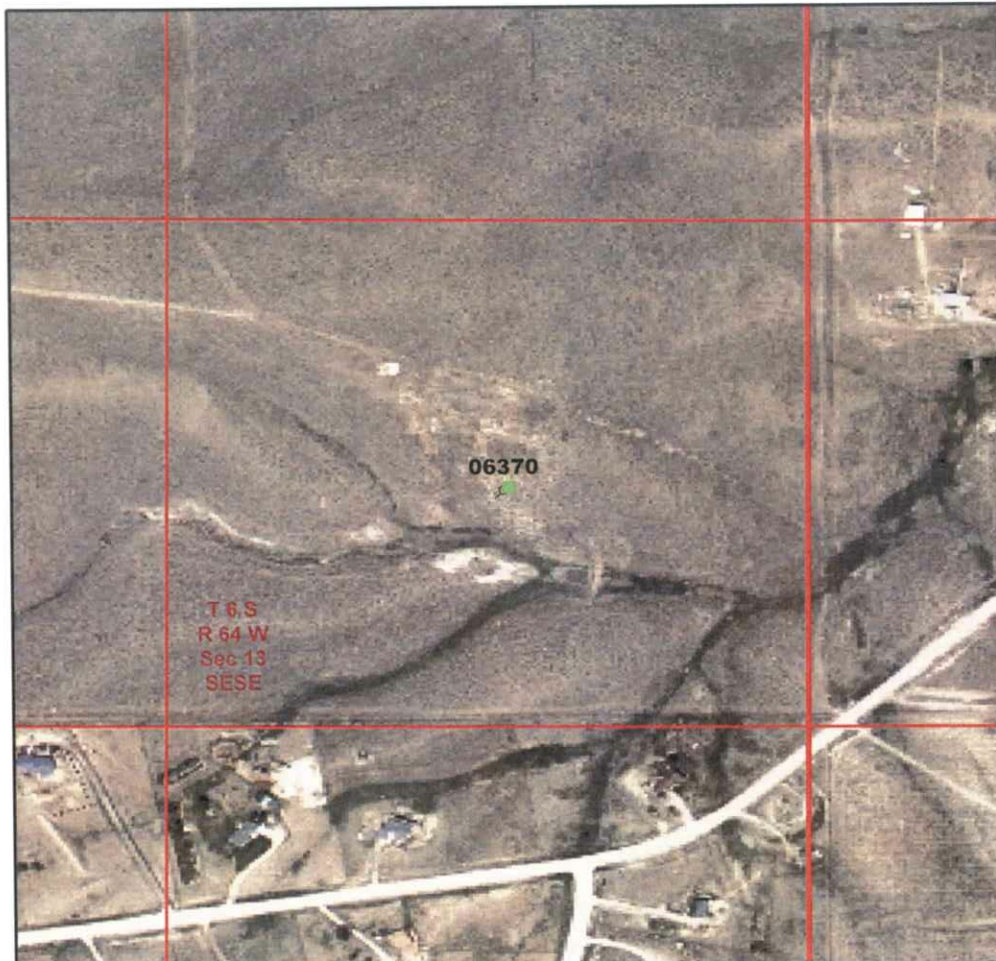
Pit Name: AMOCO 13-16

Notes: WSIF (1988) "pits backfilled & site clean"

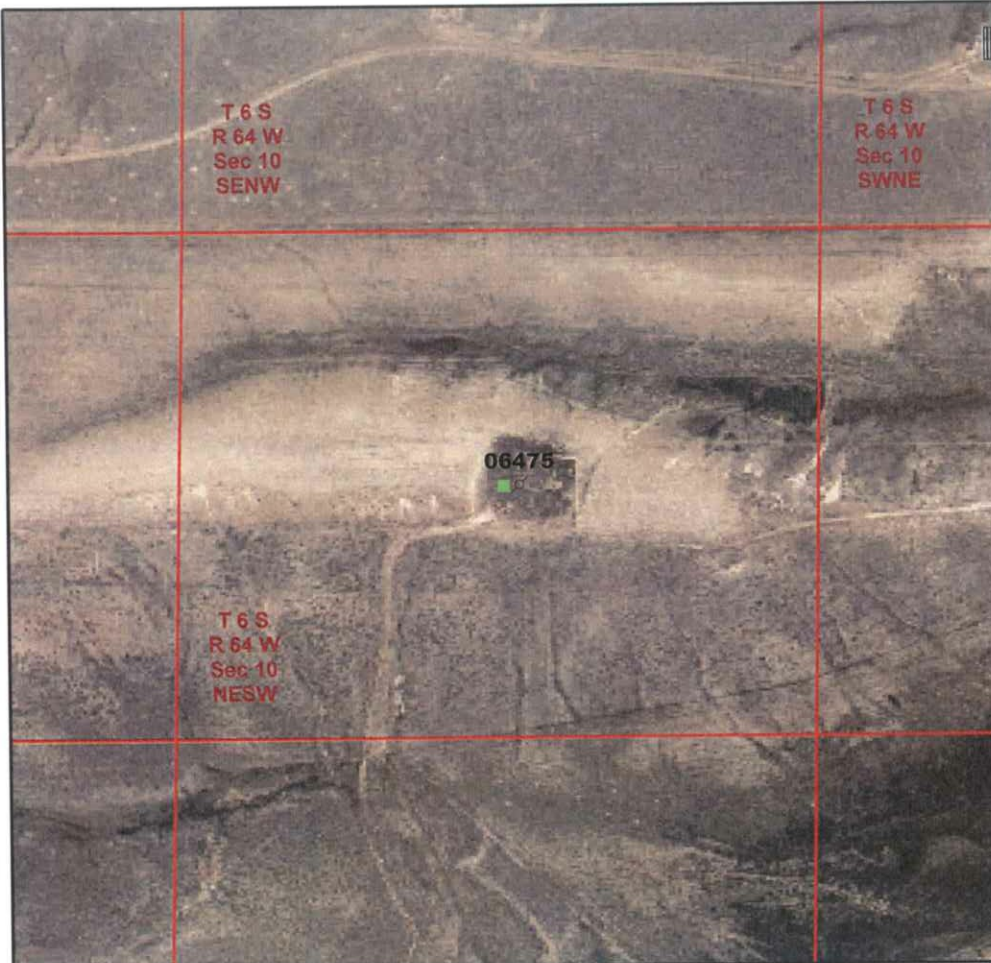
Pit Name: COGGINS 10-5

Notes: FIR(1994) "site restored"

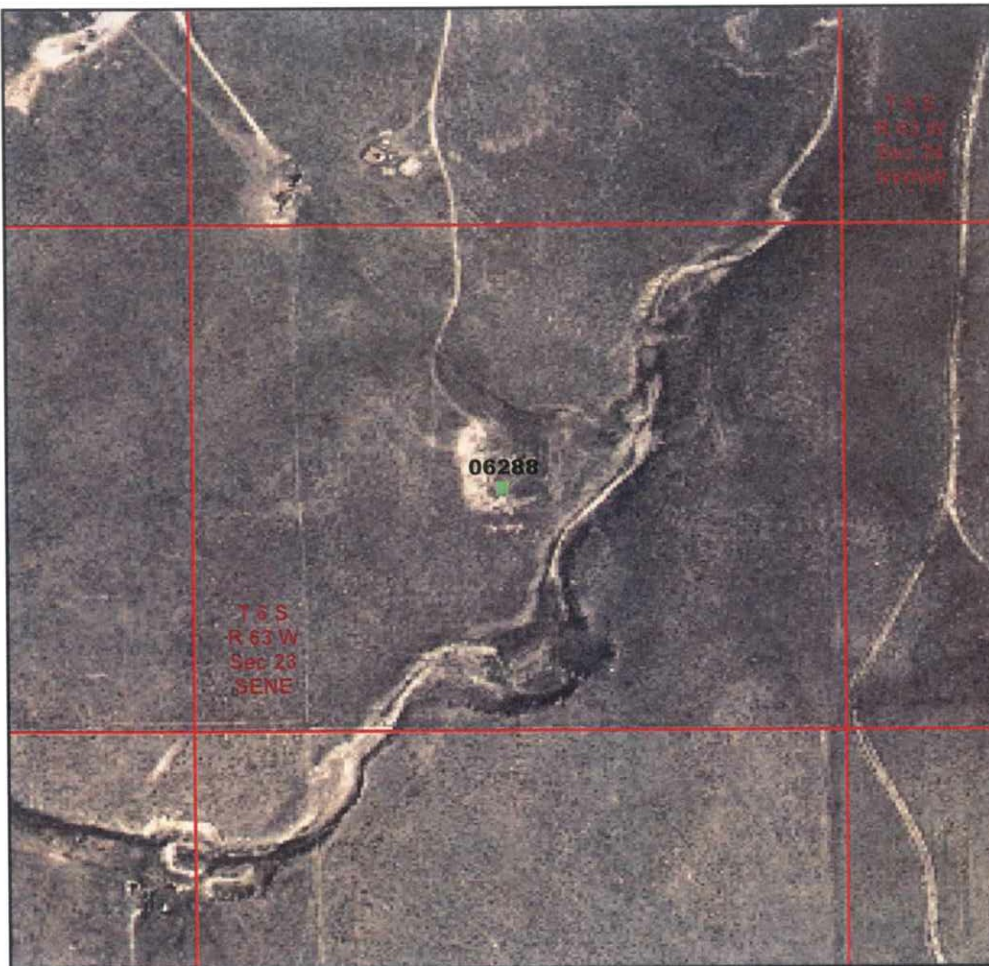
Pit Name: NEIRA 1&2

Notes: Common Use for Niera 1 (#06230) & Niera 2 (06244) PA & DA, respectively  
LF (1987) skim pit & 40' x 70' pit  
WSIF (1991) "pits backfilled & site clean"

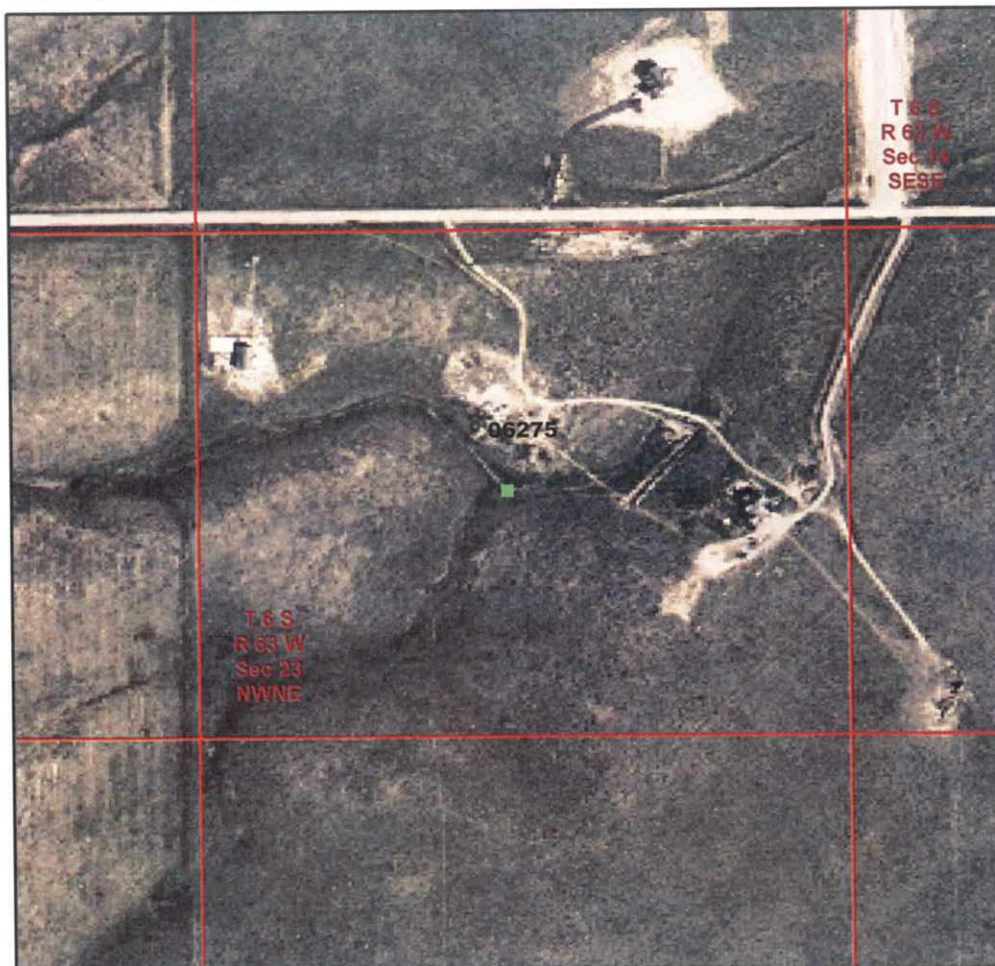
Pit Name: NEIRA 1 31-23

Notes: LIF (1987) Skimpit + pit. FIR (11-6-1997) "well has been plugged & location restored... final reclamation would be done by landowner"  
FIR (1999) Well site revegetated.

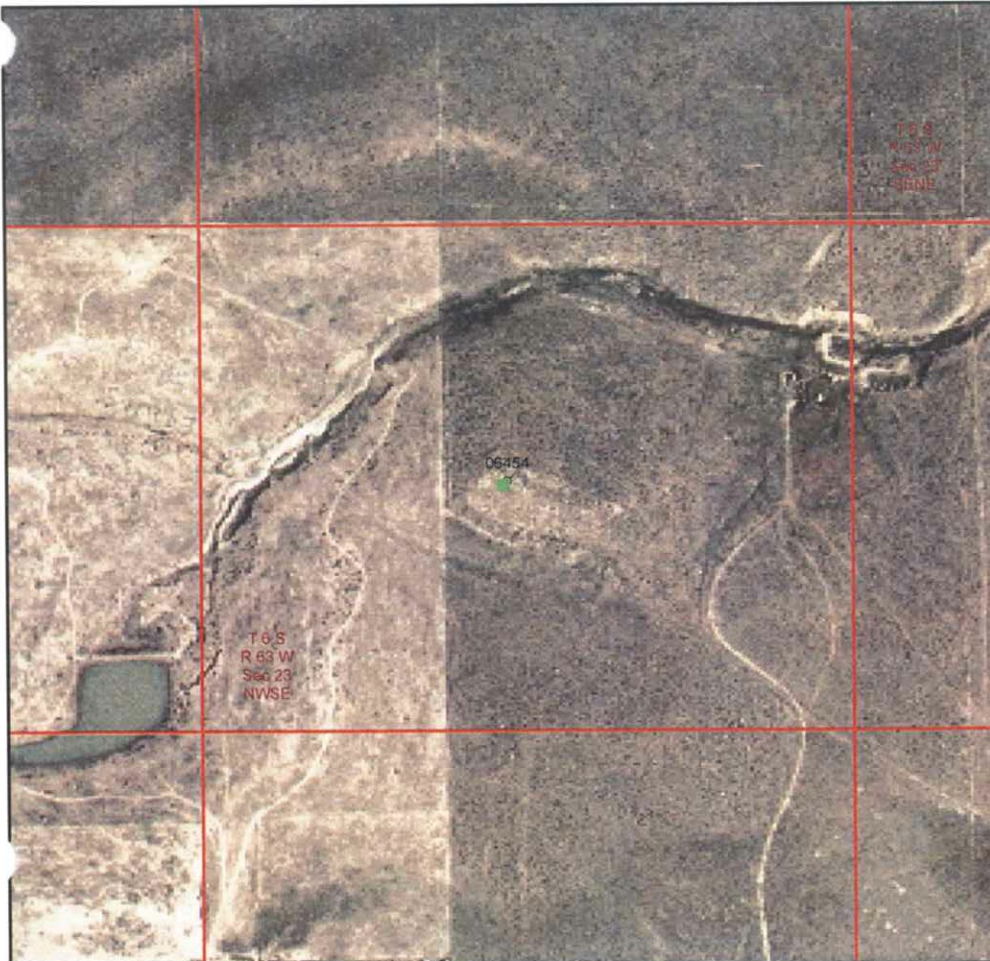
Pit Name: LAUREL 1

Notes: No Form 15. WSIF (1990) pits backfilled & site clean

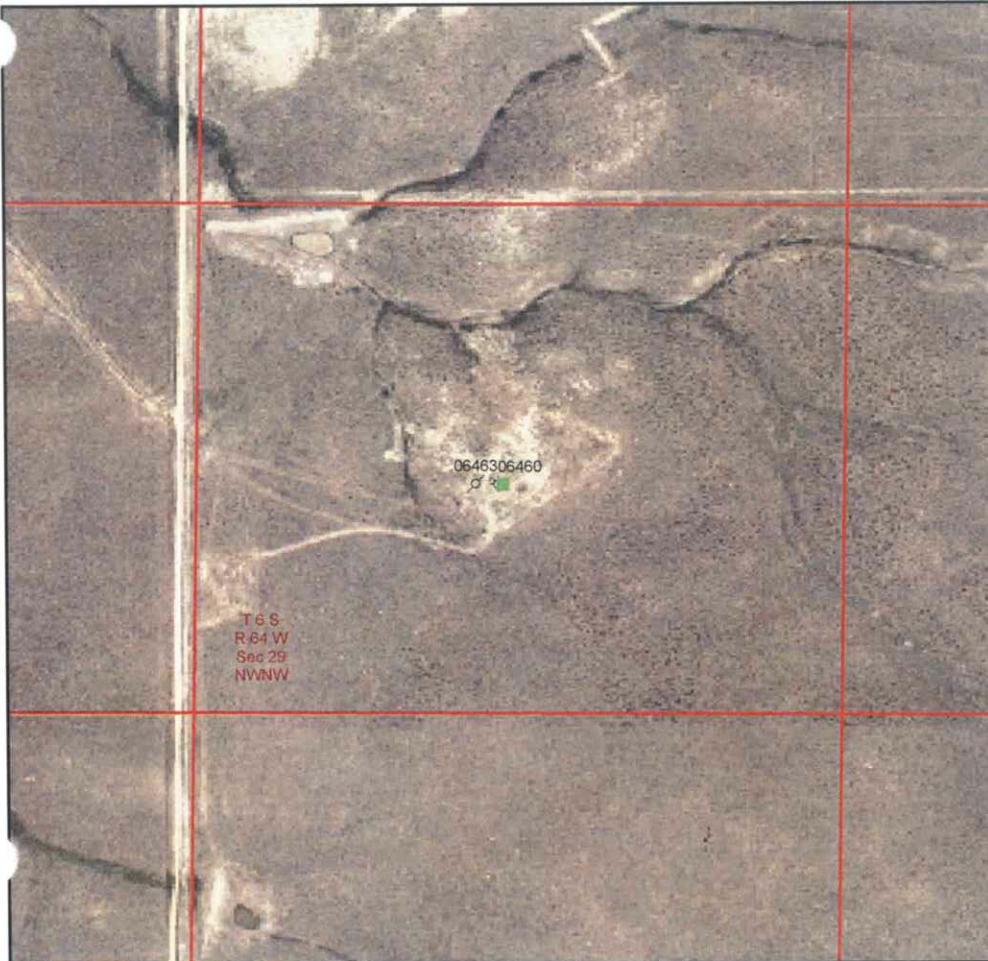
Pit Name: MILLER TRUST 1X

Notes: No Form 15. FIR (1997) "well plugged and location restored"
