PIT STATUS EVALUATION FORM

S.S. PAPADOPOULOS & ASSOCIATES, INC.

COGCC Database Information

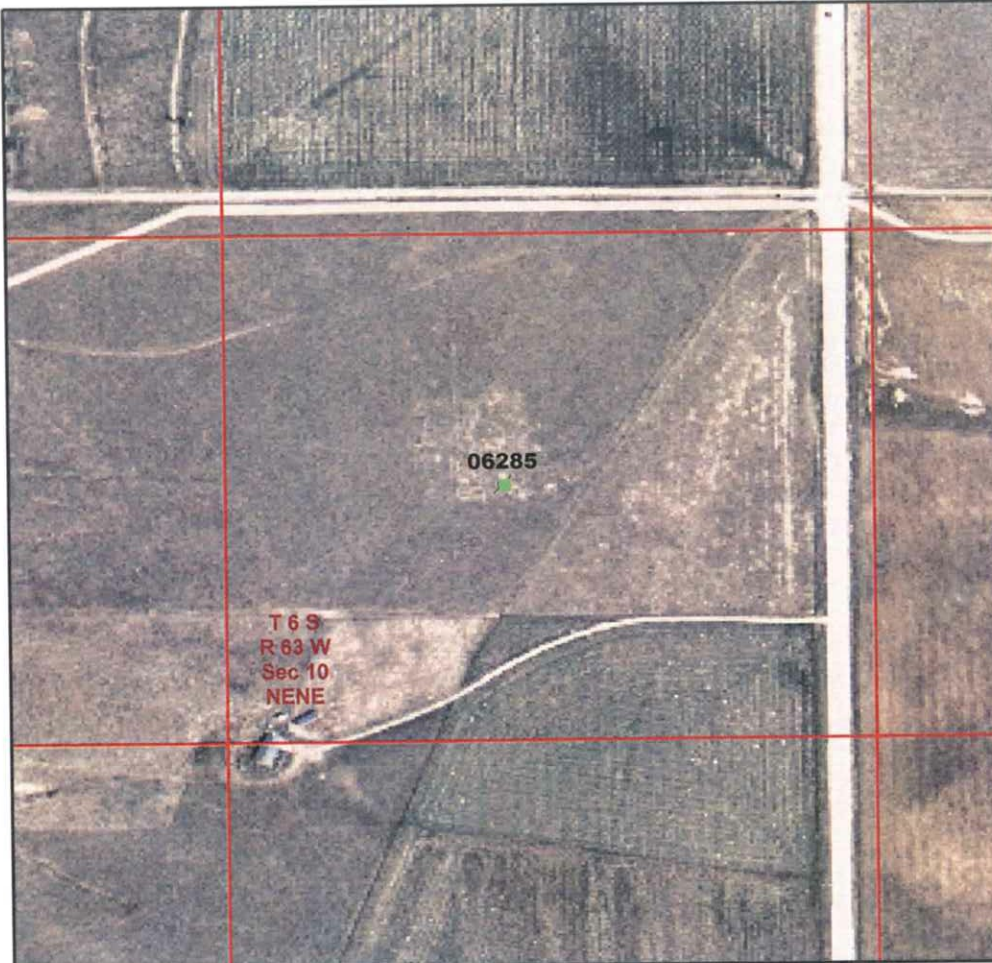
Pit Name: HANLON 10-1

Notes: LIF (1987) skimtank + pit
WSIF (1988) pit backfilled & site clean

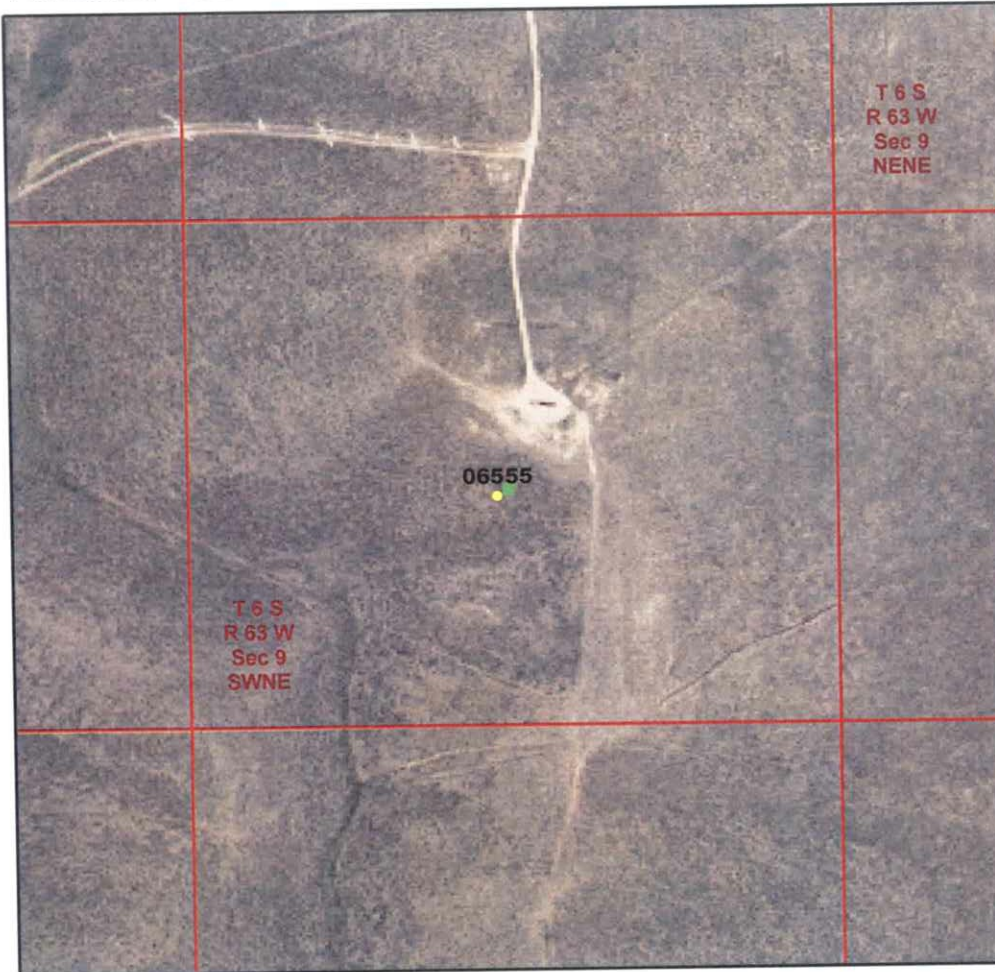
Pit Name: VETTER 2-9-6-63K 2

Notes: LIF (1987) indicates one 400 BBL fiberglass skim tank
FIR (2008) inventoried concrete vault & 300 BBL upright. No
mention of pit.

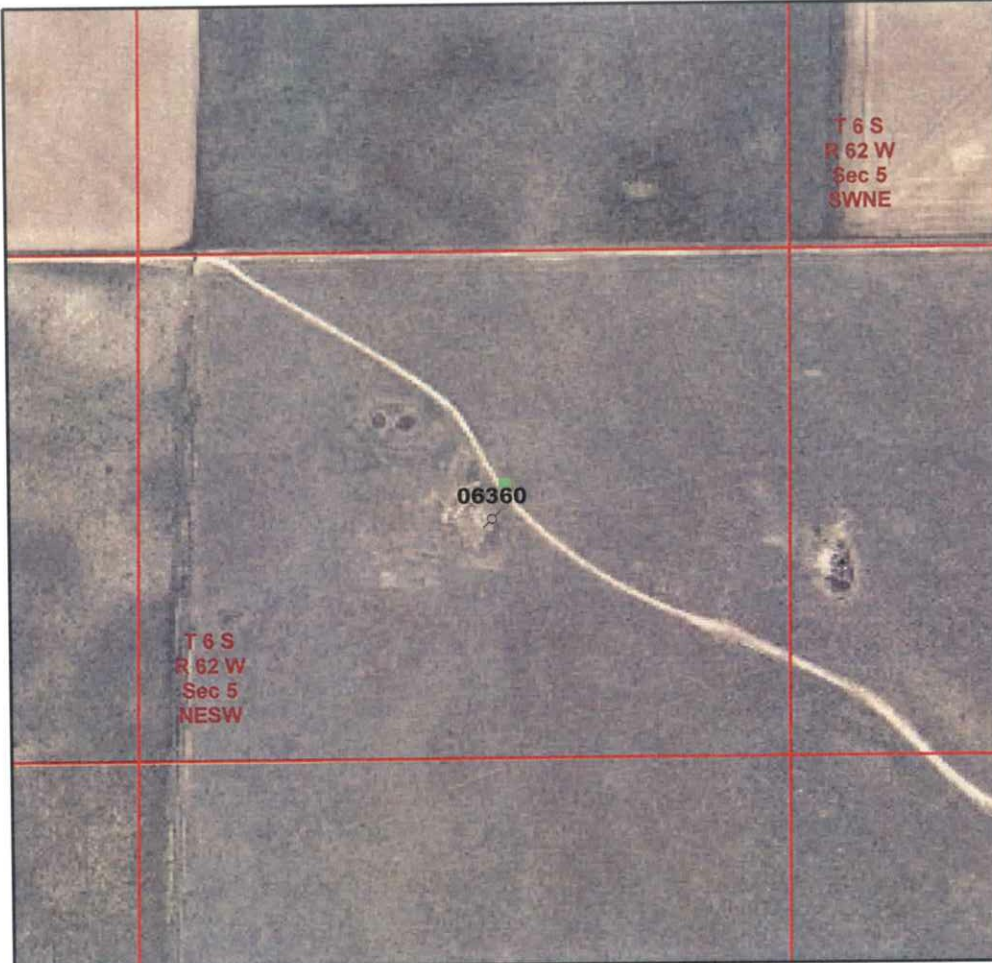
Pit Name: CHAMPLIN 569 "A" 3

Notes: Pit Status & documentation under Pit ID# 115087.
Common User for Pits Champlin 569 A 1, 2, 3, 4, 5.
FIR (1995) "location restored"

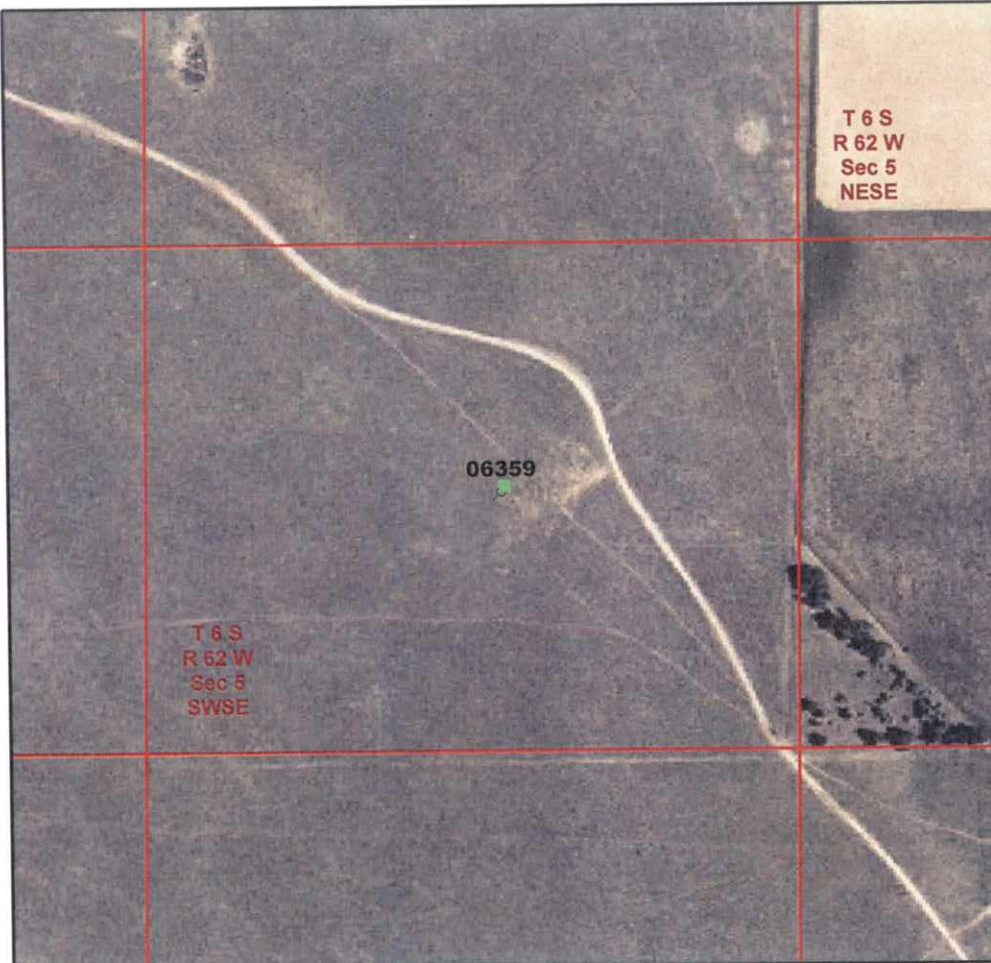
Pit Name: CHAMPLIN 569 "A" 2

Notes: Pit Status & documentation under Pit ID # 115087

Common use for Champlin 569 A 1, 2, 3, 4, 5.

FIR (1996) "well plugged & location restored"

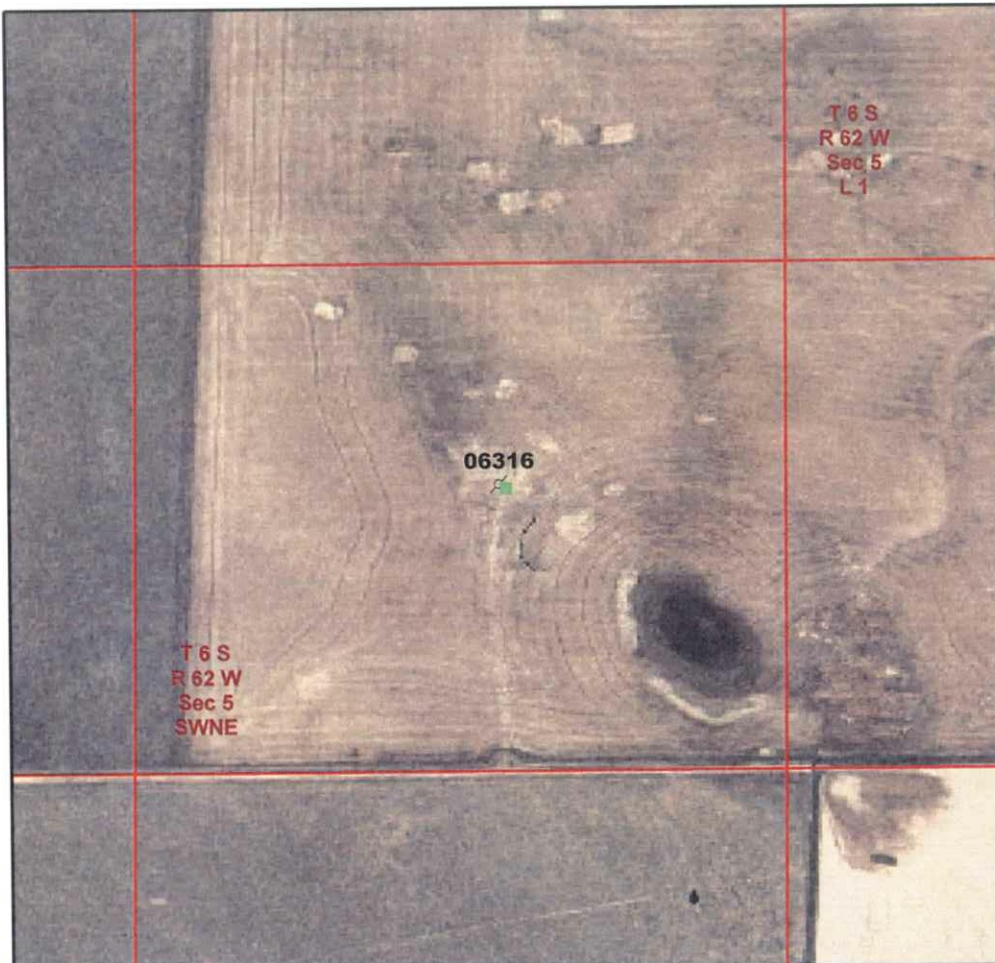
Pit Name: MILLER 32-5 2

Notes: Pit Status and documentation under #115088
Common use for Miller 41-5 #1 and Miller 32-5 #2
FIR (1998) "Final Pit Inspection & location restored"

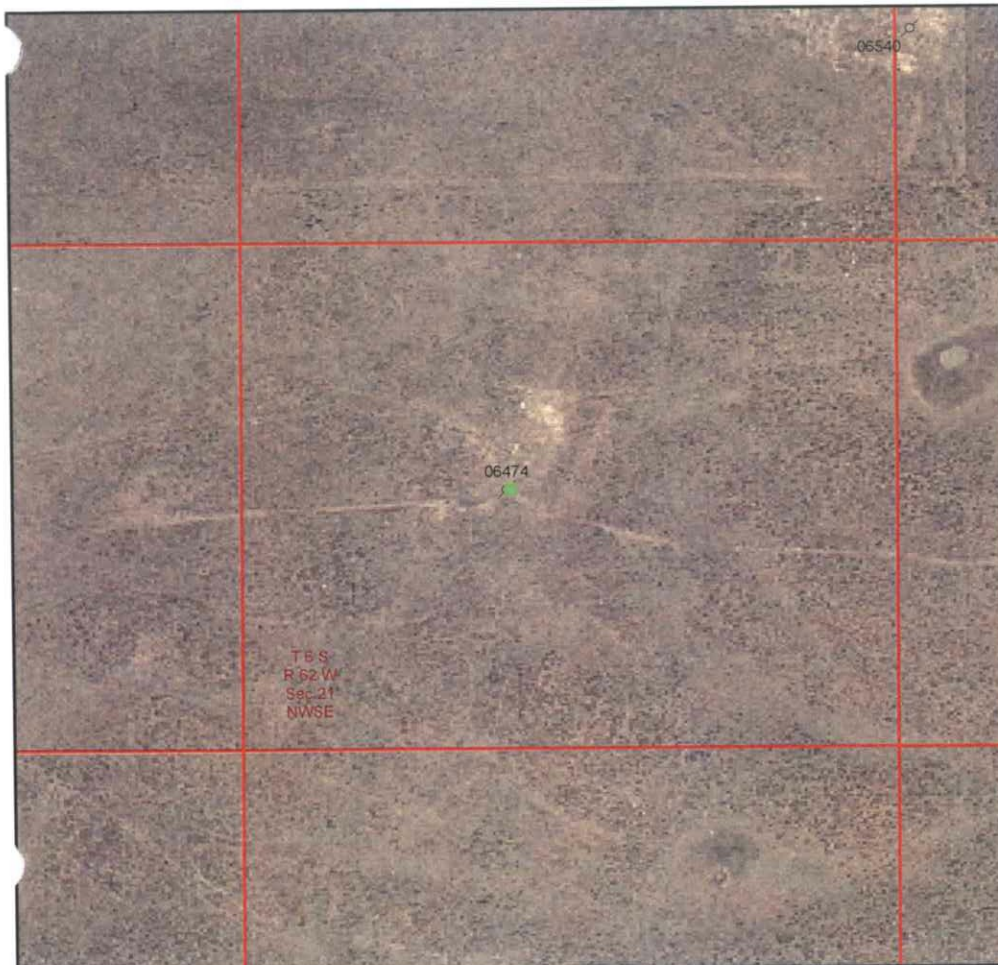
Pit Name: UPRR 21-10

Notes: LIF (1985) 20' x 20' dry pit

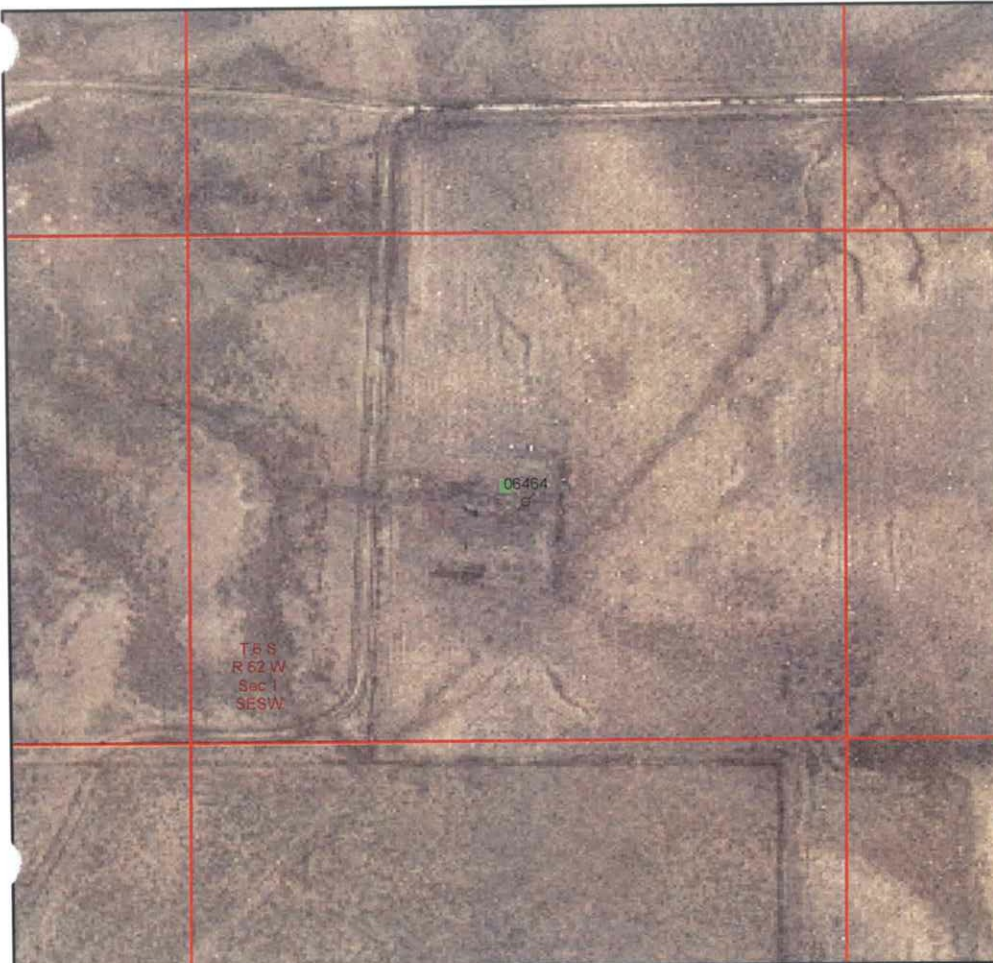
Pit Name: KEEN 24-1

Notes: LIF (1987) Fiberglass skim tank
FIR (1998) "well plugged & location restored". Gas meter flowline riser still at site.
WSIF (1989) Pit backfilled & site clean

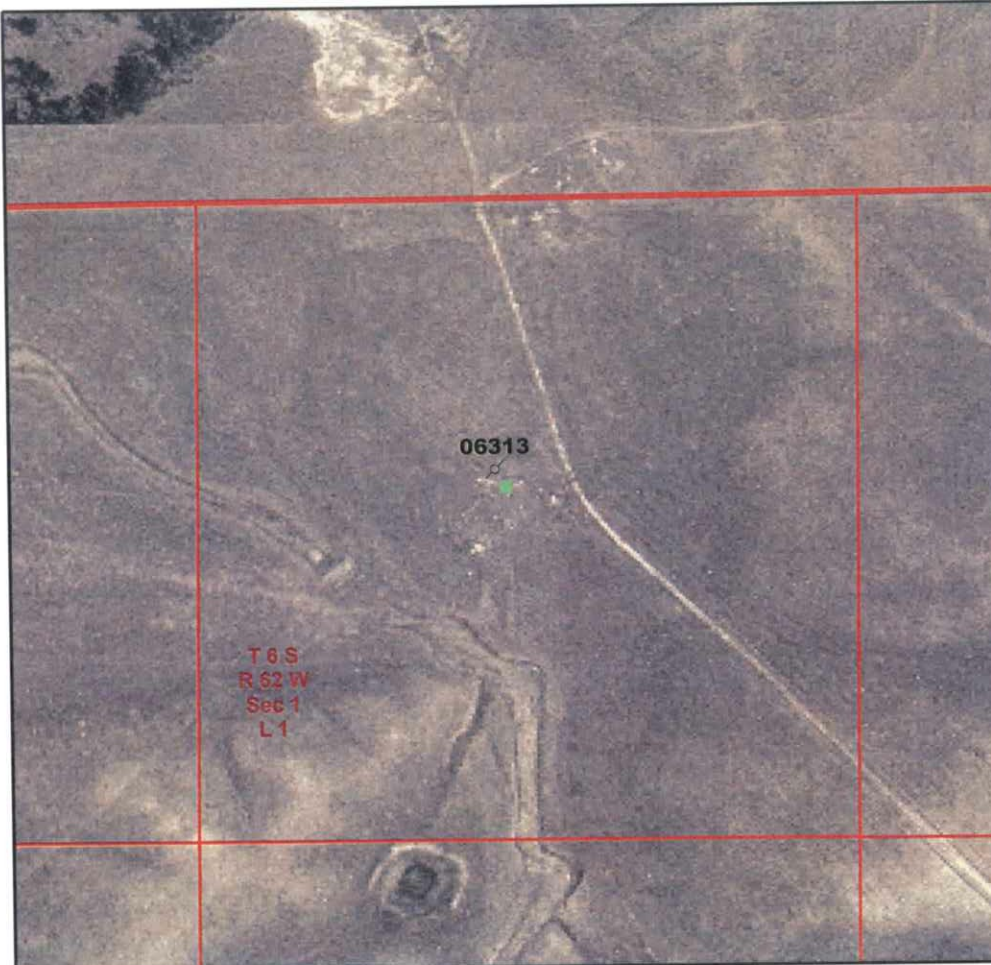
Pit Name: KEEN 31-1 1

Notes: LIF (1987) 20'x20' skimp pit
WSIF (1990) pit back filled & site clean

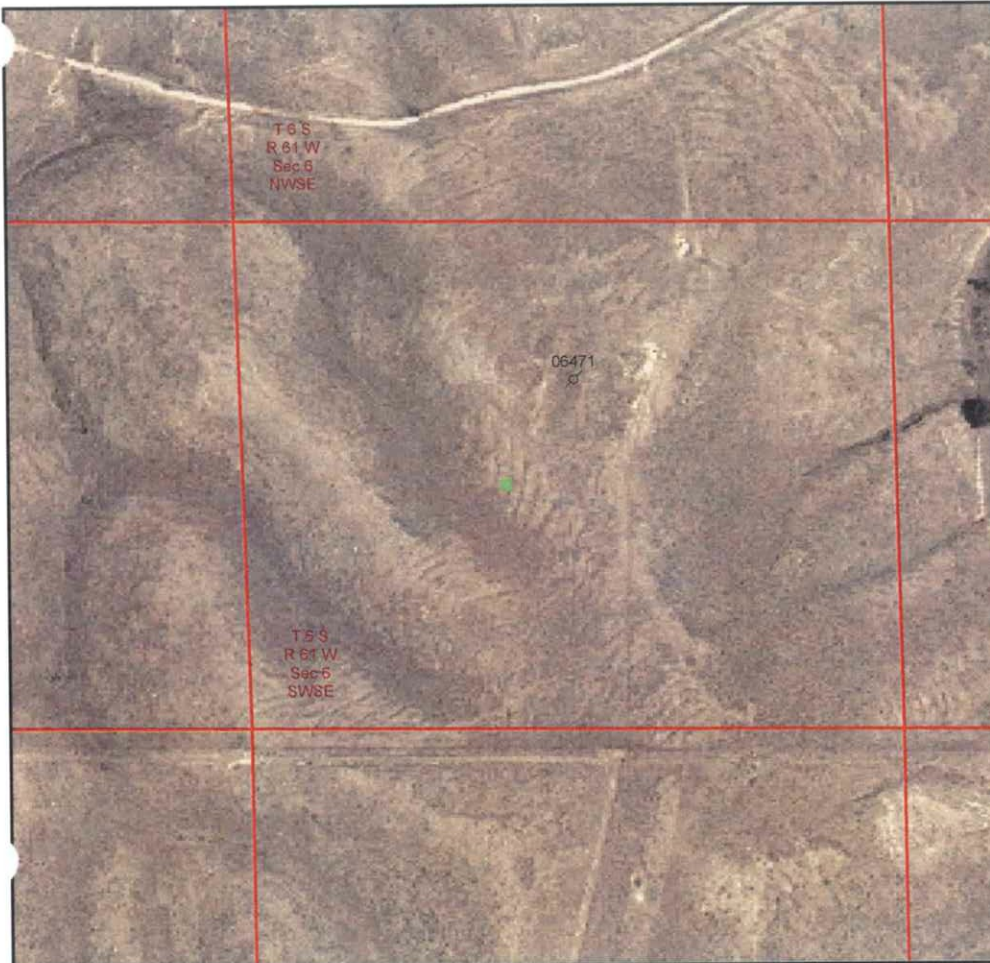
Pit Name: KEEN 34-6

Notes: LIF (5-3-1985) "Well T # A"

LIF (1986) "No pits, good P&A, acceptable surface rehab. Recommended action: file"

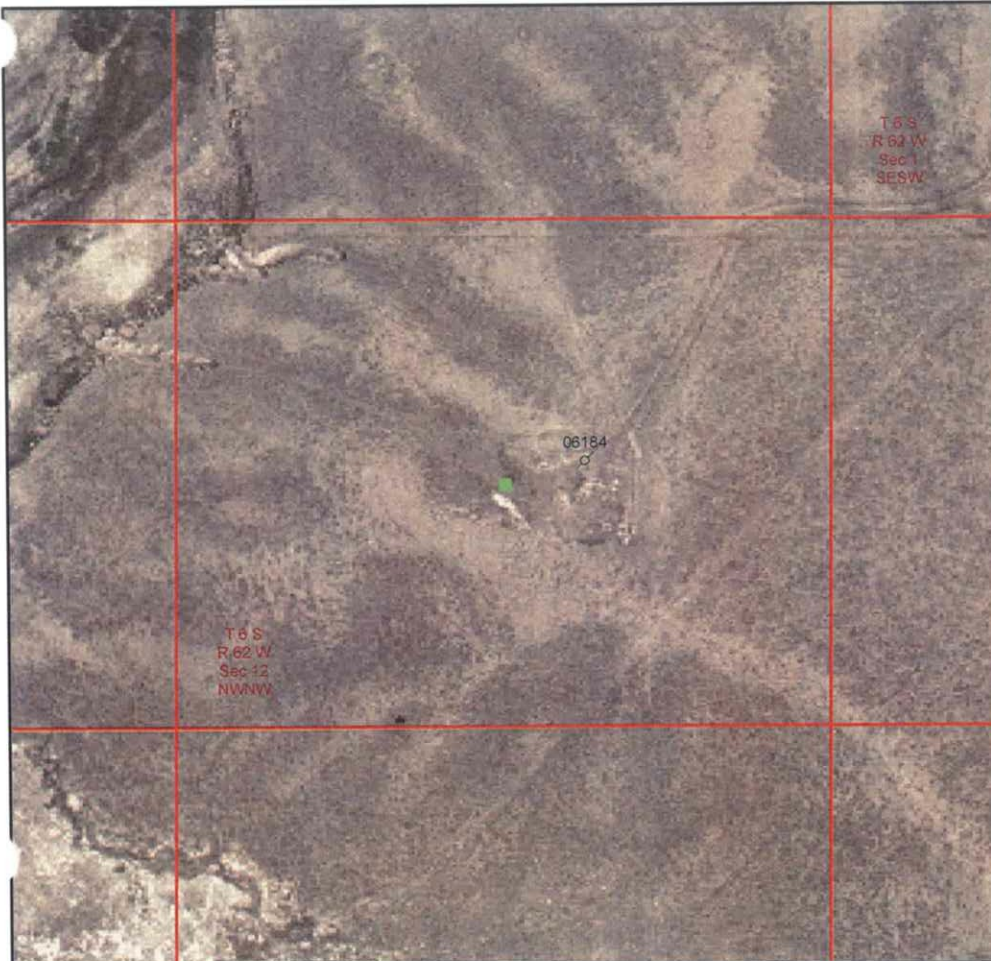
Pit Name: WHITEHEAD 1-12

Notes: LIF (1985) 15' x 15' pit, site appeared to be abandoned
WSIF (1988) pits backfilled and site clean

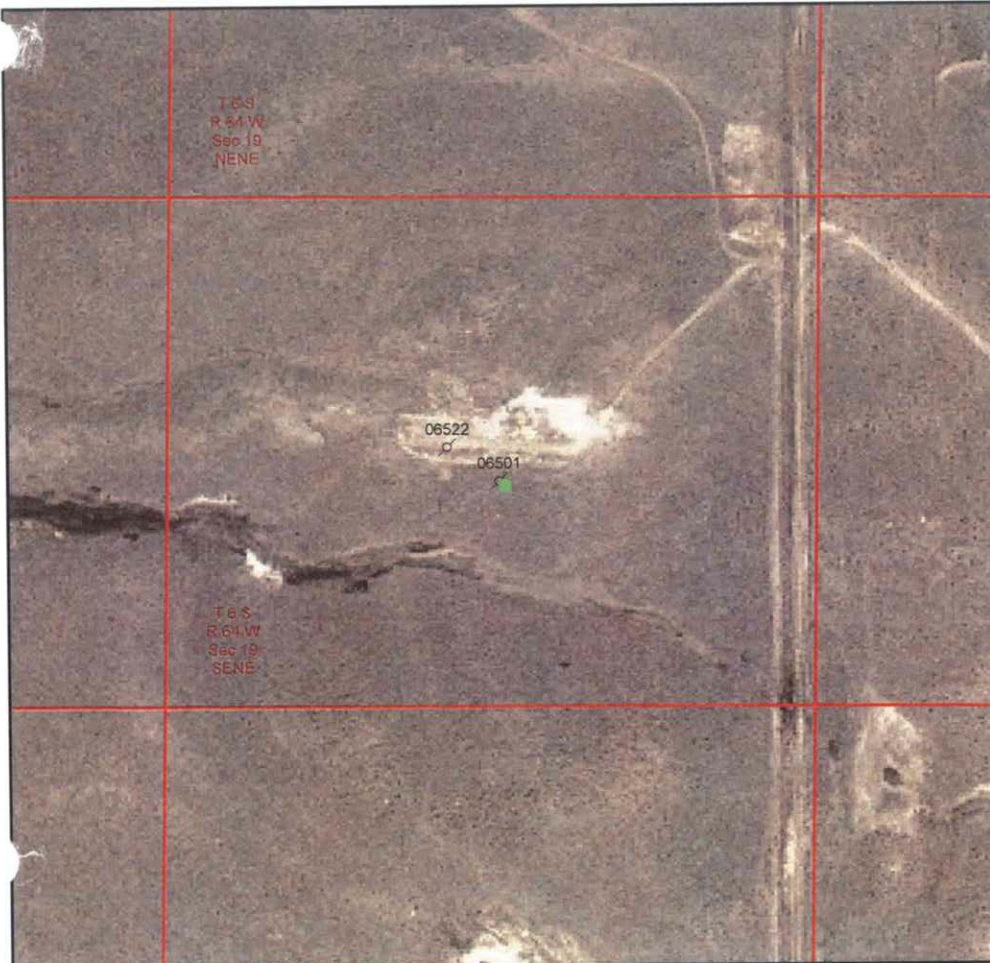
Pit Name: EVERITT 1A 42-19

Notes: Common to Pit ID# 115169 Everitt 41-19 2

LIF (1987) 2-200 BBL skim tank + 20' x 20' pit

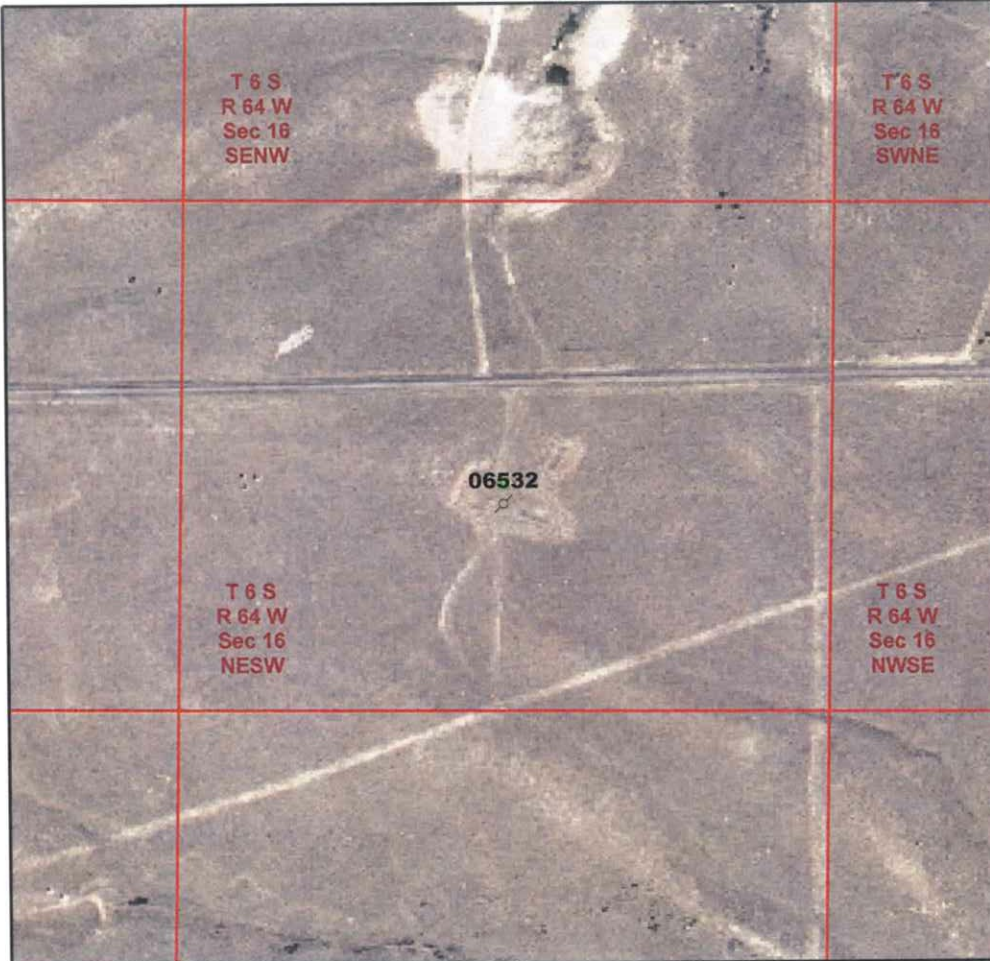
Pit Name: RUNNING CREEK 13

Notes: LIF (1985) "comment #6" (also #14 & #16 field verified 6-2008)
Pit Status & documentation under Pit ID# 115172. Battery tank
site near #16.
