PIT STATUS EVALUATION FORM

Facility ID: 115176

Pit Name: RUNNING CREEK 3

S.S. PAPADOPULOS & ASSOCIATES, INC.

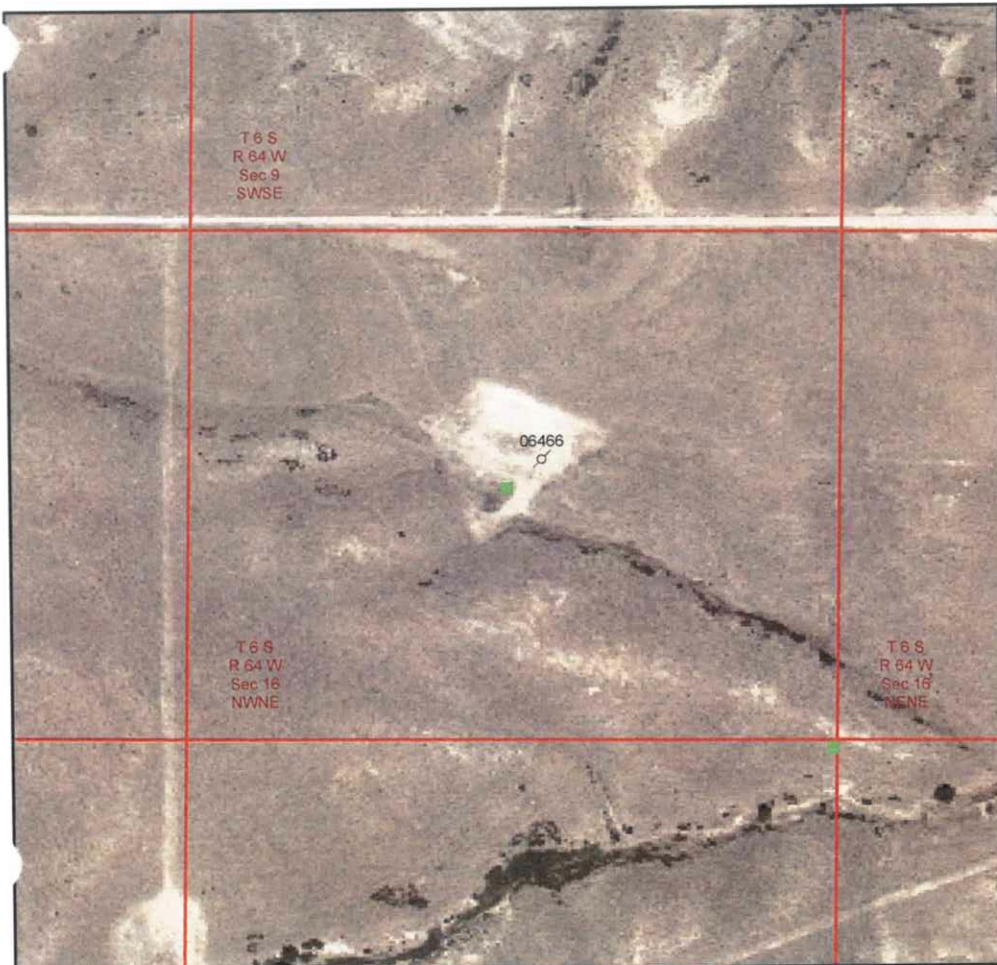
Pit Name: RUNNING CREEK 2

- ☐ Active ☐ Form 15: Pit Permit NA Assoc. Well Seq No(s) _____
☐ Other documentation _____
☐ Aerial photo verification _____
- ☒ Closed ☐ Form 27: Remediation Workplan _____
☐ Form 4: Sundry Notice _____
☐ Rule 903a.(2)B _____
☒ Evidence pit(s) existed, no closure docs & well not PR, AC or SI
Well API Seq #(s) 06466 PA (8-17-1992)
☐ Other documentation _____
- ☐ Abandoned ☐ Possible un-reclaimed pit(s) or adverse conditions, no closure docs ☐ Site Visit
☐ Unknown ☐ No Site Visit
☒ Add'l Review

Notes: LIF (1987) 30'x30' pit
WSIF# 437018 (10-14-1992) "pits NOT backfilled, site NOT clean"
genals indicate site has been remediated but no onfile docs reported.

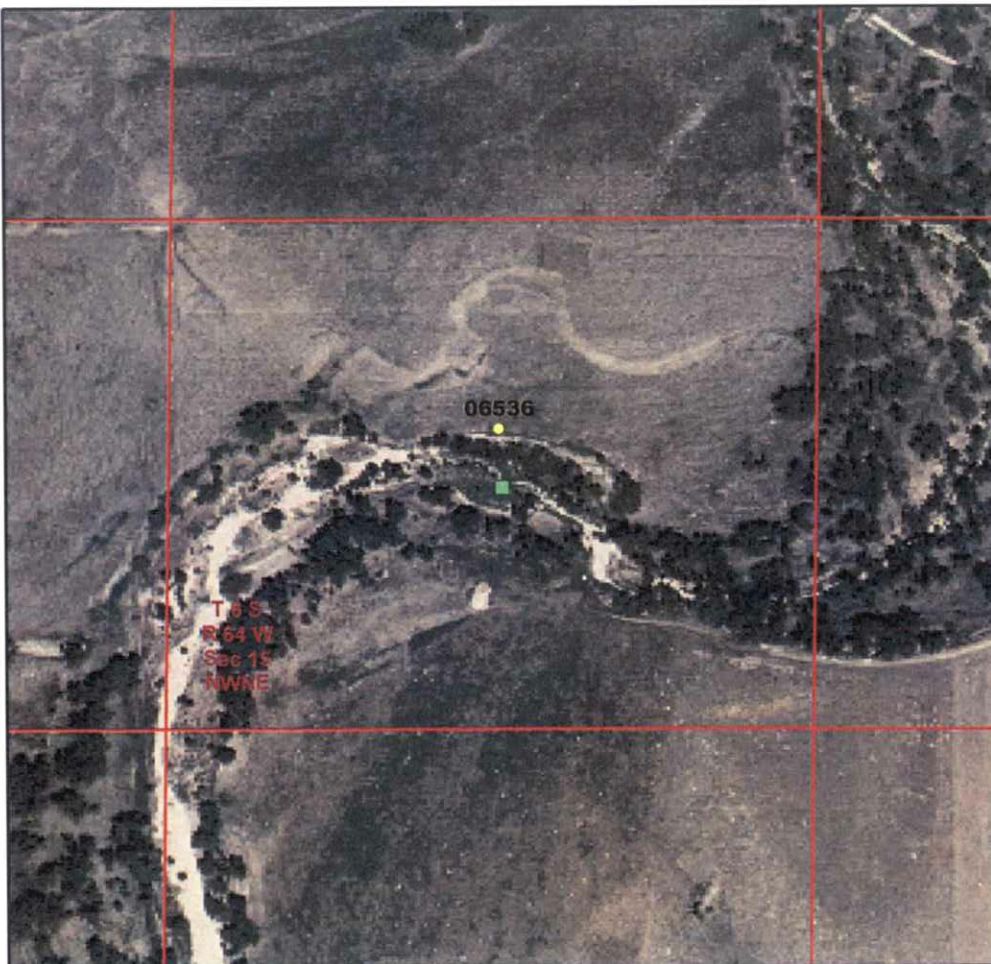
Pit Name: MUSGRAVE 15-2

☒ Closed

☒ Form 4: Sundry Notice #581303 (12-30-1997) pit closure

☒ Other documentation FIR #200082424 (12-20-2005)

Notes: Sundry Notice (1997) pit closure indicates contaminated soils.
FIR (12-2005) indicates steel water tank for storage.

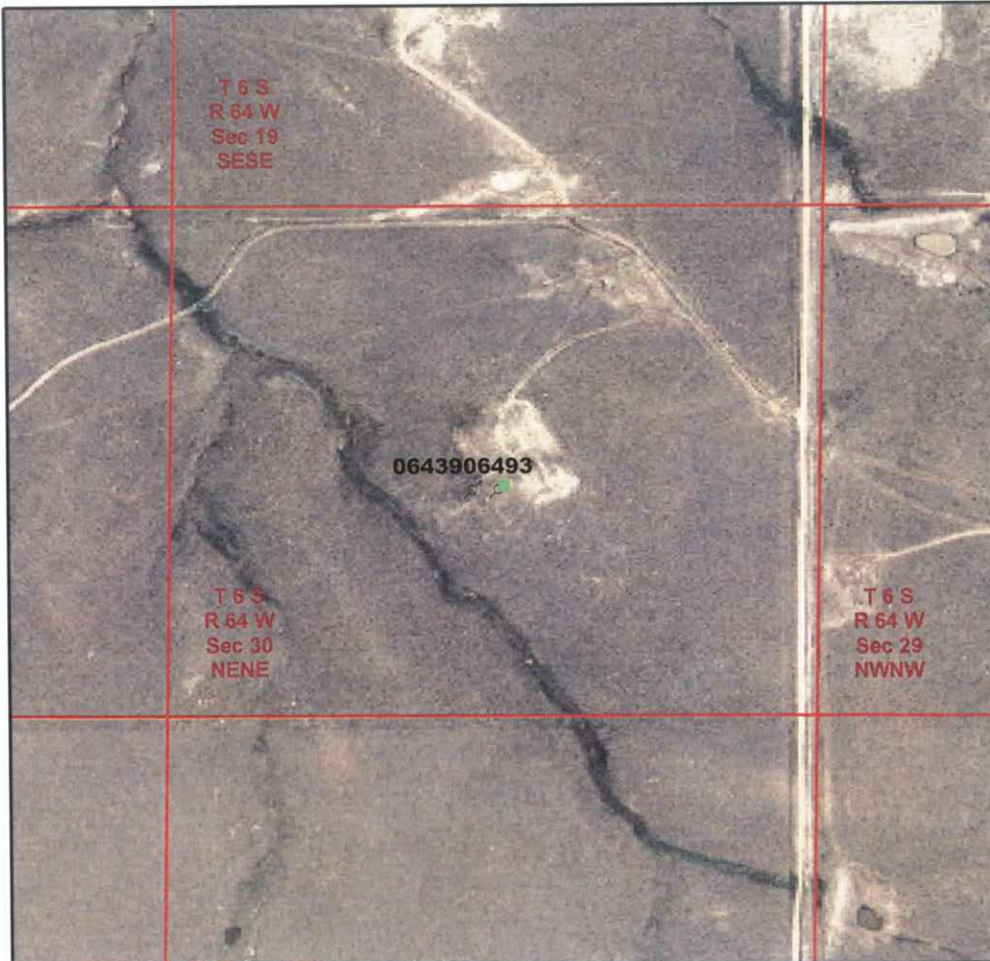
Pit Name: EVERITT "A" 41-30

- ☐ **Active**
- ☐ Form 15: Pit Permit NA Assoc. Well Seq No(s) _____
- ☐ Other documentation _____
- ☐ Aerial photo verification _____
- ☒ **Closed**
- ☐ Form 27: Remediation Workplan _____
- ☐ Form 4: Sundry Notice _____
- ☐ Rule 903a.(2)B _____
- ☒ Evidence pit(s) existed, no closure docs & well not PR, AC or SI
- Well API Seq #(s) 06493 PA (5-16-03) & 06439 AL (no date)
- ☒ Other documentation FIR # 200065616 (1-28-05)
- ☐ **Abandoned** ☐ Possible un-reclaimed pit(s) or adverse conditions, no closure docs
- ☐ **Unknown**
- ☐ Site Visit
- ☐ No Site Visit
- ☐ Add'l Review

Notes: LIF(1985) "common to #41-30 2"

FIR(2005) location restored. all wells in area appear P&A'd

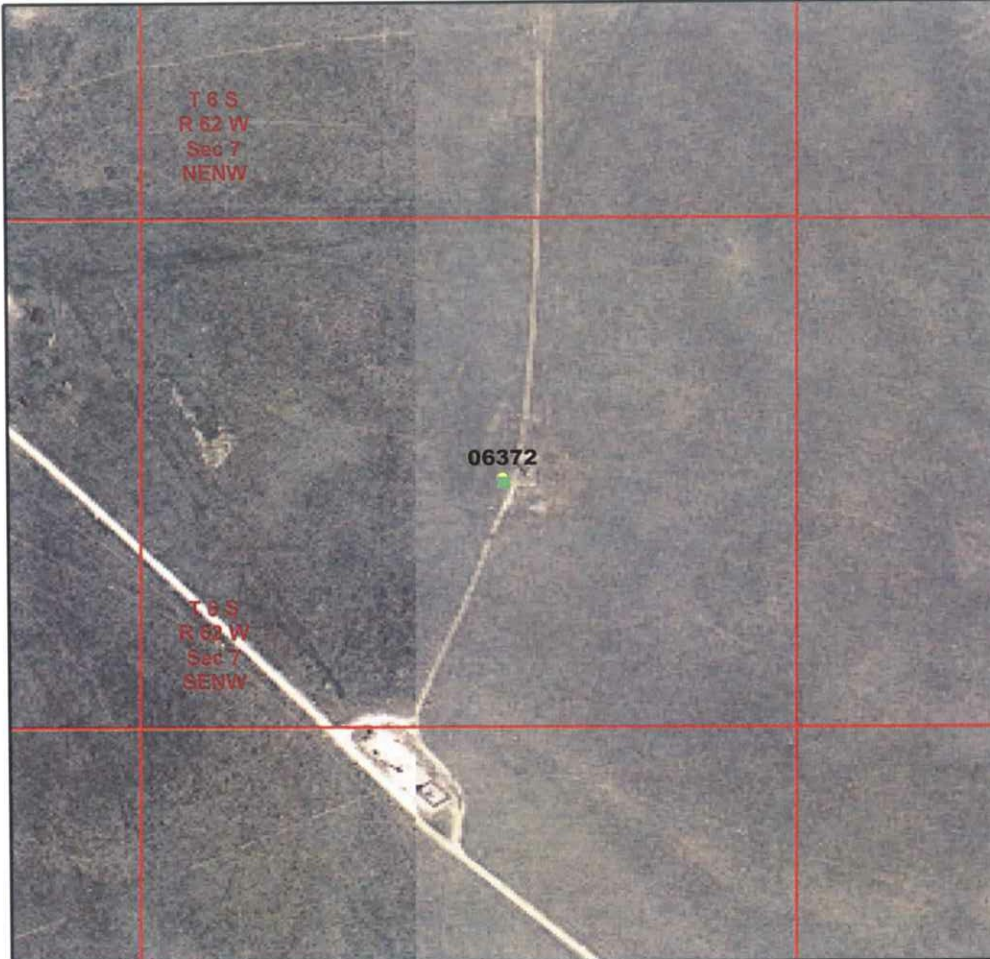
Pit Name: CHAMPLIN 569 "E" 2

- ☐ **Active**
- ☐ Form 15: Pit Permit NA Assoc. Well Seq No(s) 06372 (2-3-2004) PR
- ☐ Other documentation _____
- ☐ Aerial photo verification _____
- ☒ **Closed**
- ☐ Form 27: Remediation Workplan _____
- ☐ Form 4: Sundry Notice _____
- ☐ Rule 903a.(2)B _____
- ☐ Evidence pit(s) existed, no closure docs & well not PR, AC or SI
- Well API Seq #(s) _____
- ☐ Other documentation FIR# 436674 (5-6-1996)
- ☐ **Abandoned**
- ☐ Possible un-reclaimed pit(s) or adverse conditions, no closure docs
- ☐ **Unknown**
- ☐ Site Visit
- ☐ No Site Visit
- ☐ Add'l Review

Notes: Common use battery tank site for Champlin 569 E 1, 2, 3, 4, 5, 6
FIR (1996) "buried concrete vault". API Seq Nos 06354 (PR) 06372 (PR)
06373 (PA) 06374 (PR) 06403 (PR) 06404 (PA)

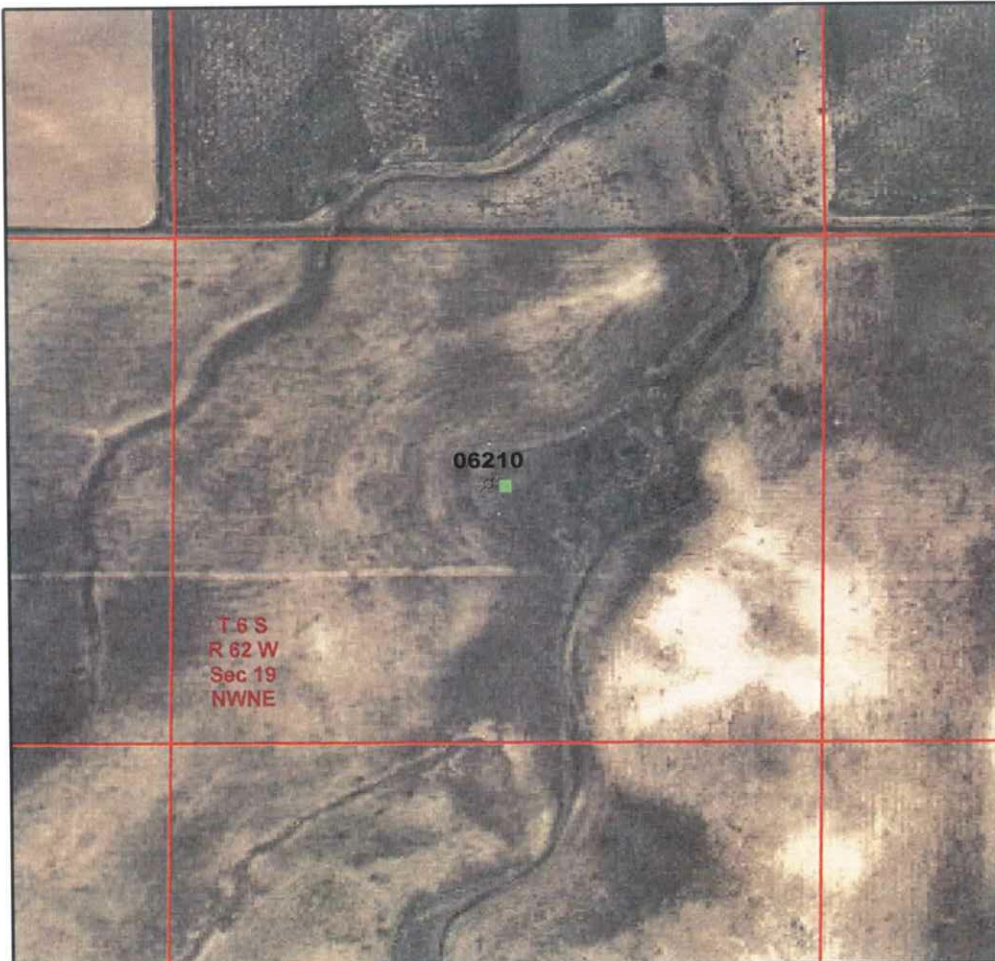
Pit Name: SABO 31-19 1

- ☐ **Active**
- ☐ Form 15: Pit Permit NA Assoc. Well Seq No(s) _____
- ☐ Other documentation _____
- ☐ Aerial photo verification _____
- ☒ **Closed**
- ☐ Form 27: Remediation Workplan _____
- ☐ Form 4: Sundry Notice _____
- ☐ Rule 903a.(2)B
- ☒ Evidence pit(s) existed, no closure docs & well not PR, AC or SI
- Well API Seq #(s) 06210 PA (9-26-1998)
- ☒ Other documentation WSIF # 429518 (11-23-1988)
- ☐ **Abandoned** ☐ Possible un-reclaimed pit(s) or adverse conditions, no closure docs
- ☐ **Unknown**
- ☐ Site Visit
- ☐ No Site Visit
- ☐ Add'l Review

Notes: LIF (1987) 30'x30' pit. Common Use for SABO #1, #2, #3
WSIF (1988) pits backfilled & site clean.

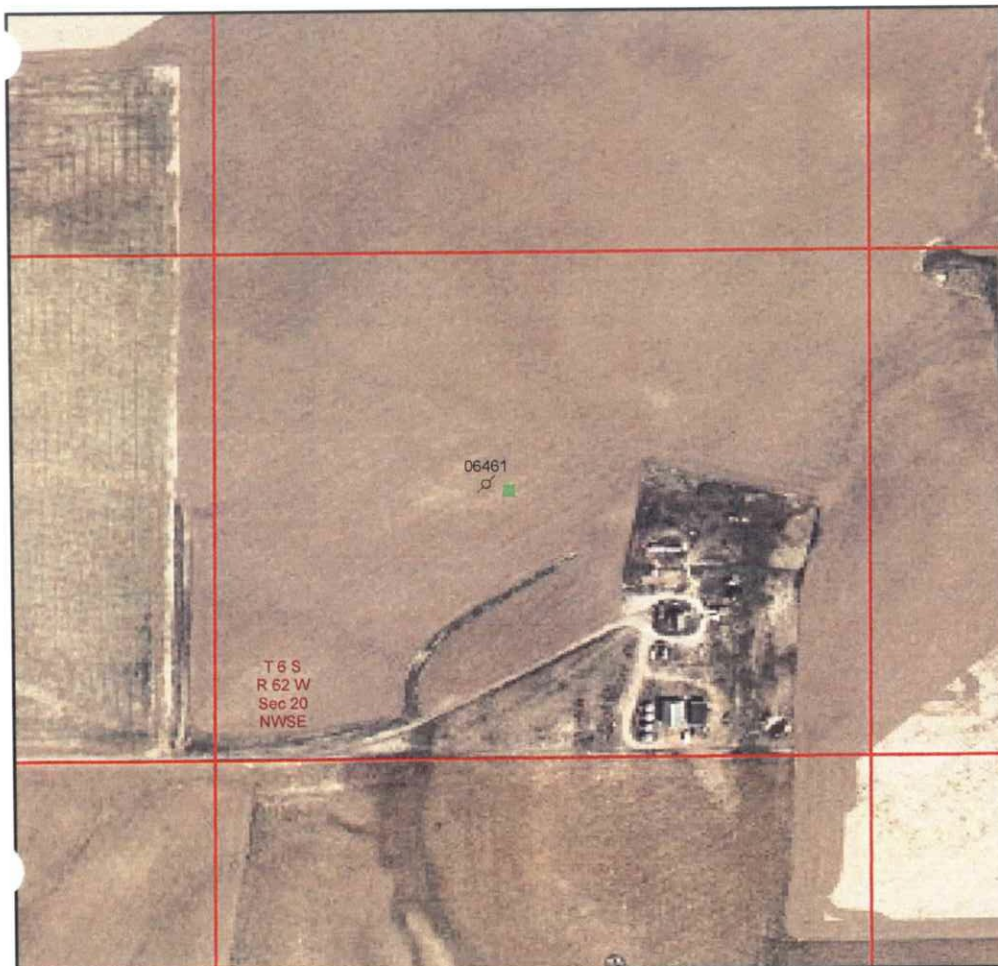
Pit Name: NOVA 20-10

- ☐ Active ☐ Form 15: Pit Permit _____ Assoc. Well Seq No(s) _____
☐ Other documentation _____
☐ Aerial photo verification _____
- ☒ Closed ☐ Form 27: Remediation Workplan _____
☐ Form 4: Sundry Notice _____
☐ Rule 903a.(2)B _____
☒ Evidence pit(s) existed, no closure docs & well not PR, AC or SI
Well API Seq #(s) 06461 PA (3-8-1997)
☒ Other documentation FIR#429595 (6-26-1997)
- ☐ Abandoned ☐ Possible un-reclaimed pit(s) or adverse conditions, no closure docs ☐ Site Visit
☐ No Site Visit
☐ Add'l Review
- ☐ Unknown

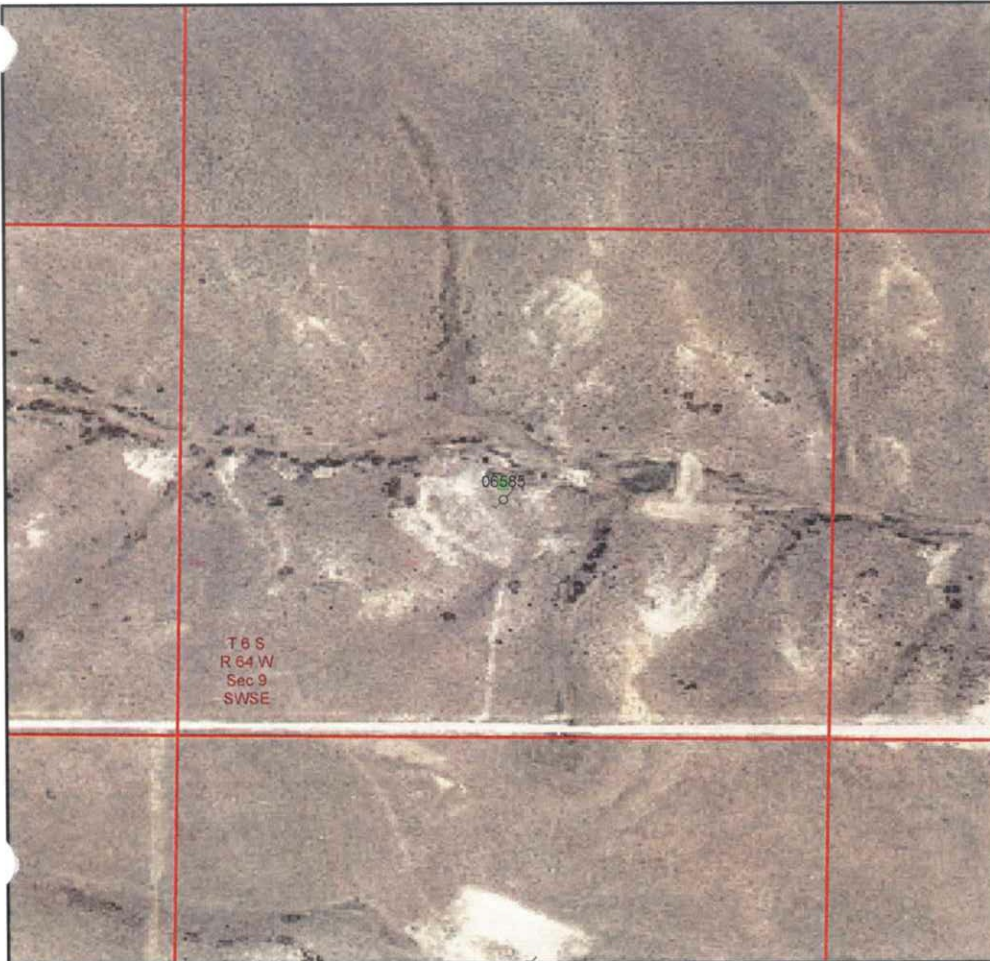
Pit Name: NORDMAN TRUST 15

- ☐ Active ☐ Form 15: Pit Permit _____ Assoc. Well Seq No(s) _____
☐ Other documentation _____
☐ Aerial photo verification _____
- ☒ Closed ☐ Form 27: Remediation Workplan _____
☐ Form 4: Sundry Notice _____
☐ Rule 903a.(2)B _____
☒ Evidence pit(s) existed, no closure docs & well not PR, AC or SI
Well API Seq #(s) 06585 PA (6-20-1990)
☒ Other documentation WSIF# 440979 (12-7-1990)
- ☐ Abandoned ☐ Possible un-reclaimed pit(s) or adverse conditions, no closure docs ☐ Site Visit
☐ No Site Visit
☐ Add'l Review
- ☐ Unknown

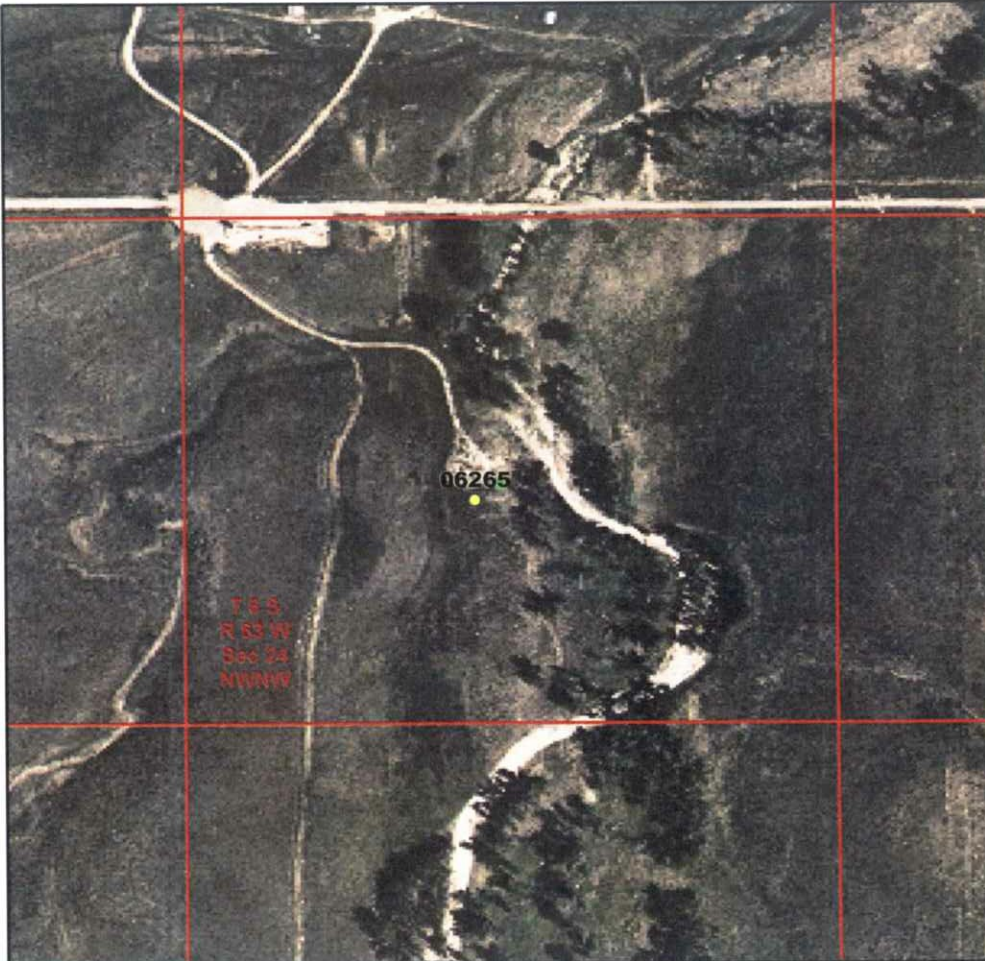
- ☐ **Active**
- ☐ Form 15: Pit Permit NA Assoc. Well Seq No(s) 06265
- ☐ Other documentation _____
- ☐ Aerial photo verification _____
- ☐ **Closed**
- ☒ Form 27: Remediation Workplan #882256 & #882735 (12-27-99)
- ☐ Form 4: Sundry Notice _____
- ☐ Rule 903a.(2)B _____
- ☐ Evidence pit(s) existed, no closure docs & well not PR, AC or SI
- Well API Seq #(s) _____
- ☐ Other documentation _____
- ☐ **Abandoned**
- ☐ Possible un-reclaimed pit(s) or adverse conditions, no closure docs
- ☐ **Unknown**
- ☐ Site Visit
- ☐ No Site Visit
- ☐ Add'l Review
