## **Appendix B**

### **Phase II Pit Status Evaluation Forms and Photographs**

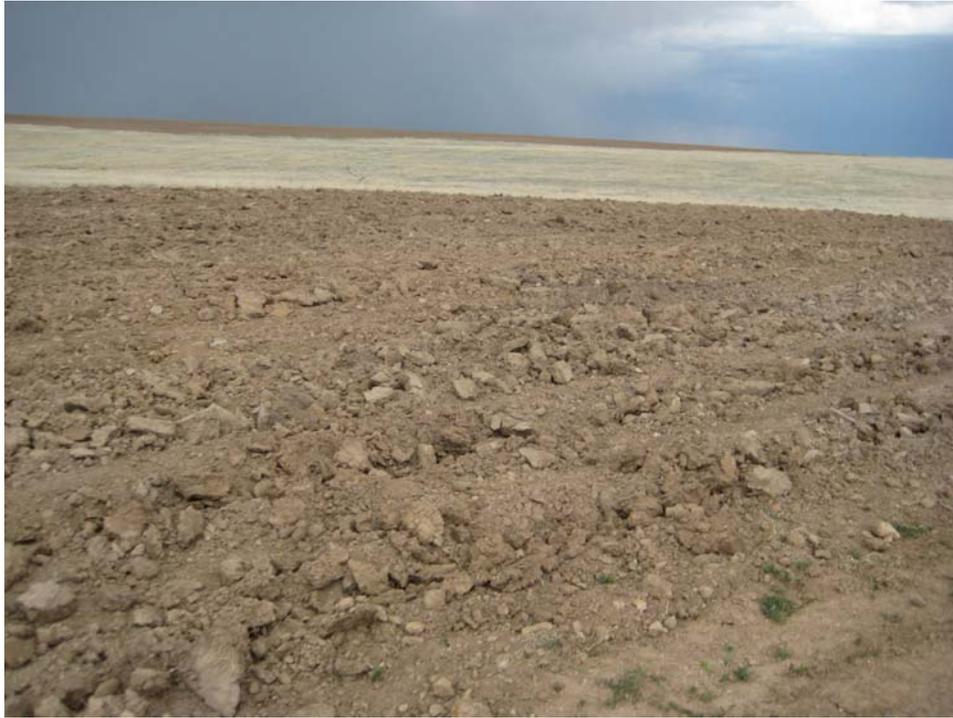
Notes: No final site inspection forms online from 2008 (post PA'D)  
Field Inspection 6-3-2008: Site has been P&A'd; reclamation complete.

**Photo 1. Looking northeast towards reclaimed pit site**

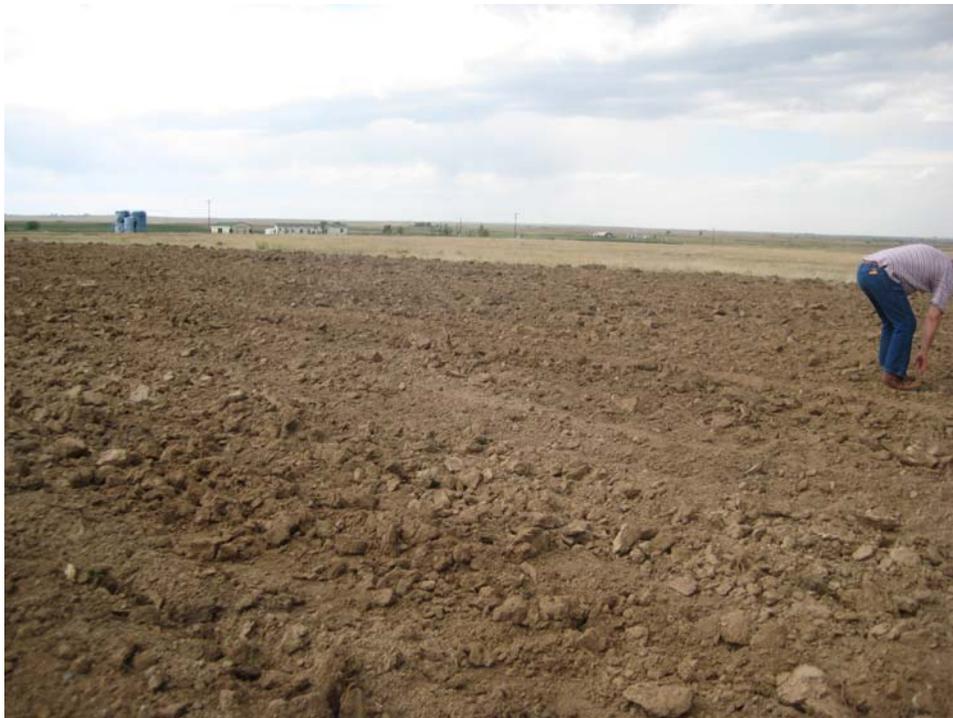
**Photo 2. Looking northwest towards nearest building**

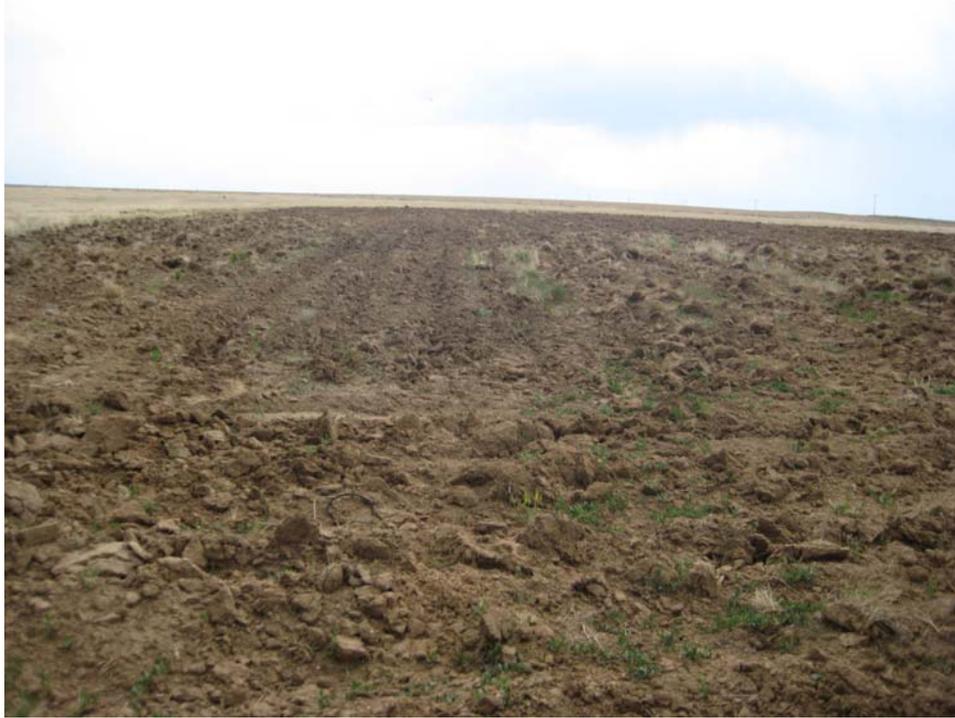
**Photo 3. Looking south towards plugged and abandoned wellhead**

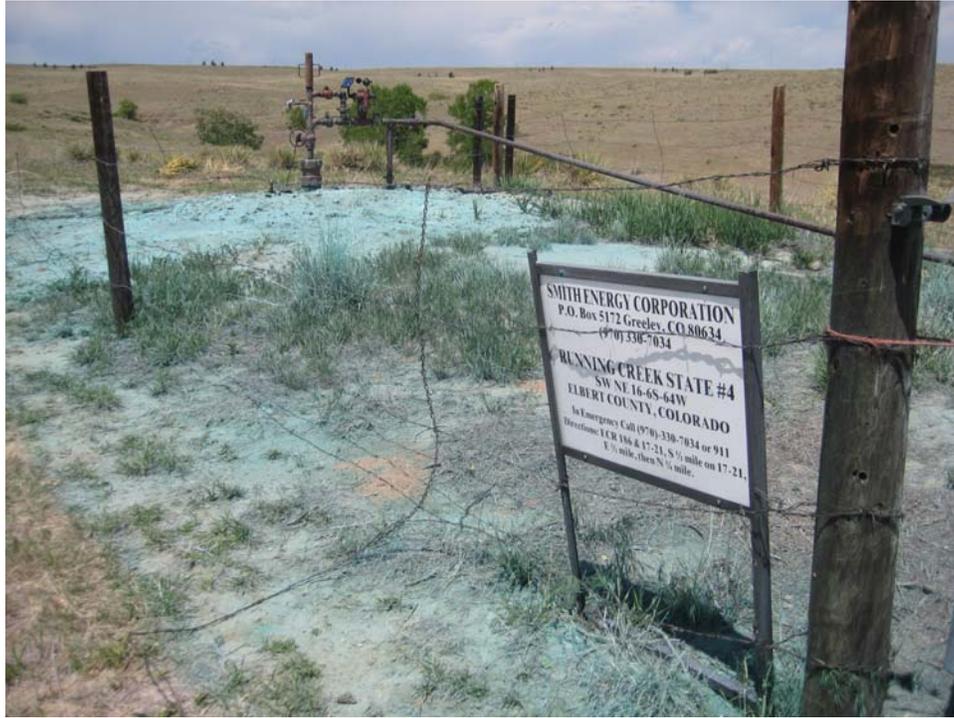
Photo 1. Running Creek State 4 wellhead near battery tank site

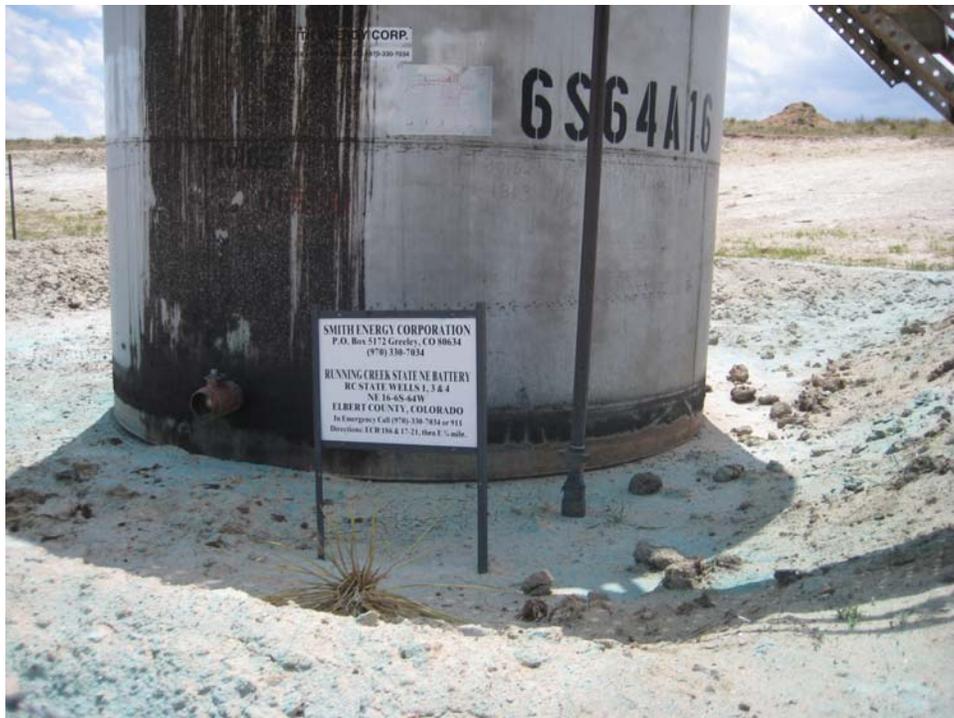
Photo 2. Looking south at 300 BBL production tank

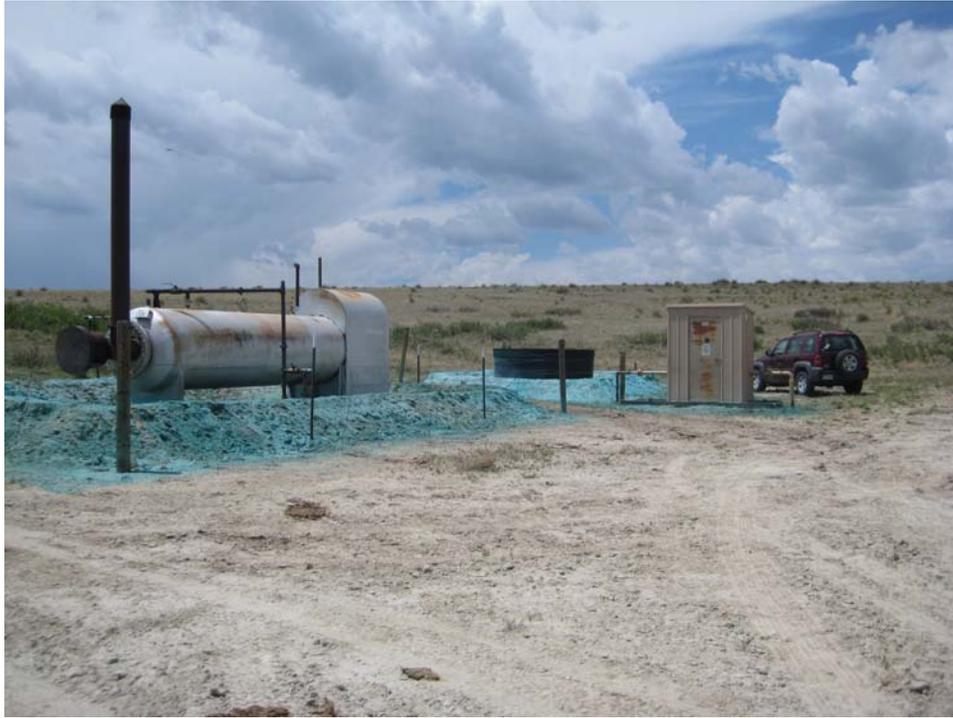
**Photo 3. Looking southwest at buried fiberglass tank and horizontal separator**

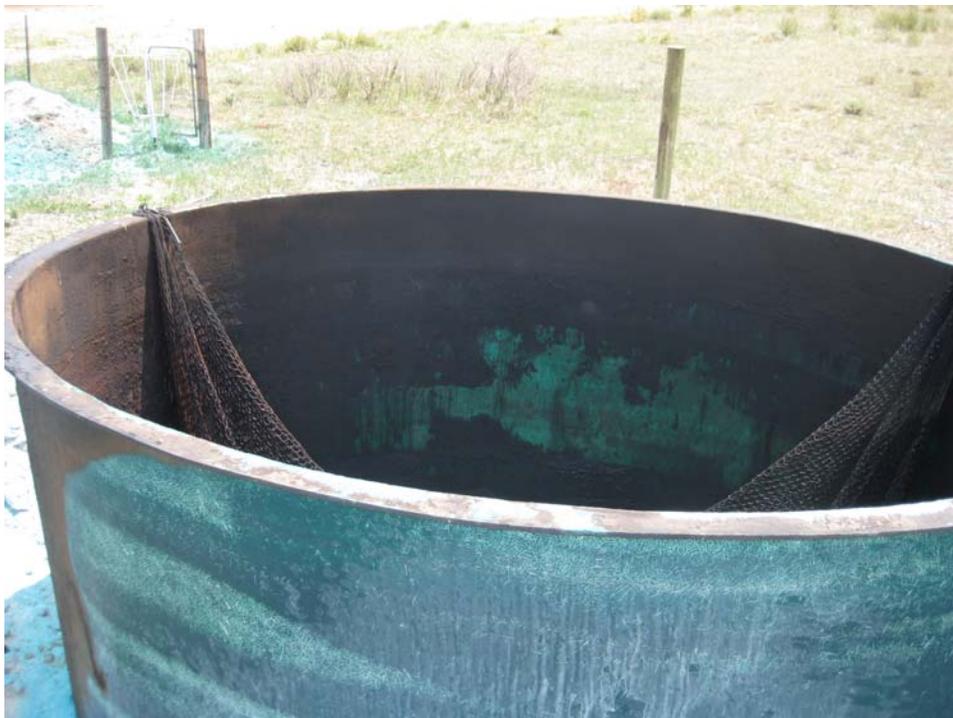
**Photo 4. Fiberglass water tank and cover**

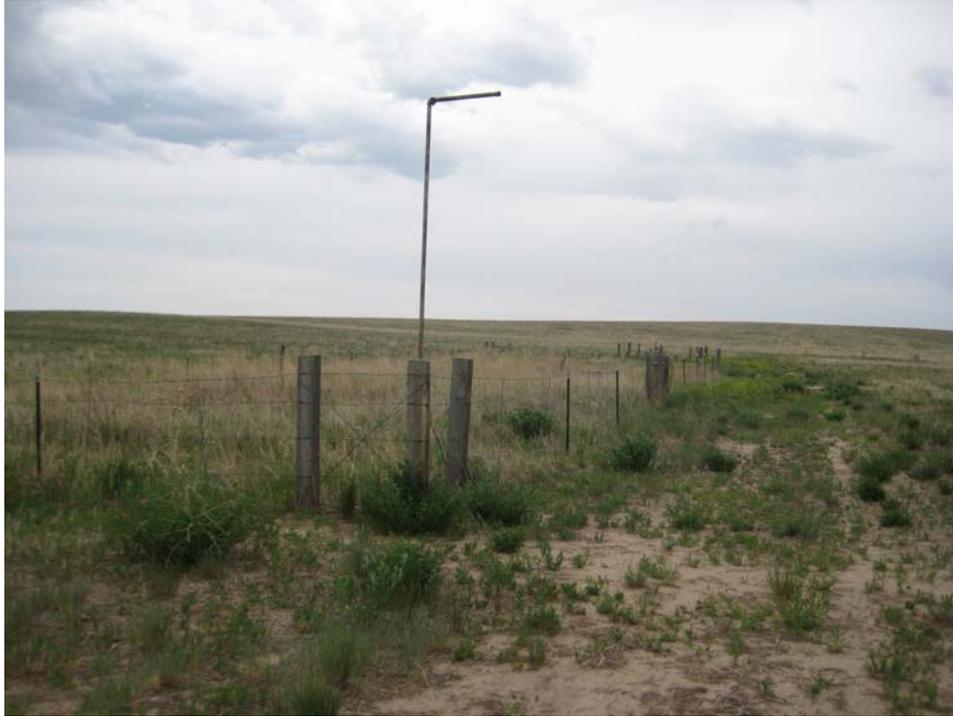
**Photo 1. Well site - temporarily abandoned well status**

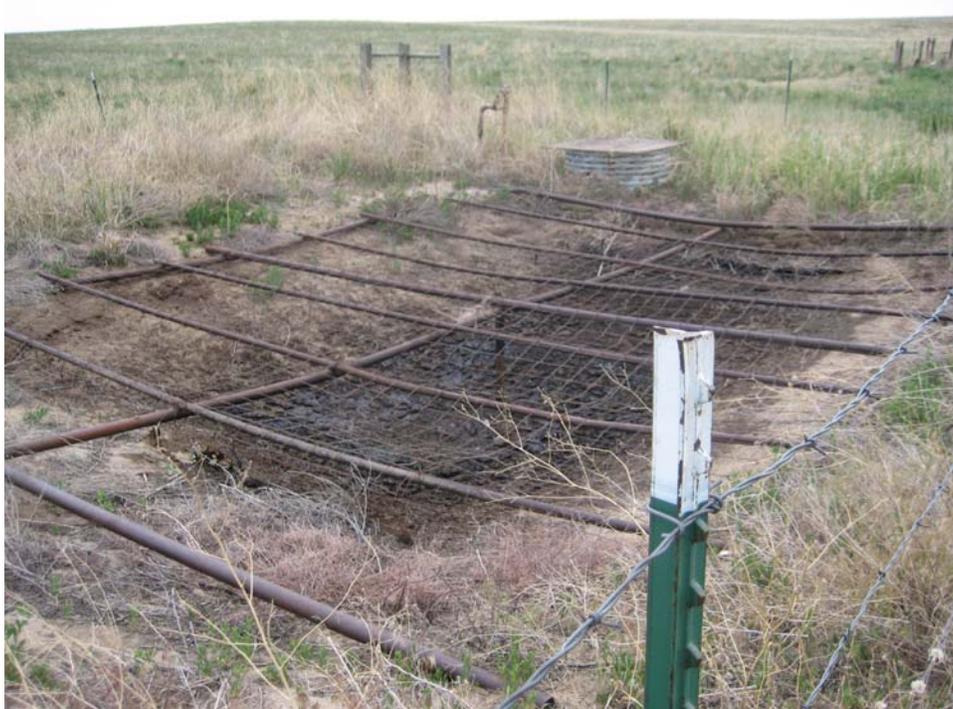
Notes: No lease inspections for Facility ID#111797. NOVA #119754 (2004) indicates well maintain TA status until 4-20-2010.  
 Field Visit 6-4-2008: Earthen Pit & Culvert found. Heavily oil saturated soils & pit cover/berm unsatisfactory.

**Photo 2. Earthen pit and culvert**

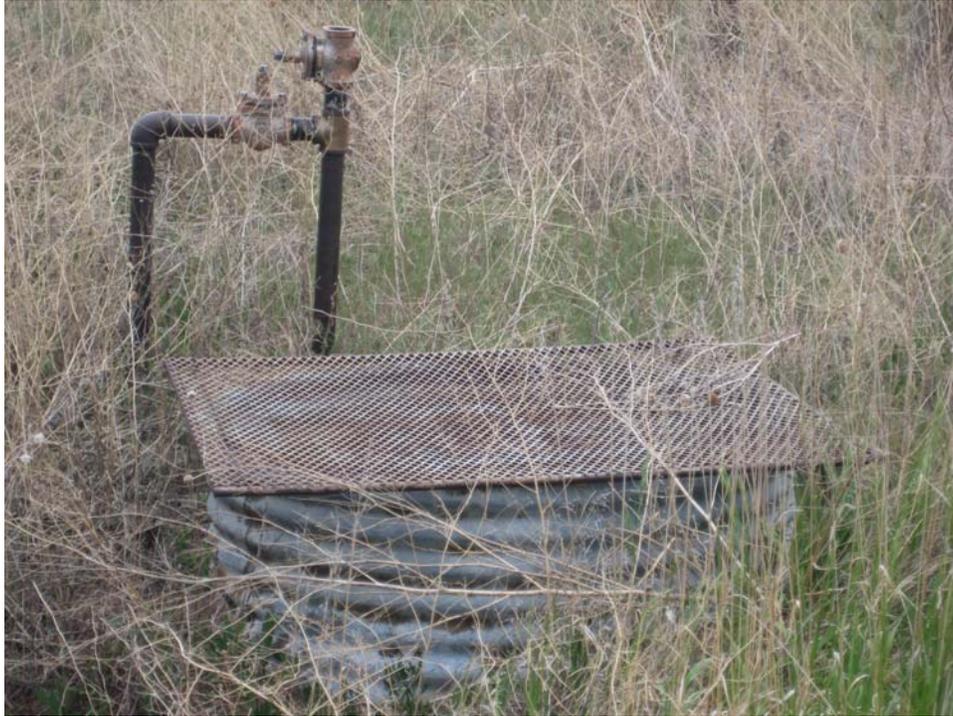
Photo 3. Culvert and cover

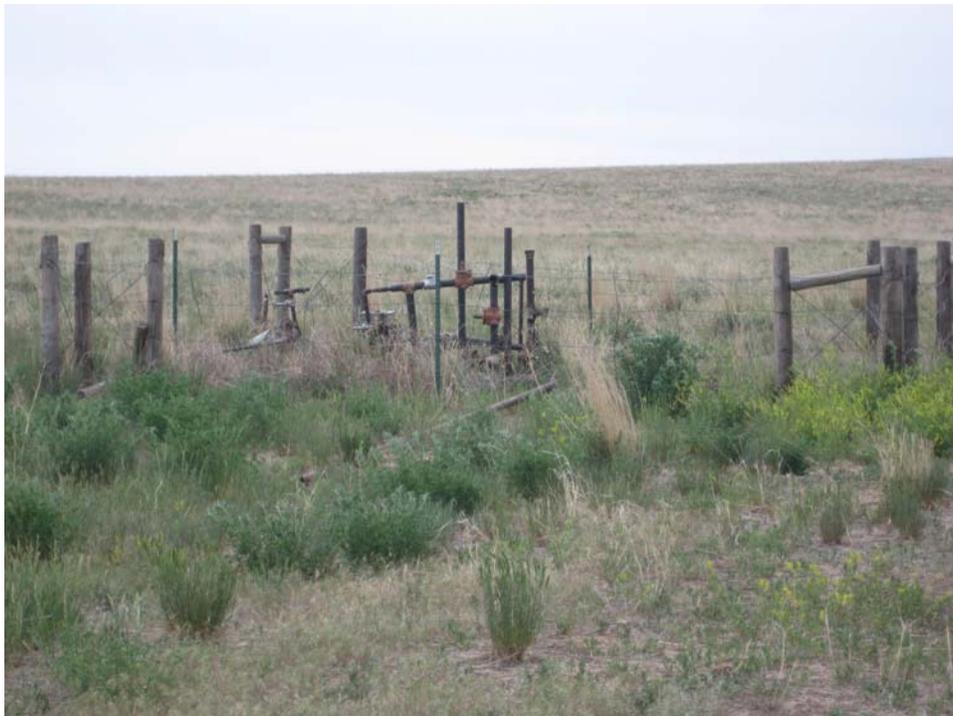
Photo 4. Wellhead equipment

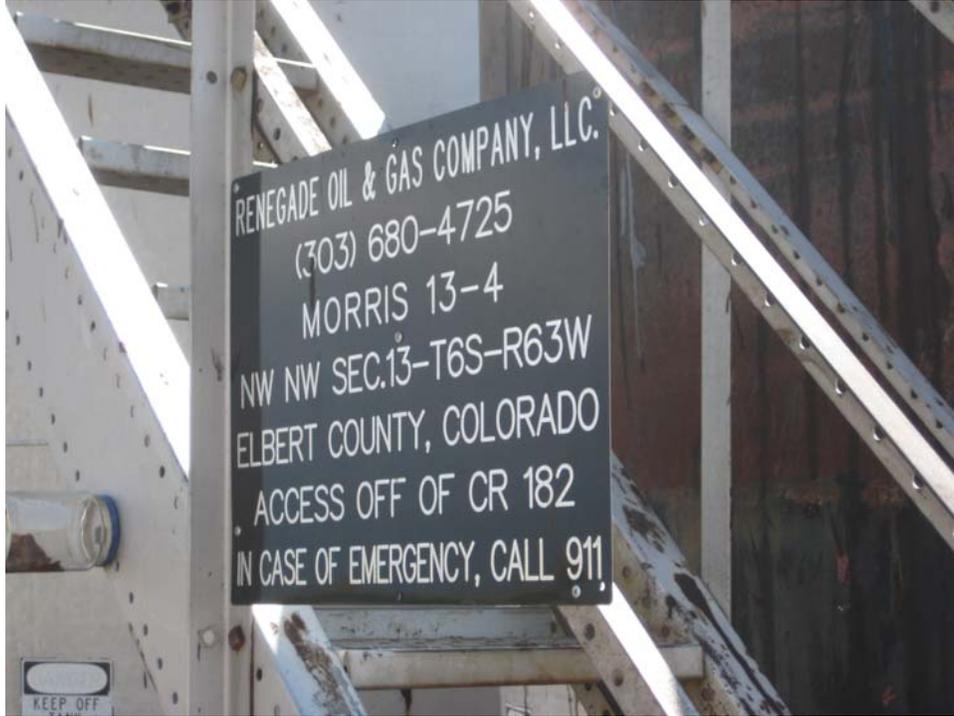
**Photo 1. Battery tank lease sign**

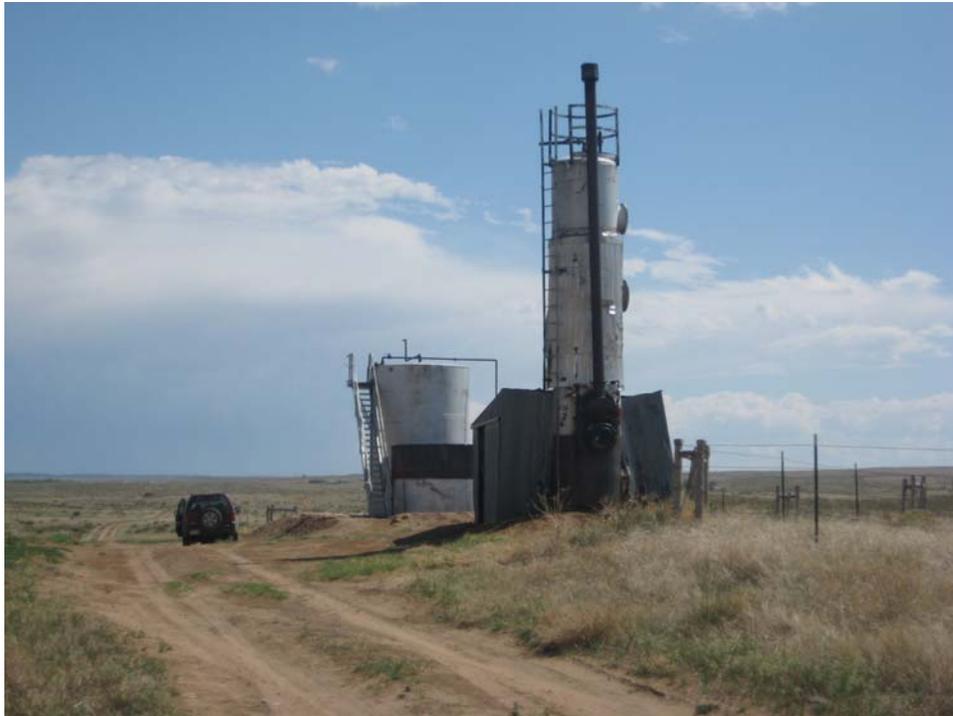
**Photo 2. Vertical separator, fiberglass tank and battery tank**

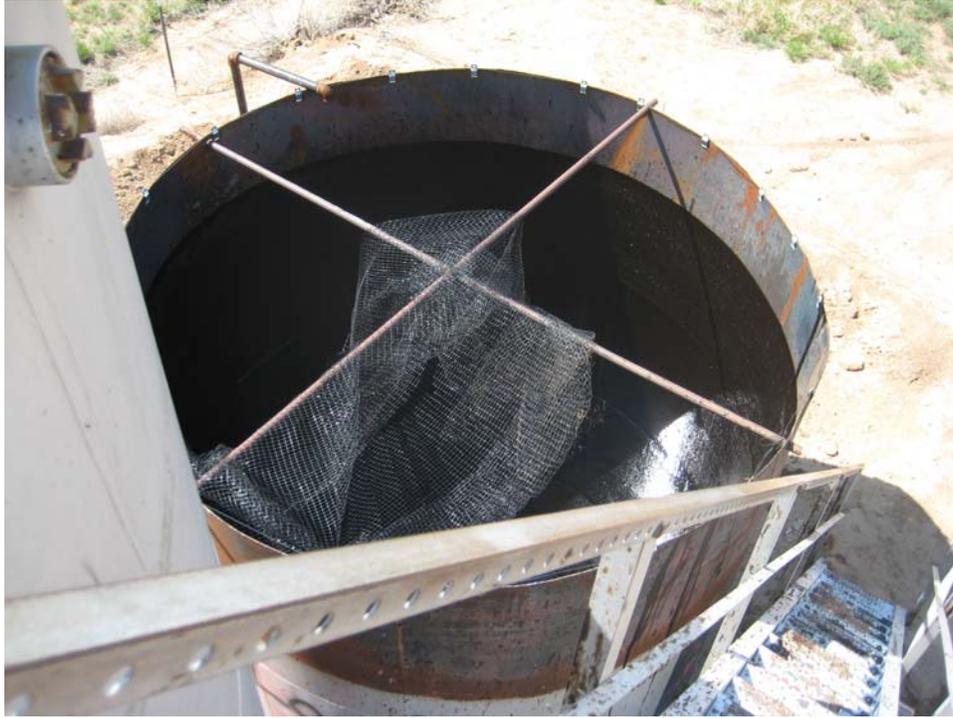
**Photo 3. Fiberglass tank and cover**

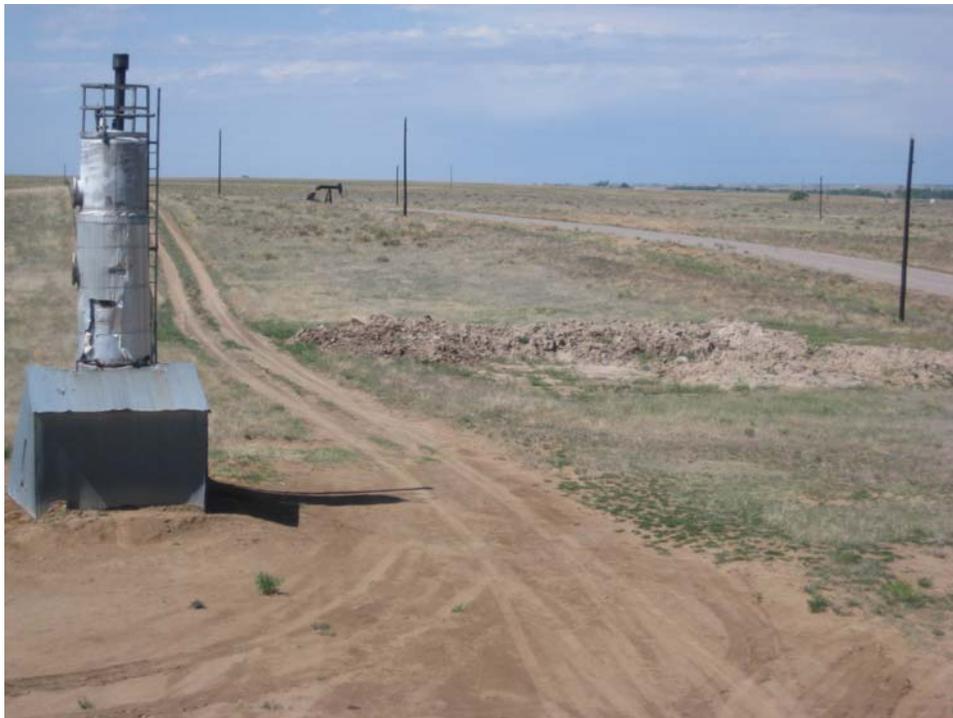
Notes: Common Use battery site for Morris 13-4 & 14-8  
 Field Visit 6-3-2008: Pit area has been turned/aerated. Battery Site Using fiberglass tank for water storage. Pit remediation recommended.

**Photo 4. Looking north towards Morris 13-4 wellhead and earthen pits in foreground**

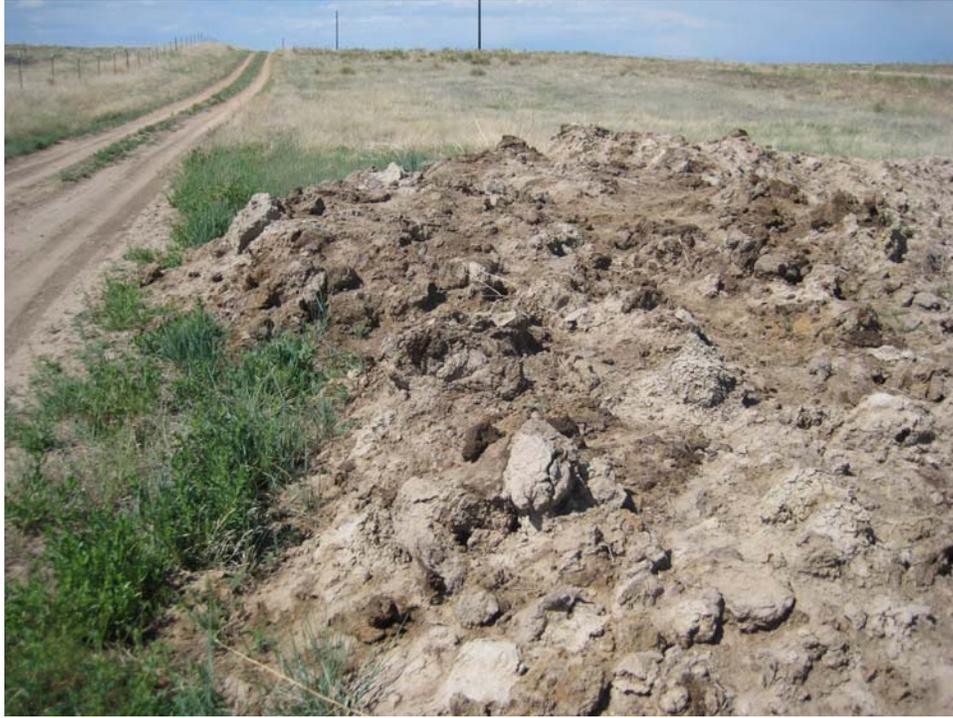
**Photo 5. Looking north along the lease road showing west portion of the skim pit**

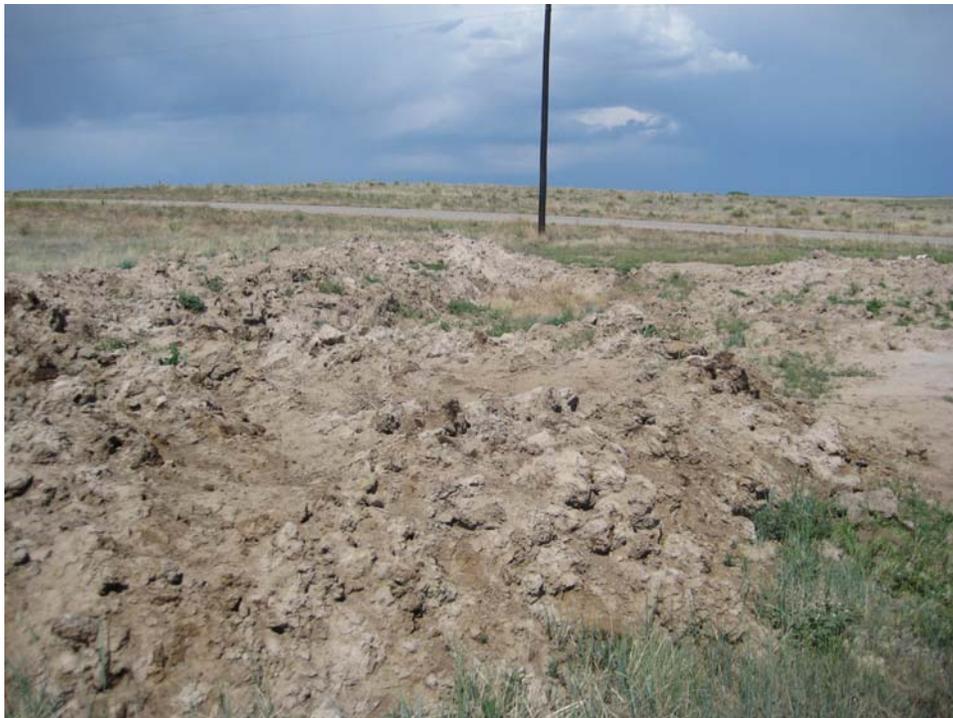
**Photo 6. Looking east showing the skim pit to the left and the earthen pit in the center and right of photo**

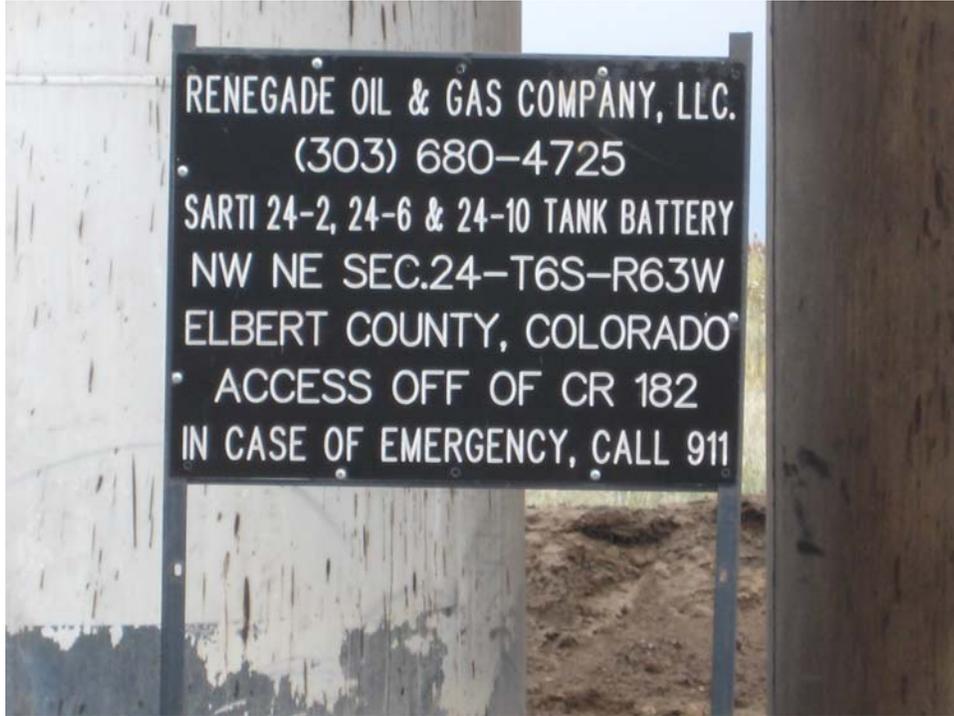
Photo 1. Tank battery lease sign

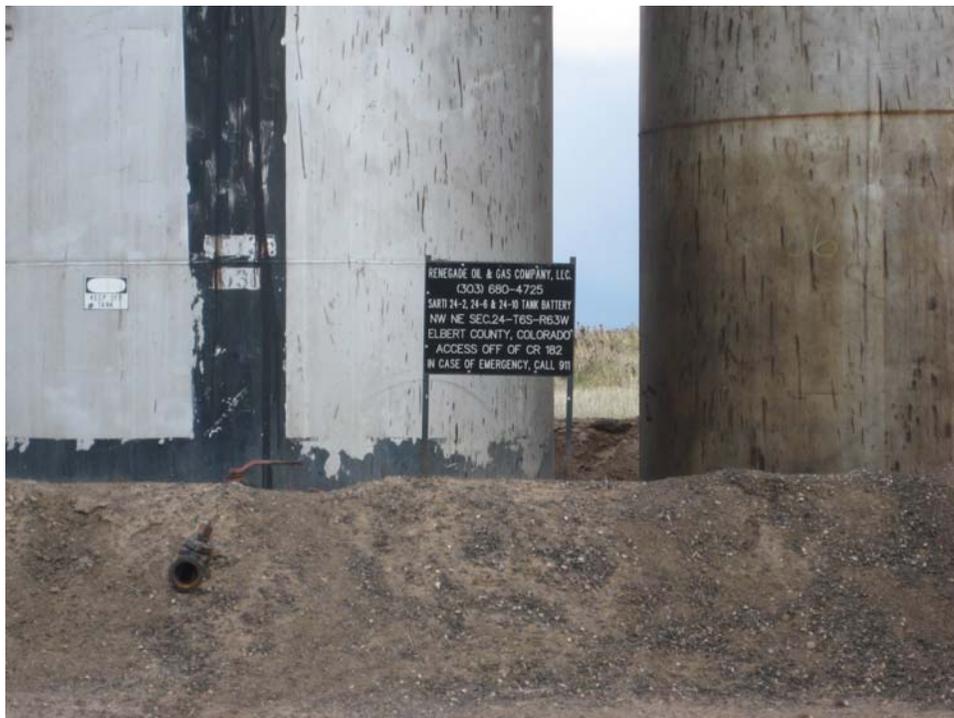
Photo 2. Two 300 BBL production tanks

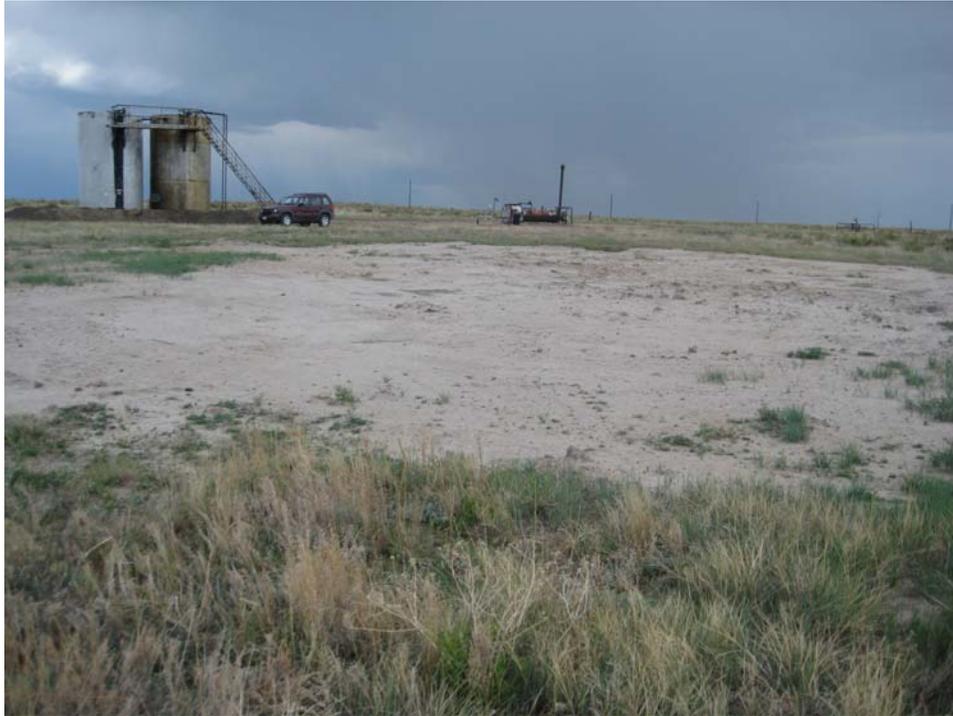
Notes: WSIF (1997) "screened earthen pit, fencing falling down" FIR (9-12-07)  
"Remove oil sat. soil; pits still open"  
Field Visit 6-3-2008: PIT IS BACKFILLED; RESEEDING RECOMMENDED.

**Photo 3. Looking Southeast towards backfilled pit site**

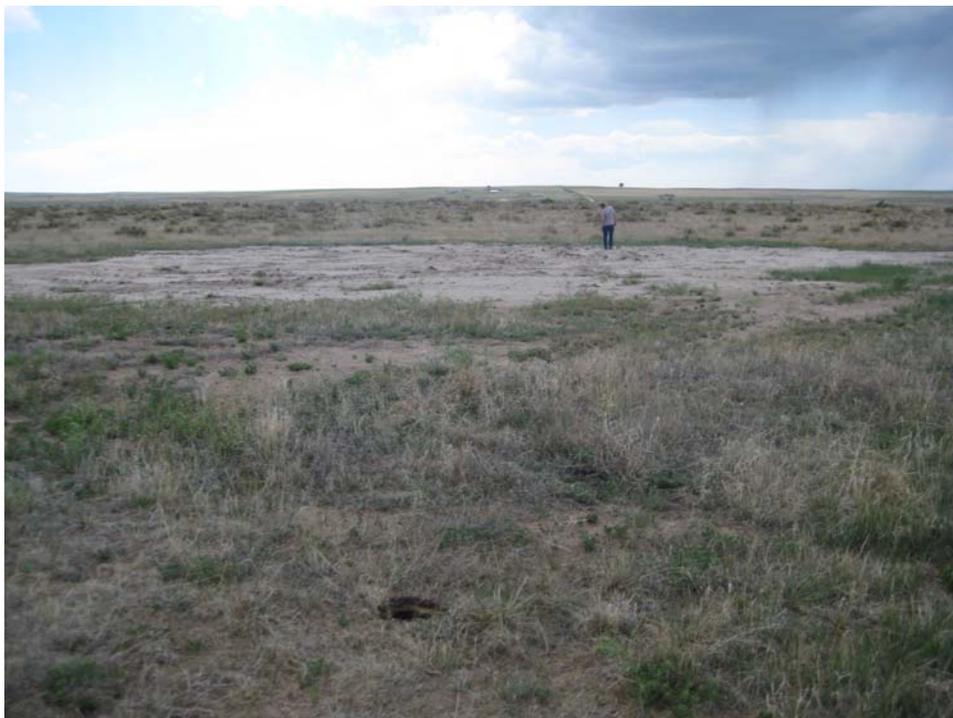
**Photo 4. Looking west at former pit site**

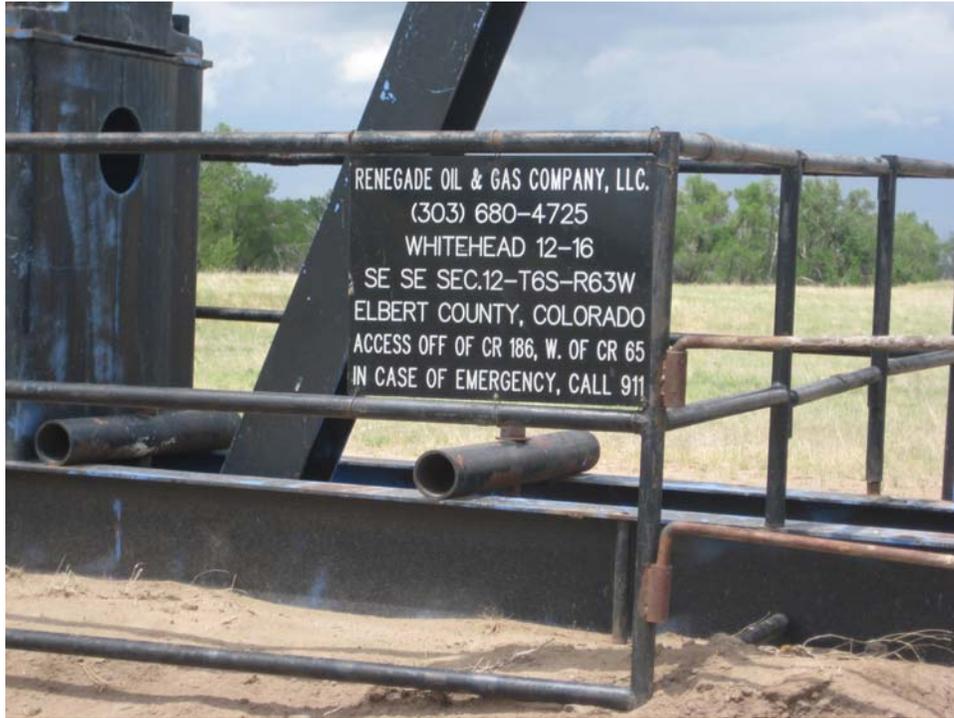
**Photo 1. Whitehead 12-16 wellhead and lease sign**

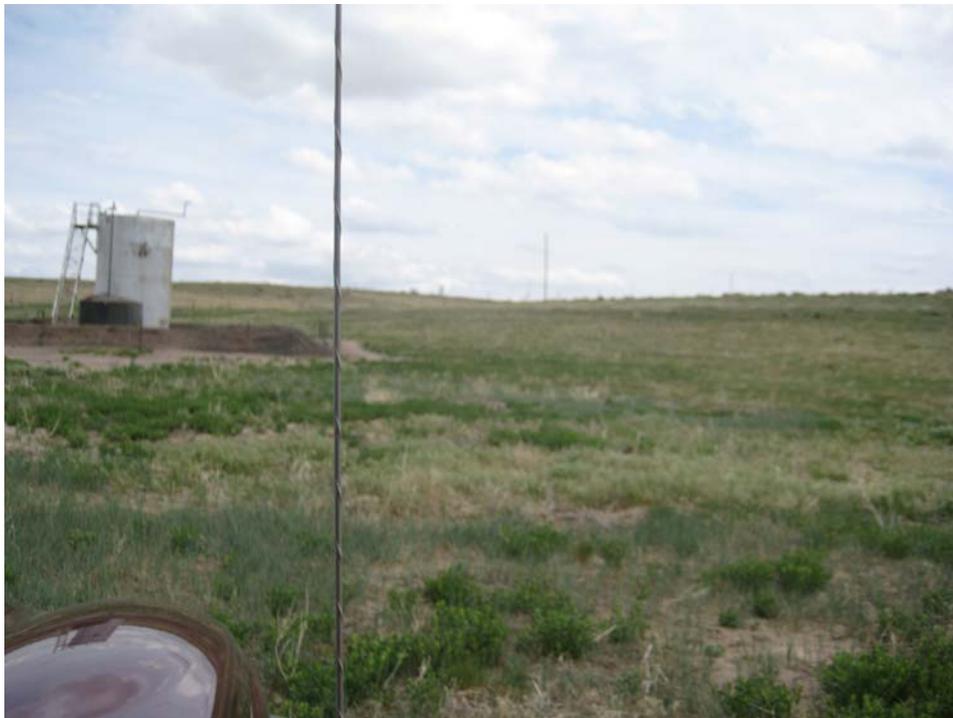
Notes: LIF (1987) 20' x 20' pit. FIR (2004) pit closed.  
FIELD VISIT 6-4-2008: PIT BACKFILLED & SITE CLEAN.  
Using covered steel tank

**Photo 2. Former earthen pit location shown in foreground and covered steel tank and battery tank in background**

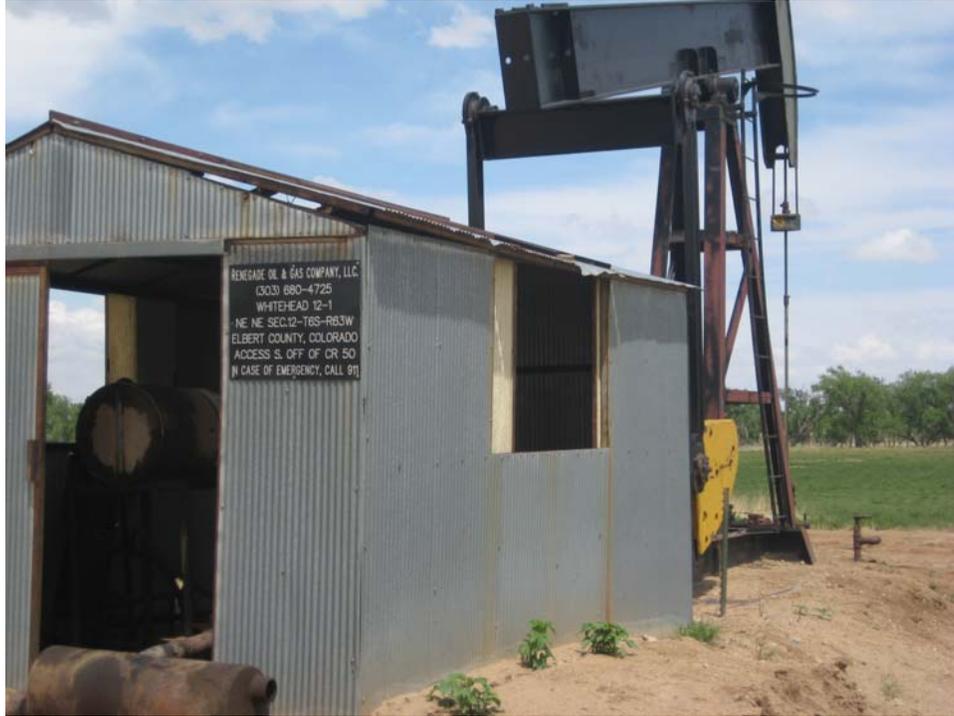
**Photo 1. Whitehead 12-1 wellhead and lease sign near battery tanks**

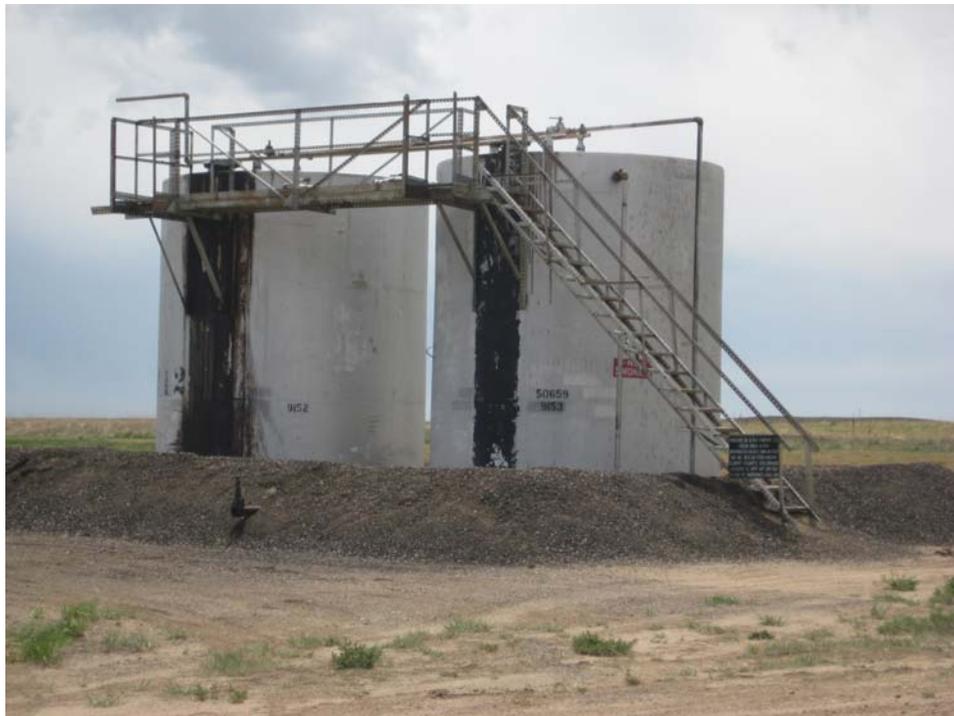
**Photo 2. Two 300 BBL tanks used for water and production**

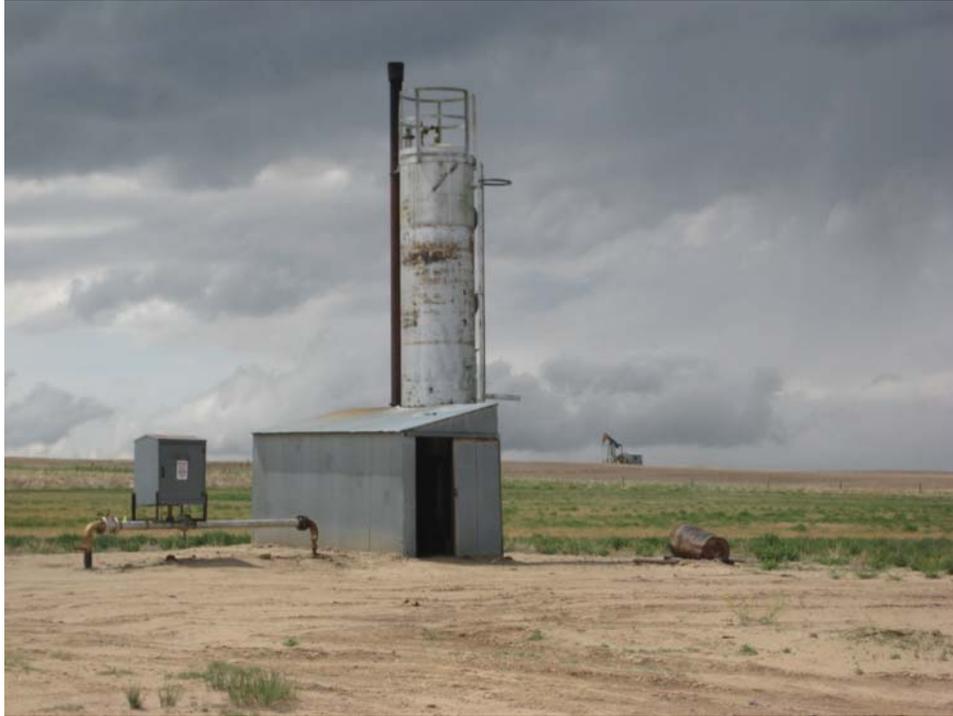
**Photo 3. Looking northwest at separator and Champlin Amoco 548 "A" 2 wellhead**

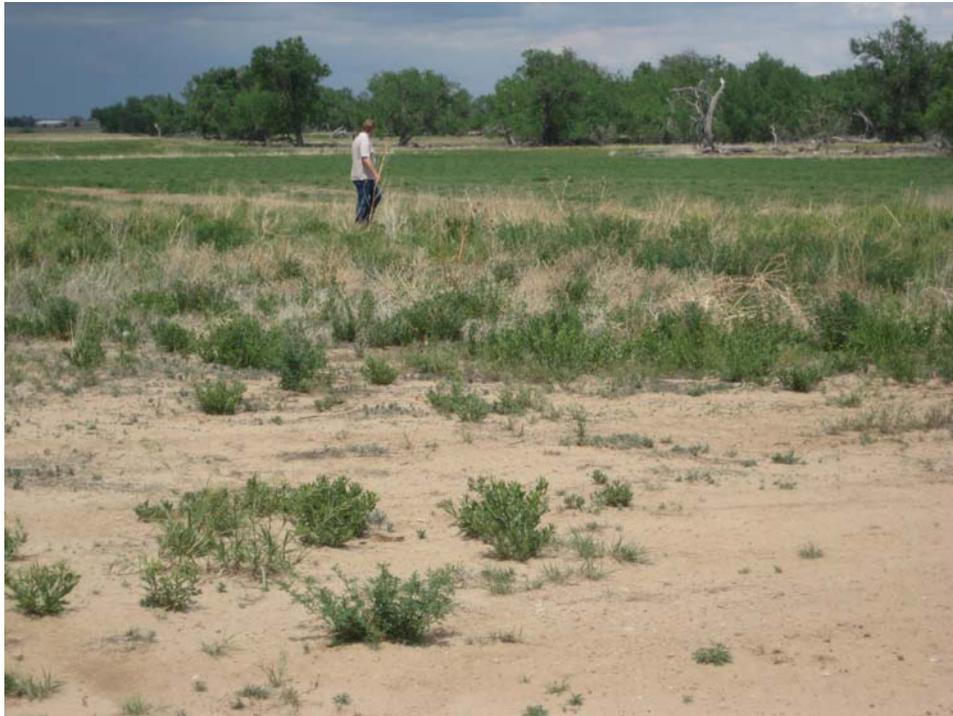
**Photo 4. Looking north at former earthen pit site**

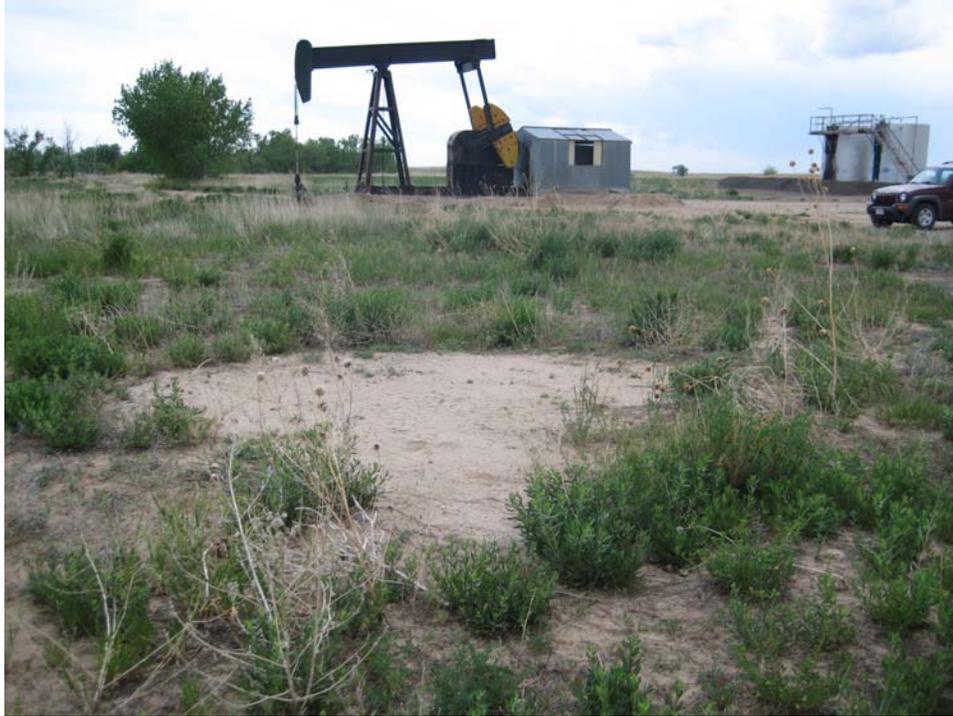
**Photo 5. Looking southwest at backfilled pit site in foreground**

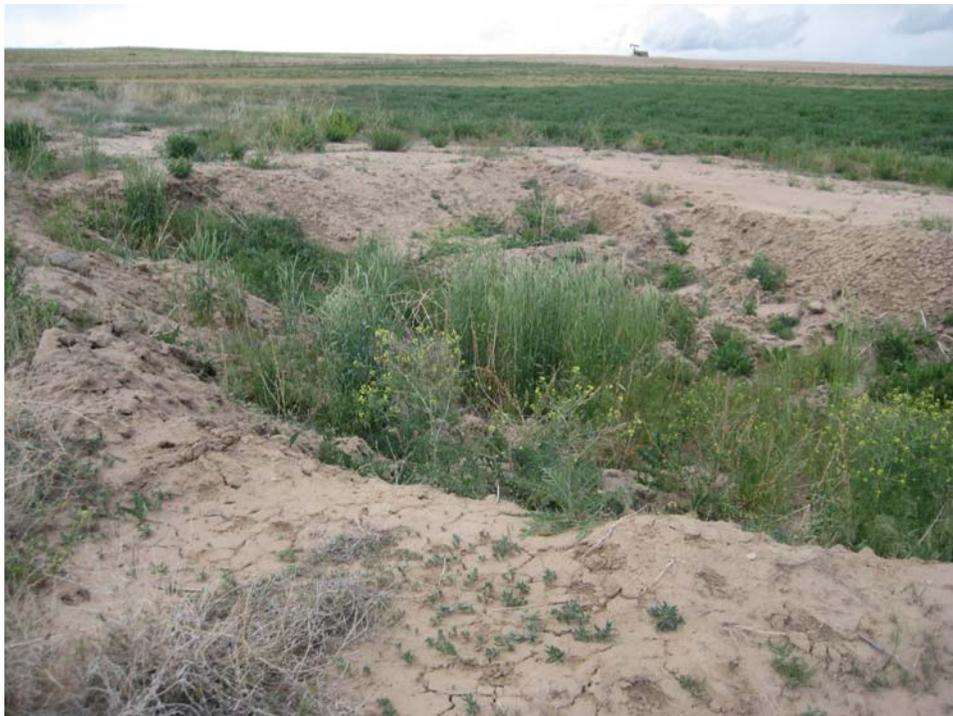
**Photo 6. Additional pit not used for produced water found north of former pit site**

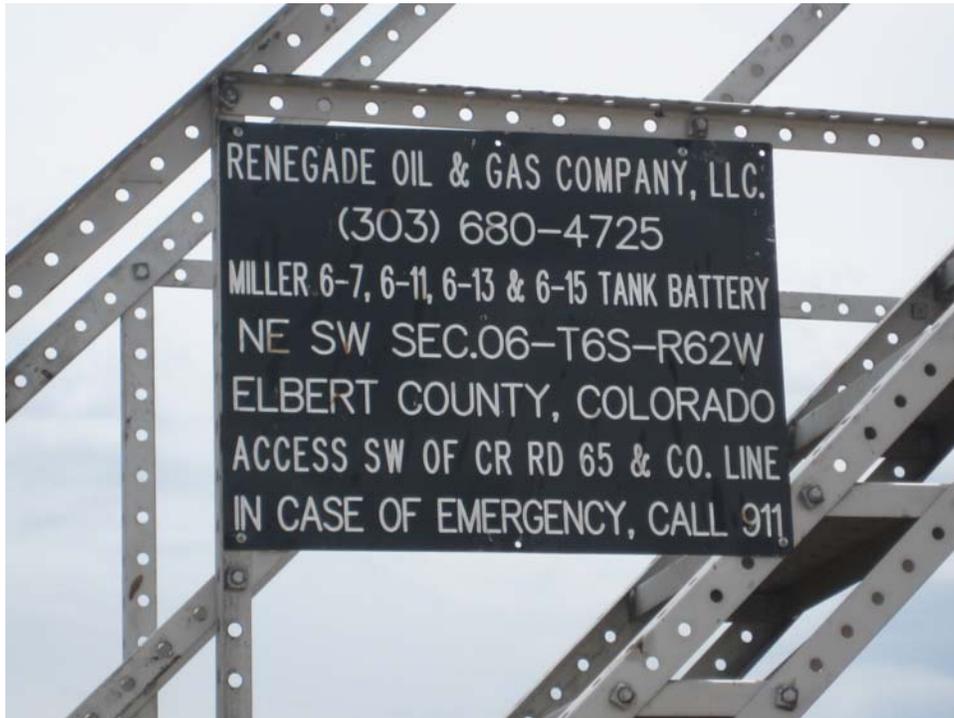
**Photo 1. Battery tank lease sign**

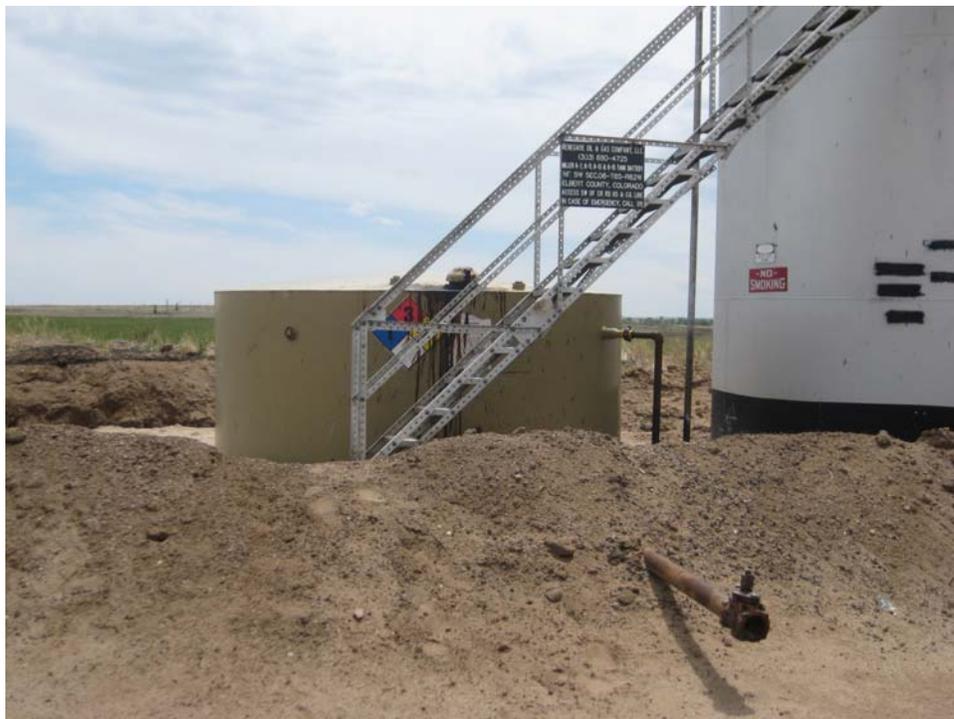
**Photo 2. Covered steel water tank**

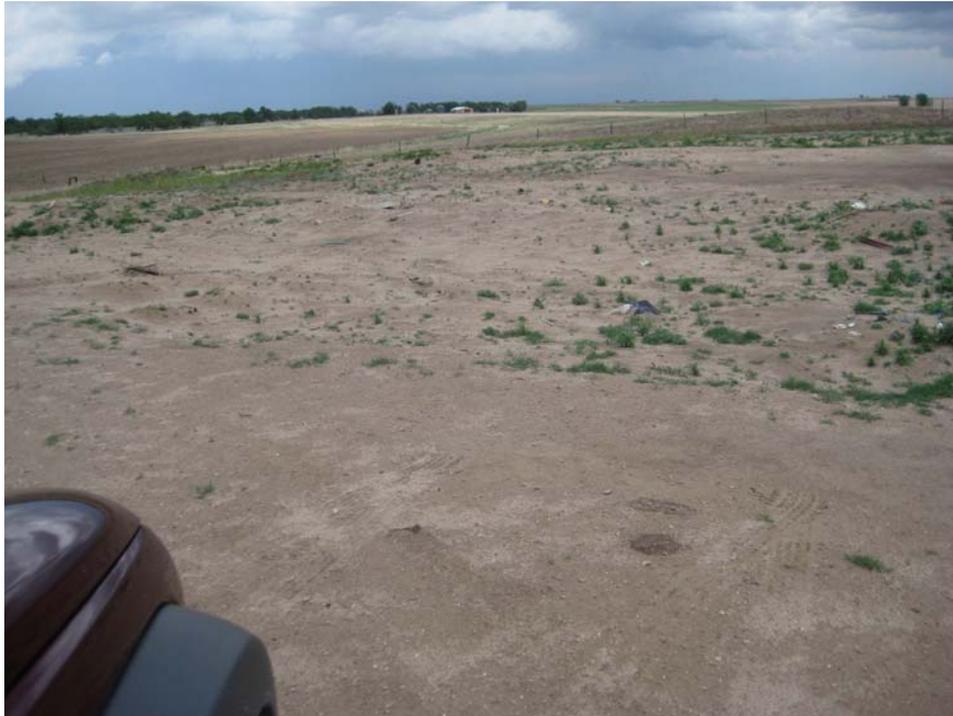
*FIELD VISIT 6-4-2008 : PIT BACKFILLED, SITE NOT CLEAN. Debris Found.*

**Photo 3. Looking north at pit site**

*Recommend Remediation*

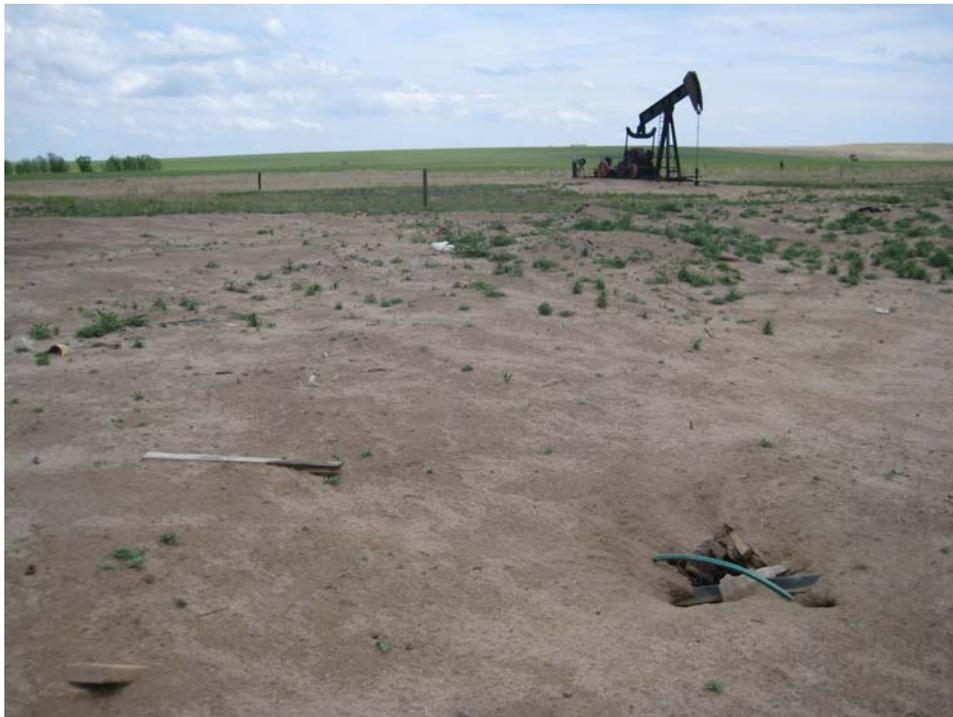
**Photo 4. Looking southeast at Miller 6-11 wellhead from pit site**
