PIT STATUS EVALUATION FORM

Facility ID: 115122

Pit Name: MYERS 12-3 1

S.S. PAPANOPULOS & ASSOCIATES, INC.

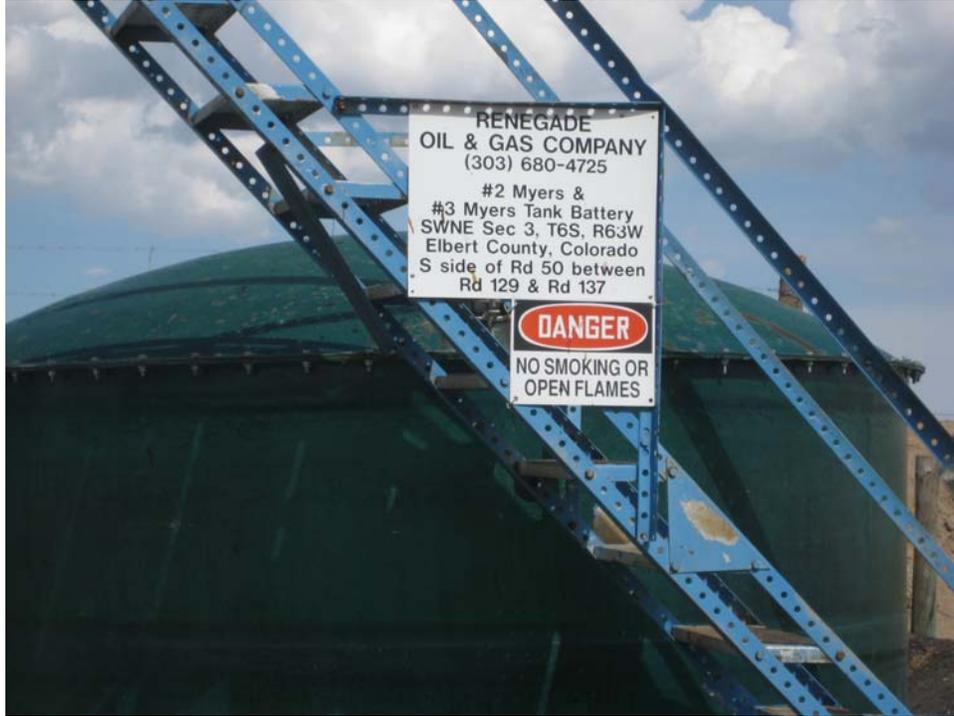
Notes: WSIF (1987) Skimpit. no earthen pit. WSIF (1995) indicates to "check for pit closure".
FIR (2007) no pit inventoried; one, 300 BBL Upright.
FIELD VISIT 6-4-2008: PIT CLOSED. Using fiberglass tank.

Photo 1. Covered fiberglass water tank and lease sign

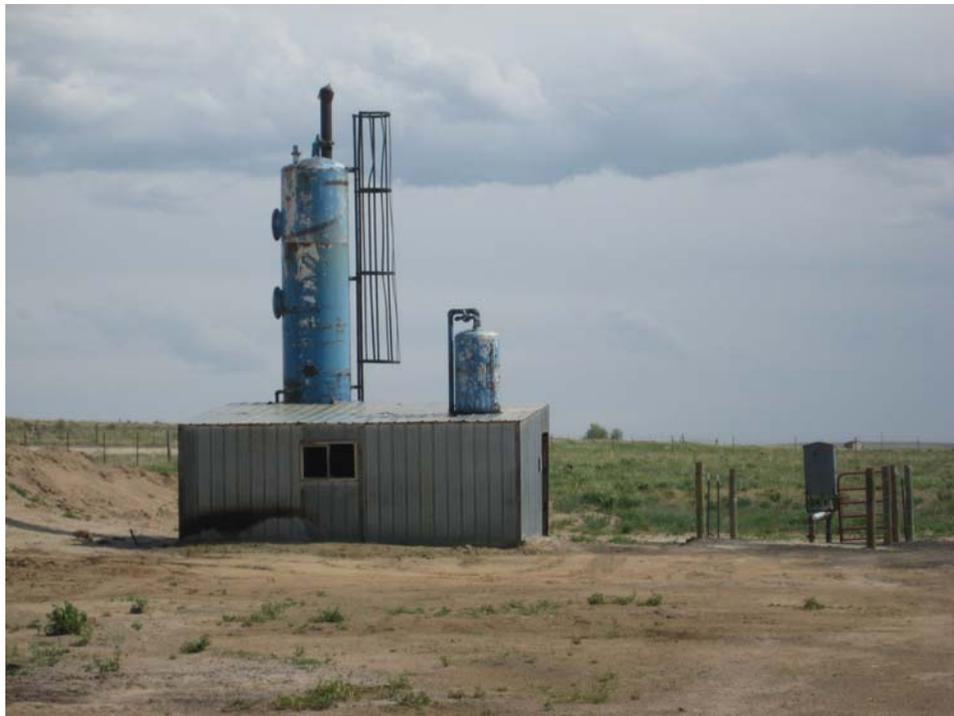
Photo 2. Separator on battery site for Myers 32-3 2

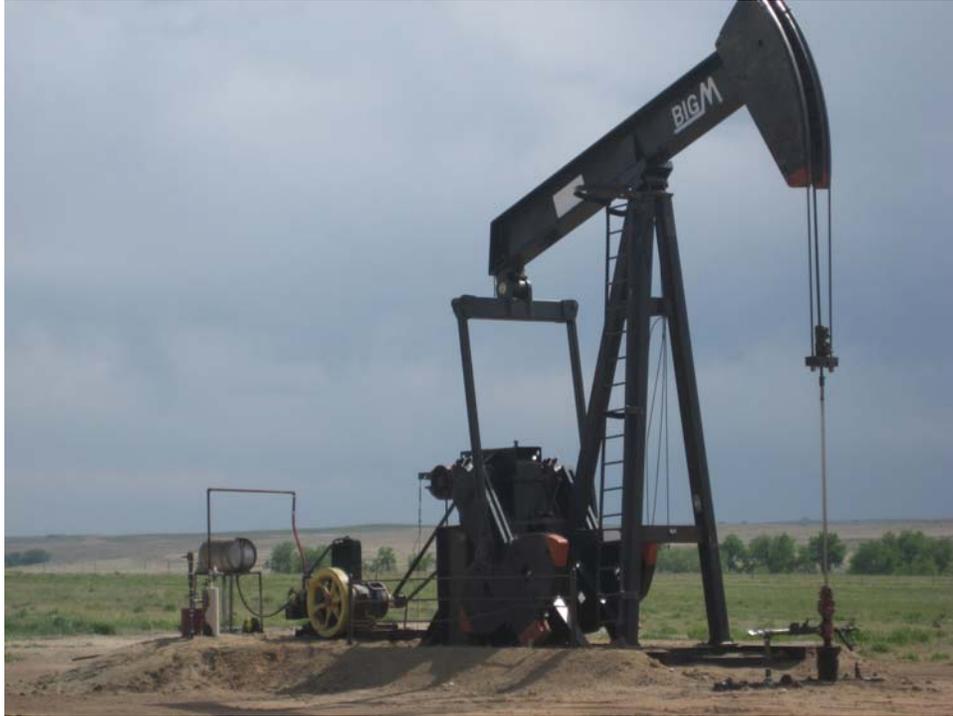
Photo 3. Myers 32-3 2 wellhead

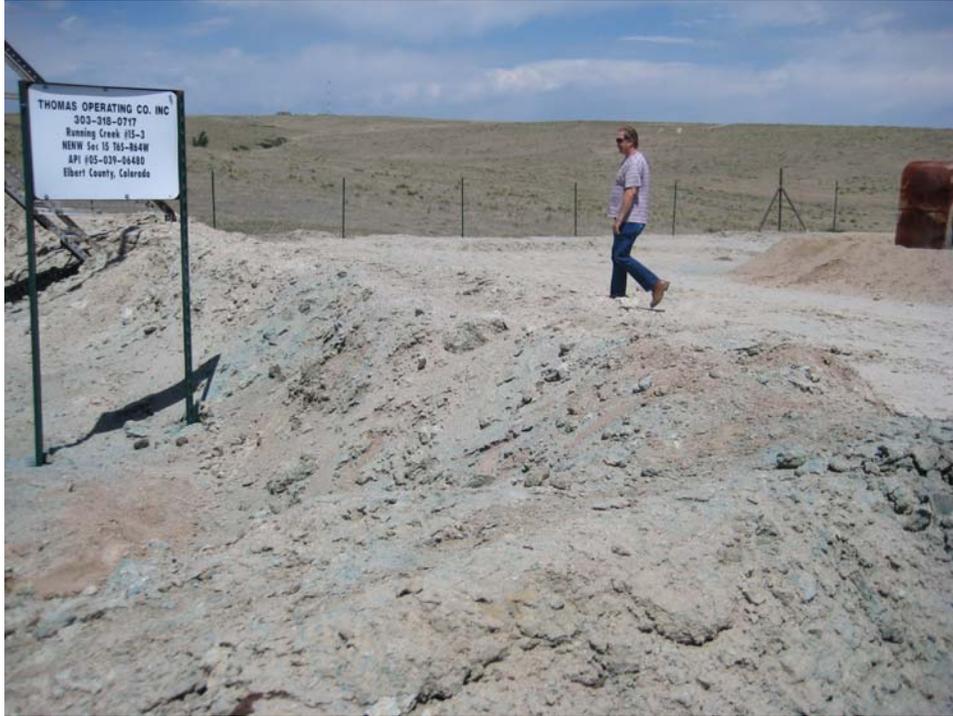
Notes: Common Use with Running Creek 15-3, 15-6, 15-5 battery tank site.
FIELD VISIT 6-3-2008: PIT BACKFILLED

Photo 1. Lease sign for Running creek 15-3 and former pit site beyond berm

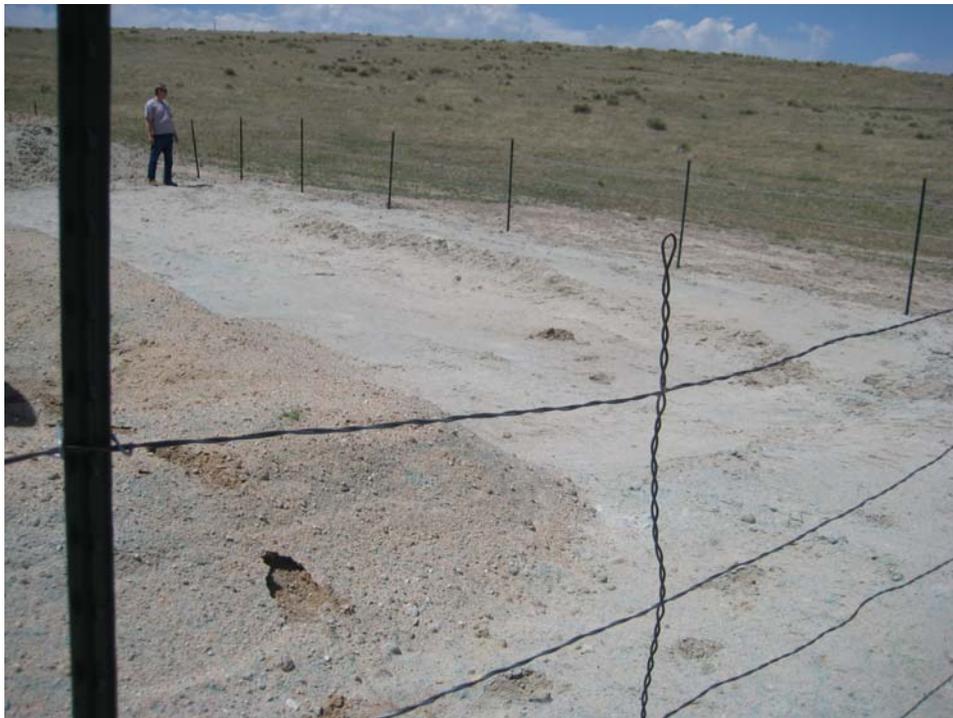
Photo 2. Looking southwest showing recently backfilled pit inside fence

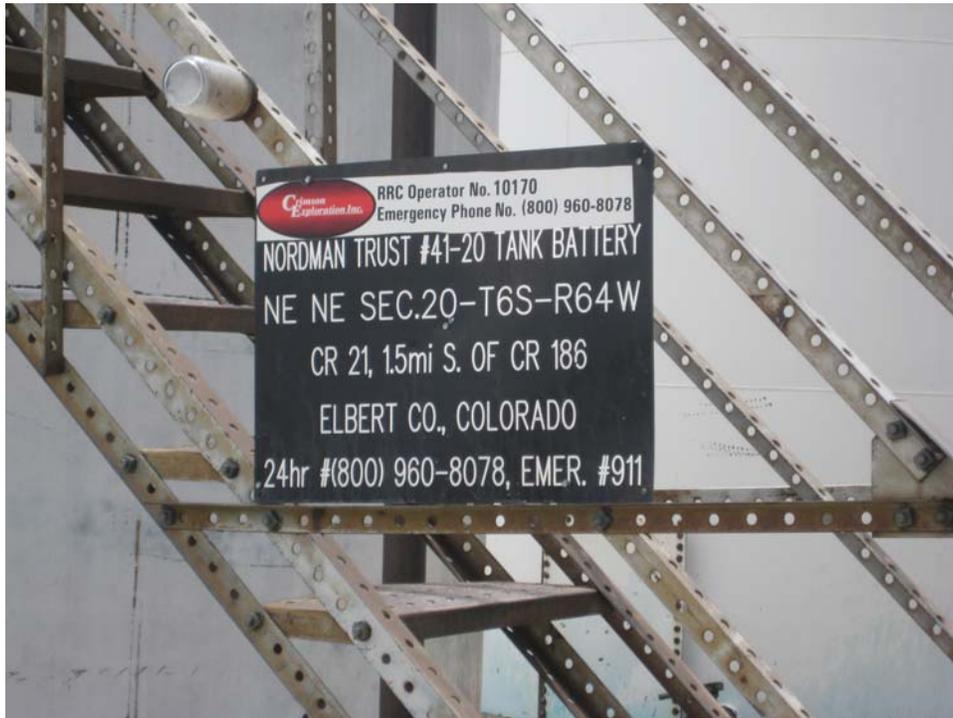
Photo 1. Battery tanks and lease signs; fiberglass tank is southeast of tanks

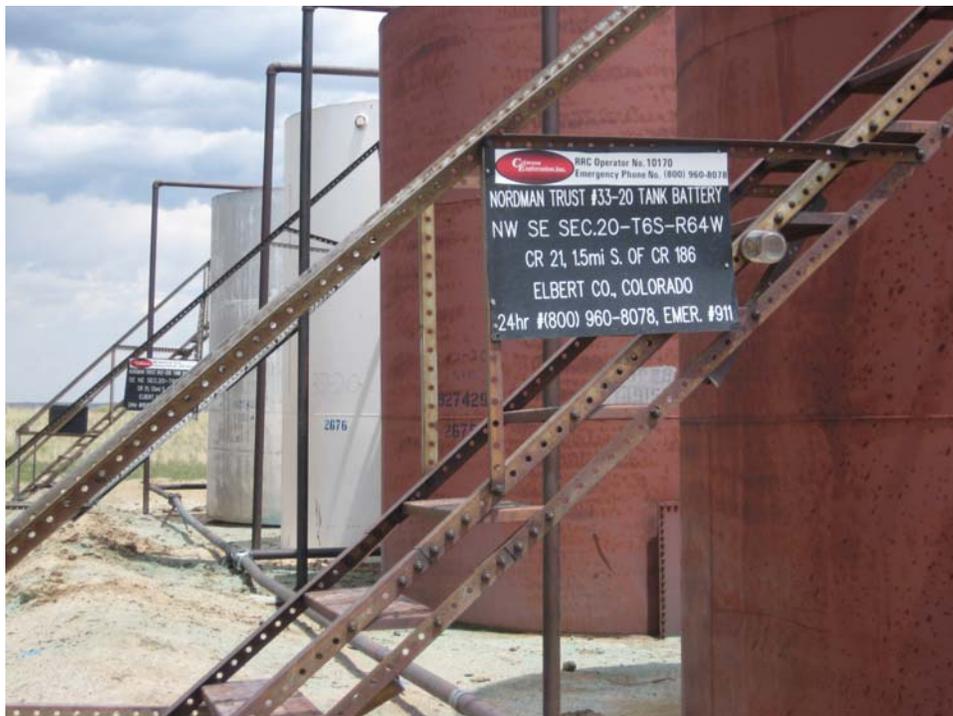
Photo 2. Battery tanks and lease signs

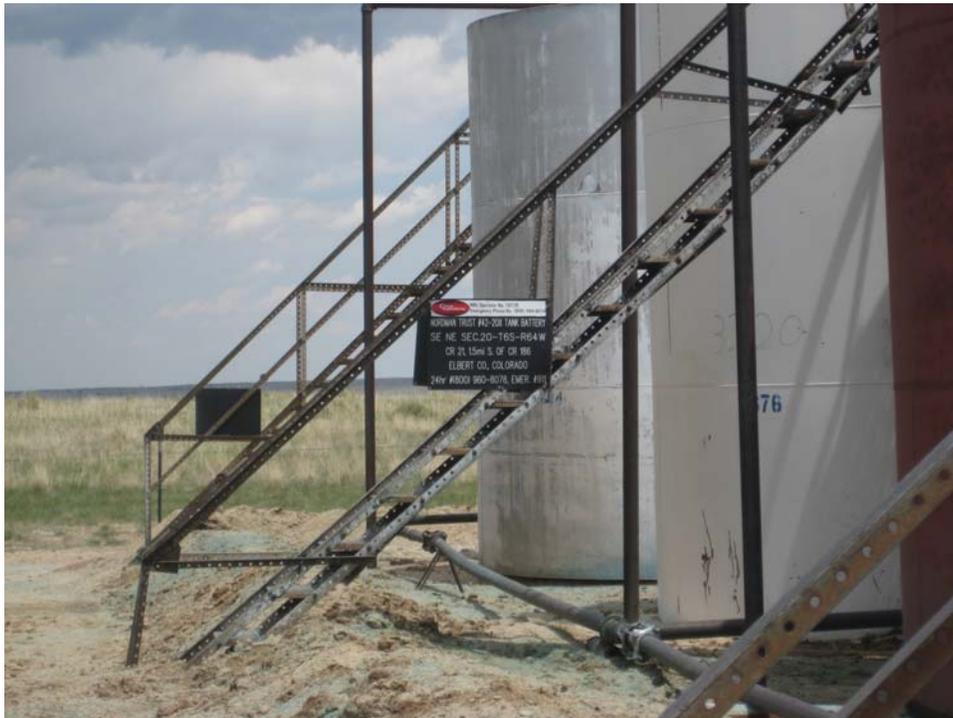
Photo 3. Battery tanks and lease signs

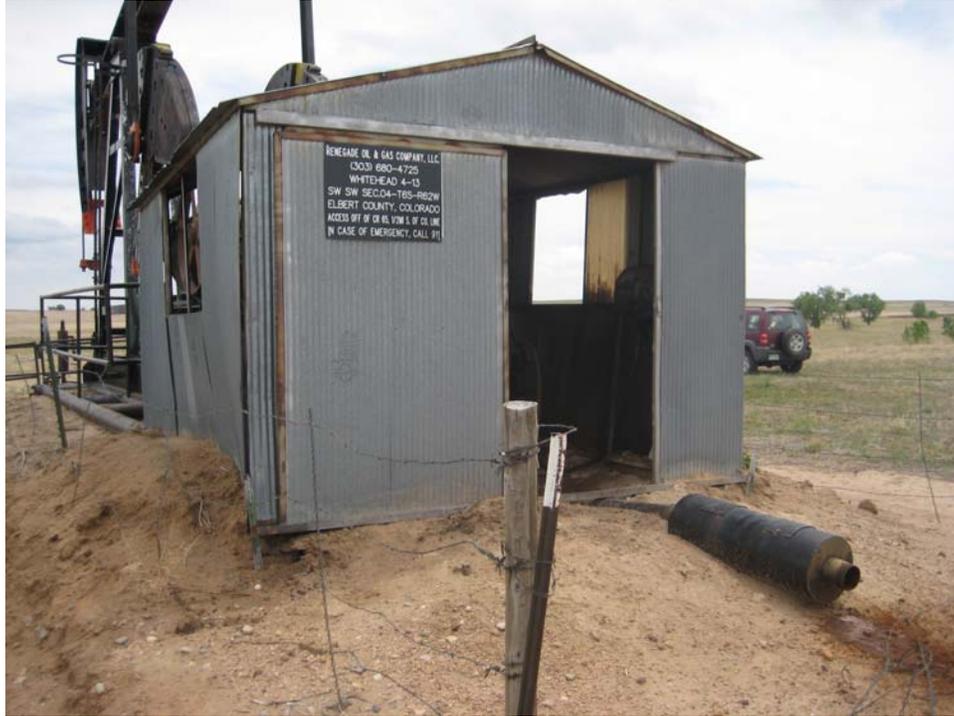
Photo 1. Whitehead 4-13 wellhead

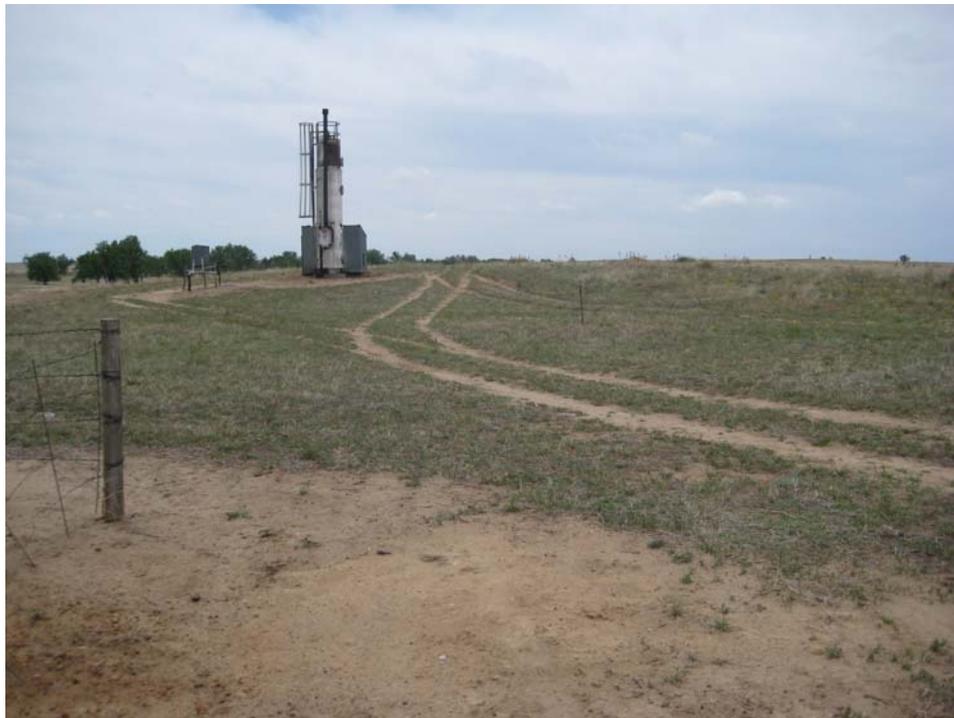
Photo 2. Looking south at vertical separator

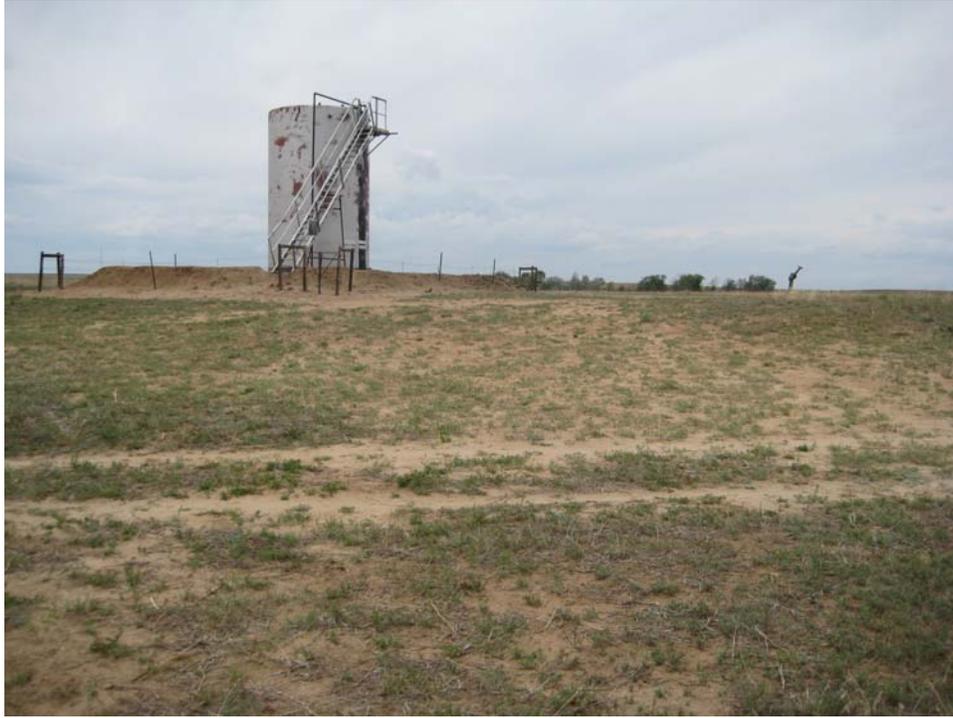
Photo 3. Looking southwest at 200 BBL tank

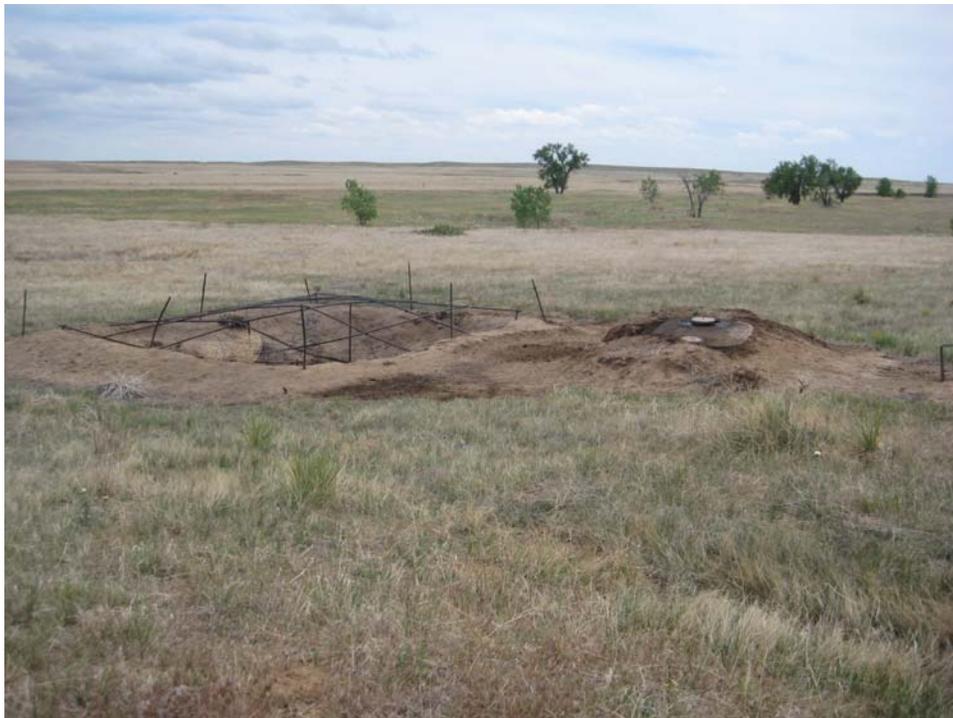
Notes: LIF(1987) 1250 GAL SKIM TANK & 30'x30' pit
FIELD VISIT 6-4-2008: EARTHEN PIT & CONCRETE VAULT FOUND WITH
OIL SATURATED SOILS & VEGETATION DISTURBANCE TO SOUTHEAST. PIT COVER
UNSATISFACTORY.

Photo 4. Covered earthen pit and concrete vault

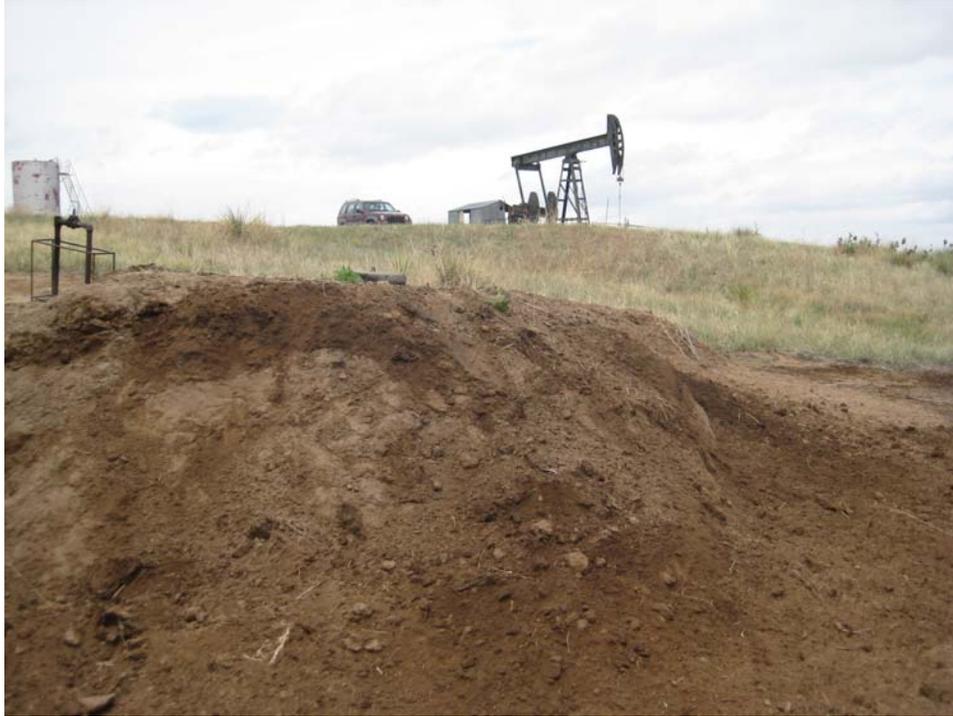
Photo 5. Looking northwest at buried concrete vault and wellpad

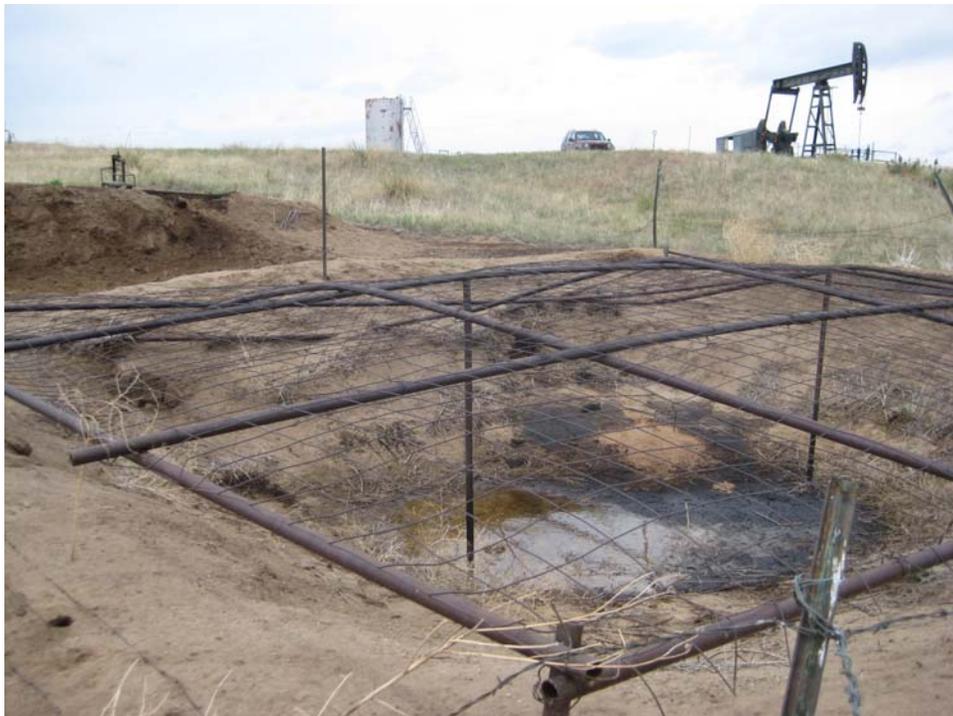
Photo 6. Earthen pit

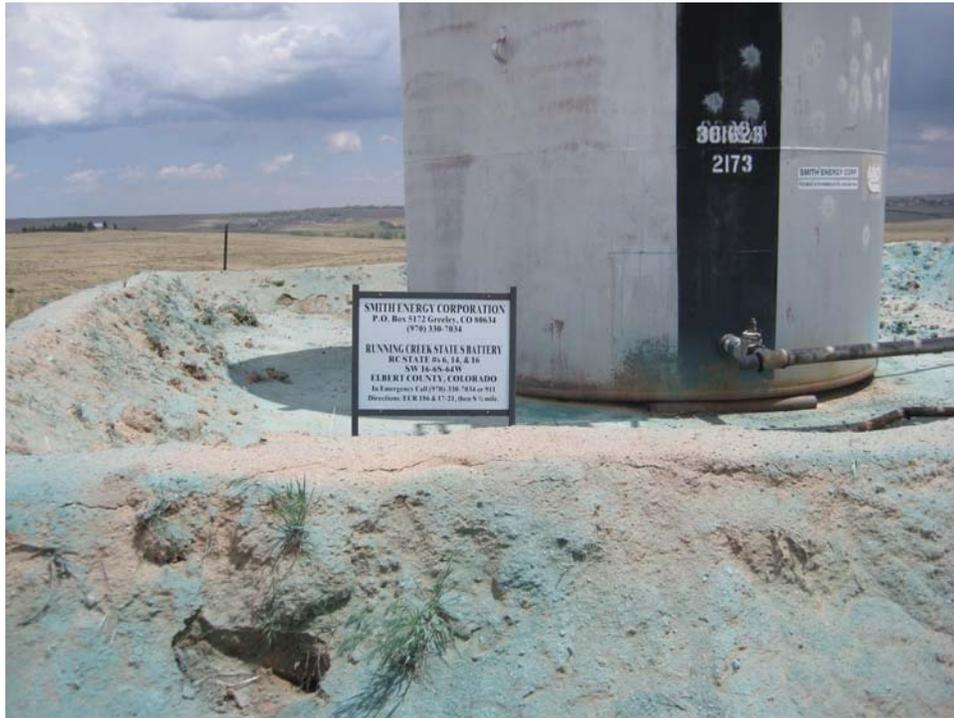
Photo 1. Tank battery sign

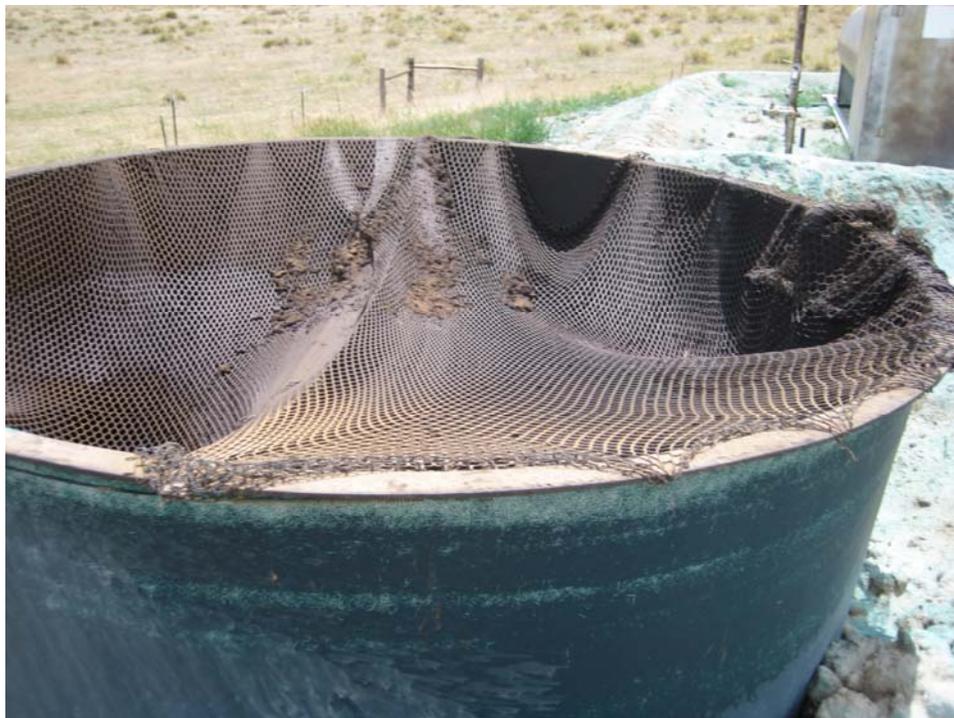
Photo 2. Covered fiberglass tank

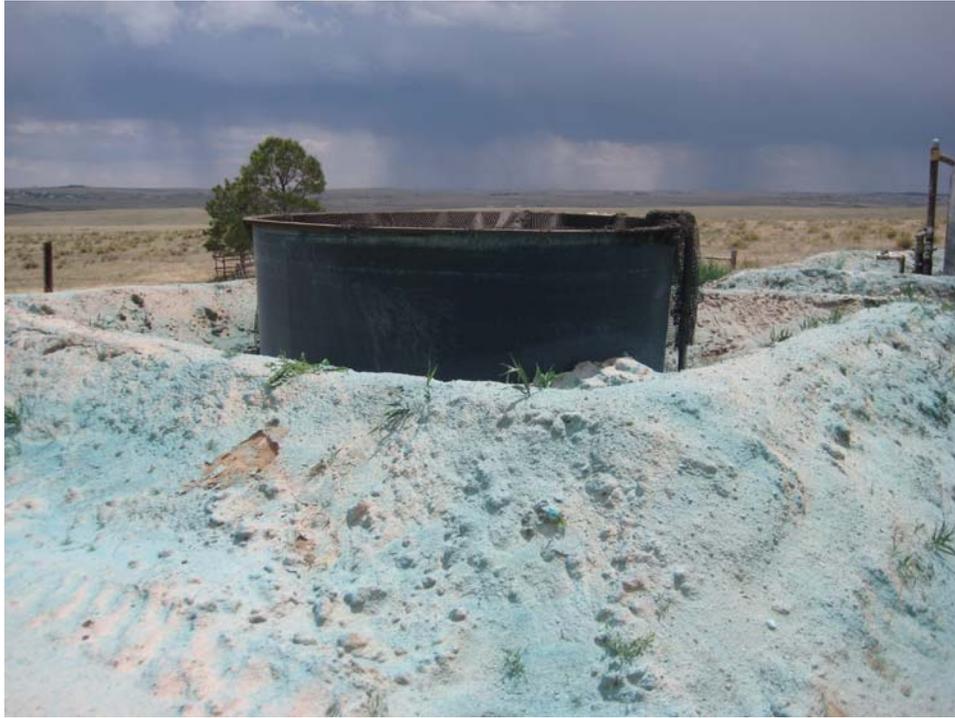
Photo 3. Fiberglass tank and berm
