June 24, 2005

RE: Methane Seep Survey Summary Letter  
Mondragon and Saint Residences  
Trinidad, Colorado

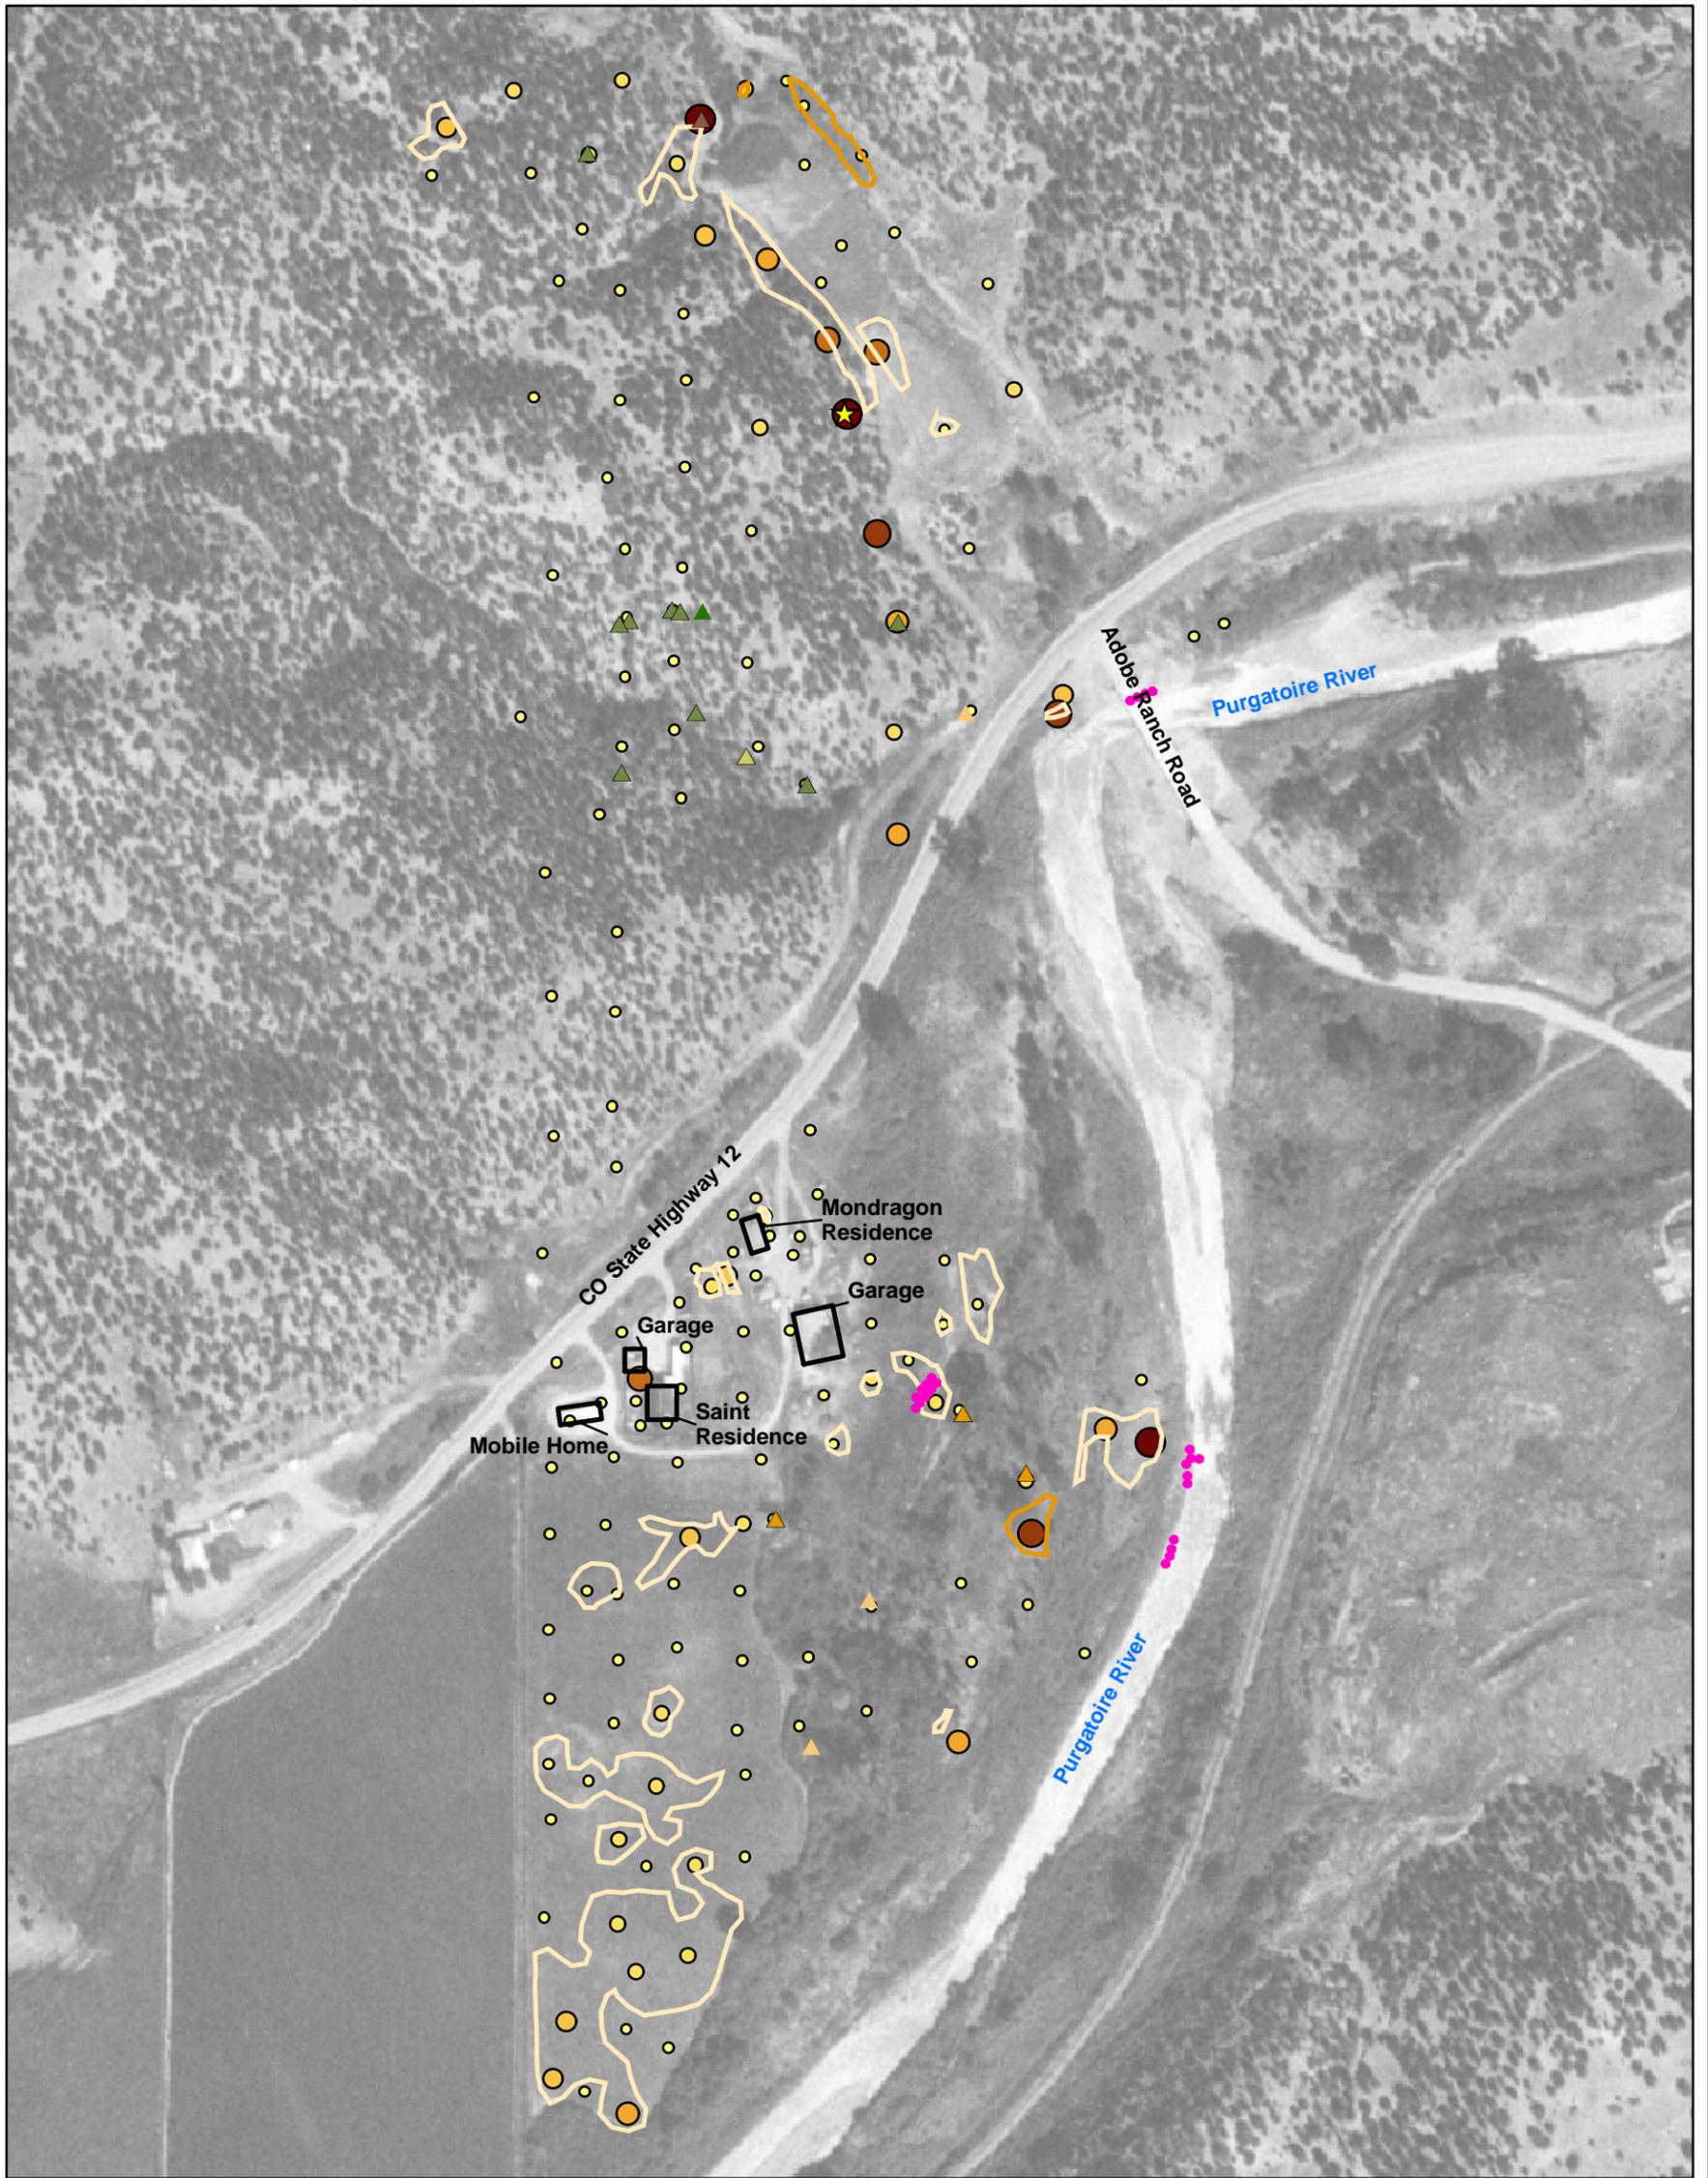
**FIGURE 2  
MONDRAGON SAINT  
DETAILED SEEP MAPPING  
JUNE 2005**

The property covers an area of approximately 60 acres and holds two residential structures, various garages and sheds, and a mobile home unit. The residential structures include the house at 28100 Highway 12 where Mr. Mondragon resides (Mondragon House), and an adjacent house used by his daughter Ms. Laura Saint (Saint House). Both residences are addressed as 28100 Highway 12. A site location map is included as Figure 1. A map illustrating the property layout is included as Figure 2.

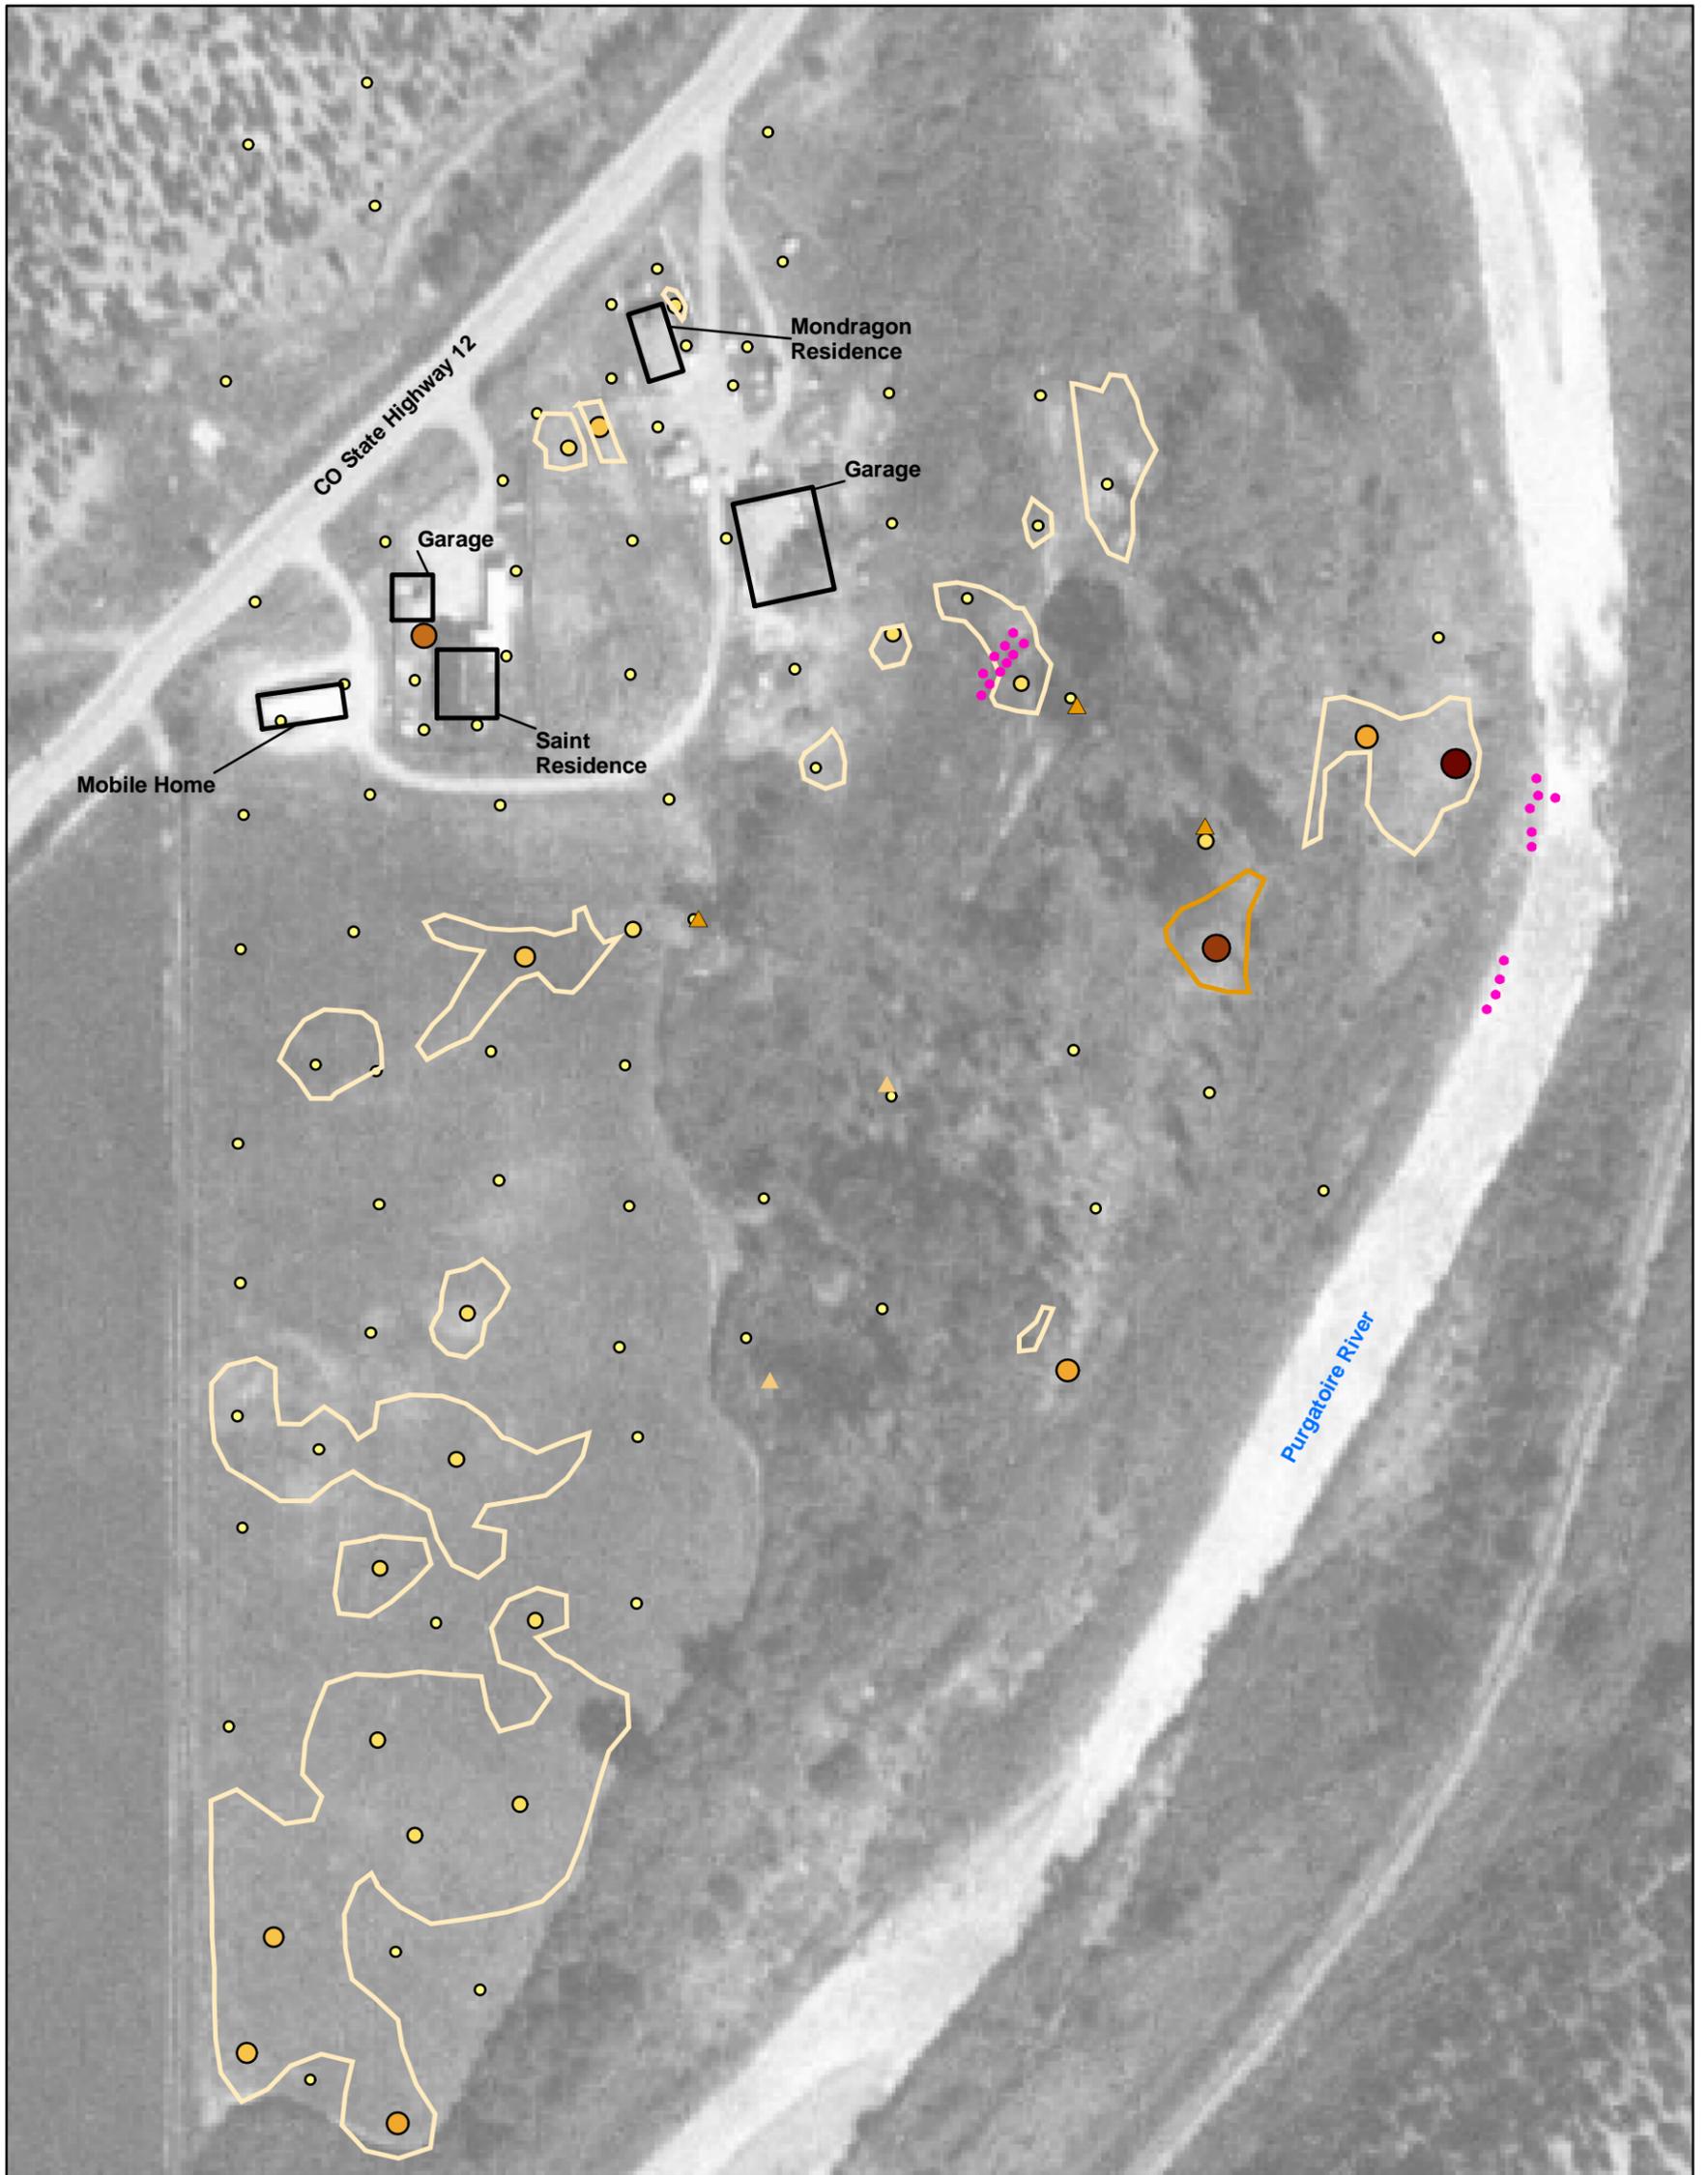
**FIGURE 3B  
MONDRAGON SAINT  
DETAILED SEEP MAPPING  
JUNE 2005**

In the area south of the highway, LTE collected subsurface methane concentration measurements at approximately 90 locations. Detected methane concentrations ranged from 3,000 ppm to 870,000 ppm (87%). Of the approximately 40 subsurface methane measurements collected in close proximity to the residential structures, only five locations detected methane at concentrations ranging from 10,000 ppm (1%) to 370,000 ppm (37%). The frequency and magnitude of detectable methane in close proximity to the residences is lower than observed during the February 2004 preliminary survey.

LTE noted relatively large areas of stressed/dead vegetation located in the field south of the residences. Approximately two acres of stressed/dead vegetation were mapped during this field event. Elevated concentrations of methane in the shallow subsurface were noted at nearly all of the stressed/dead vegetation areas mapped on the property.

LTE noted visible methane seeps within the Purgatoire River in two locations and in standing water approximately 150 feet southeast of the Mondragon garage. Figure 3B illustrates the results of the methane survey of the Mondragon property located south of the highway. Table 1 summarizes the field data collected during the methane survey.

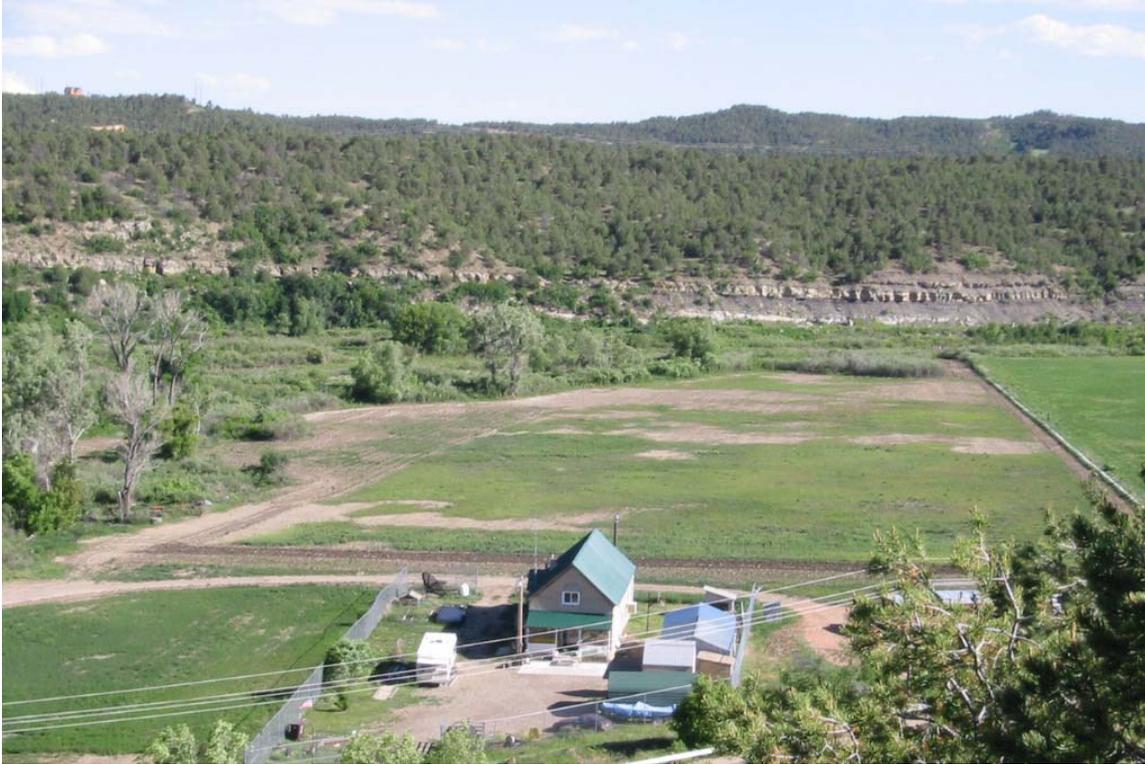
Photograph 1: Mondragon property south of highway, Saint residence in foreground, view south.

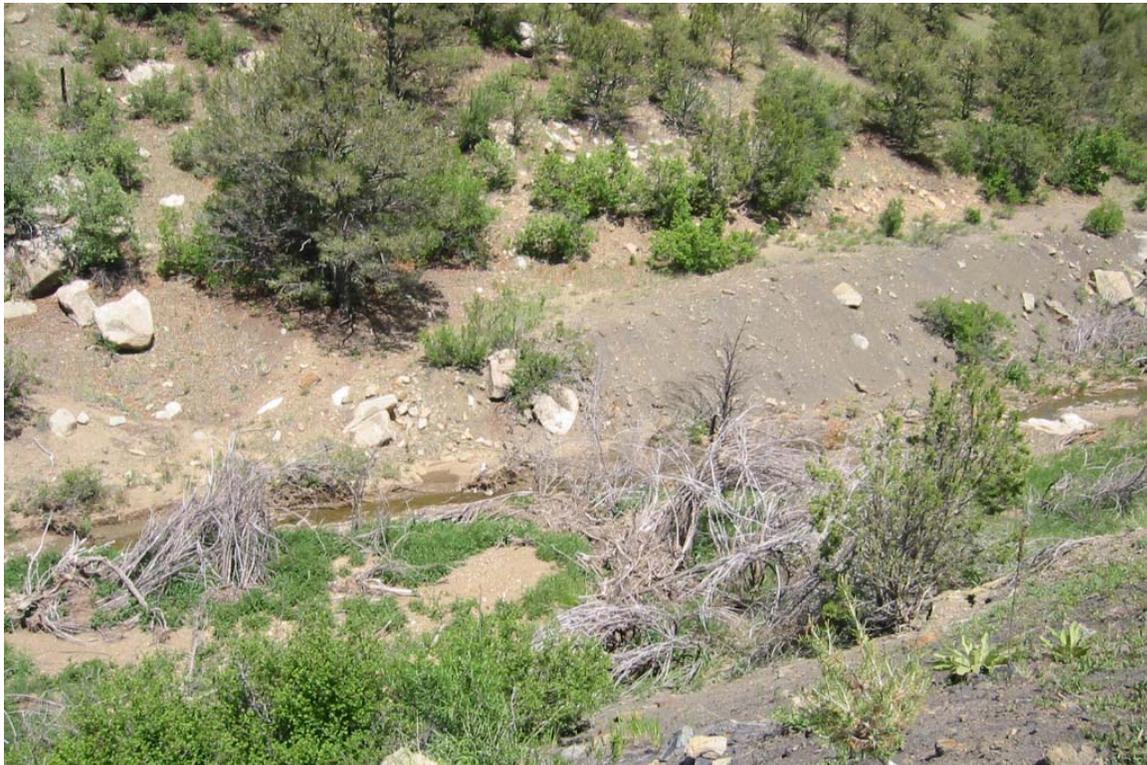
Photograph 2: Stressed/dead vegetation along alluvial valley north of highway, view east.

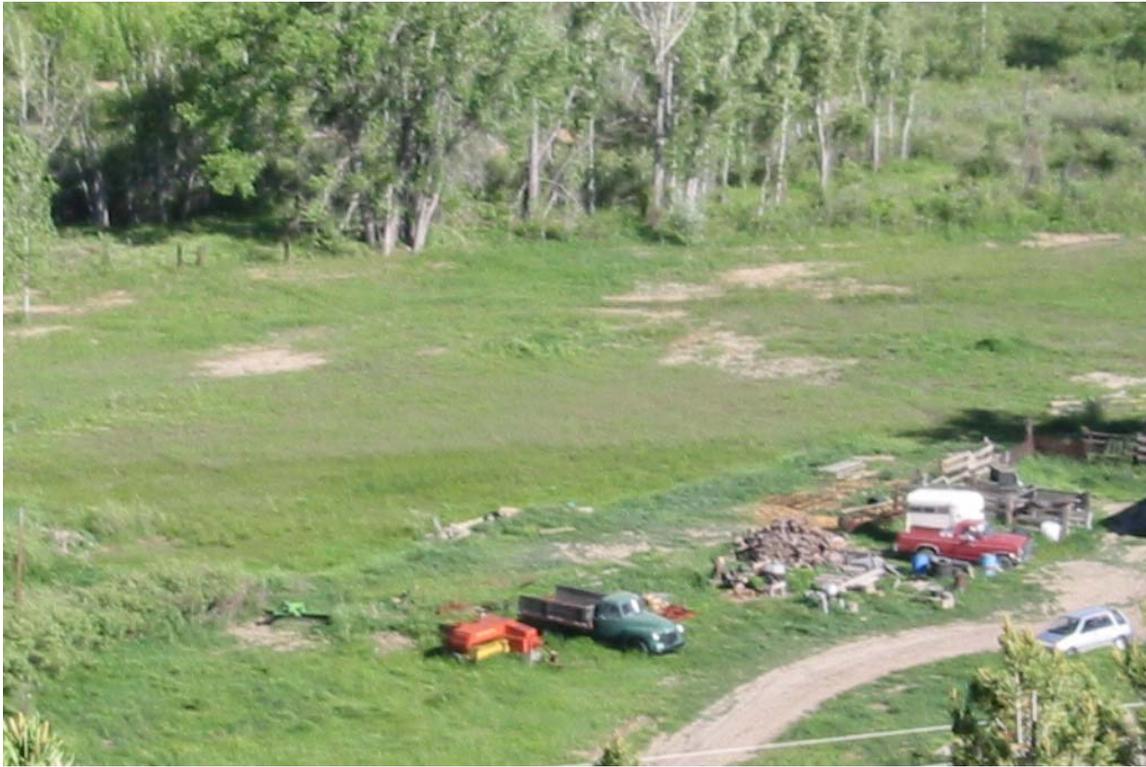
Photograph 3: Stressed/dead vegetation southeast of Mondragon residence, view southeast.

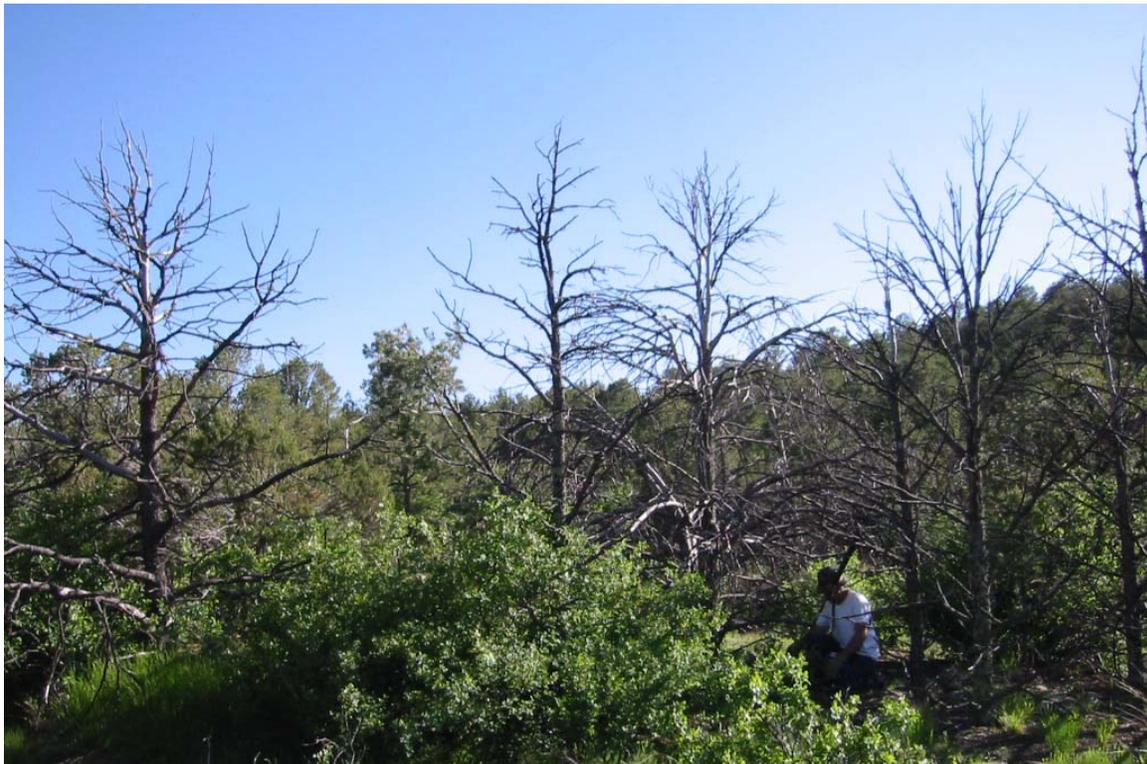
Photograph 4: Dead pine trees located north of highway, no methane detected, view north.
