PROJECT - 4622

August 21, 2008

RE: Preconstruction Notification for the Rock Spring Incident - Garfield County, CO.

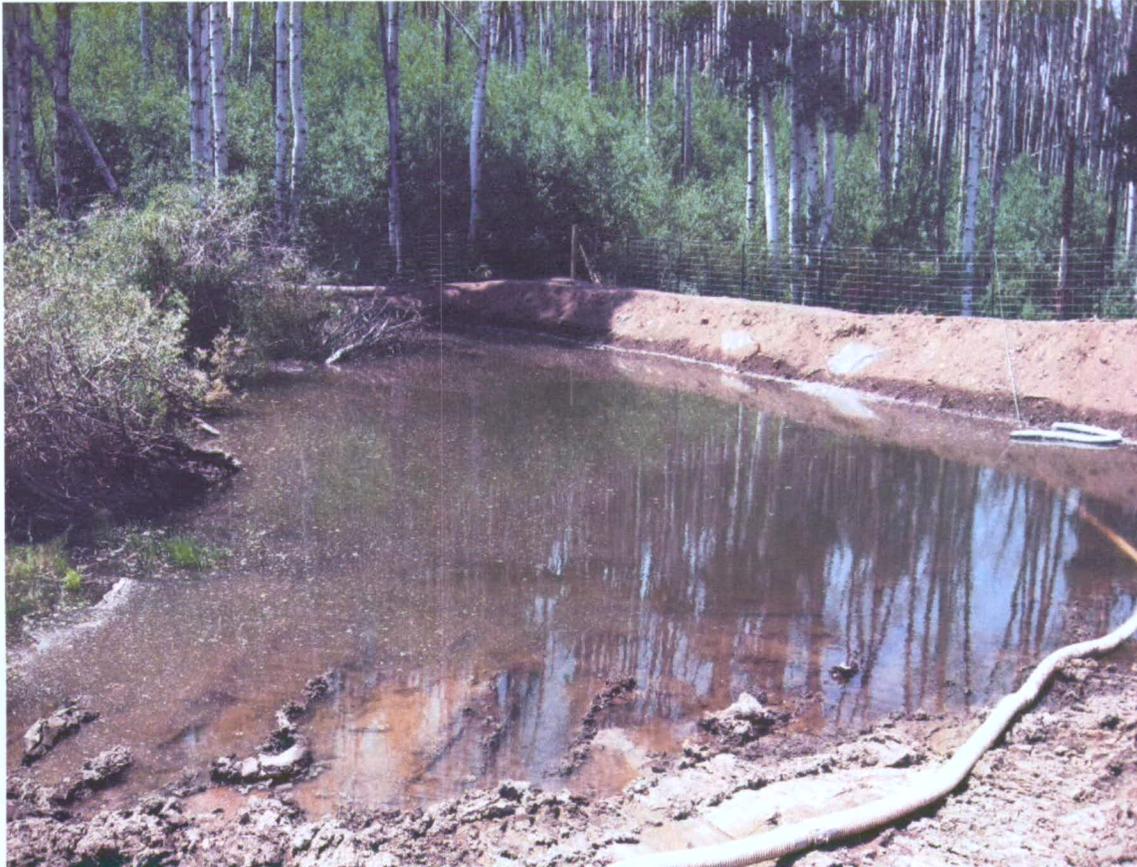
6/16/2008. No sheen was visible on the water. Two point sources of the spring were identified and referenced as North Spring and Rock Spring. The following morning additional samples were collected from the two point sources and downstream to establish an area of possible impact. On 6/19/2008 OXY re-sampled both springs, lined and bermed the drainage creating an impoundment with which to contain the release (Photo 1).

Photo 1- Lined and bermed impoundment at the point source of Rock Spring

Samples results were positive for hydrocarbons. The impacted water was pumped from the impoundment to a portable frac-tank located on the OXY 605-1 well pad. On 06/24/2008 a sheen appeared within the impoundment and spill response BMPs were installed to capture surface product. Samples collected from below the impoundment have tested below detection limits for analyzed chemicals of concern.

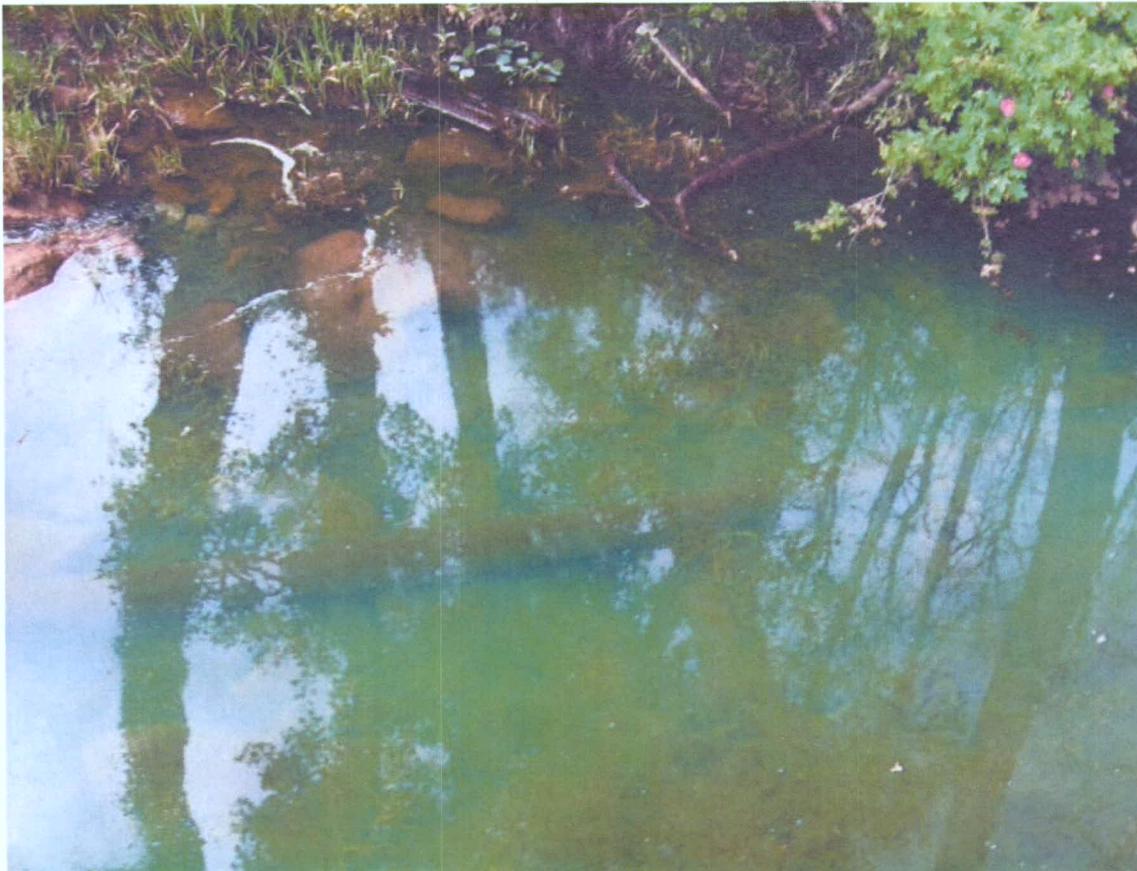
The Colorado Oil and Gas Conversation Commission (COGCC), was notified as required and concluding an onsite investigation on 06/25/2008 a Notice of Alleged Violation (NOAV) was issued for the OXY 605-1 well pad. At approximately 14:00 hours on 06/25/2008, OXY filled the suspected pit on the 605-1 well pad with 40 barrels of fresh water and 2 barrels of Uranine 2313 Yellow tracer. The non-toxic tracer was spotted from the North Spring 11 hours later at 01:00 am (Photo 2).

Photo 2- Tracer dye emanating from point source of Rock Spring

Upon verification of a hydrologic connection between the OXY 605-1 reserve pit and the Rock Spring complex, OXY has taken several additional precautions to ensure downstream habitat and water quality. The surface hydrology from the spring source to the canyon rim has been identified and mapped (Appendix A, Figure 2). Seven seeps, three unnamed springs, and one wetland were identified (*HCSI, M. Foye, Wetland Scientist*). Historically, a large number of cattle have been present, and appear to have impacted riparian vegetation within these areas and down gradient.

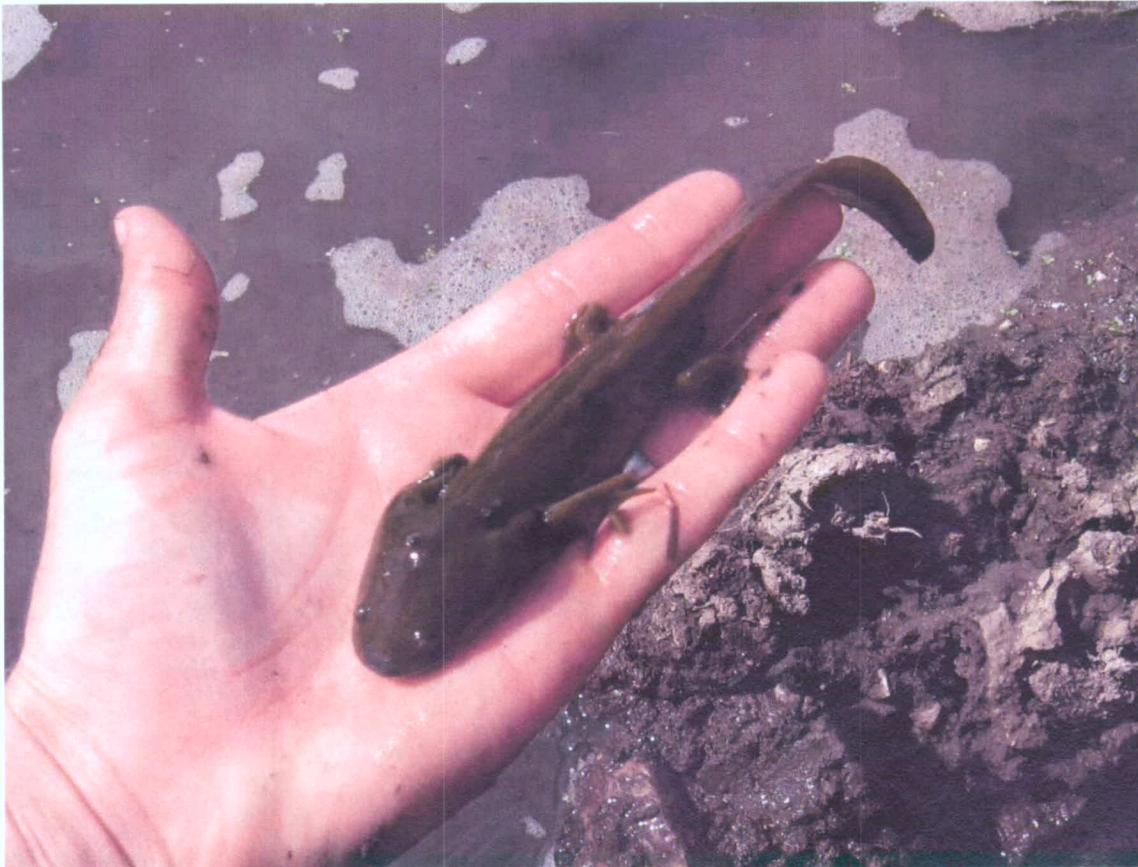
While investigating the potential downstream impacts and identifying surface hydrology, a large and healthy population of larval stage tiger salamanders, *ambystoma tigrinum*, was observed lower in the Rock Spring watershed (Photo 3), *Amphibians and Reptiles in Colorado*, G. Hammerson pg. 60. This is significant due to the fact that these amphibians are very sensitive to any deviations within their environment. It appears that the quick response by OXY to this release has captured any impacted water. During a site visit with the Army Corp of Engineers (ACOE) on July 17, 2008 the population was still evident and active.

Photo 3- Larval stage tiger salamander found in the lower cattle pond within Rock Spring complex
