From: Fernandez, Frank [Frank.Fernandez@encana.com]
Sent: Sunday, August 15, 2010 1:35 PM
To: Fernandez, Frank; Andrews, David
Cc: Asuchak, Edward A.; Candelaria, Larry R.
Subject: RE: WF04B-22 surface depth request

Regarding Patterson rig 303 drilling ops on Encana's K22 pad.

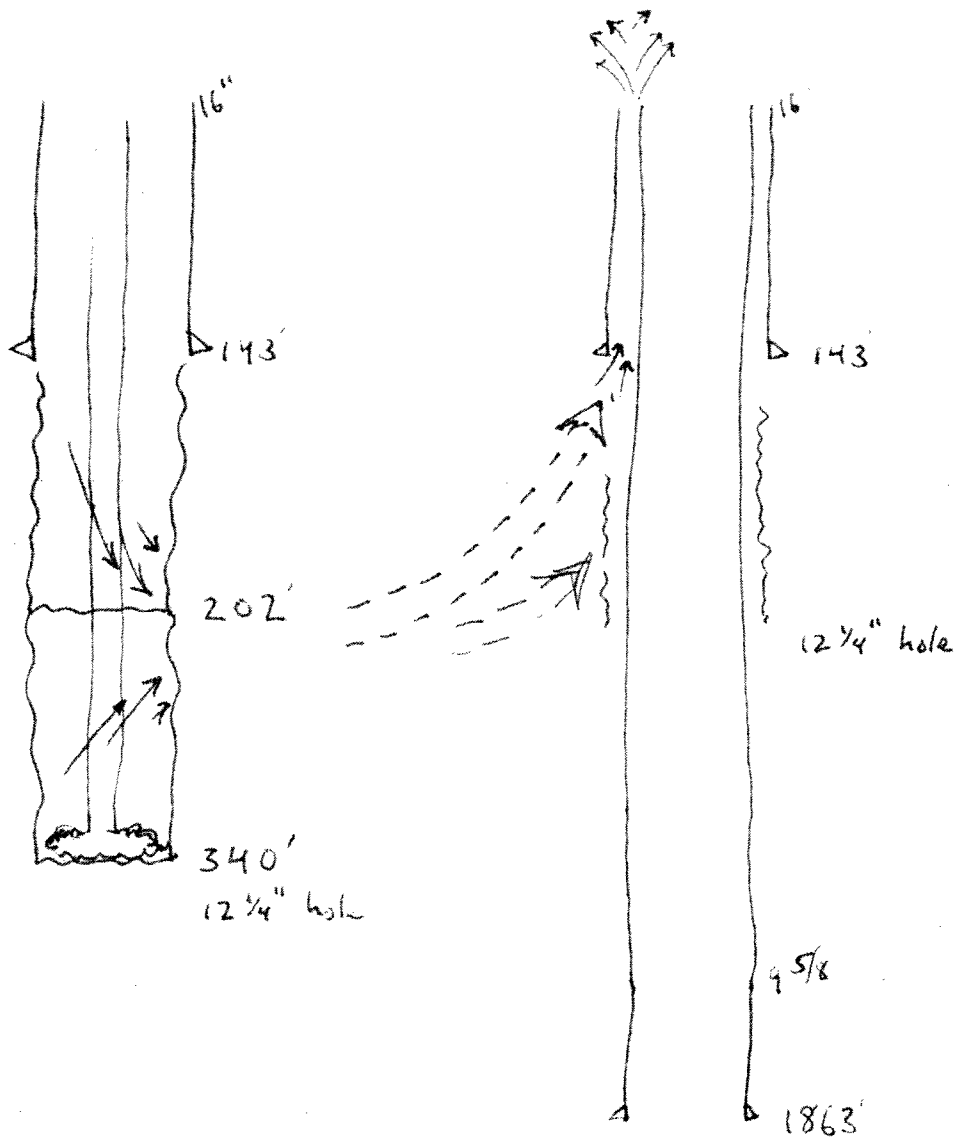
At roughly 11:00 Wed 8/11 rig Patterson 303 was drilling on WF14D-22 @ 202' when flow-back was reported on the previously drilled surface string WF04B-22 between the 16" conductor and 9-5/8" surface casing. Pumps were stopped and operations halted until plans were organized to stop the cross-flow.

At 339' MD the drilling fluid breached surface through the WF04^B~~D~~-22 conductor/surf csg annulus once again. Plans were ordered to heal the fracture system via cement.

Footnote: On the WF04B-22 we lost cement returns on the surface cement job at 14 bbls before bumping the plug. Theoretically, that would have put us close over the conductor. This cement plan may possibly heal the lost circ fracture zone and fill missing cement on the WF04B-22.

It is believed the cmt plugged the fracture zone and isolated the 2 wells. It does not appear that cmt made it to the WF04B-22 annulus.

The cement plug has been drilled out. As of 18:30 we are drilling @ 585'. Cross flow between wells is no longer occurring.

$$\frac{15.75^2 - 4.5^2}{1029.4} (113) = 31.7$$

$$\frac{15.75^2 - 9.625^2}{1029.4} (113) = 21.6$$

$$\frac{12.25^2 - 4.5^2}{1029.4} (59) = 7.4$$

$$\frac{12.25^2 - 9.625^2}{1029.4} (59) = 3.3$$

$$\frac{12.25^2 - 4.5^2}{1029.4} (138) = 17.4$$

① → 81.4 bbls plus fracture system

1. flush mud system from WF14D-22 open hole, fracture system and WF04B-22 exposed annulus. (I made this decision as to help prevent the fracture system from closing up on us as it did when we attempted to replicate the original drilling conditions)

2. RIH with 4-1/2" drill pipe open ended as close to drill depth and still be able to swedge up cement equipment. (319')
3. Pump full cement volume to fill WF14D-22, fracture system and WF04B-22 exposed annulus. Add 100% excess.

4. Pull drill pipe and flush (displace cmt) with water as we pull out of the hole.
5. obtain a dredge pump to suck out cellars
6. Circulate excess cement to catch tank.

7. After setting time is reached go in hole with a 12-1/4" tri-cone bit and drill out cement down to the conductor shoe.
8. Wait another ~couple hrs and begin drill out formation cement. Assess cuttings to continue drilling cement to MD TD (319')

9. TOOH and build directional BHA.
10. Return to normal drilling operations.
