Re: Gebauer #1 (API #121-06776)
NOAV #200273766
NWNE Sec. 15, T-1-N, R-54-W
Washington County, Colorado

COGIS - Field Inspection Report

Fritzler Resources, Inc. - Gebauer #1, API #121-06776
NWNE Sec 15, T-1-N, R-54-W, Washington County
Inspection #200290315 December 22, 2010

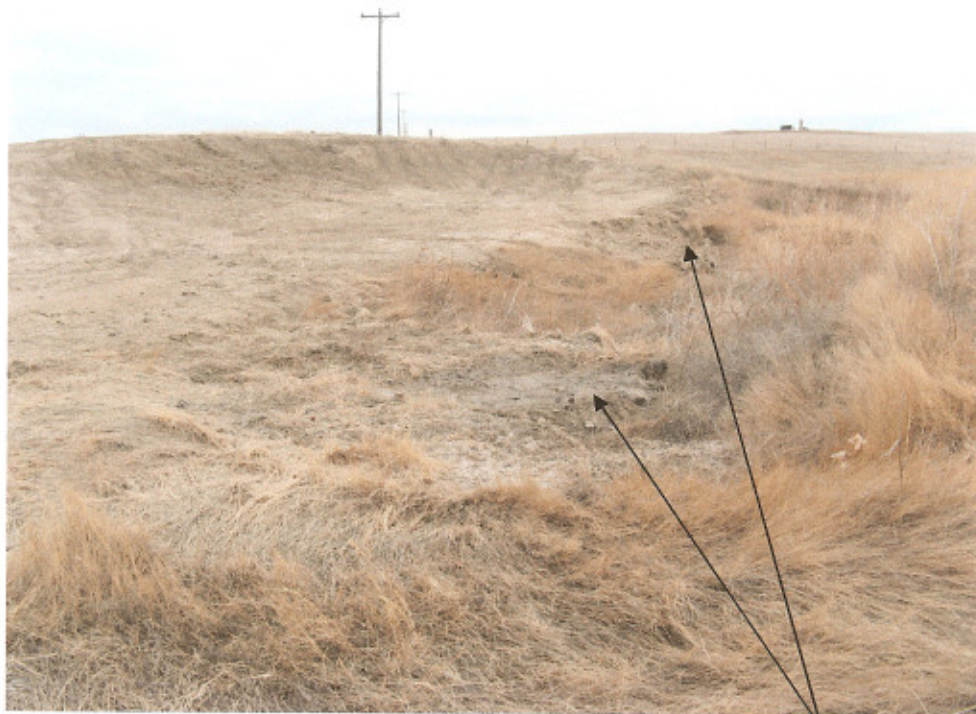
It was also noted that two to three cubic yards of dirt had been pushed into the drainage adjacent the water pit in two locations. In addition, the areas disturbed by recent construction had not been stabilized and no stormwater controls were installed to prevent sediment migration into the drainage. Immediately remove the dirt in the drainage and install stormwater controls such as silt fence or straw bales until the disturbed areas are revegetated.

Areas with dirt in drainage adjacent to water pit.

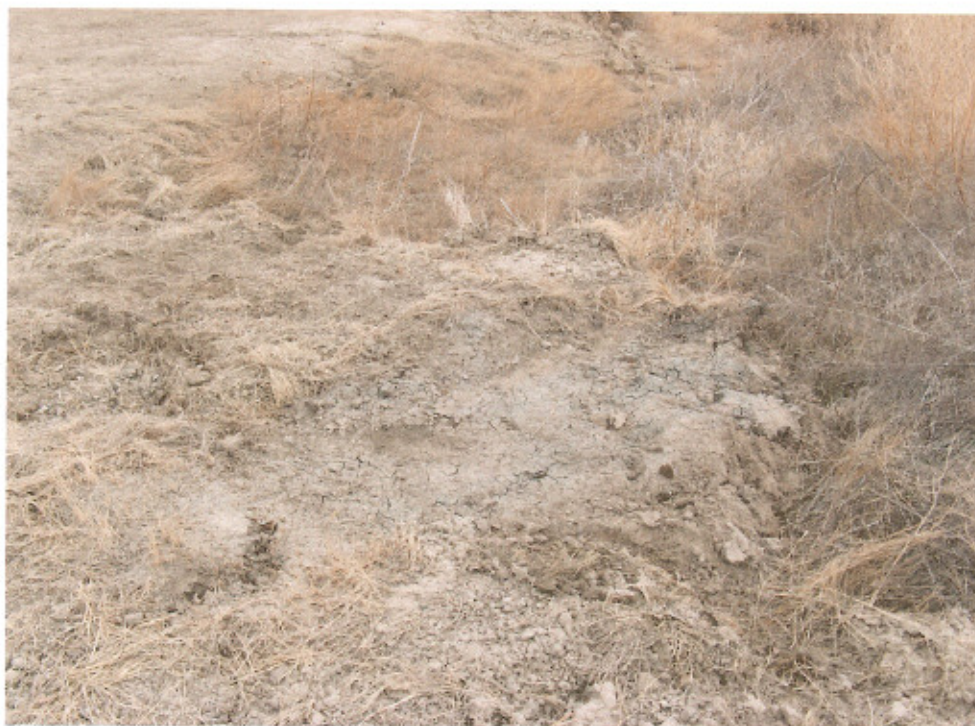
Close up of dirt pushed into drainage.

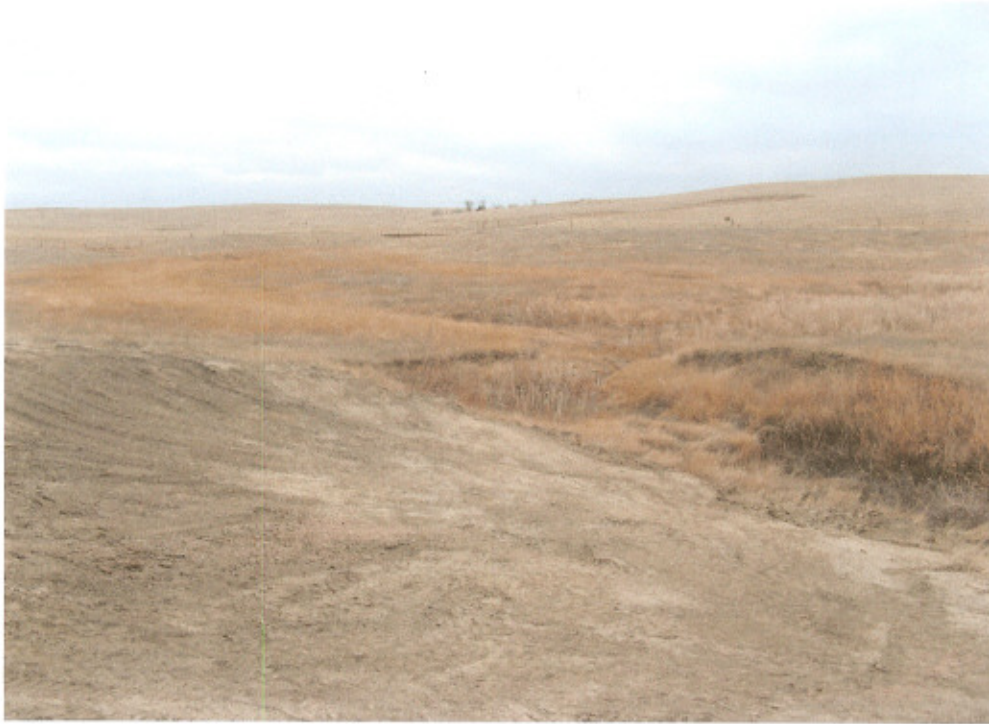
Area adjacent to drainage needs stormwater controls to prevent sediment migration.

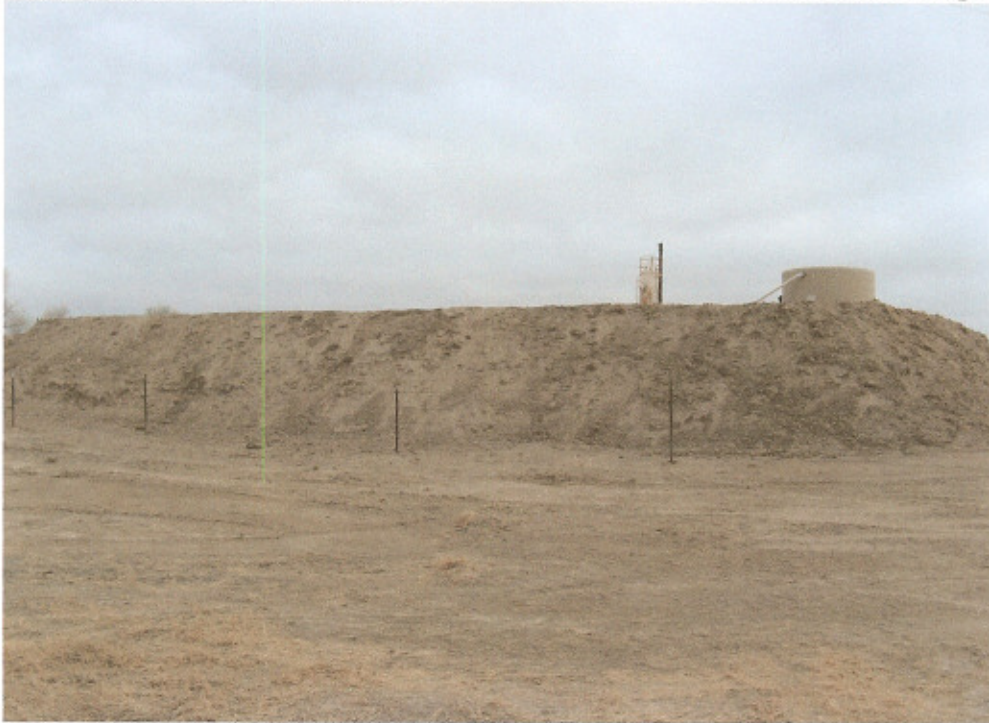
Disturbed area below water pit needs stormwater controls.
