**From:** Baroumand, Soraya  
**Sent:** Monday, May 02, 2011 1:35 PM  
**To:** Baroumand, Soraya  
**Subject:** FW: inspection report for wells 05-045-13388 and 13387  
**Attachments:** IMG00188-20110303-1118.jpg; IMG00189-20110303-1119.jpg; IMG00190-20110303-1120.jpg; IMG00191-20110303-1121.jpg; B33NETreatmentHistory.snp; IMG00185-20110303-1017.jpg; IMG00186-20110303-1018.jpg

Report		COGIS - Field Inspection	
API Number:	05-045-13388	Name:	COX #33-1 (B33NE)
Location:	NWNE 33 6S 92W	Lat: 39.49031	Long: -107.66752
Operator #:		Operator Name:	ENCANA OIL & GAS (USA) INC
Inspection Date:	2/17/2011	Inspector:	SORAYA BAROUMAND

ENCANA API #S 05-045-13387 & 87 COX #33-1 & 33-3A

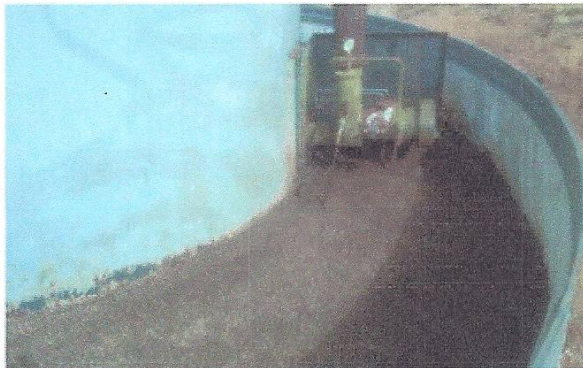
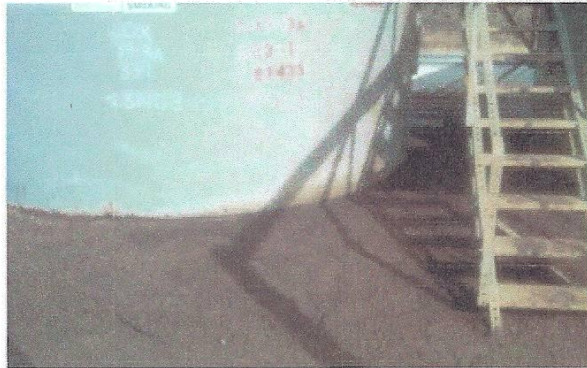
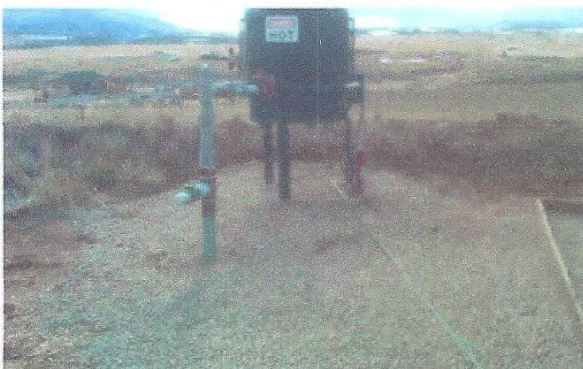
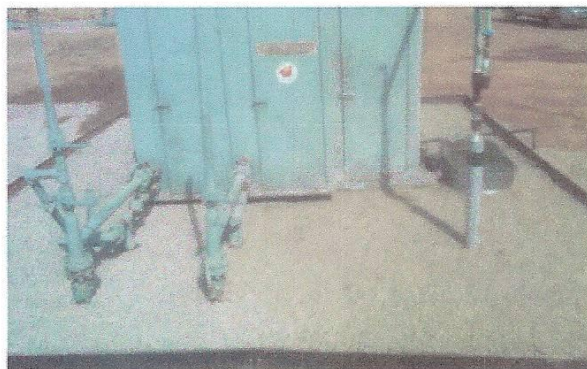
- photos of the location after clean up
- Pesticide application history

Also, with regards to equipment modifications, a screened trough and plumbed scrubber were installed off the separator to limit the possibility of paraffin being ejected from the equipment in the future.

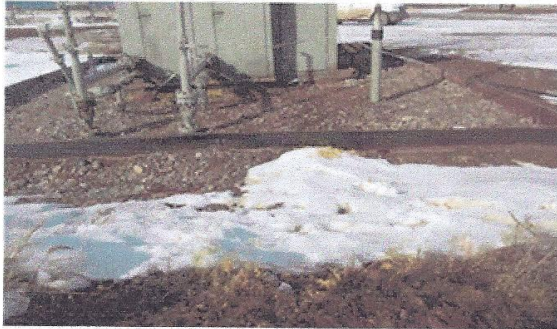
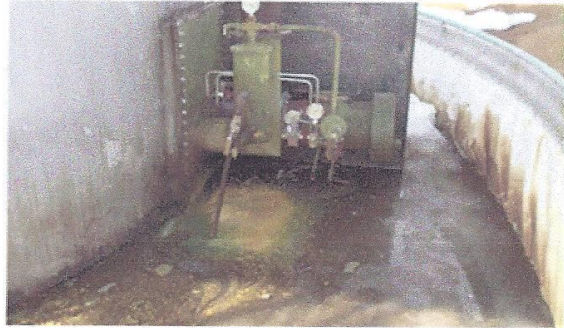
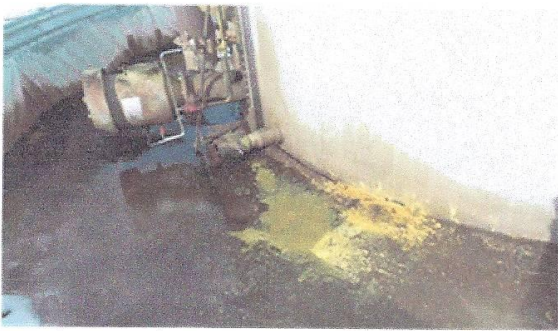
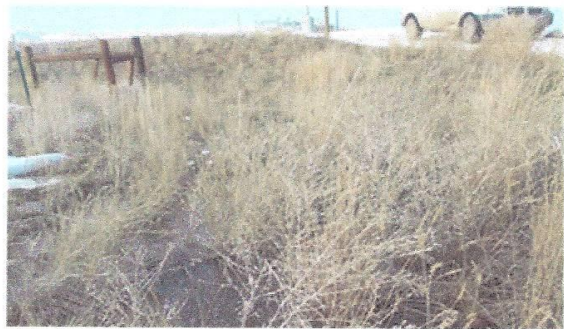
Insp. Comment	Inspection/Violation Comments
ACTION	MAINTAIN/REPAIR SEPARATOR AND EMISSION BURNER, AND REPAIR ASSOCIATED LEAKS. REMOVE CONDENSATE FROM THE TANK BATTERY'S SECONDARY CONTAINMENT AND IMPACTED SURFICIAL GRAVELS. INITIATE CONTINUAL WEED MITIGATION EFFORTS SELECTIVE FOR RUSSIAN KNAPWEED.
FIREWALL	3' METAL SECONDARY CONTAINMENT AROUND TANKS AND 6" METAL DIKE AROUND SEPARATORS.
GENHOUSE	POOR
SPILCOM	CONGEALED CONDENSATE HAS ACCUMULATED WITHIN THE TANK BATTERY'S SECONDARY CONTAINMENT, AND AROUND THE VERTICAL SEPARATORS AND EMISSIONS BURNER, WHICH REQUIRE REMOVAL AND PROPER DISPOSAL. NOTE: VISUAL ESTIMATION OF VOLUME IS WELL BELOW THE SPILL REPORTING REQUIREMENTS.
SURFRH	A PATCH OF RUSSIAN KNAPWEED WAS IDENTIFIED NEAR THE SOUTHERN REGION OF THE WELL PAD.
TANKBAT	2-300 BBL PRODUCED WATER/CONDENSATE TANKS, ELEVATED METHANOL TANK, COMBUSTOR, DIFFUSER, VERTICAL SEPARATORS, 2 WELLHEADS, PLACARDS AND SCREENS IN PLACE.
