COGIS - Field Inspection Report

API Number: 05-121-08776	Name: CHURCH #2
Location: SENE 25 3S 51W	Lat: 39.766844 Long: -103.031013
Operator #:	Operator Name: CAERUS WASHCO LLC
Inspection Date: 8/18/2011	Inspector: JOHN AXELSON

COGCC Inspection #200319859 – Church #2 (121-08776)
Remediation Project #4301
NOAV #200191177
Inspection Date: 8/18/11

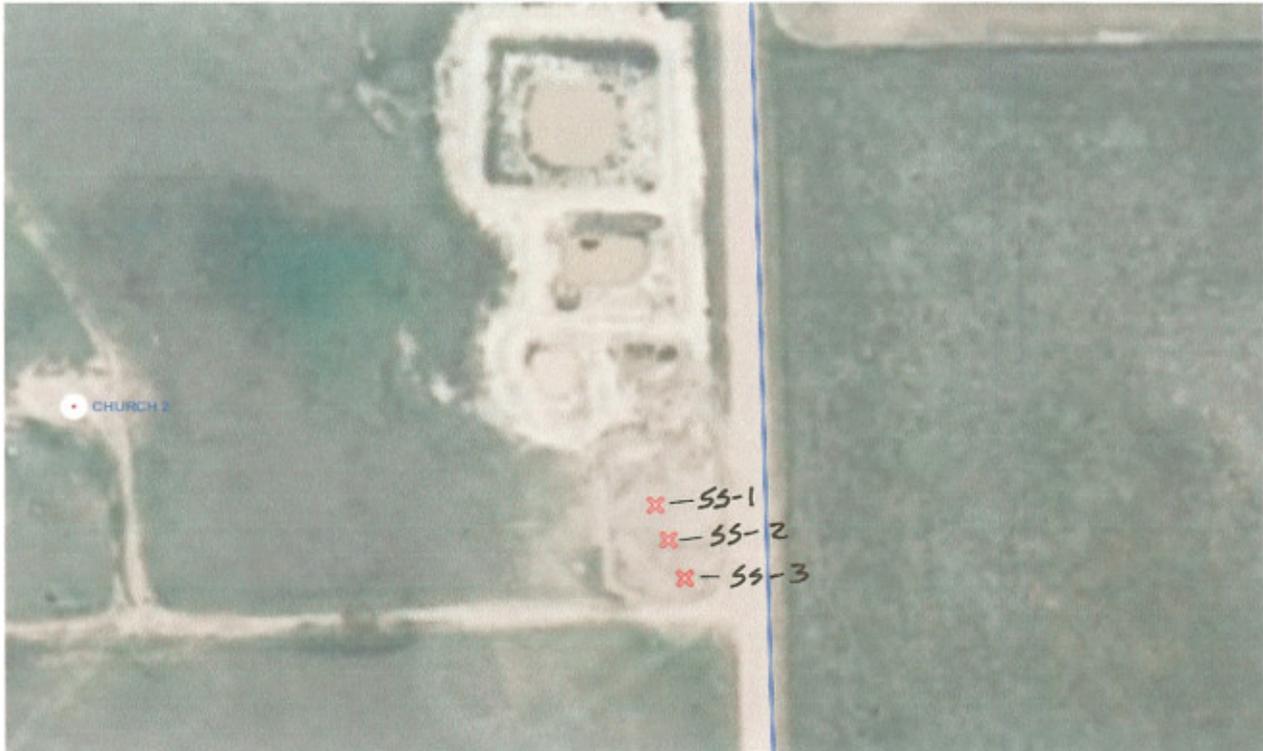
Church #2 Landfarm - Soil Sample Location Diagram

MISC	(REFERENCE DOC #200280265). STILL MUCH OIL CRUSTED MATERIAL AT SURFACE. HAND DUG POTHOLES IN TEN (10) LOCATIONS ACROSS LANDFARM. SEVEN (7) POTHOLES EXHIBITED PETROLEUM ODOR AND STAINING. OIL SATURATED SOIL STILL OBSERVED IN MOST AREAS. COLLECTED THREE DISCRETE GRAB SAMPLES 0-6" IN DEPTH ACROSS LANDFARM. SS-1 LOCATED NEAR MIDDLE OF LANDFARM IN HEAVILY STAINED AREA WAS SATURATED WITH OIL AND EXHIBITED STRONG PETROLEUM ODOR. SS-2 COLLECTED FROM AREA WITH NO STAINING OR PETROLEUM ODOR. SS-3 COLLECTED FROM SOUTHERN PART OF LANDFARM EXHIBITED SOME STAINING AND PETROLEUM ODOR. ANALYTICAL RESULTS FOR ALL THREE SOIL SAMPLES EXCEEDED 500-MG/KG LEVEL FOR TOTAL PETROLEUM HYDROCARBONS.
SURFRH	PIT COMPLEX AREA SURROUNDING ONE REMAINING OPEN PIT HAS BEEN GRADED WITH SOME INVASIVE VEGETATION/WEEDS. LANDFARM AREA IS APPROXIMATELY 110' X 135'.

Insp. Comment	Inspection/Violation Comments
ACTION	IF LANDFARMING IS CONTINUED TO TREAT THE CONTAMINATED SOIL, TREATMENT MUST BE DONE IN ACCORDANCE WITH COGCC RULE 907.E.(2). IF LANDFARMING IS CONTINUED, SUBMIT A STATUS UPDATE REPORT WITH THE DATES THE MATERIAL WAS AERATED, THE TYPE AND QUANTITY OF MICROBES AND NUTRIENTS ADDED, AND SAMPLE RESULTS WITH A SUFFICIENT NUMBER OF REPRESENTATIVE SOIL SAMPLES COLLECTED FROM THE MATERIAL BEING TREATED. NOTIFY COGCC AT LEAST 5-DAYS IN ADVANCE OF SOIL SAMPLE COLLECTION. AN ANNUAL STATUS REPORT WILL BE REQUIRED FOR THE DURATION OF THE PROJECT. IMMEDIATELY REMOVE ALL PLASTIC AND REMAINING DEBRIS FROM THE LANDFARMED MATERIAL AND PROPERLY DISPOSE. CONTROL WEEDS IN PIT COMPLEX AREA. REVEGETATE ALL DISTURBED AREAS IMMEDIATELY NORTH OF THE ONE REMAINING OPEN WATER PIT. CONTROL STORMWATER IN LANDFARM AREA. AS AN ALTERNATIVE - IMMEDIATELY DISPOSE OF ALL REMAINING OILY WASTE AT A PROPERLY PERMITTED SOLID WASTE DISPOSAL FACILITY. DOCUMENT VOLUME AND FINAL DISPOSITION OF CONTAMINATED SOIL. COLLECT CONFIRMATION SOIL SAMPLES FROM NATIVE SOIL BELOW TREATED MATERIAL TO VERIFY NO IMPACT TO UNDERLYING SOIL SINCE PLASTIC WAS SHREDDED. FINISH BACKFILLING OPEN PIT, GRADING AND REVEGETATE ENTIRE DISTURBED AREA. SUBMIT CLOSURE REQUEST WITH DISPOSAL DOCUMENTATION AND CONFIRMATION SAMPLE RESULTS.

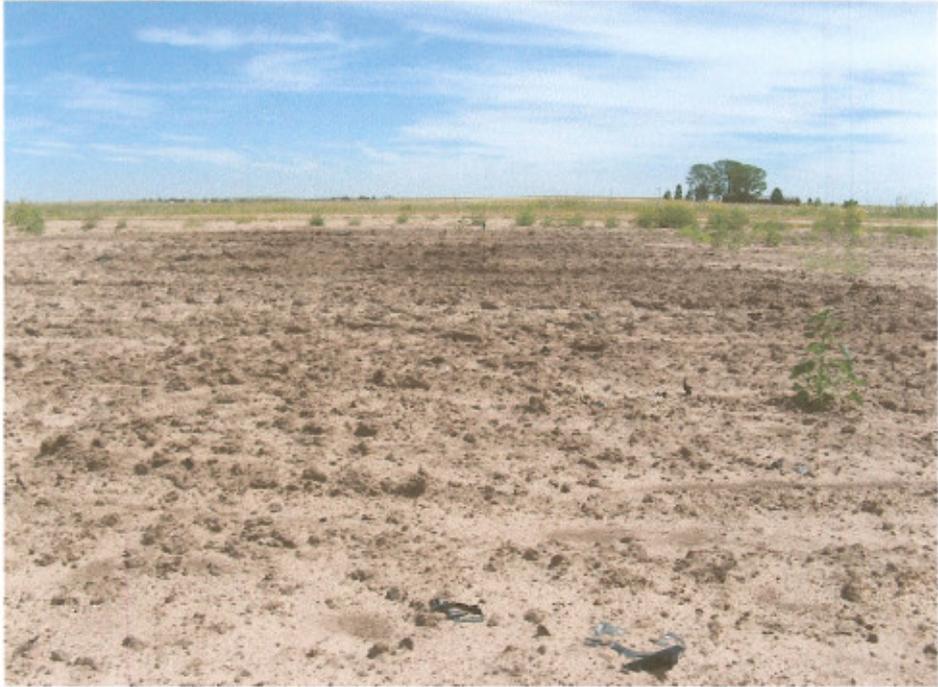
Landfarm area looking east - heavily stained area.

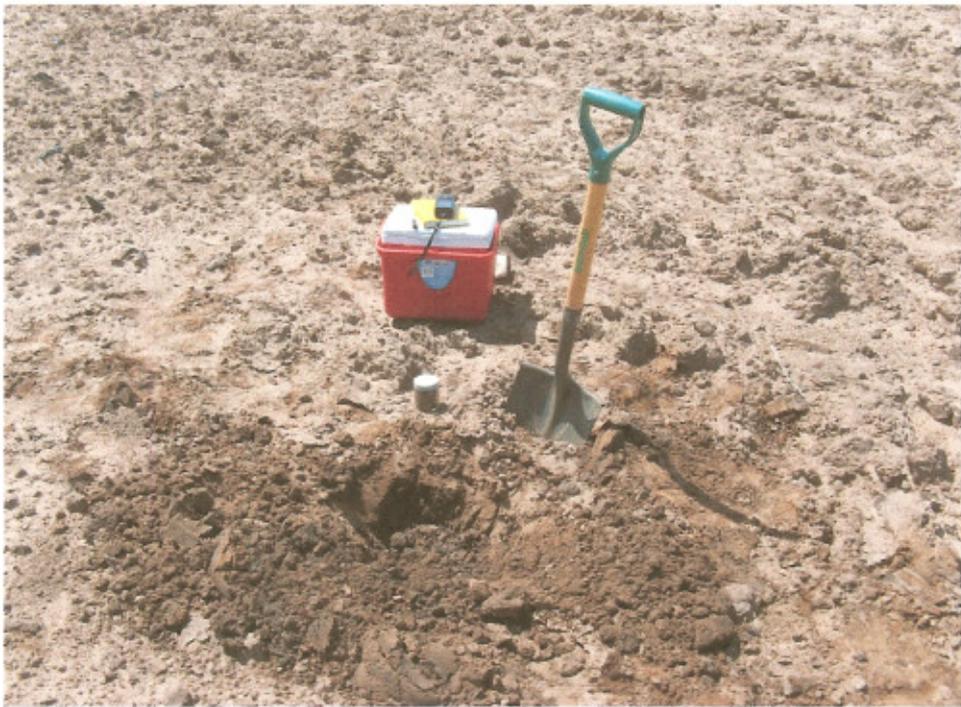
Soil sample SS-1

Lab Sample ID	Client Sample ID	Result	Qualifier	Reporting Limit	Units	Method
280-19343-1	CHURCH 2, SS-1					
Gasoline Range Organics (GRO)-C6-C10		130		6.0	mg/Kg	8015B
Diesel Range Organics [C10-C28]		15000		170	mg/Kg	8015B
Motor Oil Range Organics [C24-C36]		12000		510	mg/Kg	8015B
Percent Moisture		11		0.10	%	Moisture
280-19343-2	CHURCH 2, SS-2					
Diesel Range Organics [C10-C28]		680		43	mg/Kg	8015B
Motor Oil Range Organics [C24-C36]		740		130	mg/Kg	8015B
Percent Moisture		6.6		0.10	%	Moisture
280-19343-3	CHURCH 2, SS-3					
Diesel Range Organics [C10-C28]		7400		86	mg/Kg	8015B
Motor Oil Range Organics [C24-C36]		4400		260	mg/Kg	8015B
Percent Moisture		11		0.10	%	Moisture

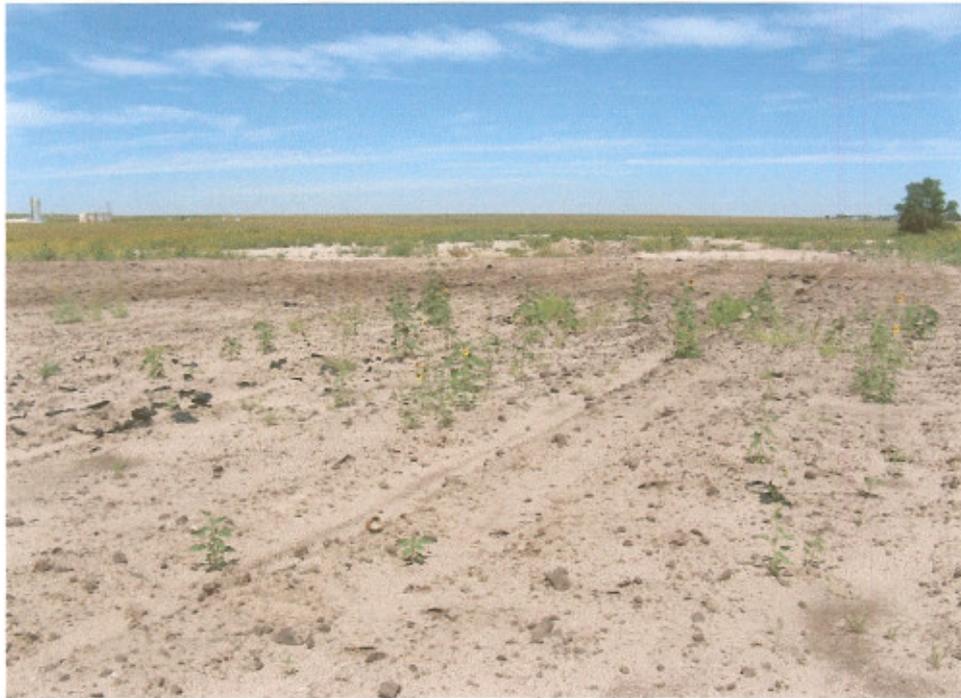
GENHOUSE	STILL SOME DEBRIS AND PLASTIC IN LANDFARMED MATERIAL. PLASTIC PREVIOUSLY UNDERLYING PETROLEUM CONTAMINATED SOIL WAS SHREDDED DURING TILLING AND IS DISTRIBUTED THROUGHOUT LANDFARM. DEBRIS IS MOSTLY OLD PIPING.
	INSPECTION PERFORMED IN REGARD TO CLOSURE REQUEST FOR REMEDIATION #4301/NOAV #200191177. LANDFARMED MATERIAL APPEARS TO BE IN SAME CONDITION AS INSPECTED ON 9/28/10

Landfarm area looking north with shredded plastic throughout oily waste.

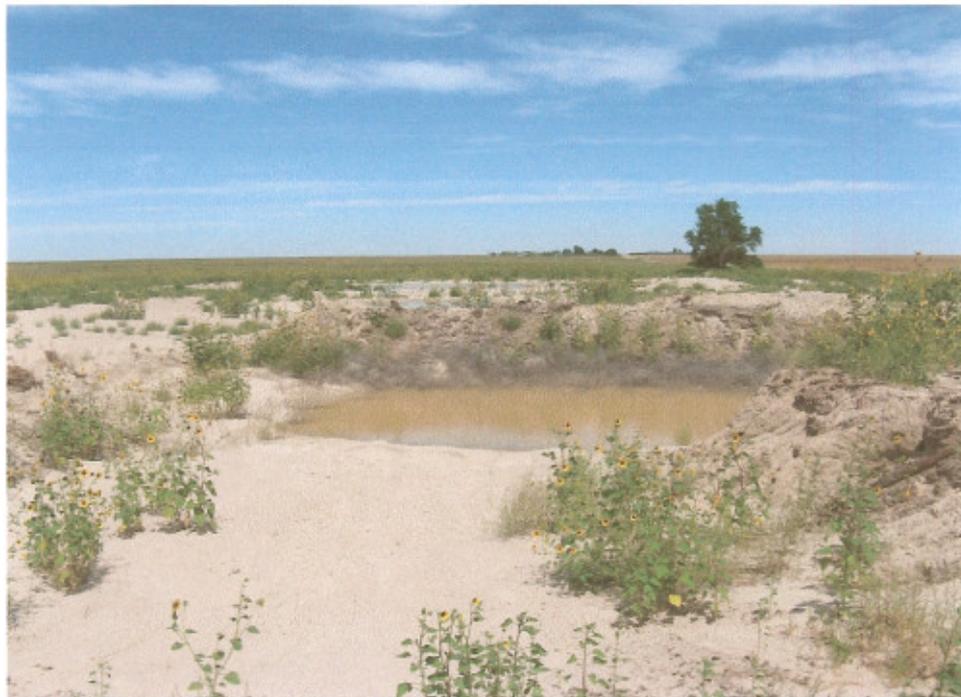
Pit Type: **PW** Oil on Pit: Freeboard:
 Number of Pits: **1** Number covered or lined: **0** Number uncovered or unlined: **0**
 Comments: **PORTION OF 1 PRODUCED WATER PIT IS STILL OPEN. OTHER PITS ASSOCIATED WITH LOCATION WERE CLOSED PER APPROVED FORM 27 REM #4301**

Remaining open water pit and disturbed area to north.
