SPILL/RELEASE REPORT

Date of Incident: 13-Jul-11	Facility Name & No: Rangely Weber Sand Unit	County: Rio Blanco
Type of Facility (well, tank battery, flow line, pit): 20" Inlet Header West Water Plant	QtrQtr: NWSE	Section: 23
Well Name and Number: N/A	Township: 2N	Range: 103
API Number: N/A	Meridian: 6PM

CHEVRON-WEST WATER PLANT 20" INLET HEADER

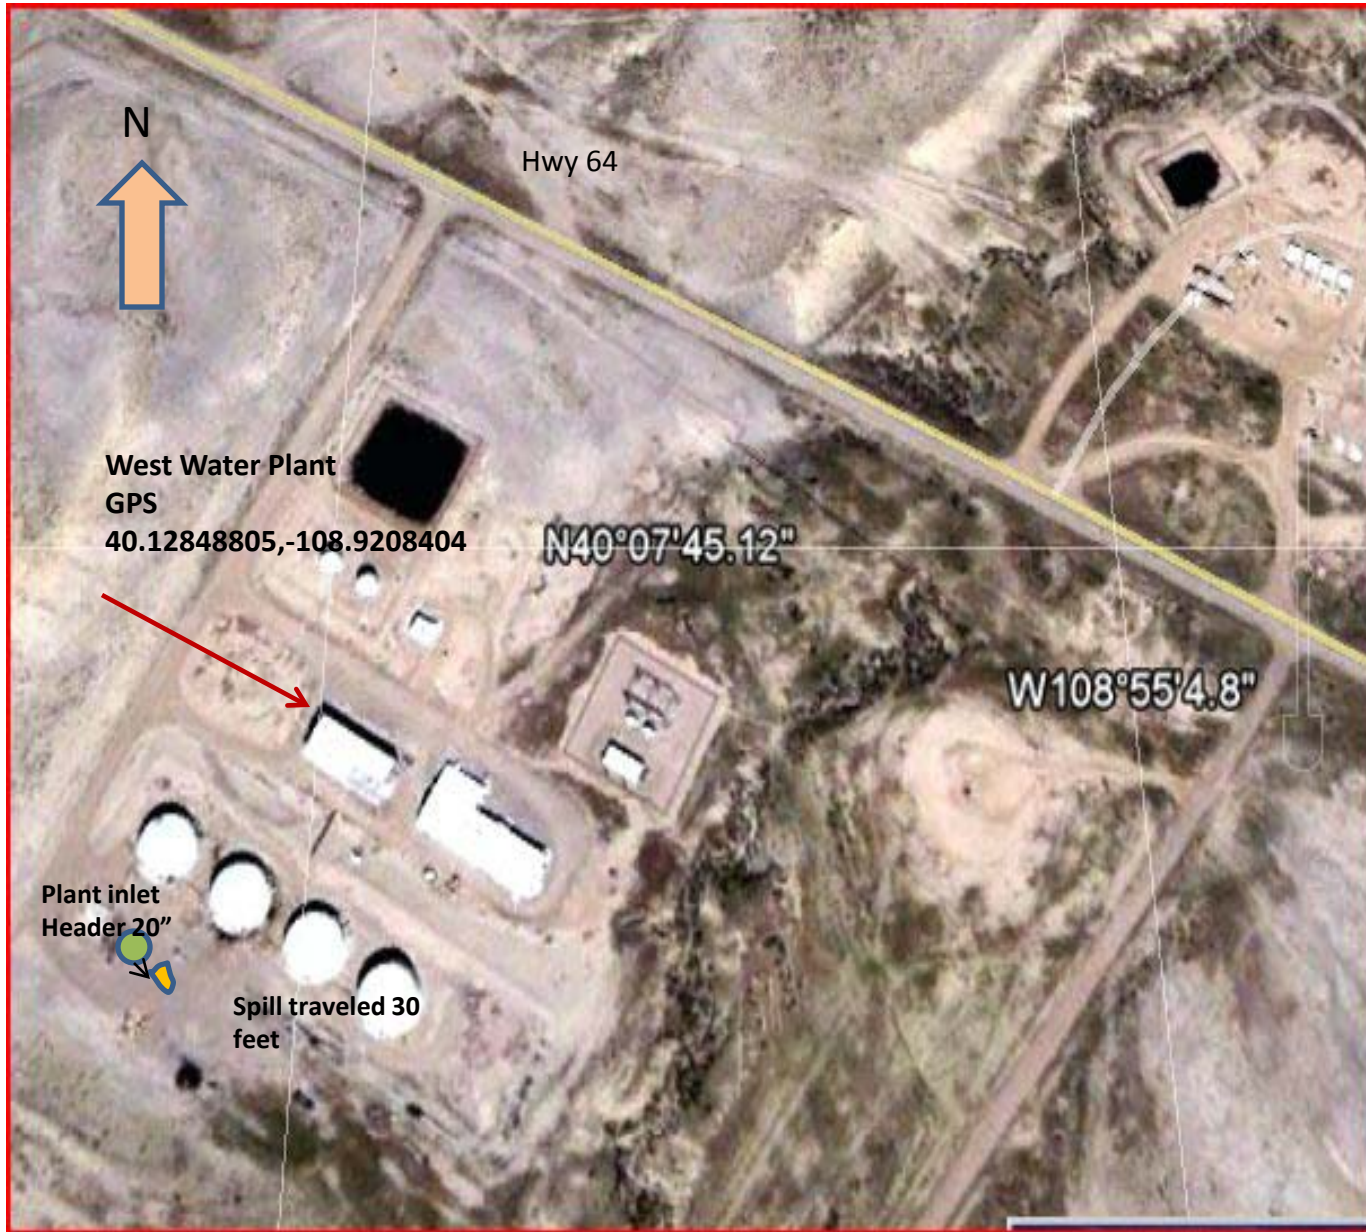
A leak occurred on a 20 inch steel pipe approximately 75 yards south of the west water tanks located at the west water plant. Fluids traveled approximately 30 feet where recovery was made by vacuum trucks.

Describe measures taken to prevent problem from reoccurring: The damaged section of the 20 inch steel pipe will be repaired and retuned to service.
