## ***Fox Engineering Solutions, Inc.***

June 29, 2012  
Rev. July 3, 2012

Re: Xenon Pits –Liner Conditions and Recommendations  
COGCC Facility #286608, 427370, 427371 & 427372t  
N ½ Section 12, Township 7 North, Range 93 West, 6th P.M.  
Moffat County, Colorado

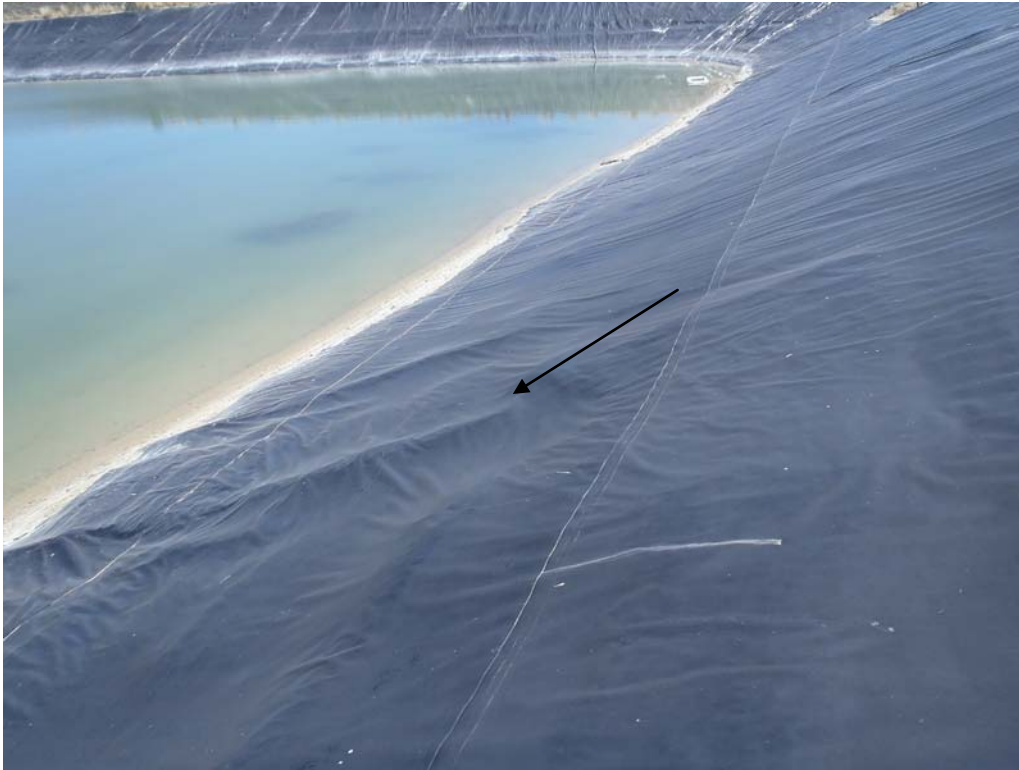
In general, the four pit liners above the fluid level had significant wildlife damage. Punctures caused by deer and possibly elk, tears caused by animal claws and holes from rodent activity were numerous. Our cursory count indicated 204, 38, 66, and 32 holes/tears in the Xenon Main, Upper, Middle and Lower pits, respectively. Leakage through the holes and tears of the liners has caused slumping of the side slopes at numerous locations.

Xenon Upper Pit – Slope slumping under liner.

The liners should be removed and the slope surface soils re-compacted to a depth of at least 3 feet. A new lining system, following the requirements of the Colorado Oil and Gas Conservation Commissions' Series 900 Rules, should be installed. The recommend liner system is a 60 mil polyethylene primary liner followed by a 40 mil polyethylene secondary liner underlain with a geosynthetic clay liner. A wildlife-proof perimeter fence is also recommended.

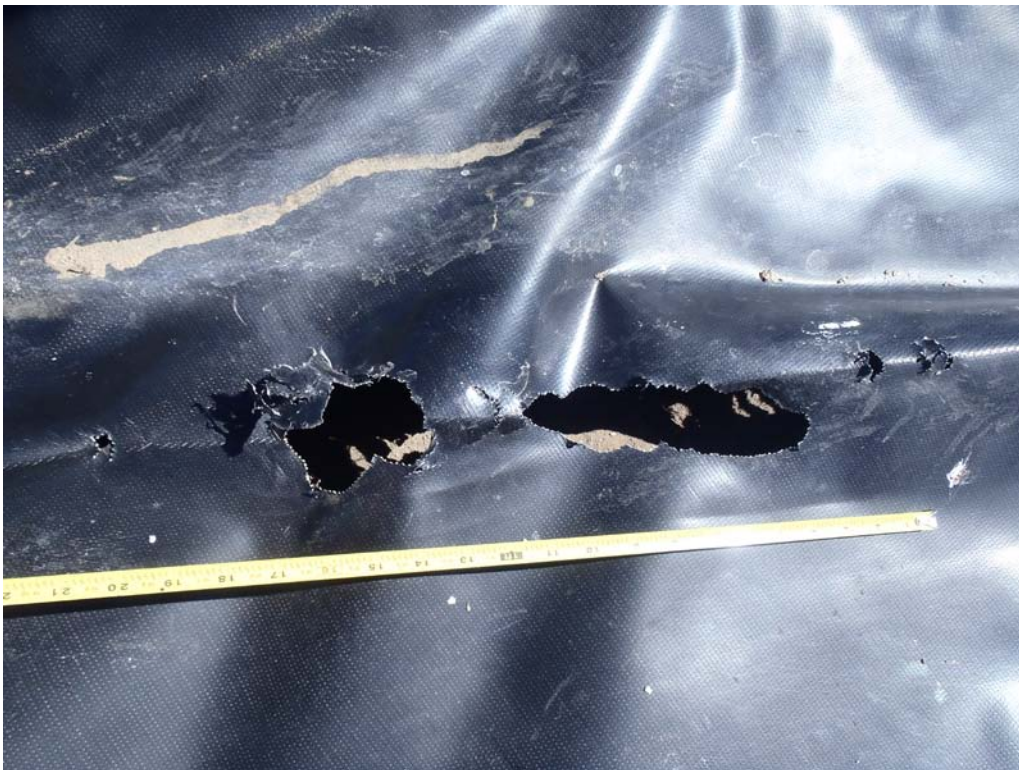
Xenon Upper Pit – Rodent damage.

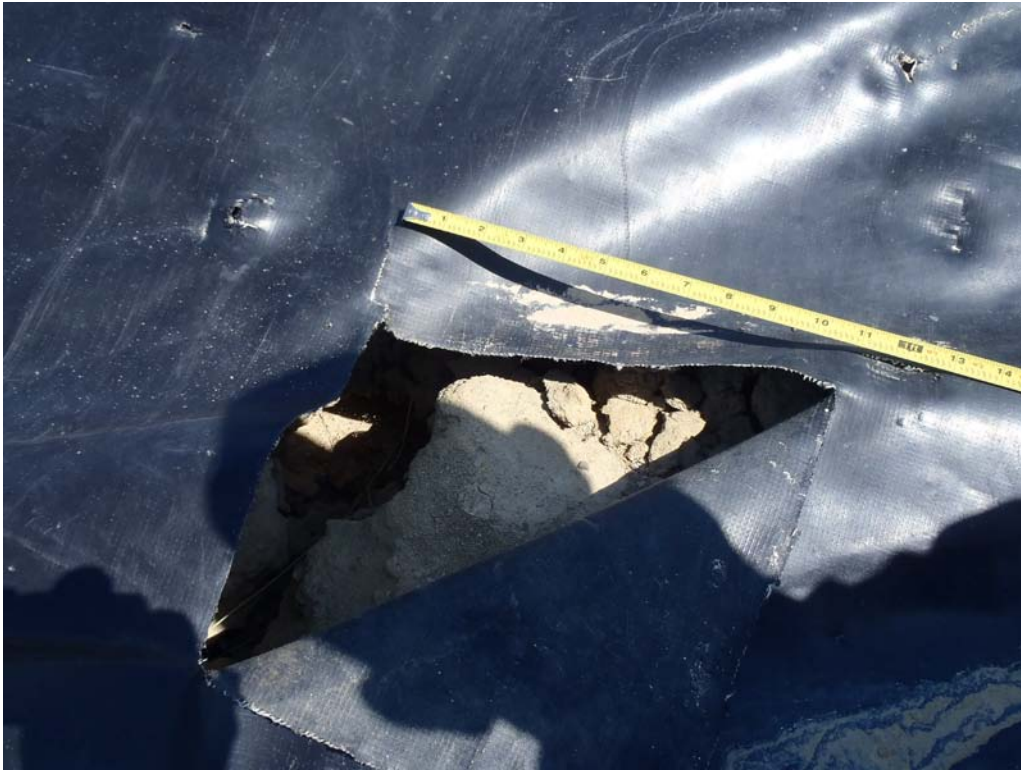
Concerning liner installation, we believe that liner was not installed per industry practice or standards. All of the pits showed signs of poor or inadequate subgrade preparation. This was evident by complete and partial protrusion of rocks through the liners. Significant portions of the liner seams are oriented horizontally, that is, running parallel with rim of the pit. Standard practice is to orient the seams vertically, running from the pit rim to the bottom of the pit. Improper orientation causes stress on the seams and is evident with a seam failure noted in the Lower Pit. There was no evidence of a woven fabric underlayment below the 24 mil liner. The fabric underlayment is an industry standard to provide protection of the liner.

Xenon Upper Pit – Complete rock protrusion.

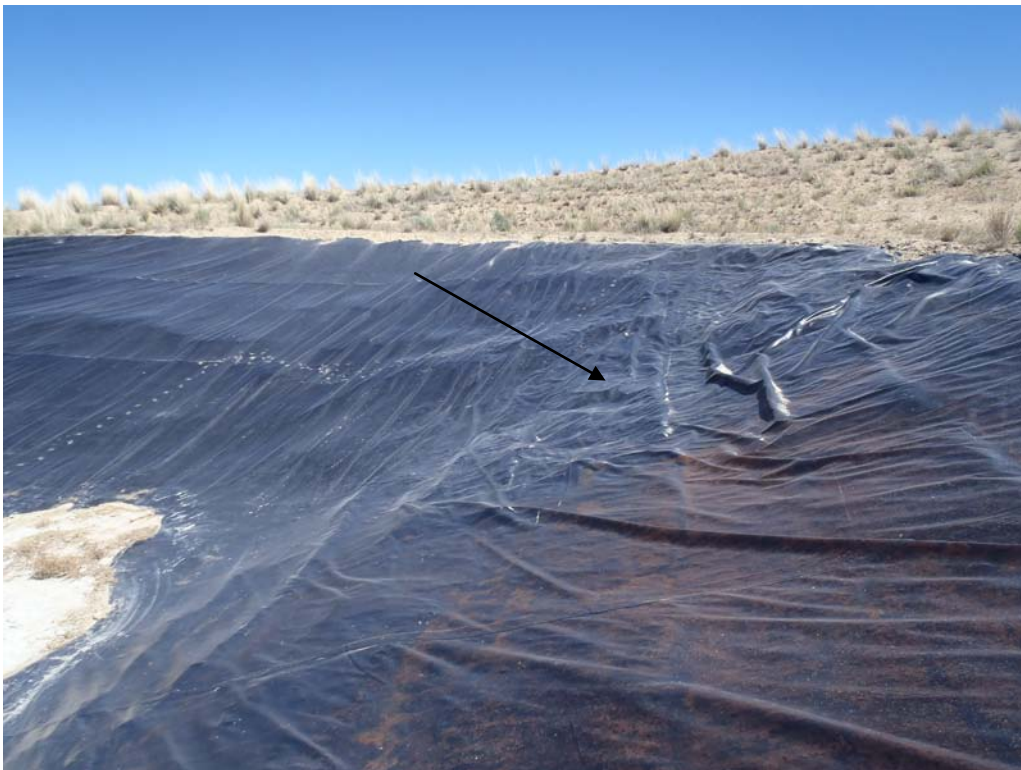
Xenon Upper Pit – Slope slumping under liner.

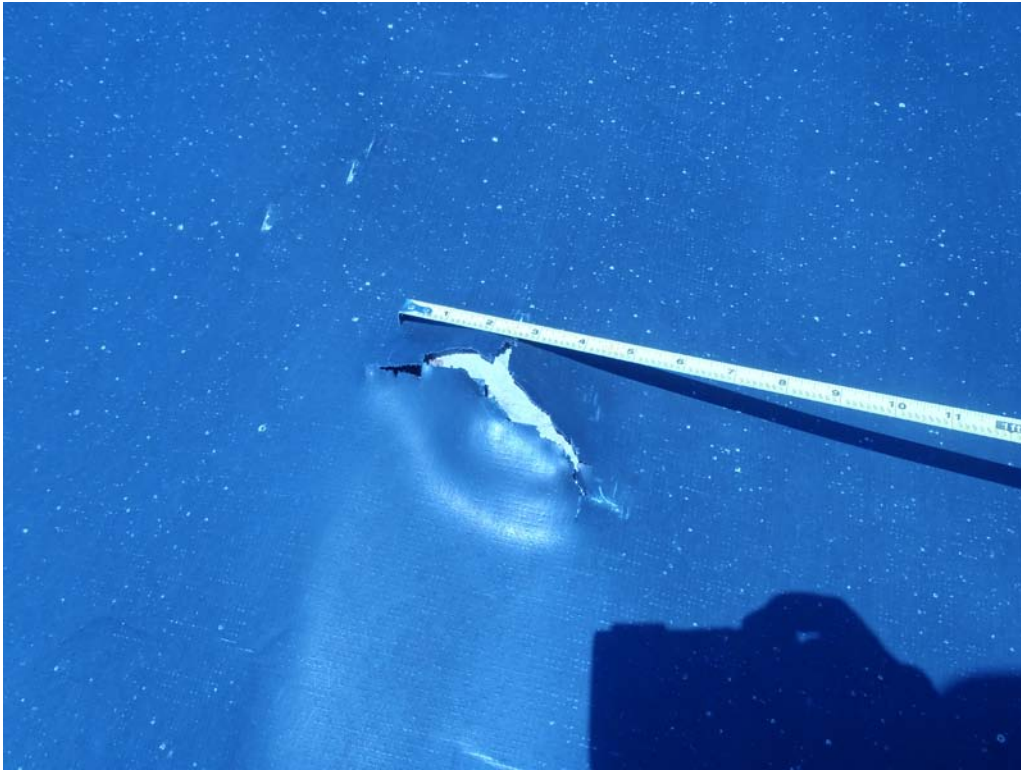
Xenon Middle Pit – Complete rock protrusion.

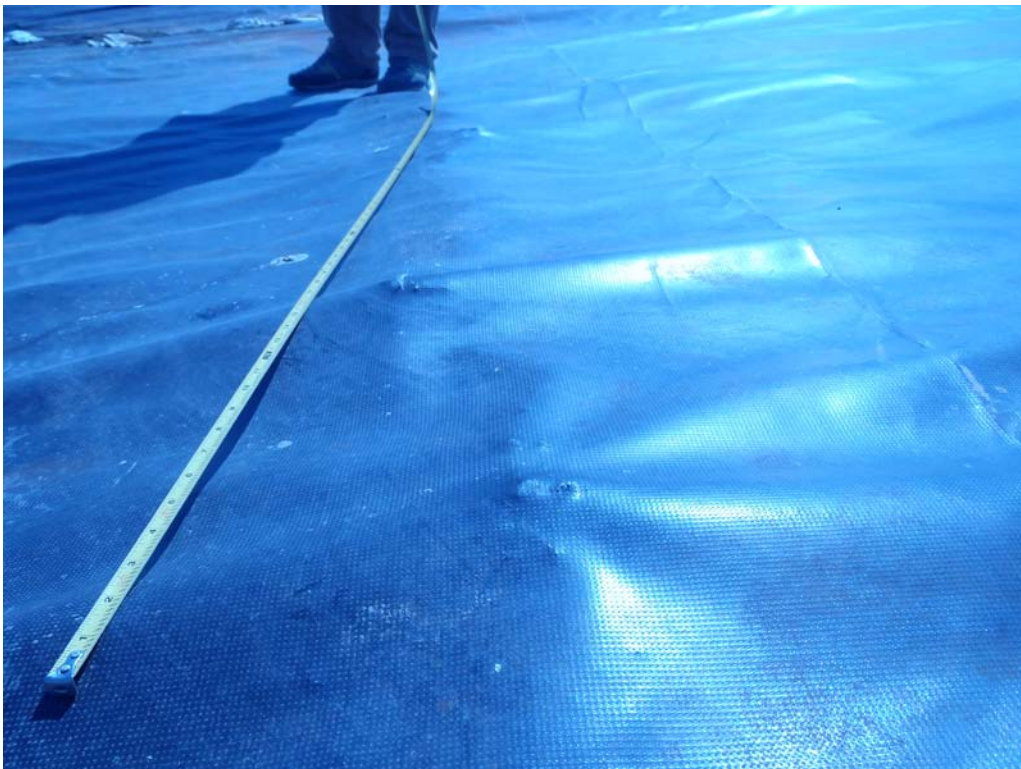
Xenon Middle Pit – Partial rock protrusions

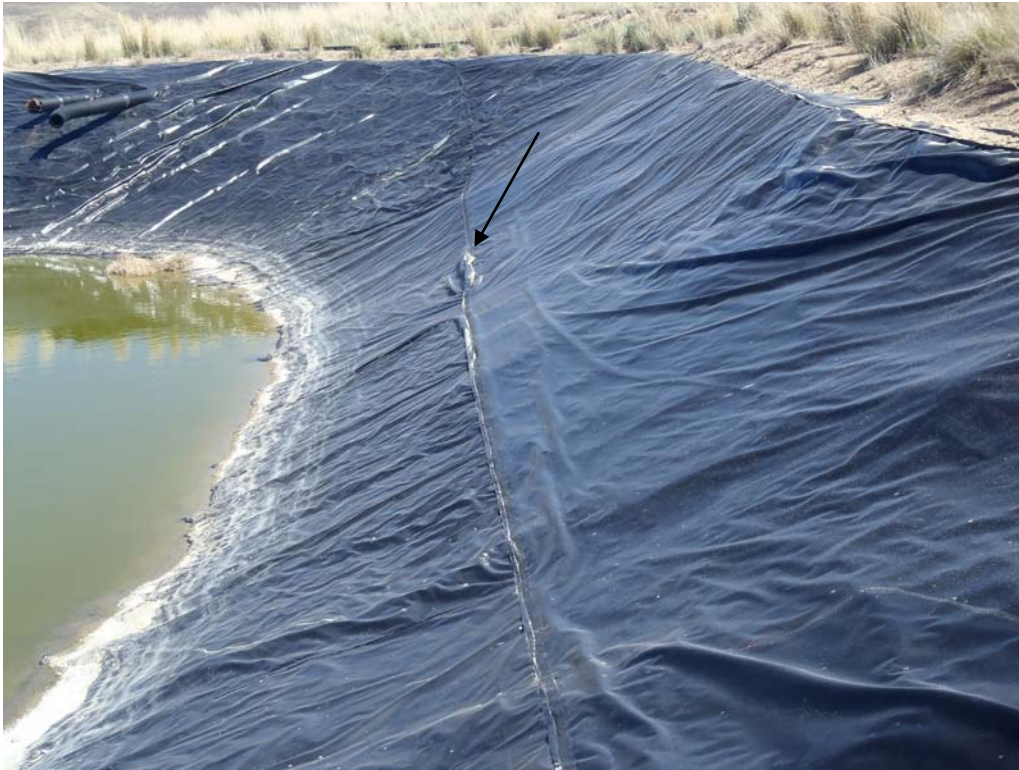
Xenon Lower Pit – Seam failure.

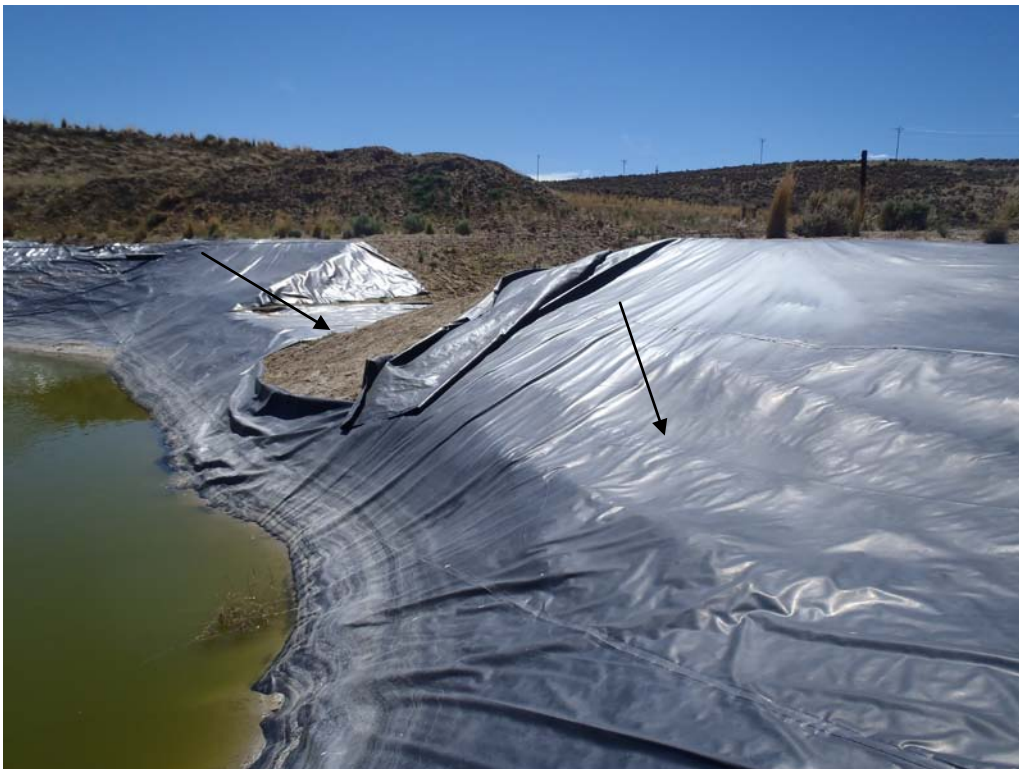
Xenon Lower Pit – Spillway liner tear and slumping.
