Re: Xenon Main Pit - COGCC Facility #427372 – Hydrostatic Pit Integrity Test  
N ½ Section 12, Township 7 North, Range 93 West, 6th P.M.  
Moffat County, Colorado

# Hydrostatic Pit Testing

# HYDRO-TEST EXHIBIT QUICK SILVER MAIN PIT

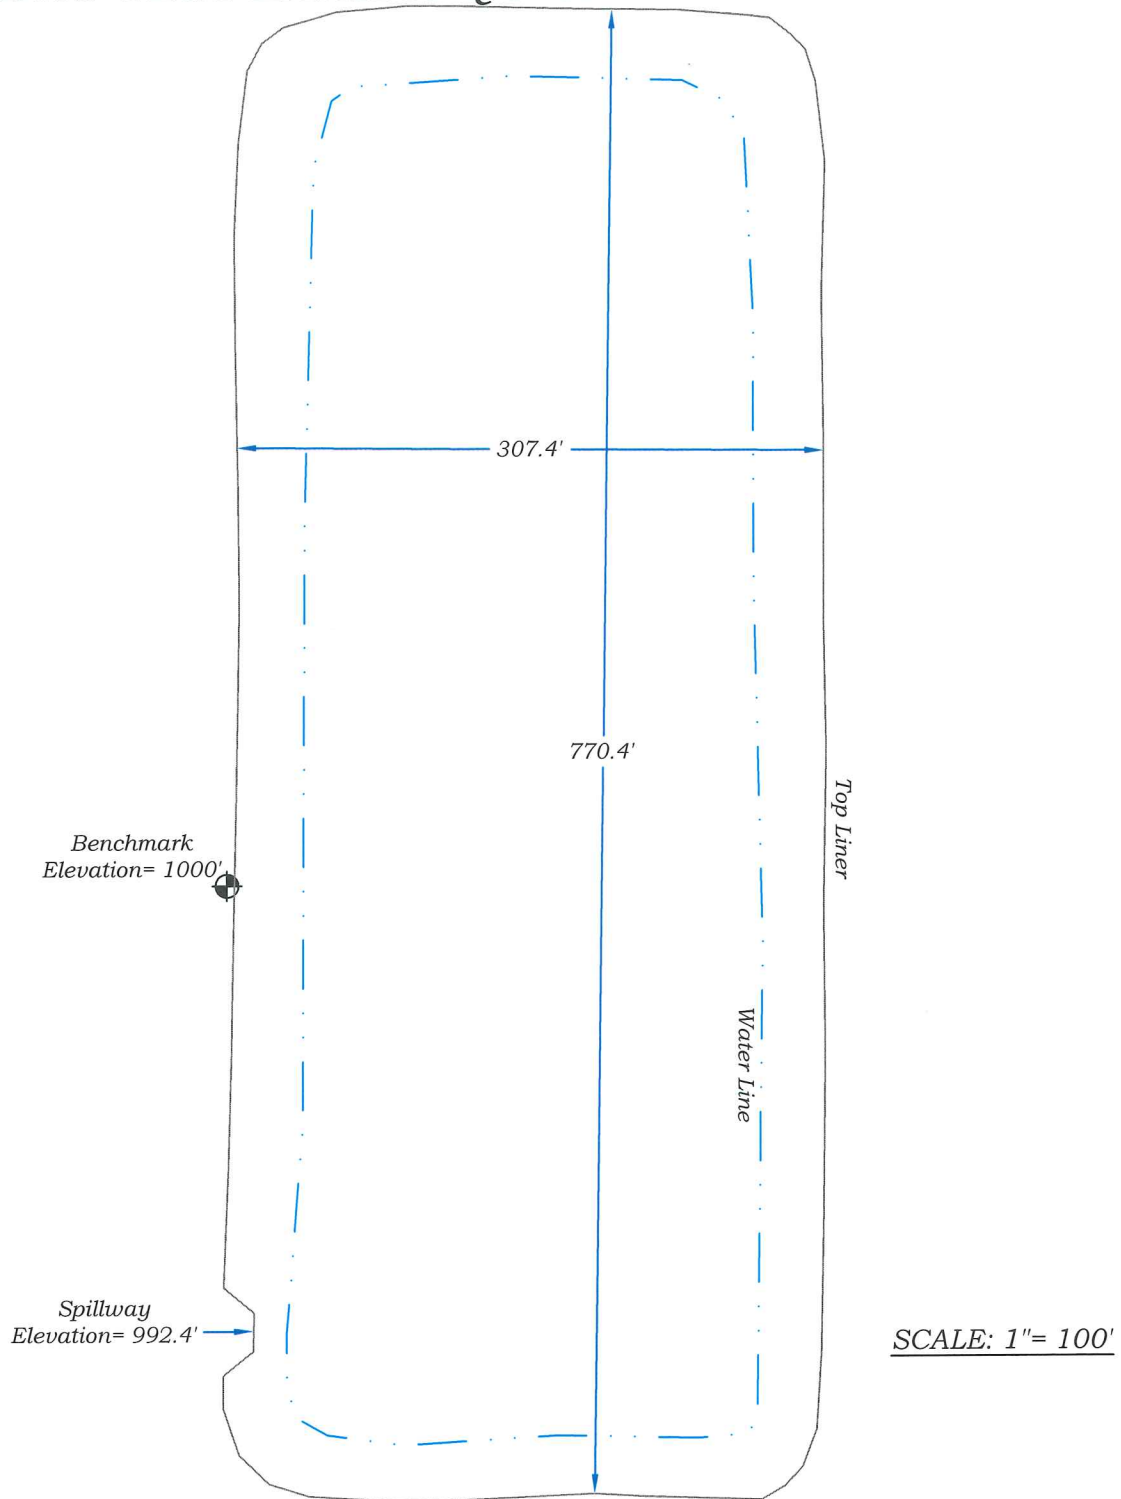
TOP WATER ELEV. (JUNE 18, 2012)= 985.235'  
TOP WATER ELEV. (JUNE 21, 2012)= 985.154'

TOP OF TRIBUTARY AREA SURFACE AREA = 236,178 sq. ft.  
TOP WATER SURFACE AREA = 166,509 sq. ft.  
TRIBUTARY AREA = 69,669 sq. ft.
