## BERRY PETROLEUM COMPANY M-16 595 PAD Location #311634

Photo date: Oct 3, 2012

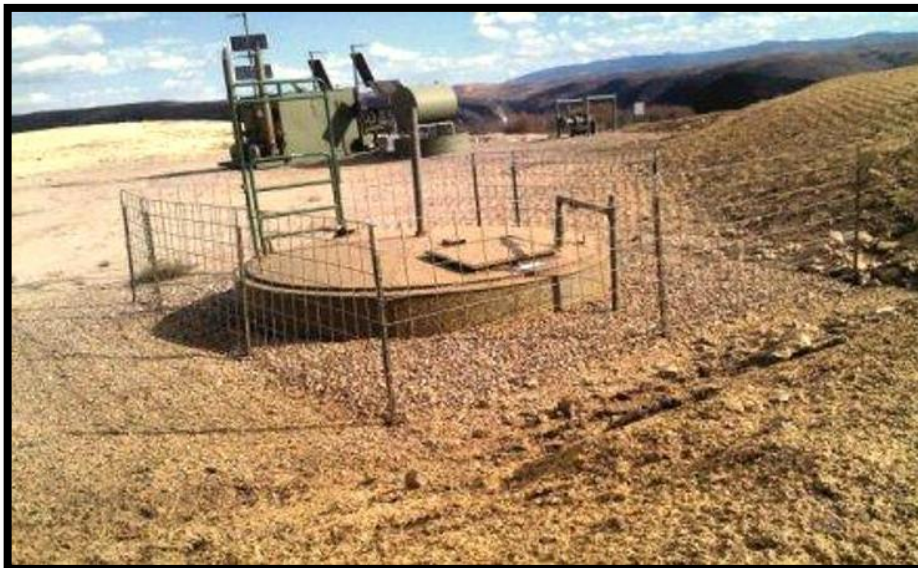
View of re-contoured slopes,, w/contoured disking, & mulching. PBV is clean & well fenced but requires secondary containment.

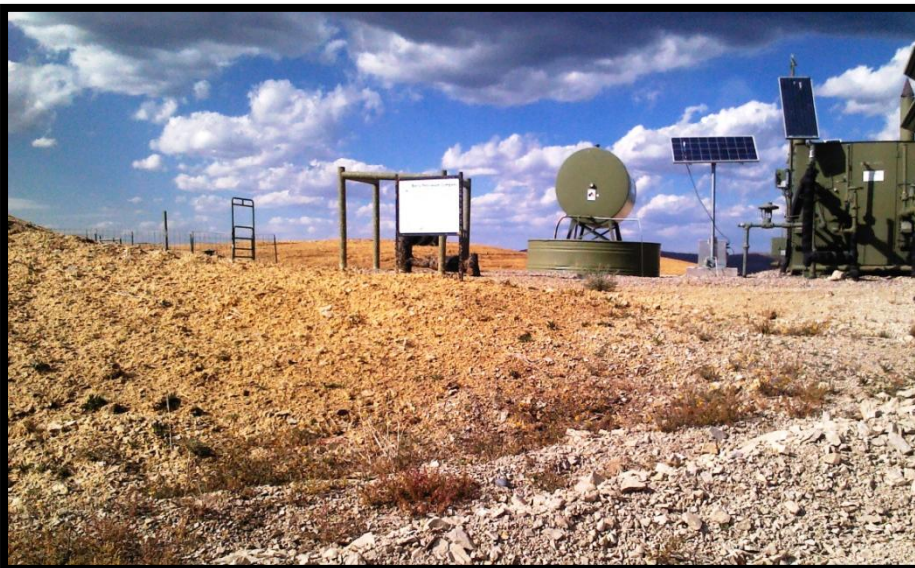
View of Location near entrance, signage, mulched & surface prepared perimeter exteriors & secondary containment for methanol tank.

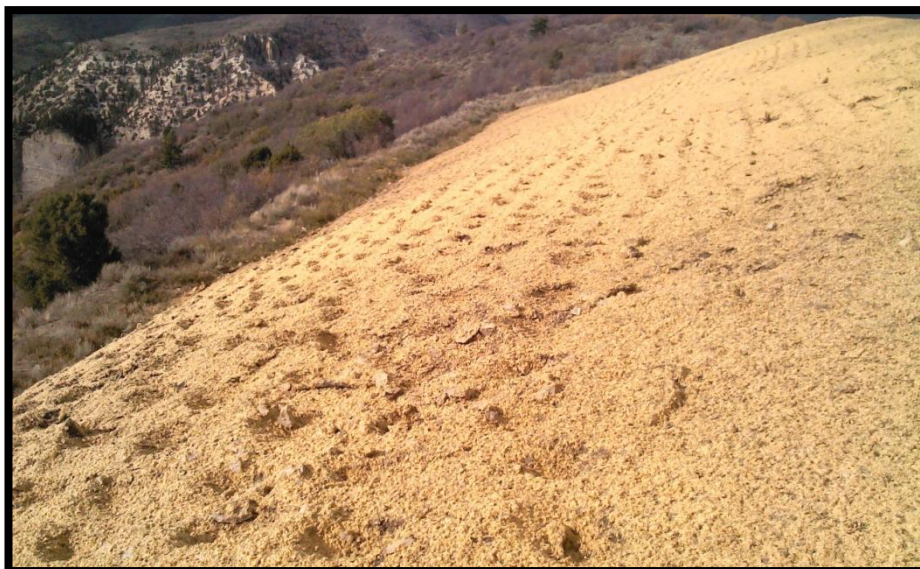
Reworked surface areas enclosing pad. Surfaces are tilled, mulched, & have pocket-hole design features. Vegetated 2ndary ditches & berms along toe of pad area.

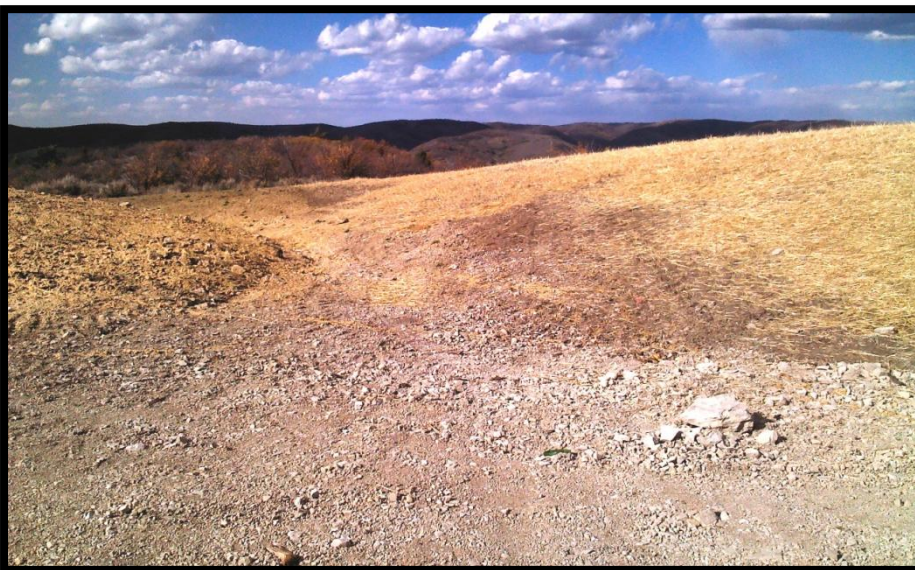
Viewing north from northern end of location: Re-countered slopes w/ landform-designed drainage basins. Surfaces tilled, disked, & mulched.

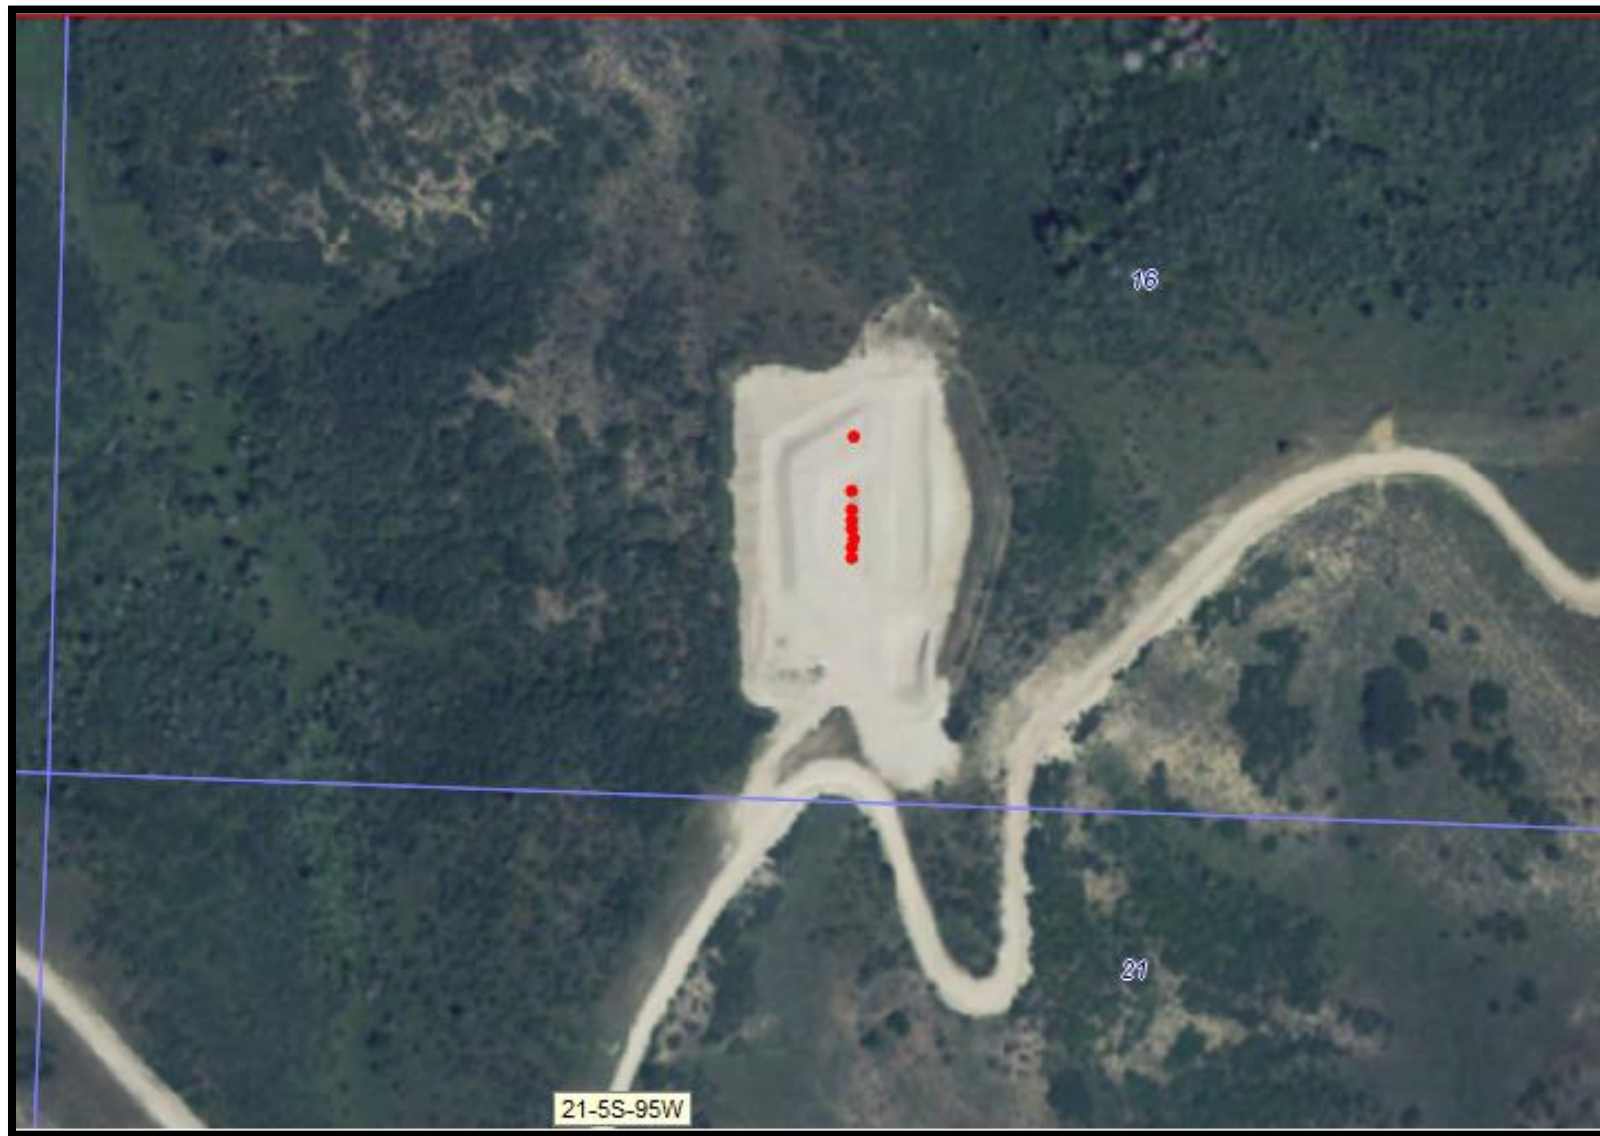
COGCC Map guide 8/2011 Aerial Photo: re-bermed areas

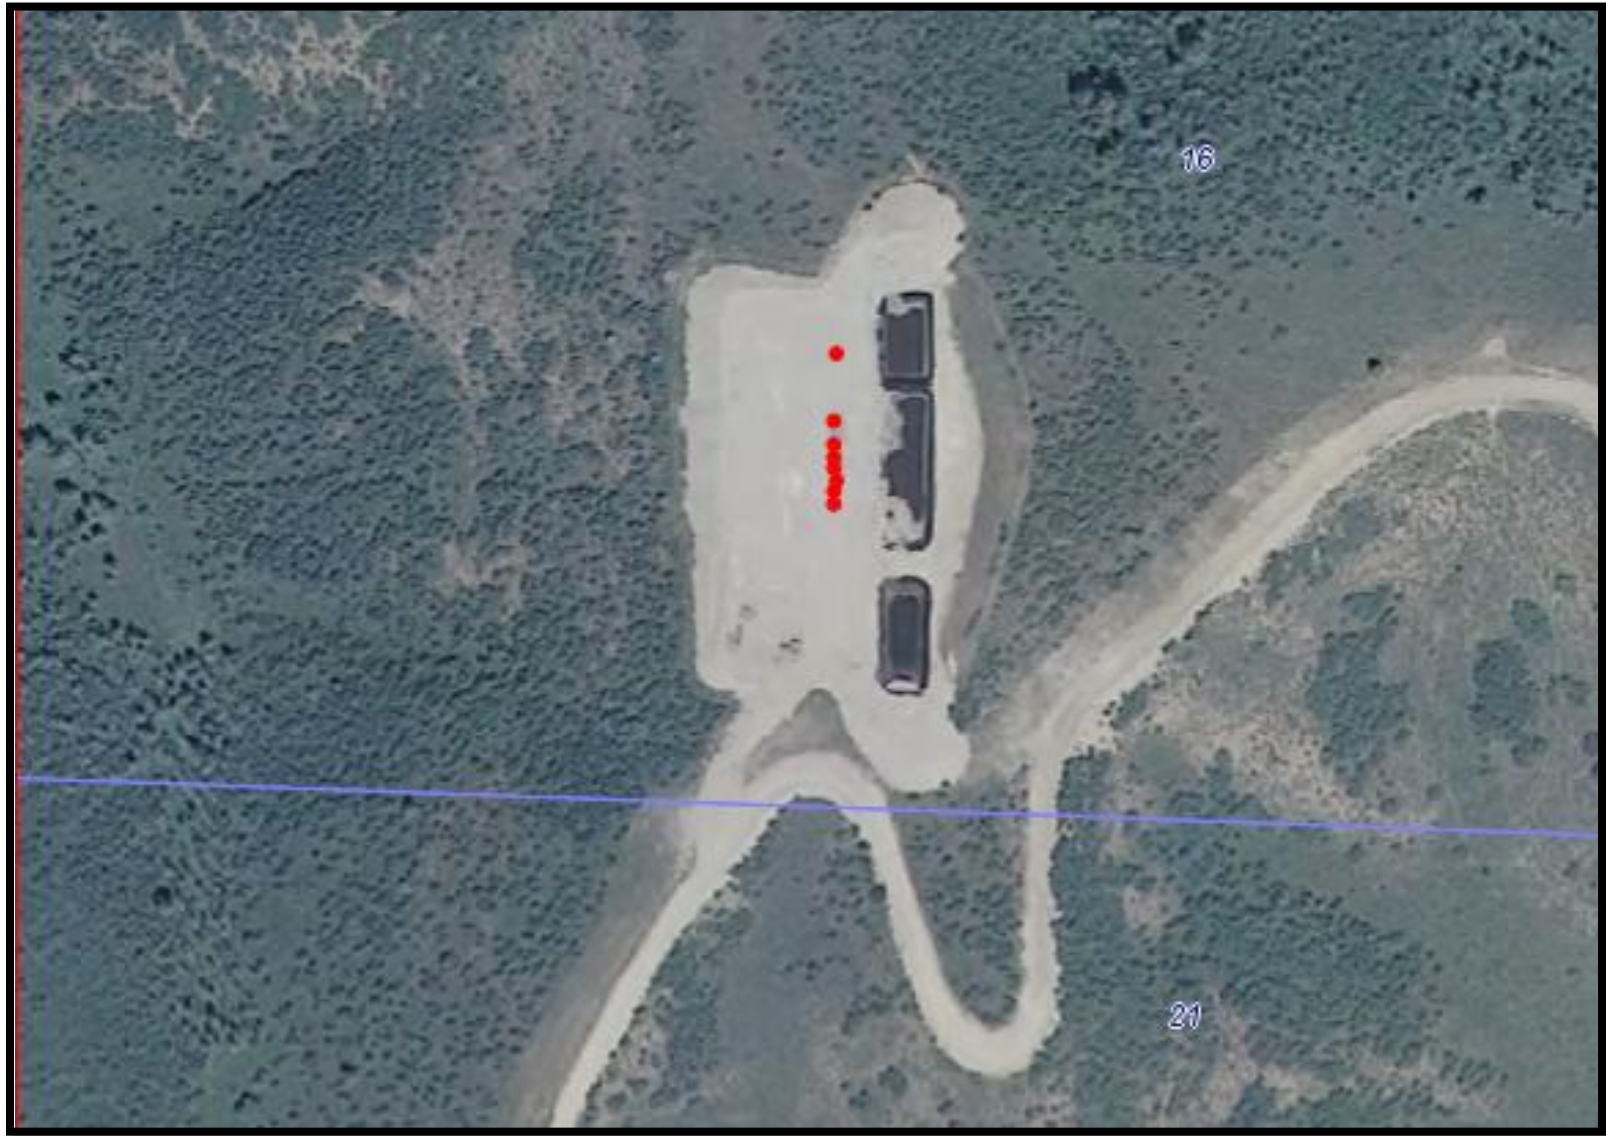
COGCC Map guide 2009 Aerial Photo: Drilling reserve pit, (which is now backfilled & graded)
