WELL SITE INSPECTION FORM

WELL NAME Dunbar-McKinley 1
 OPERATOR Underwood
 LOCATION SWSE 9-9N-61W
 FIELD Keota

Dunbar-McKinley #1 SWSE 9-9N-61W (Inspected 11/20/86)

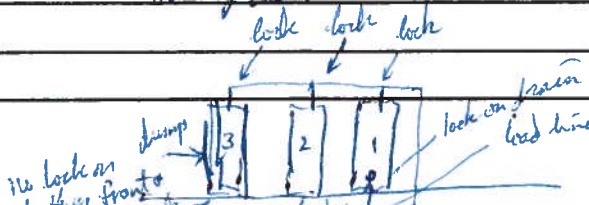
Pump jack not operating,
w/ line from tank #2 to prod. pit
dump line from tank #3 - up (wired off)
& no problems observed, looks like tank 2
overflowed through this hatch, little from #3
in post.

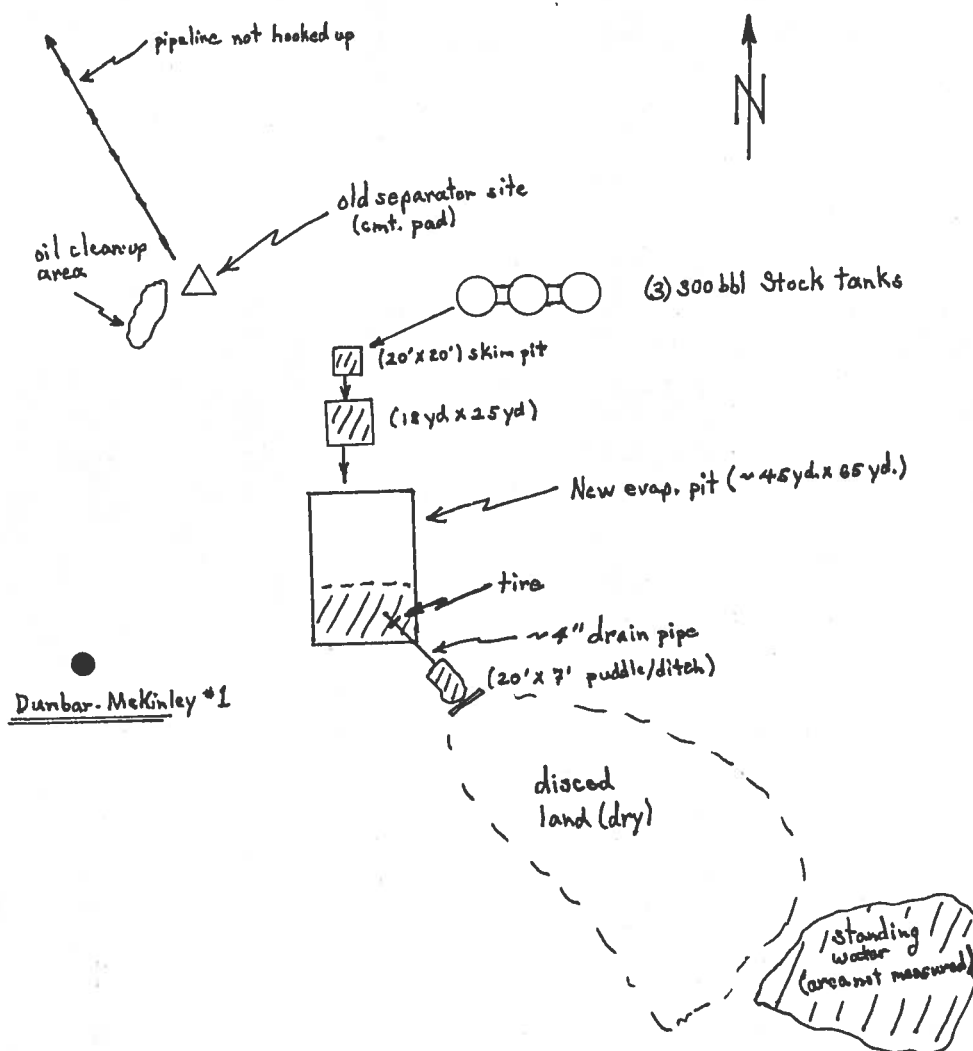
Well was producing at time of inspection. Produced water was being disposed of in a new evaporative pit. Pit was about 1/3 full, drain pipe located in the south-east corner of pit below water level (pipe marked by old car tire), ditch on other side of berm measuring 7'X20' full of water, water level appears to be at same level as pit water. Could not see any indication of any gel or bentonite liner in pit or on location. Water in the skim pit is milky green, no oil or screen on pit. Evap. pit water clear.

Fresh oil spill clean-up was observed at old separator location. Powder Expl. removed the separator and in the process dumped its contents thinking it was empty when the manway cover was removed. (Spoke to Mr. Sichel and Mr. Henry). I instructed Mr. Sichel to place clean fill dirt at this spot. (see diagram B)
