**RE: South Fork of Texas Creek Final Monitoring Report; SPK-2008-01183-DC**

# **FINAL MONITORING REPORT**

**U.S. ARMY CORPS OF ENGINEERS  
SPK -2008-01183-DC**

**SOUTH FORK OF TEXAS CREEK  
LA PLATA COUNTY, COLORADO**

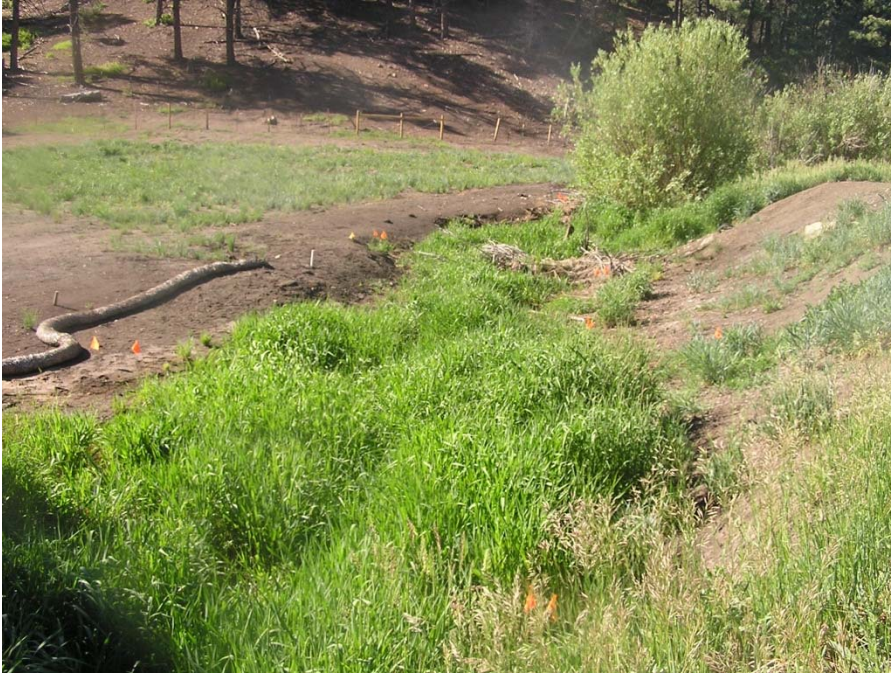
Photograph 1: 6/30/10: View of Texas Creek to the east prior to temporary impacts.

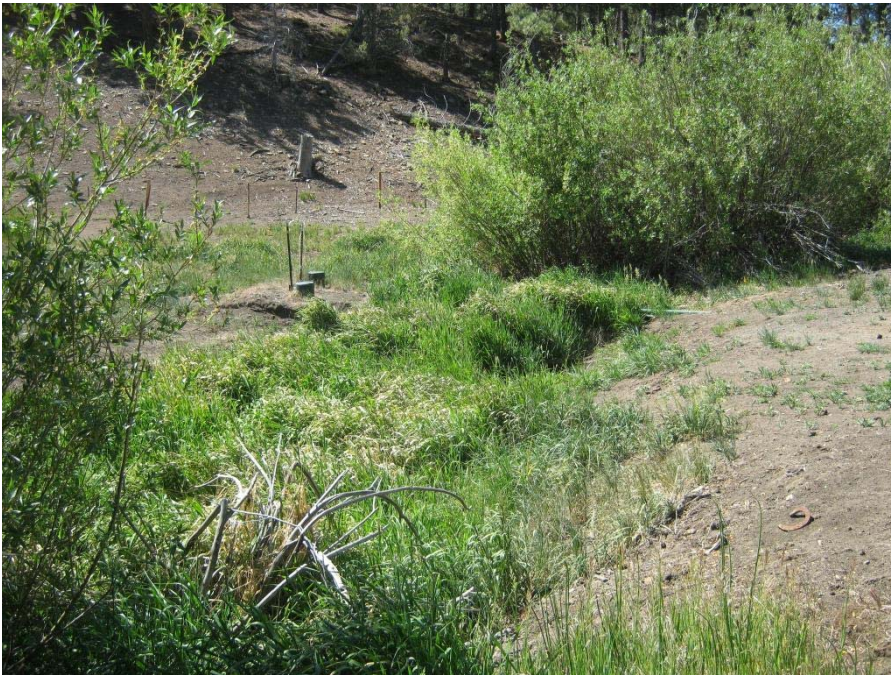
The Site appears to be restored to its original condition of 0.021 acres of palustrine emergent wetlands and 0.025 acres of water below the OHWM. Due to drought conditions during 2012, the vegetation at the Site appears to be slightly more stressed than would be observed under normal precipitation conditions. Texas Creek did not contain any surface flow from July through December 2012. All special conditions outlined in the verification letter, dated May 27, 2010 have been met; therefore, LTE recommends discontinuing monitoring of this Site.

Photograph 2: 6/13/12: View of Texas Creek to the east 3 years after temporary impacts. Vegetation looks slightly stressed in bed of Texas Creek due to severe lack of precipitation and drought conditions present in 2012.

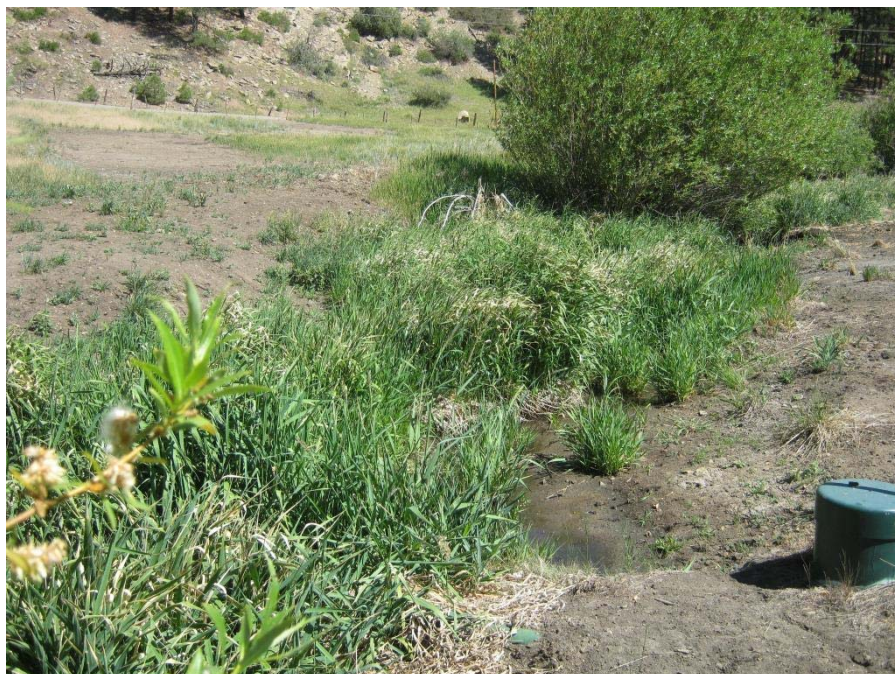
Photograph 3: 6/13/12: View to west of Texas Creek on north bank at location of temporary impact. Vegetation looks slightly stressed in bed of Texas Creek due to severe lack of precipitation and drought conditions present in 2012.

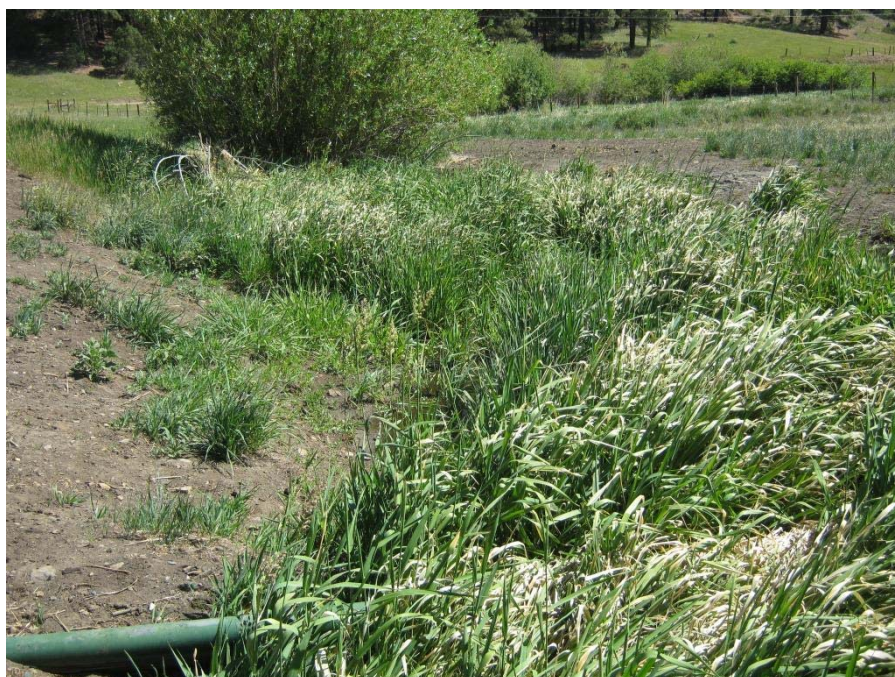
Photograph 4: 6/13/12: view to west of Texas Creek on south bank at location of temporary impact. Vegetation looks slightly stressed in bed of Texas Creek due to severe lack of precipitation and drought conditions present in 2012.
