Memorandum

To: Well File **COMPASS EXPLORATION, INC.**
BONDAD #3-1

From: Mark Weems, P.E. **SENE 1 32N 10W**
Regional Engineer - SW Colorado **05-067-05191**

Subject: Well Review and Assessment

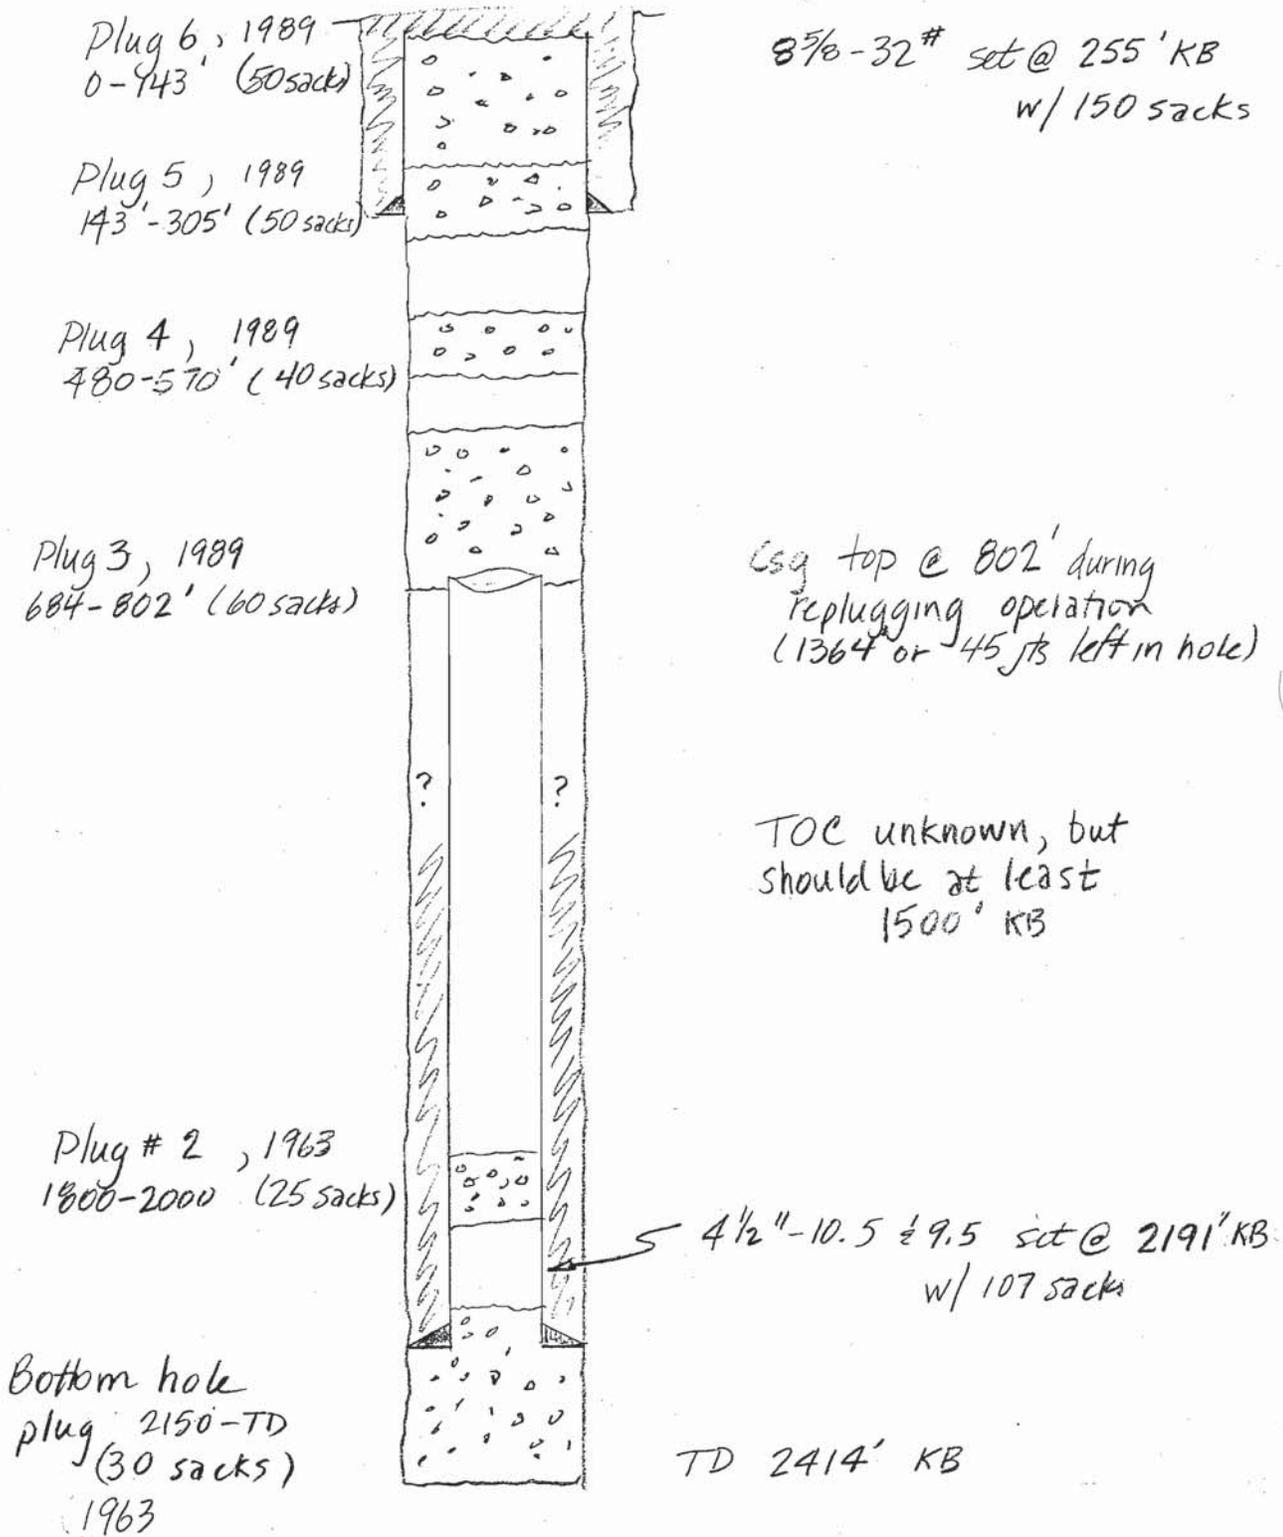
Compass Bondad 3-1 Well Sketch

Tested @ 1500psi @ surface, 11/13/89, no bleed off, no sign of gas
