Parachute Valley Gathering System Release, Project #2120

Date: 03-19-2013

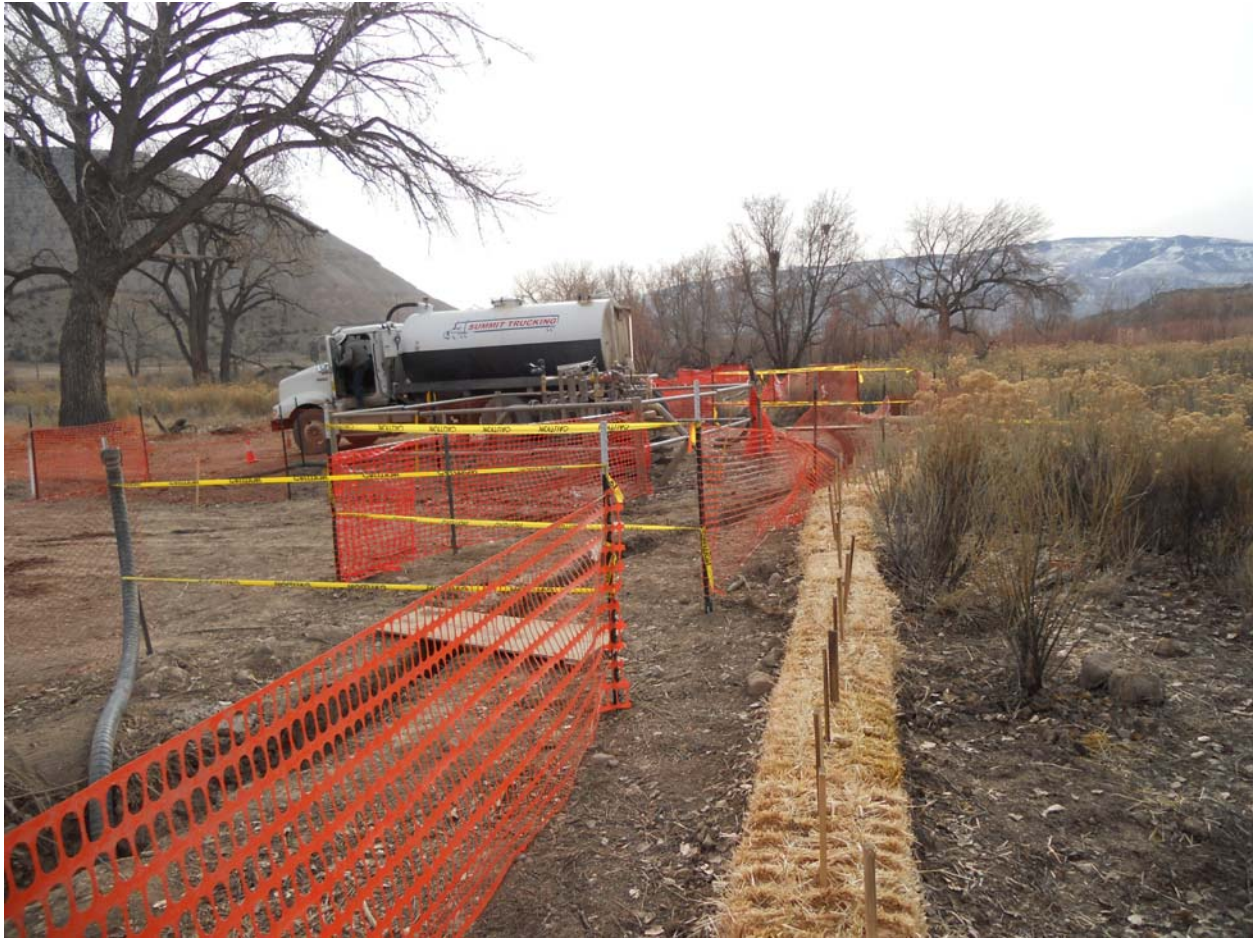
File Name: 2120_dda_03-19-2013-01

Description: Interceptor trench with fencing and stormwater BMP (hay bales); above-ground facilities, including piping, valves, and gauges associated with natural gas liquids (NGL) line and vacuum truck in background; vacuum hose (not in use) in left foreground.

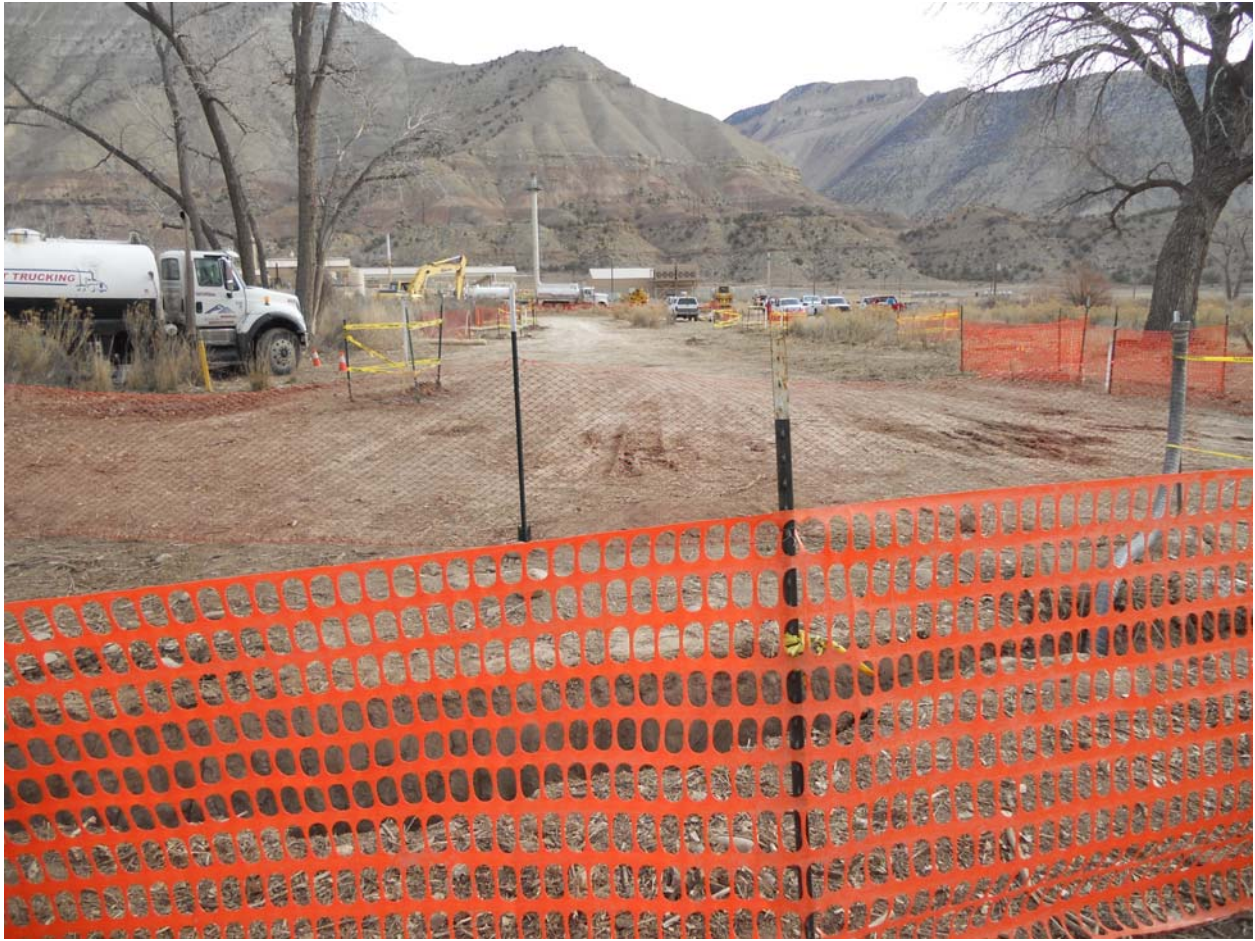
File Name: 2120_dda_03-19-2013-02

Description: View across interceptor trench, along access road to southern end of gas plant in background; pothole hydrojet excavations delineated with caution tape along both sides of access road; vacuum truck on the left; vacuum hose (not in use) on right.

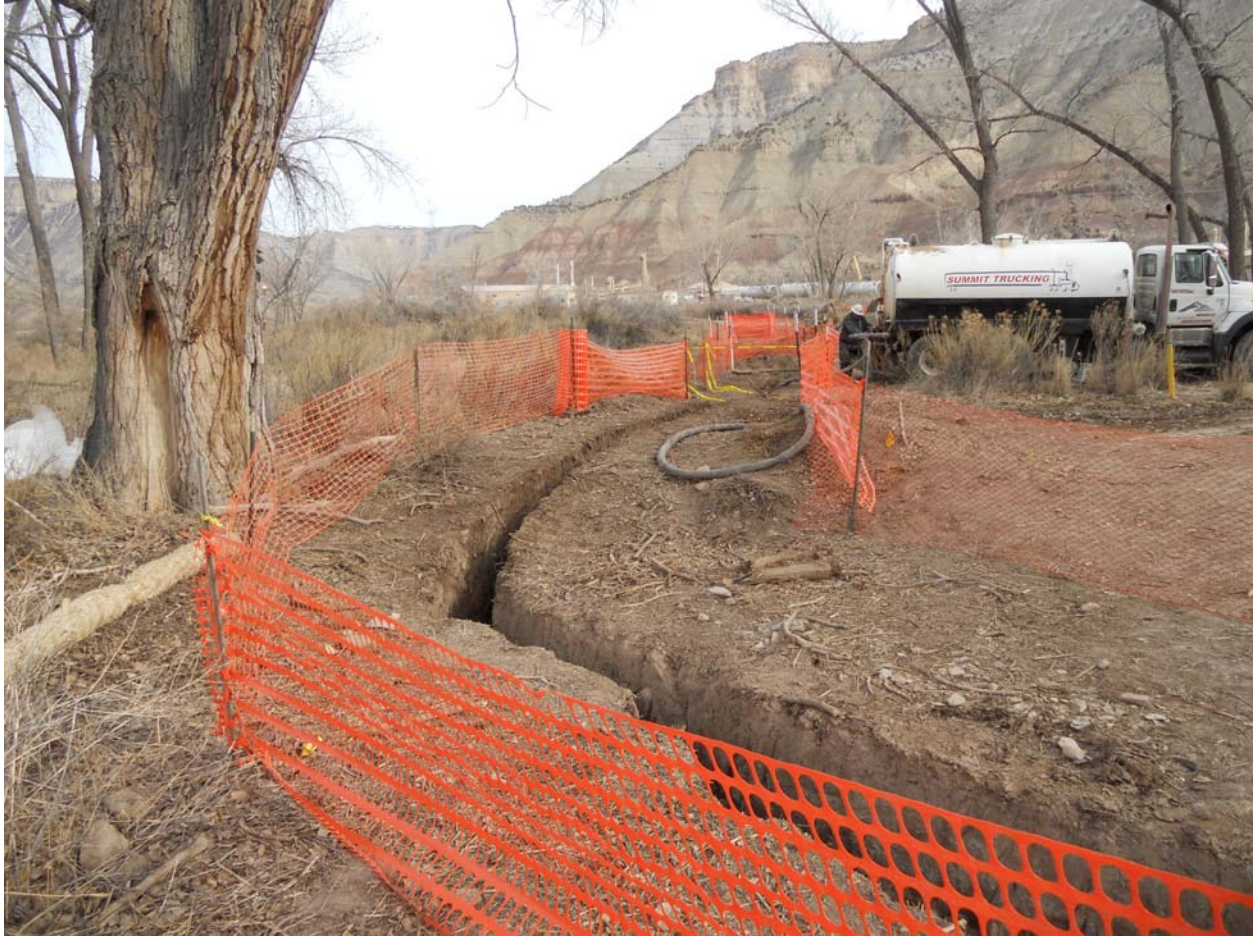
File Name: 2120_dda_03-19-2013-03

Description: View along interceptor trench, which changes direction from northwest-southeast (in foreground) to north-south (in background); distant view of north end of gas plant; vacuum truck on right.

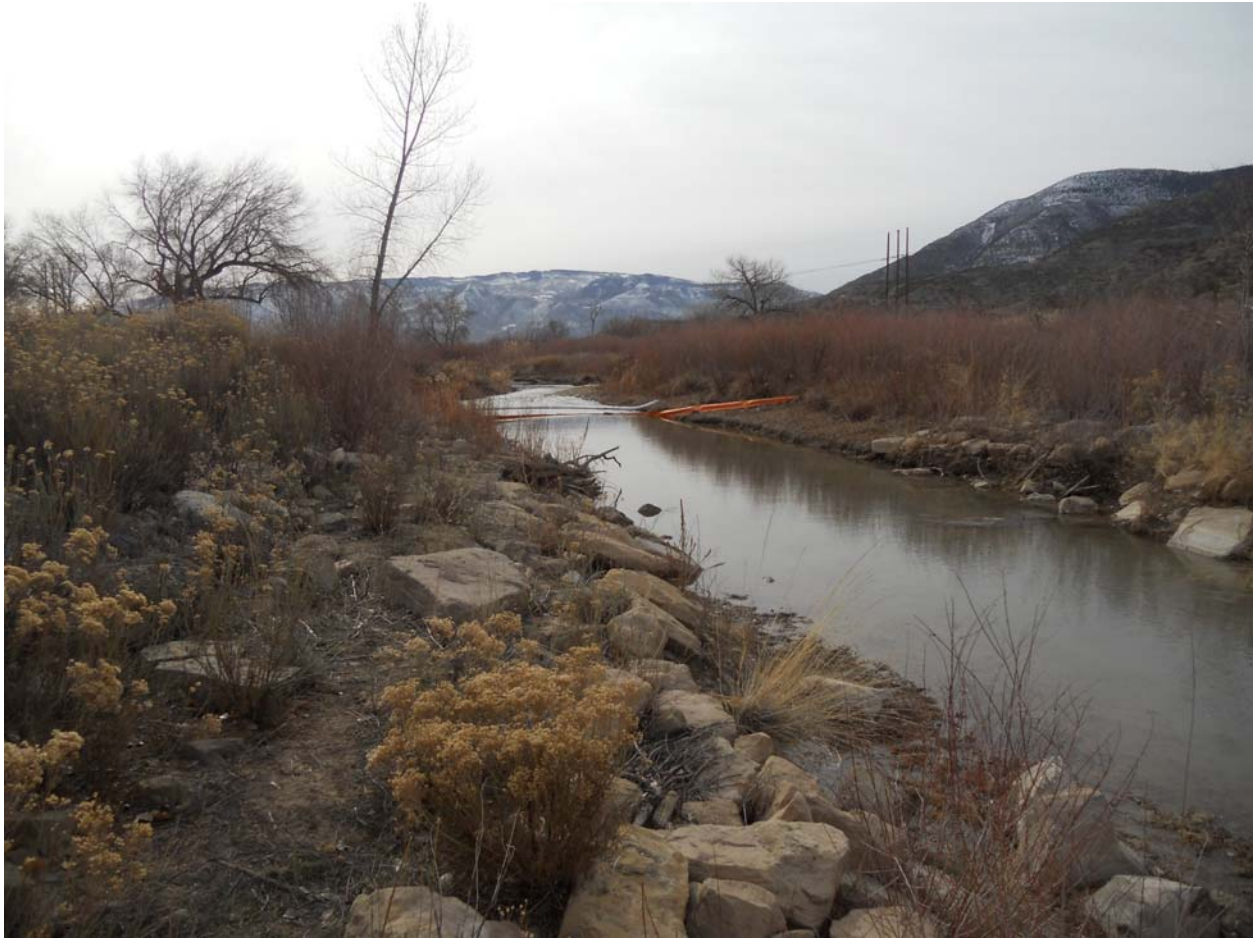
File Name: 2120_dda_03-19-2013-04

Description: View of Parachute Creek, looking downstream at precautionary absorbent booms.

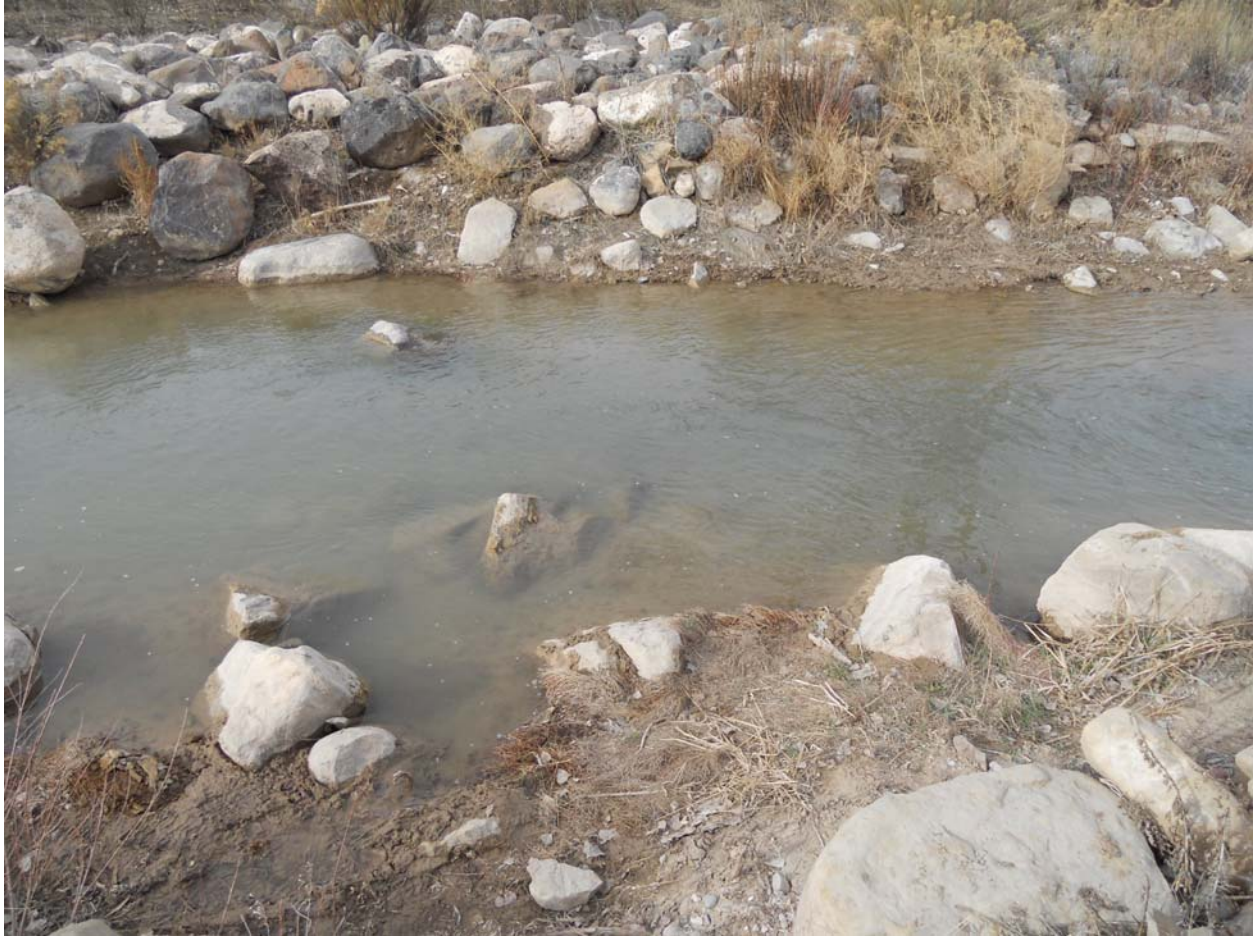
File Name: 2120_dda_03-19-2013-05

Description: View of Parachute Creek, adjacent to active remediation area. No visual indications of impact.

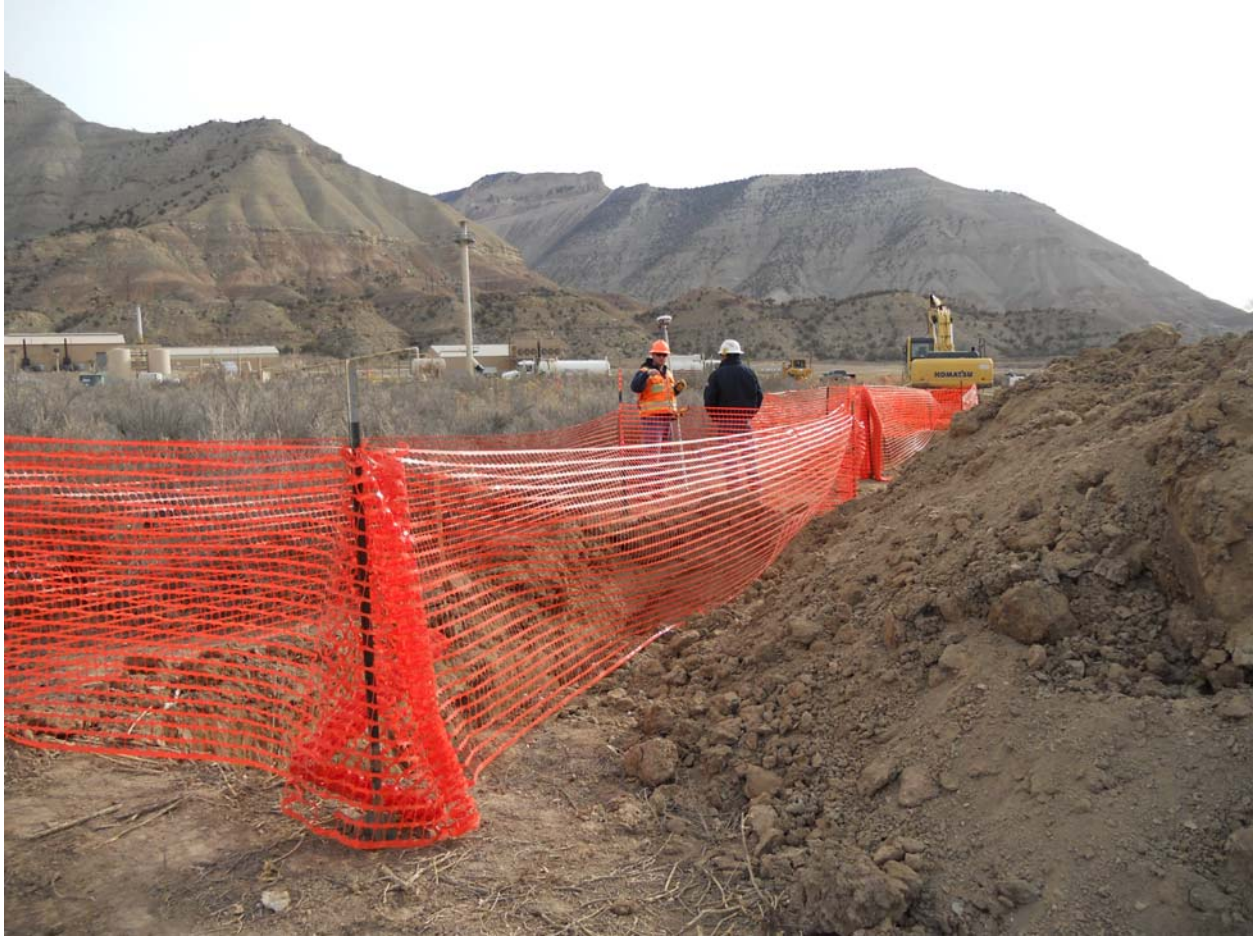
File Name: 2120_dda_03-19-2013-06

Description: View of newest delineation trenches, located north of active remediation area; surveyor standing between trenches; southern portion of gas plant in background.

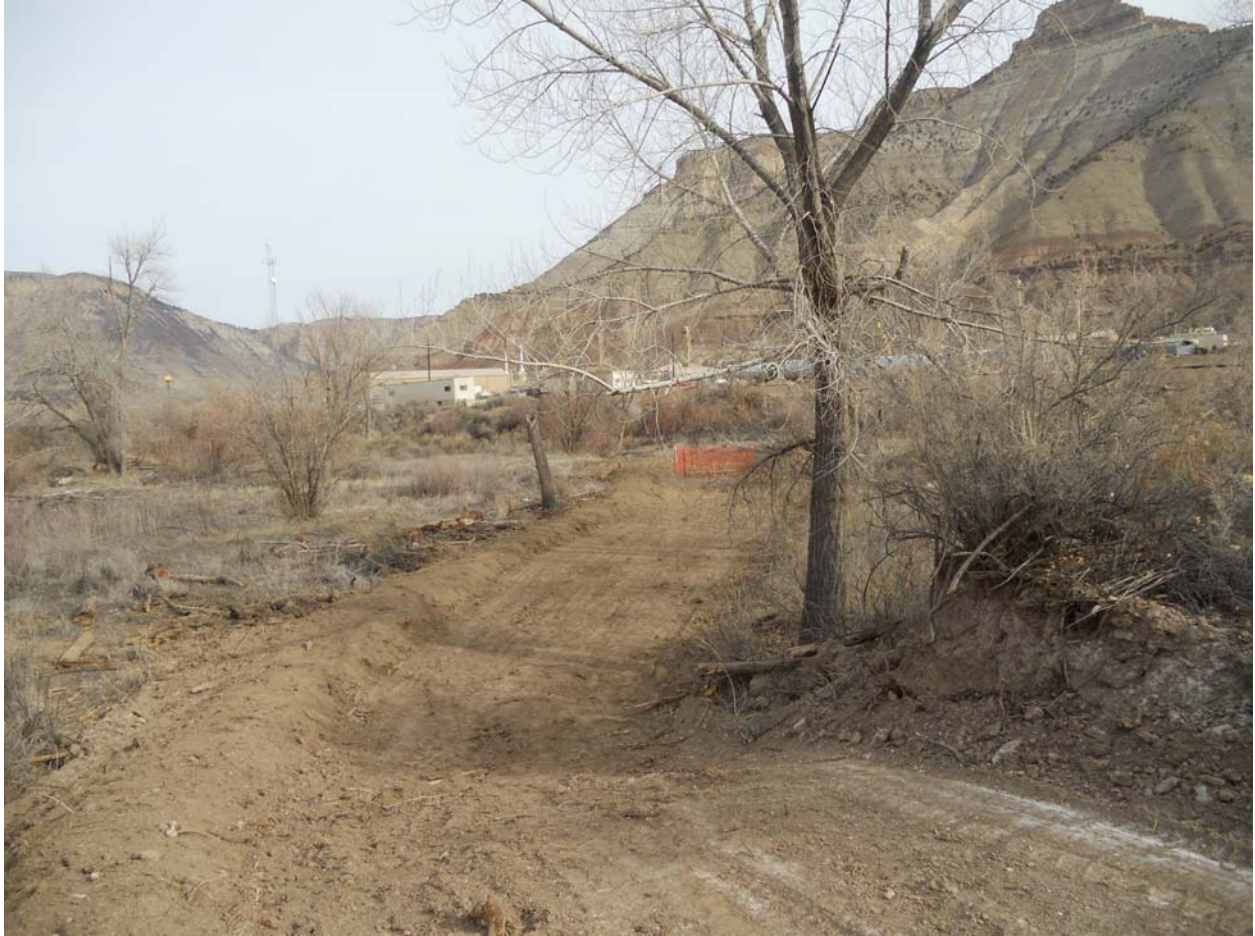
File Name: 2120_dda_03-19-2013-07

Description: View of northernmost trench, located in a low-lying area, a few hundred feet north of active remediation area; northern end of gas plant in background.

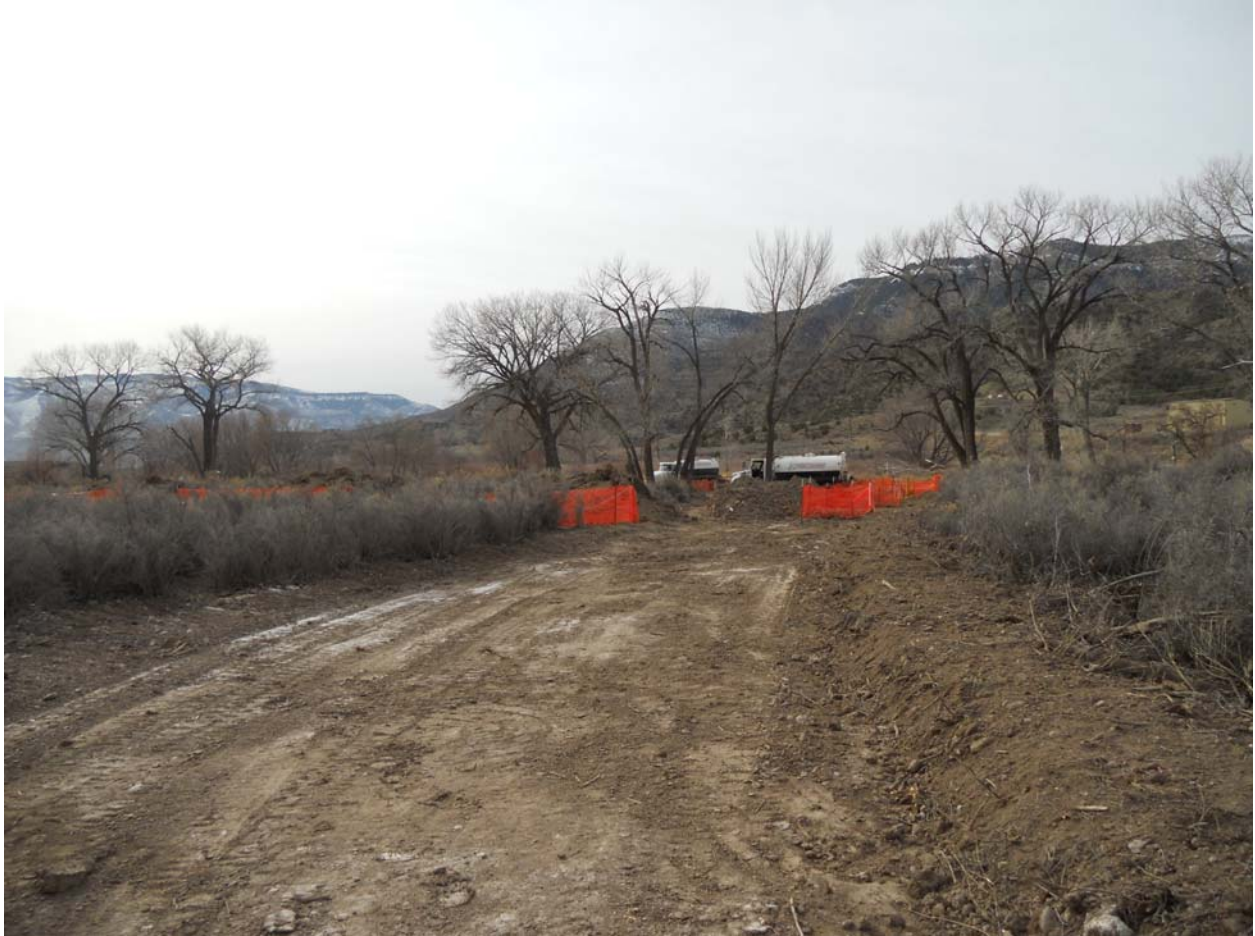
File Name: 2120_dda_03-19-2013-08

Description: Distant view of delineation trenches and active remediation area.

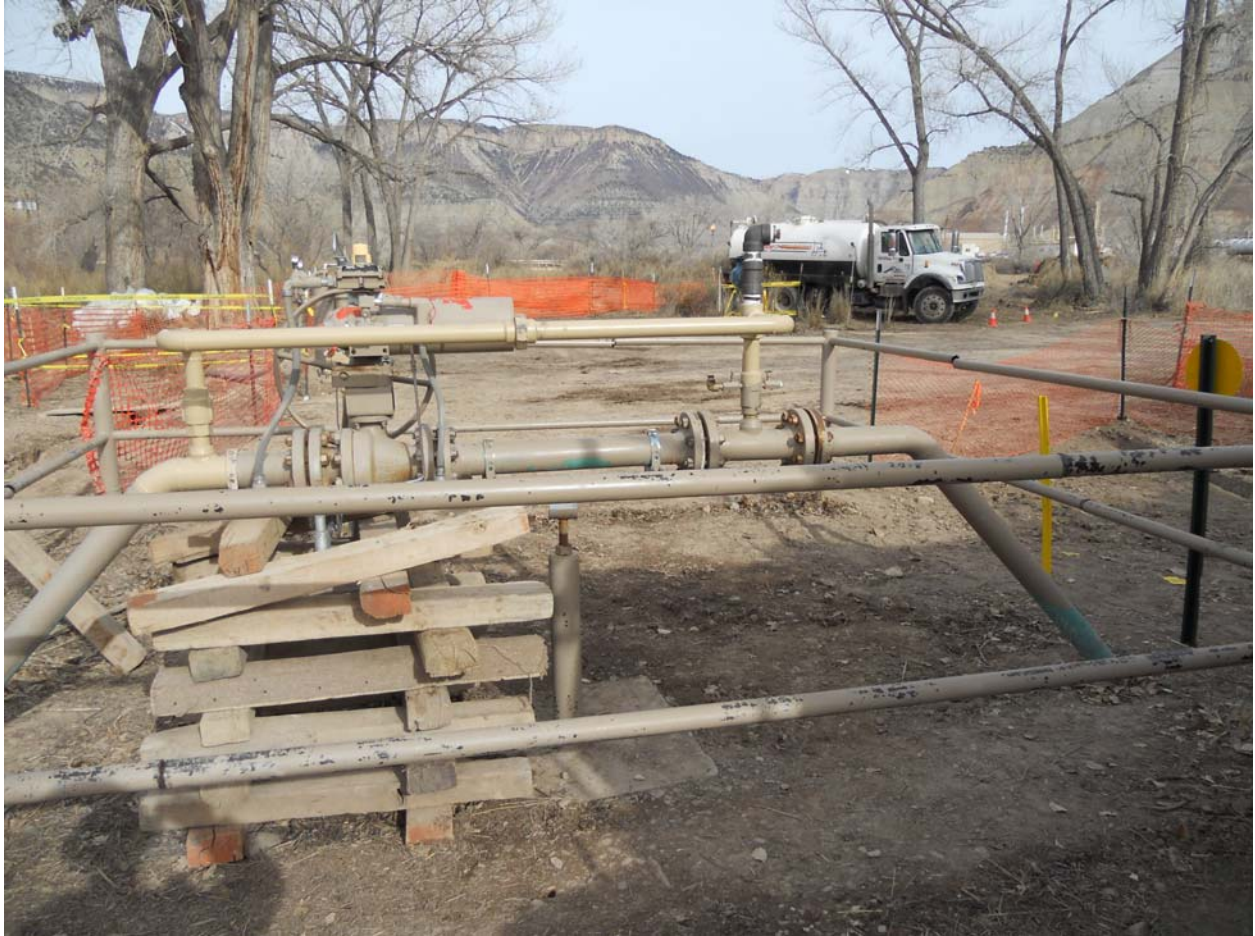
File Name: 2120_dda_03-19-2013-09

Description: Above-ground facilities, including piping, valves, and gauges associated with NGL line, located adjacent to interceptor trench; gauge connection, which was the source of a non-reportable release, located below the black elbow in the upper right; protective barrier pipes have been cut, and flanged connections (on left) have been blocked and supported in preparation for excavation below flanged connections on right; vacuum truck in background.

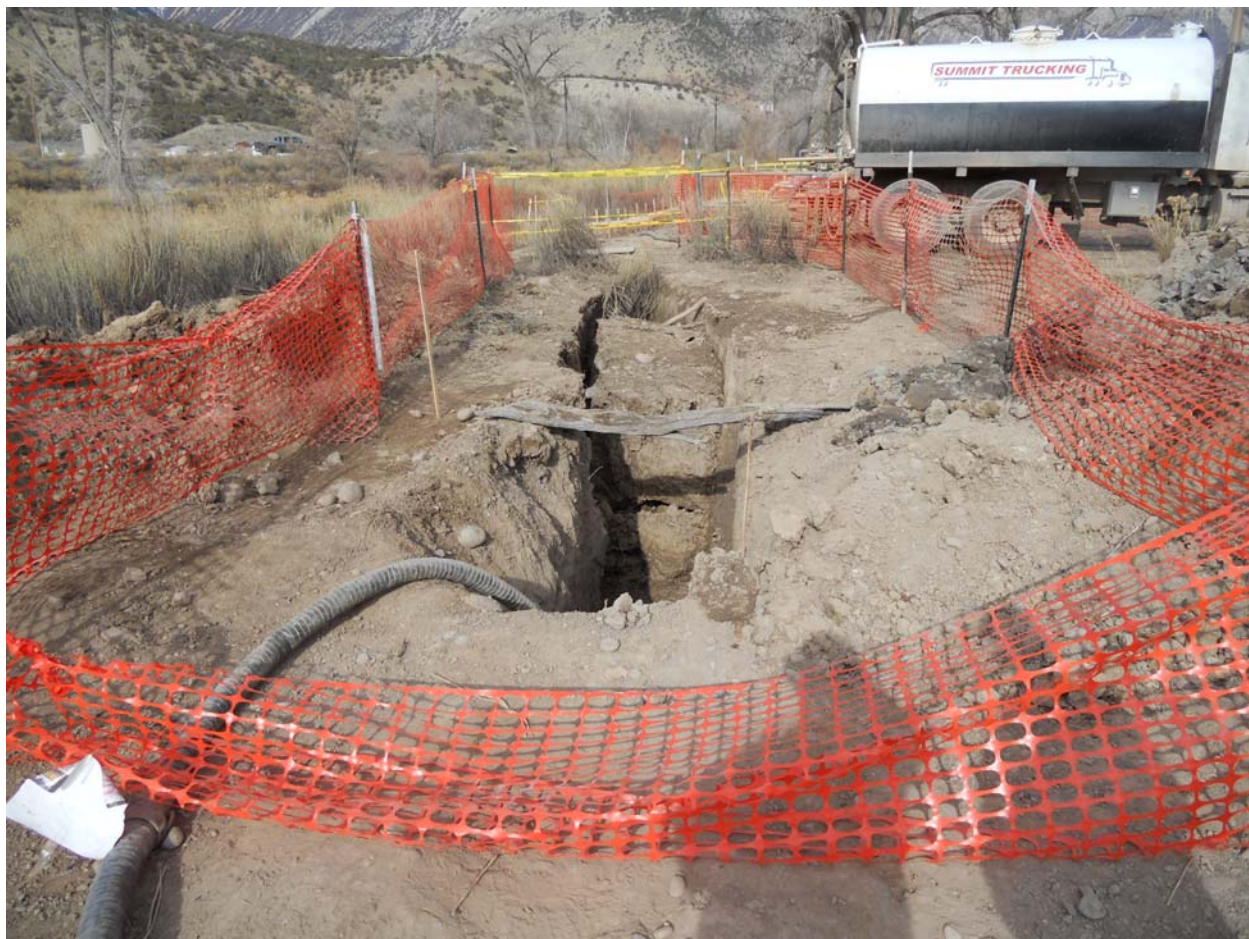
File Name: 2120_dda_03-19-2013-10

Description: View of slump block in interceptor trench at southern end of active remediation area; vacuum truck in background on right.

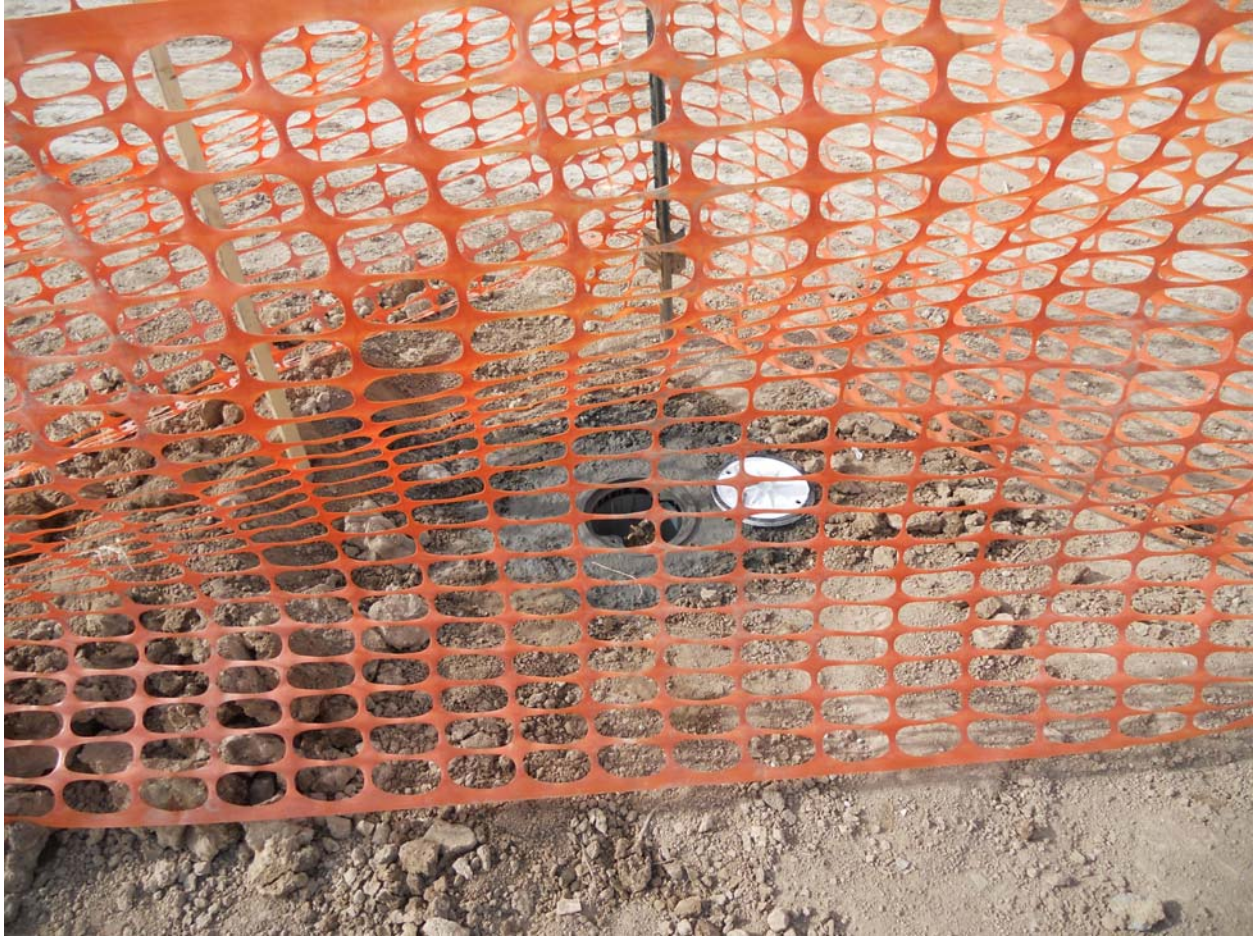
File Name: 2120_dda_03-19-2013-11

Description: View of newly installed groundwater monitoring well, located up-gradient of active remediation area, near well pad and tank battery.
