Redwine Bond Claim, South Nucla Unit 1-32, API No. 05-085-06047

Date: 10-15-2012

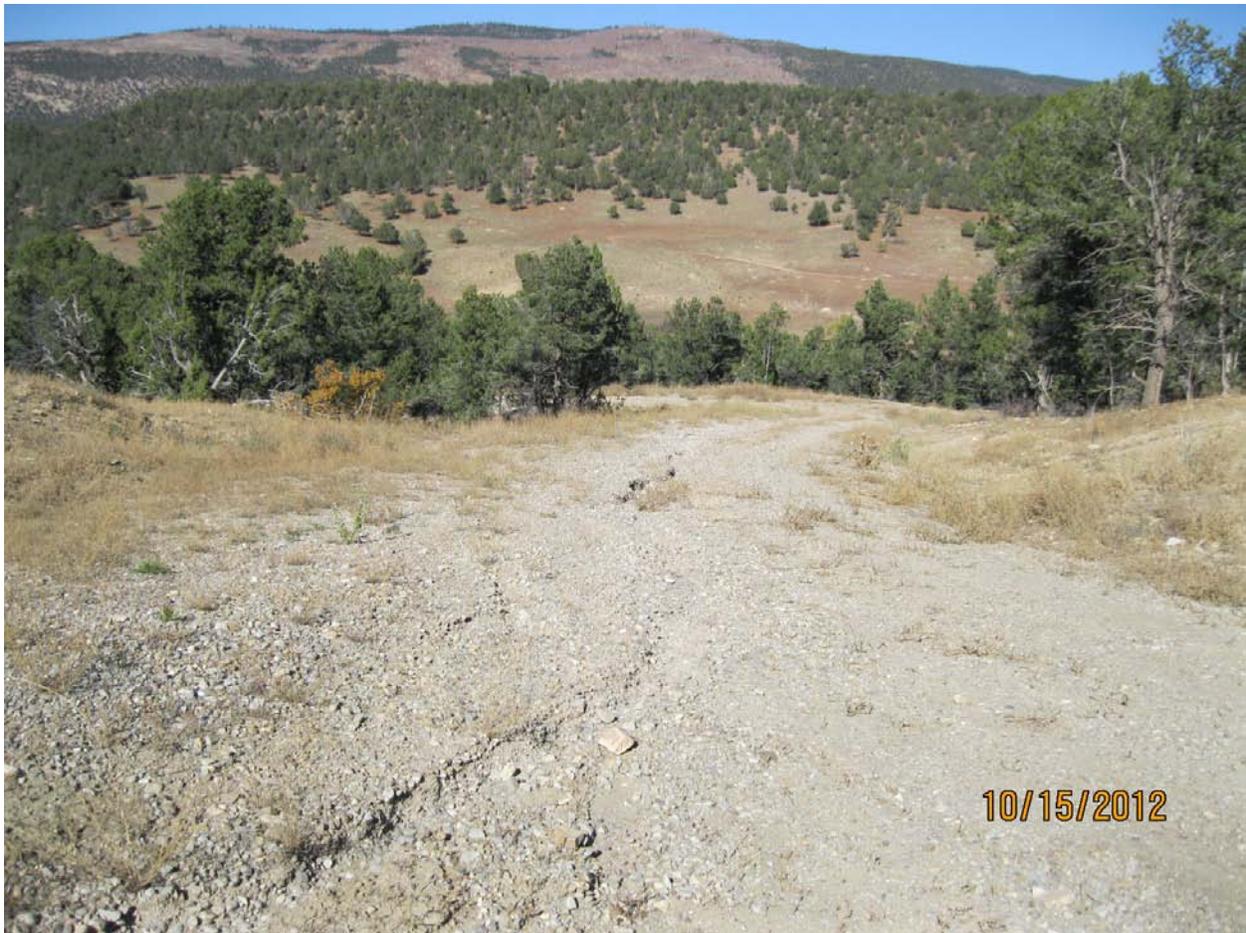
File Name: SNU1-32_dda_10-15-2012-01

Description: Erosion along access road, taken near top of access road near northwest corner of well pad.

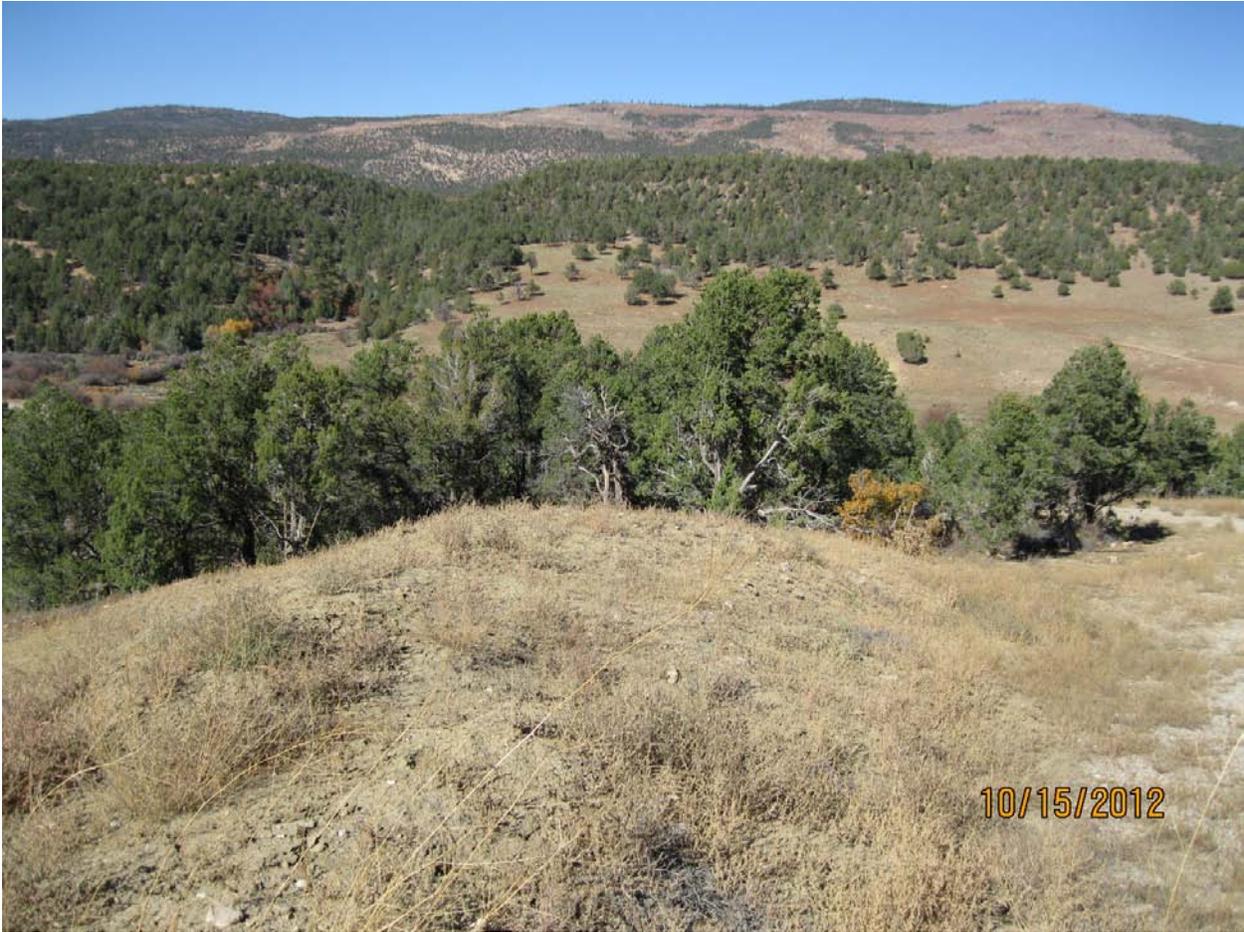
File Name: SNU1-32_dda_10-15-2012-02

Description: View from northwest corner of pad; weeds on pad perimeter berm.

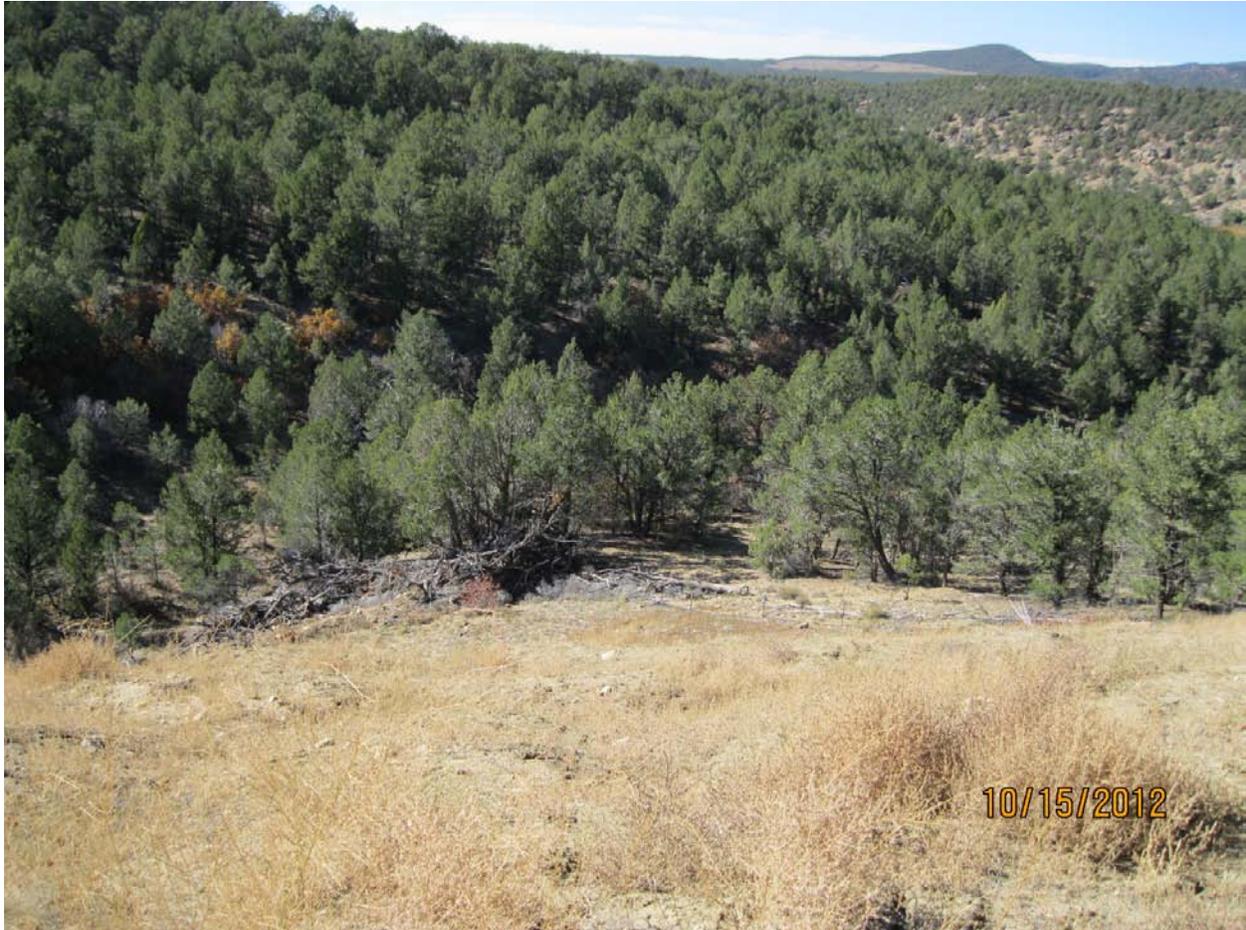
File Name: SNU1-32_dda_10-15-2012-03

Description: View downslope to drainage, which runs from south to north along toe of fill slope on west side of pad; weeds on fill slope with debris pile near toe of slope.

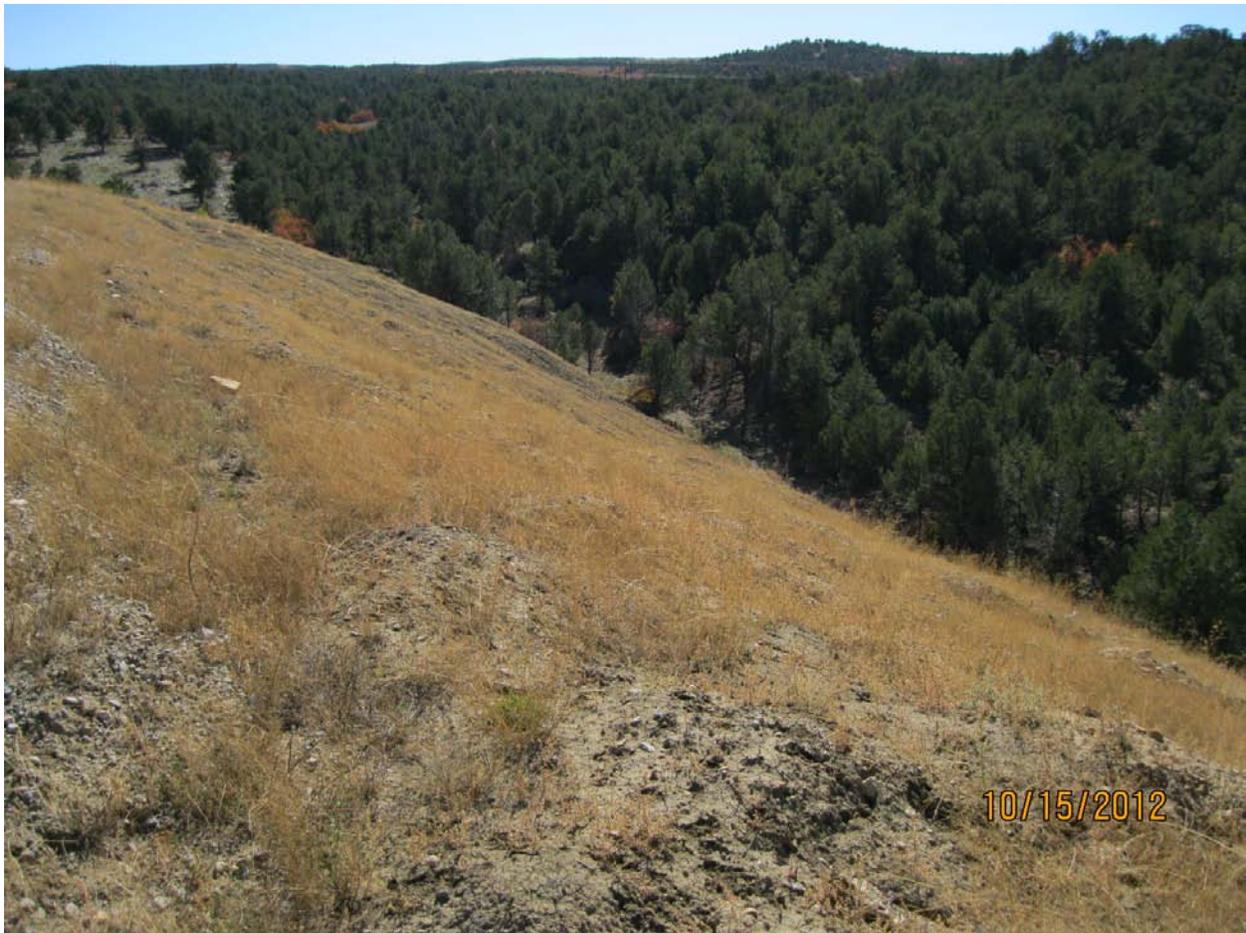
File Name: SNU1-32_dda_10-15-2012-04

Description: View of fill slope on west side of pad and adjacent drainage, taken from the northwest corner of the pad; weeds on fill slope.

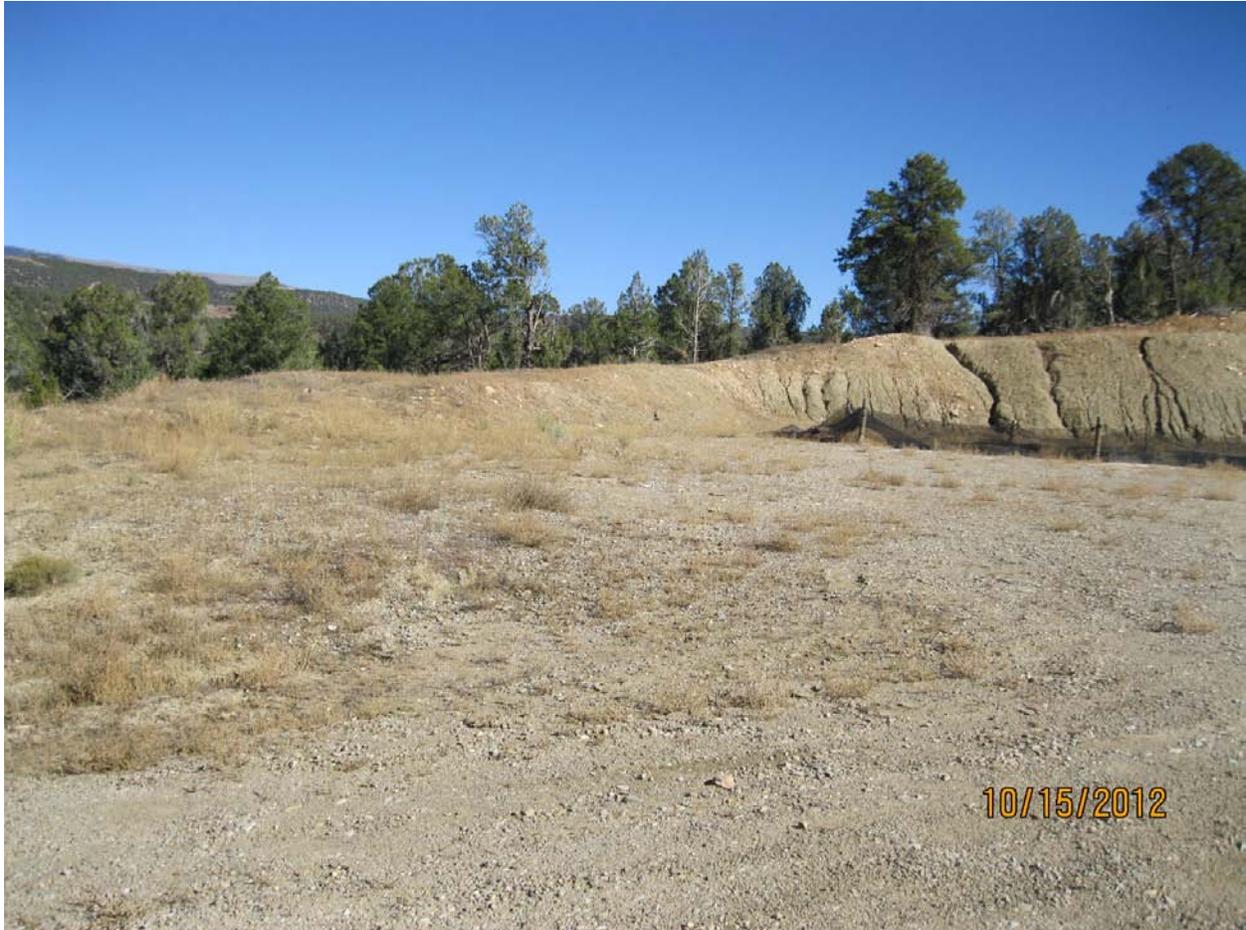
File Name: SNU1-32_dda_10-15-2012-05

Description: View of northern edge of pad with weeds on fill; erosion on cut face and netting over pit in upper right.

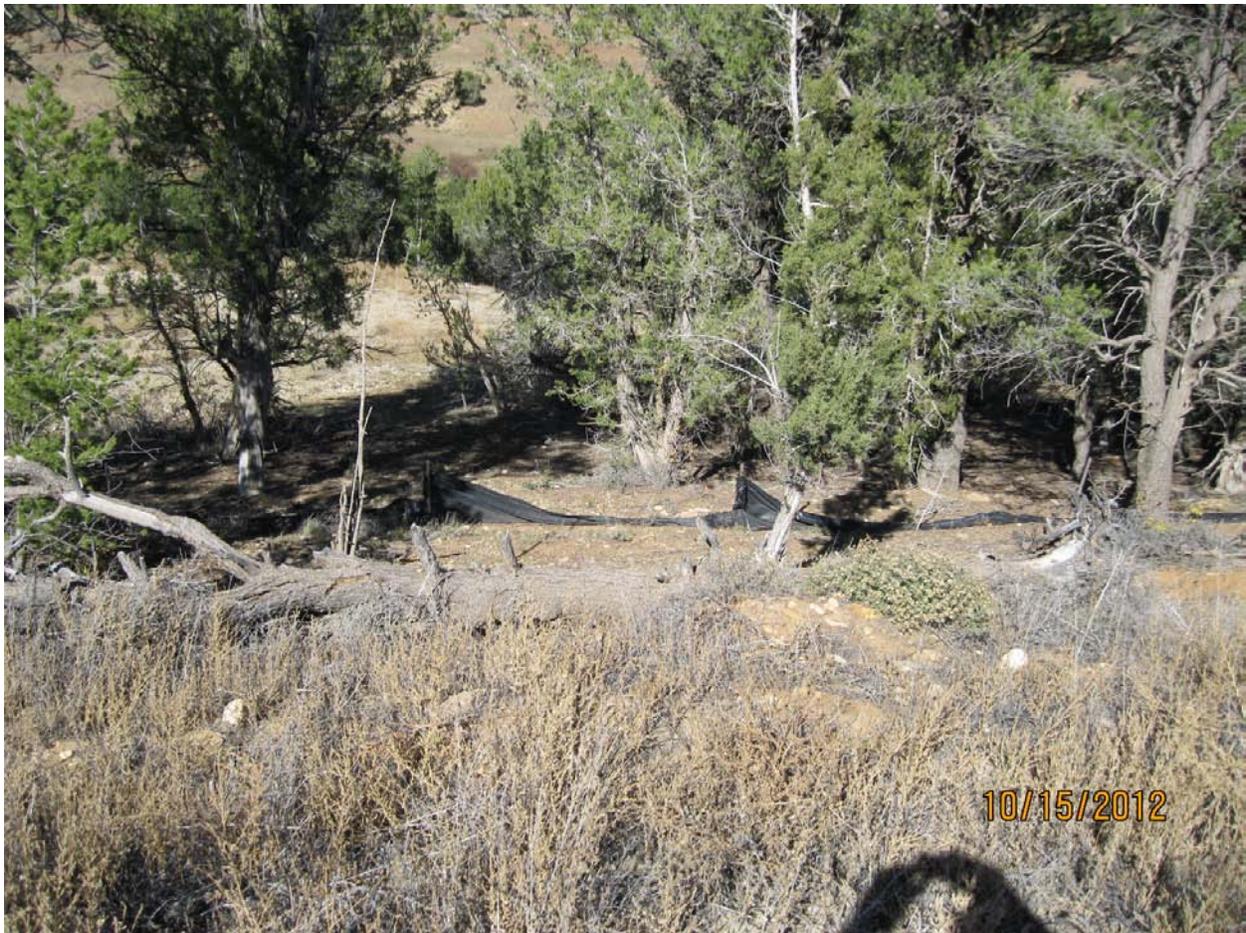
File Name: SNU1-32_dda_10-15-2012-06

Description: View of silt fence in disrepair downslope and to the north of the pad, taken near the northeast corner of the pad.

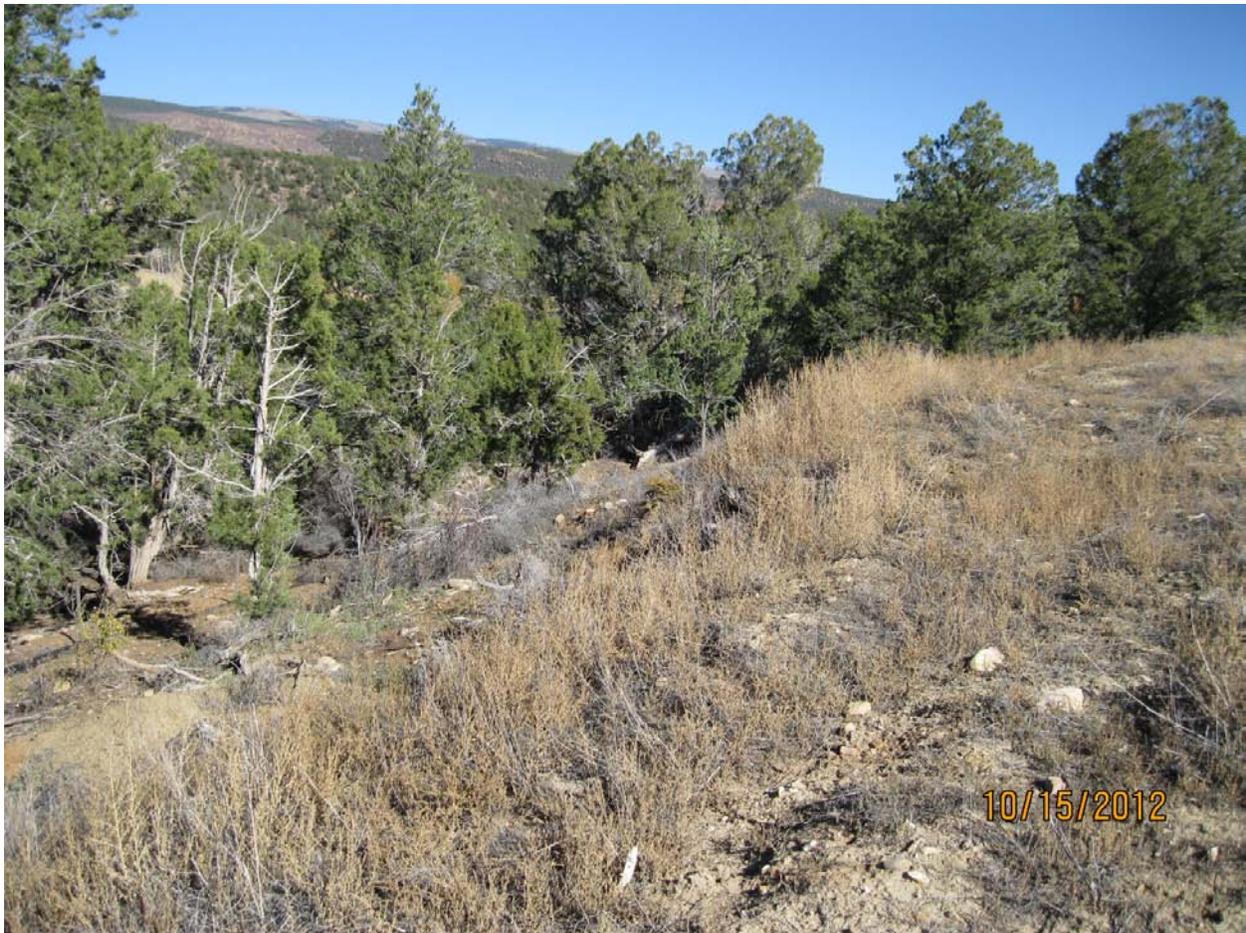
File Name: SNU1-32_dda_10-15-2012-07

Description: Weeds on fill at the northeast corner of the pad; silt fence in disrepair in background.

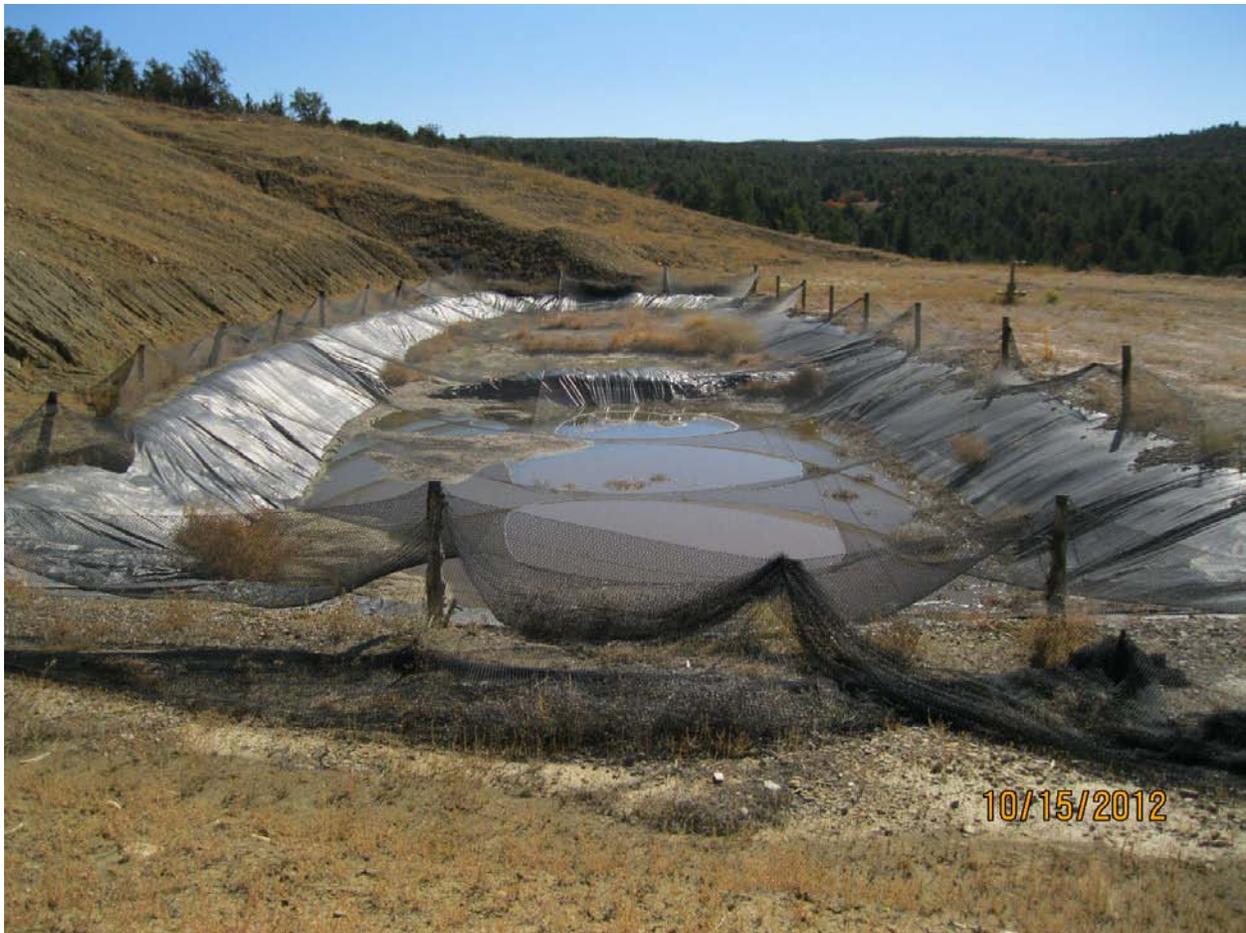
File Name: SNU1-32_dda_10-15-2012-08

Description: Lined drilling pit with netting; netting under water in several places, with gaps allowing access to pit along the perimeter; water present in northern end of pit (foreground), but mostly evaporated on southern end; wellhead in background on right; erosion along cut slope on left.

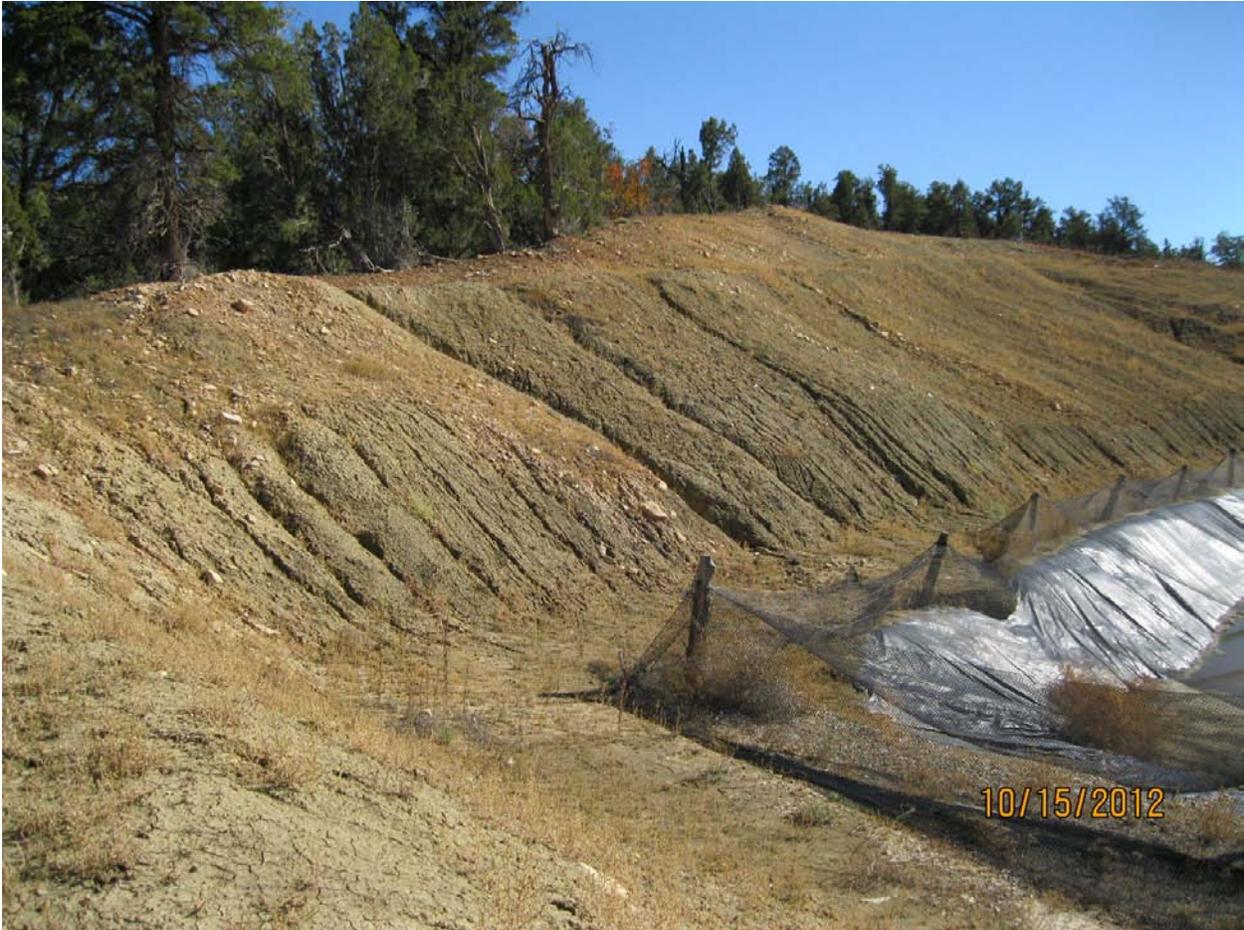
File Name: SNU1-32_dda_10-15-2012-09

Description: Northeast corner of pit and erosion along cut slope.

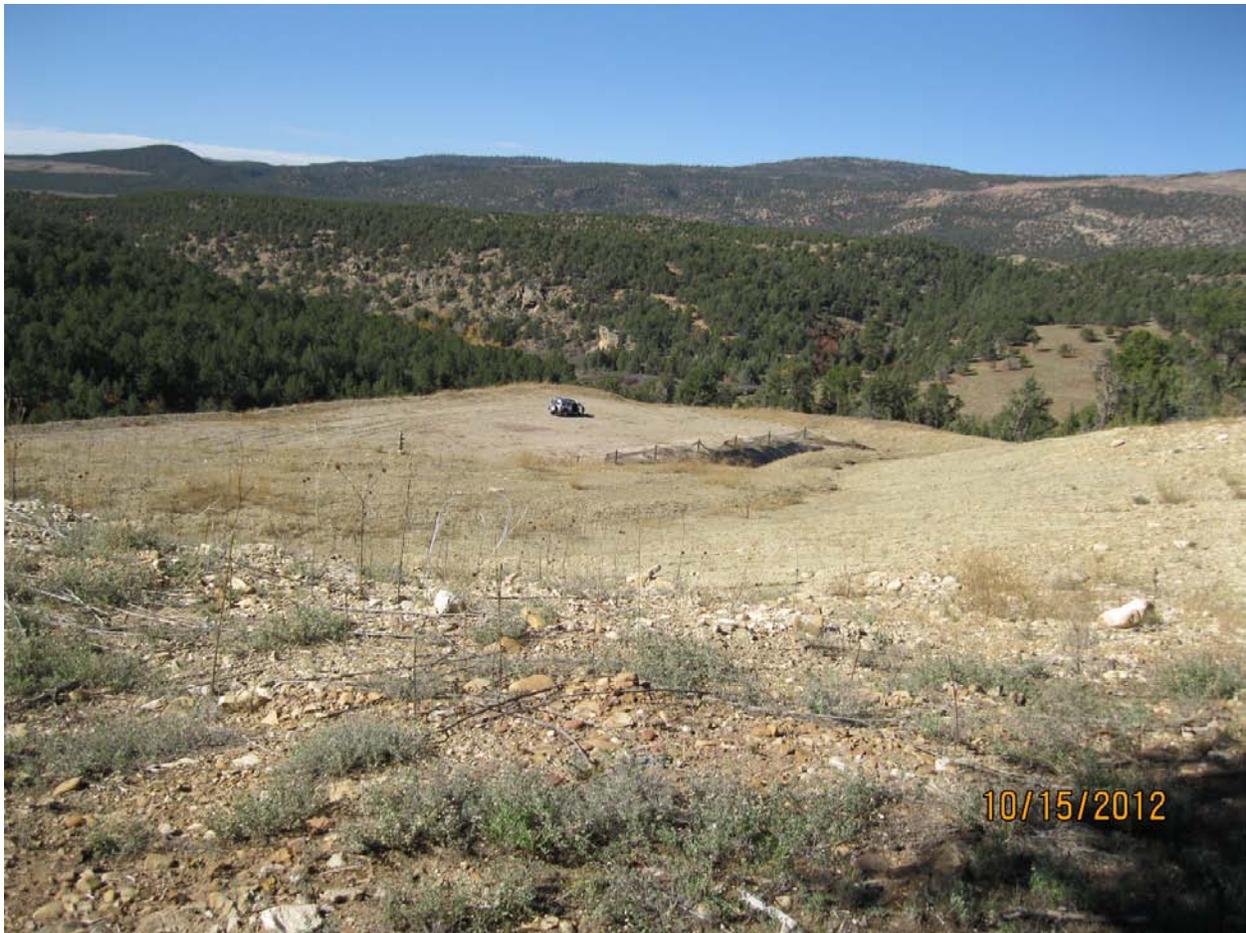
File Name: SNU1-32_dda_10-15-2012-12

Description: View of debris pile and weeds near southeast corner of the pad.

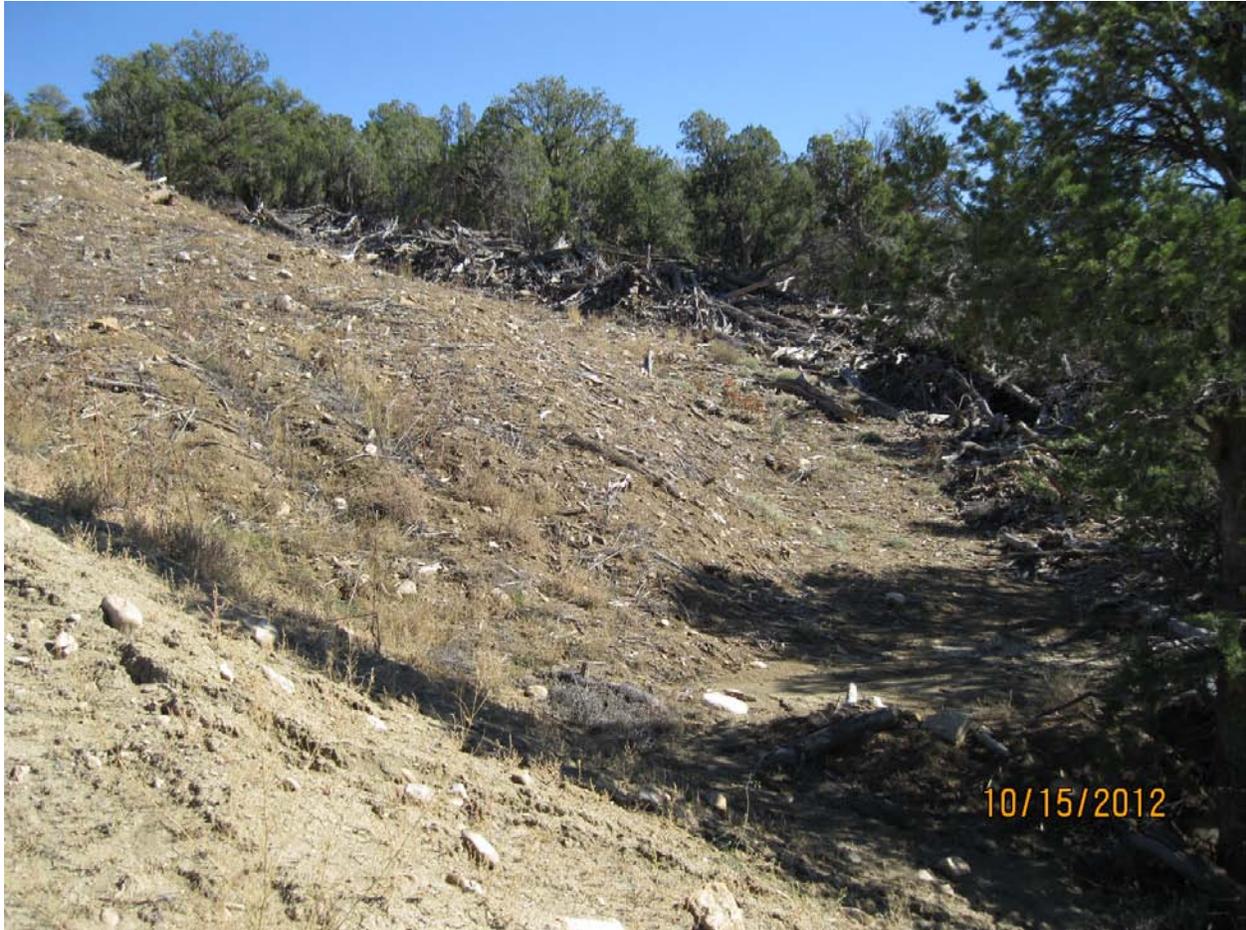
File Name: SNU1-32_dda_10-15-2012-15

Description: Fill slope with weeds and debris pile along southern side of well pad.

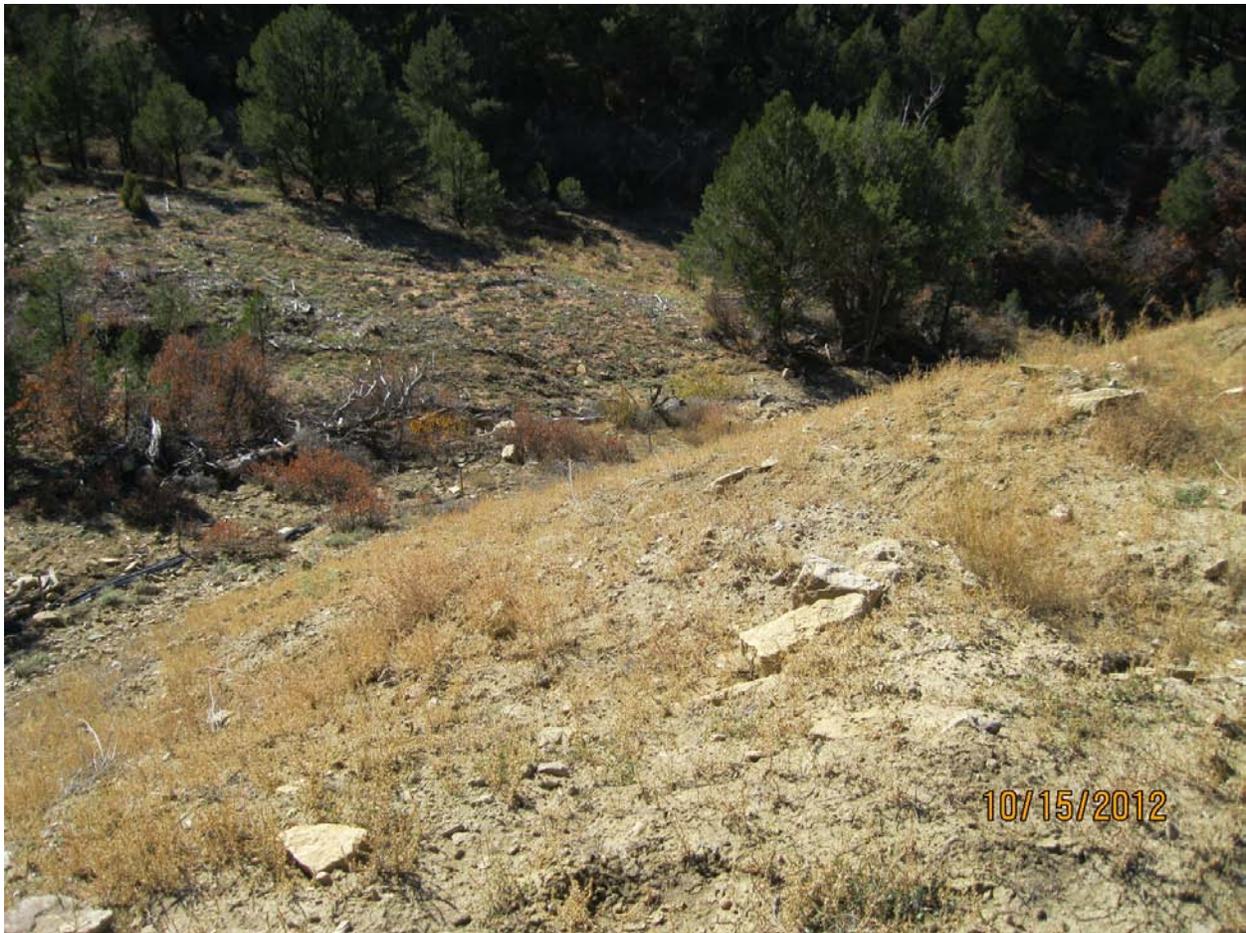
File Name: SNU1-32_dda_10-15-2012-16

Description: Fill slope and weeds; silt fence in disrepair at toe of slope near southwest corner of well pad.

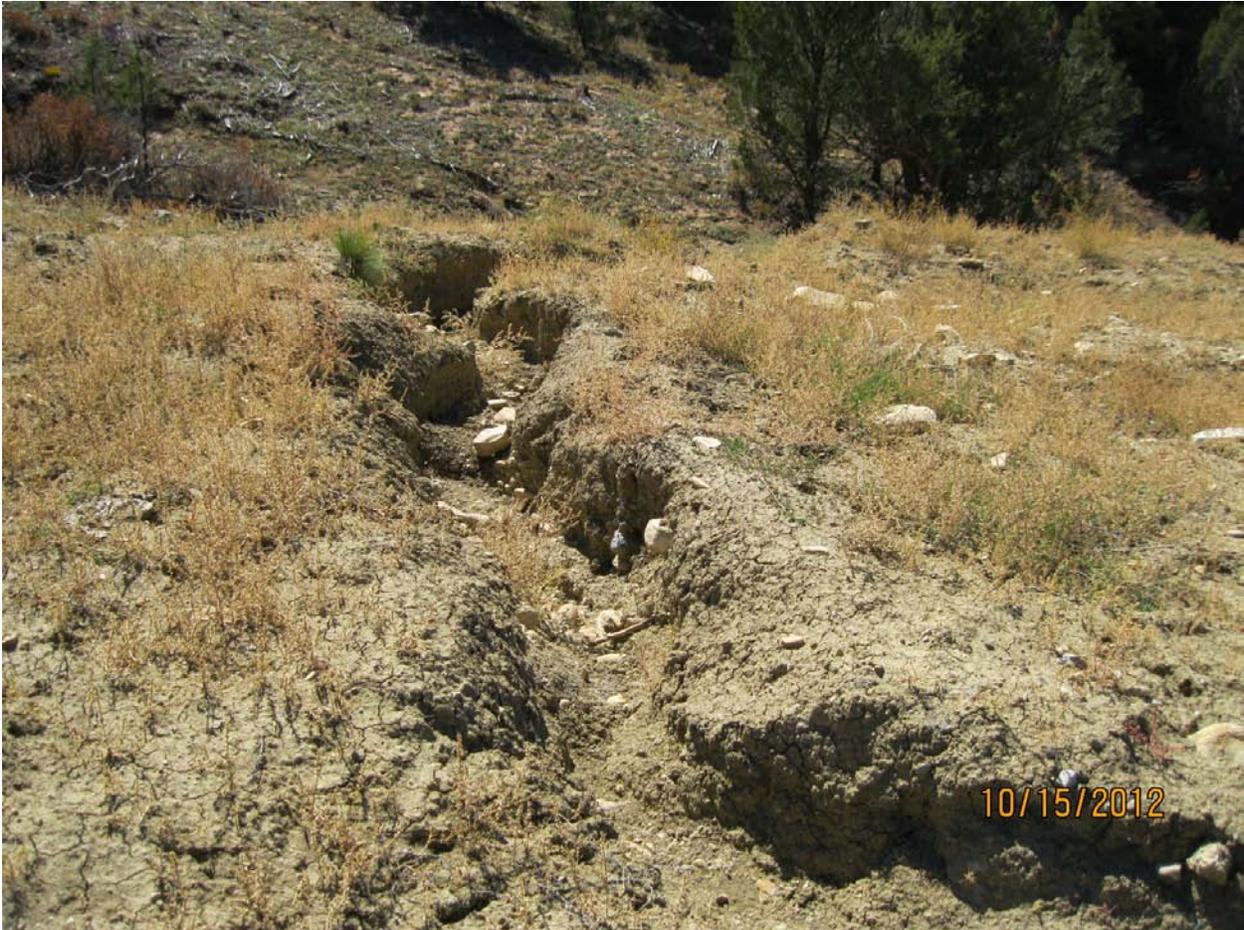
File Name: SNU1-32_dda_10-15-2012-17

Description: Erosion channel in fill slope near southwest corner of well pad.

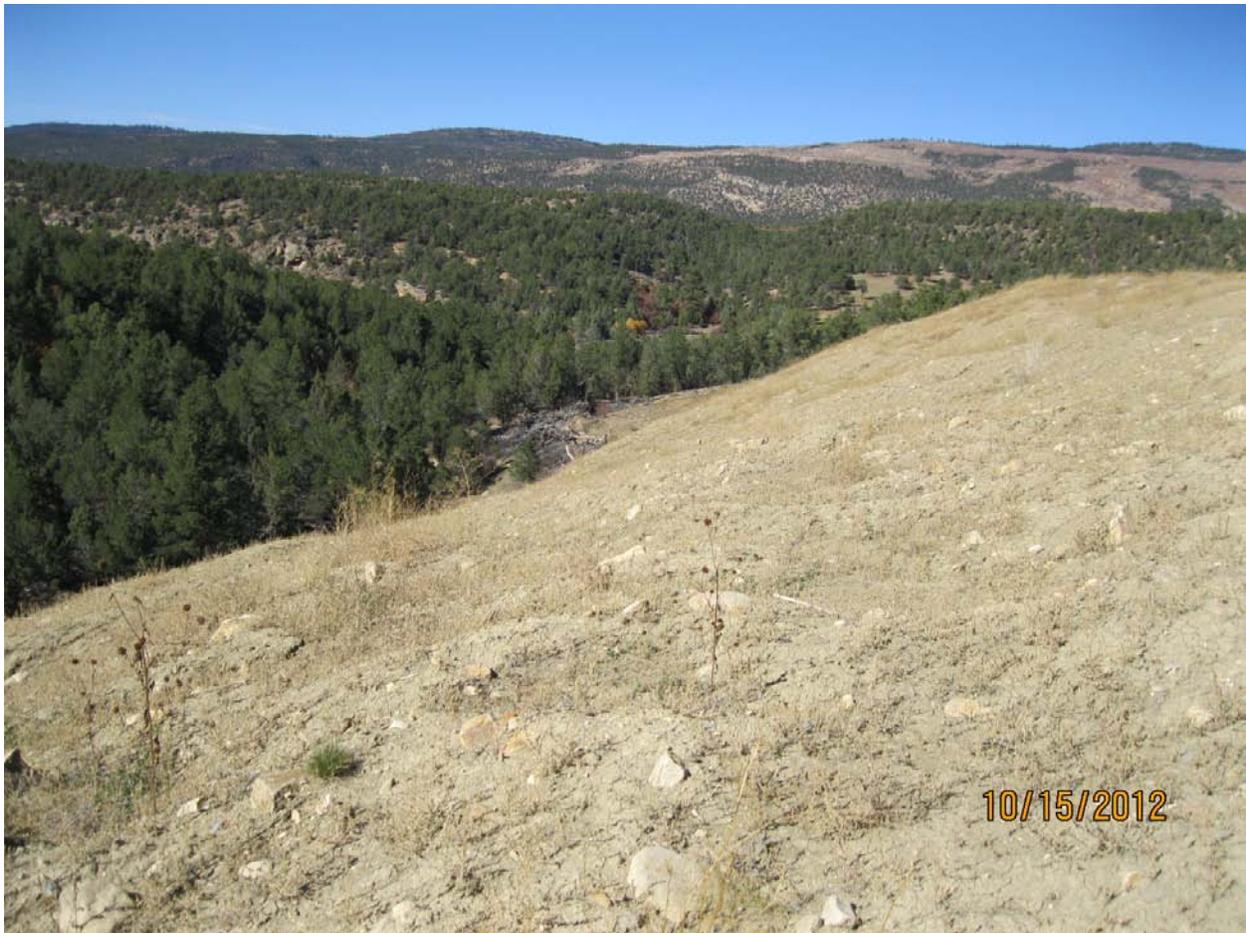
File Name: SNU1-32_dda_10-15-2012-18

Description: Fill slope with weeds along west side of well pad; drainage, running south to north, along toe of fill slope.

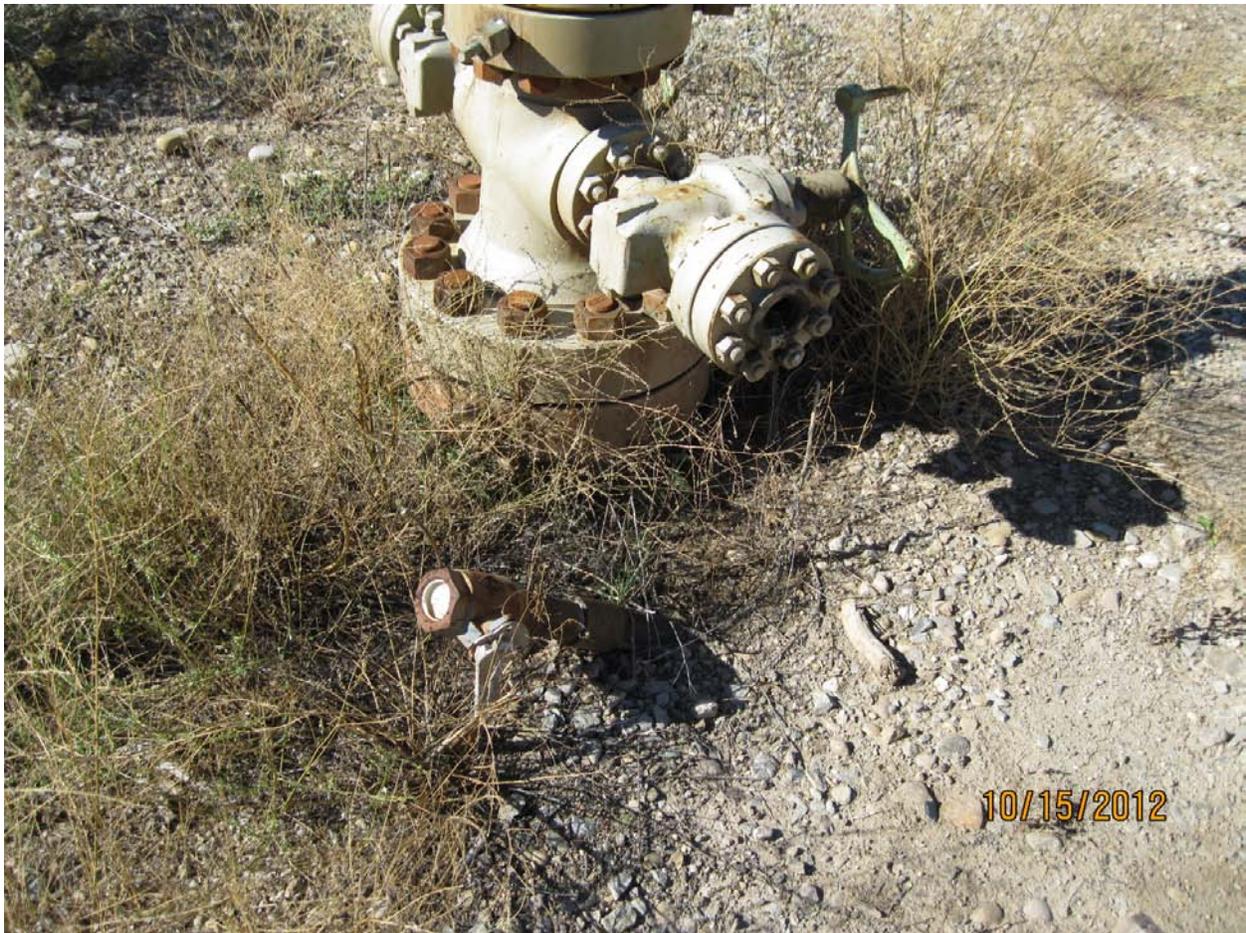
File Name: SNU1-32_dda_10-15-2012-21

Description: Bradenhead valve in foreground and well head in background, surrounded by weeds.

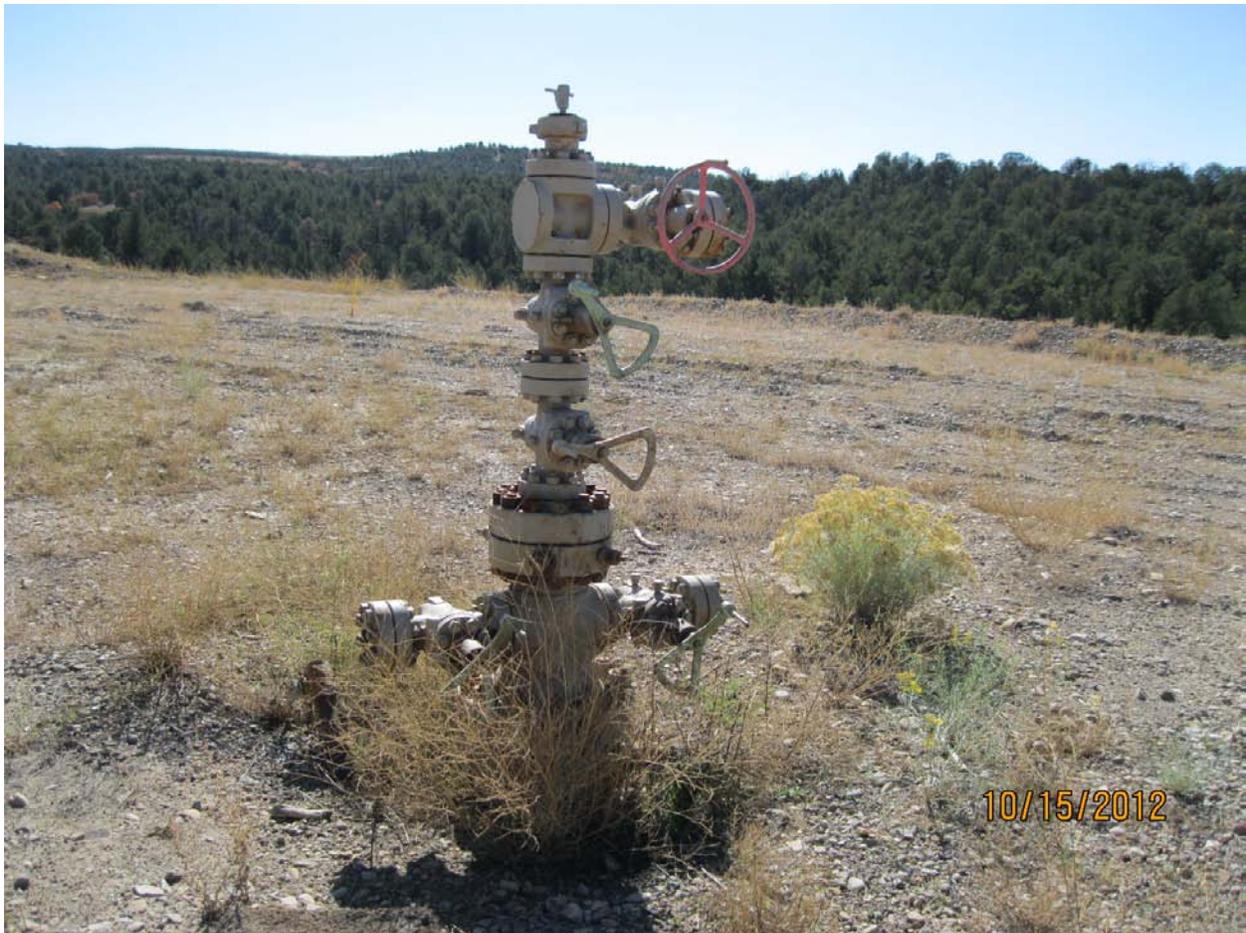
File Name: SNU1-32_dda_10-15-2012-22

Description: Wellhead surrounded by weeds in foreground; marked anchor in background.

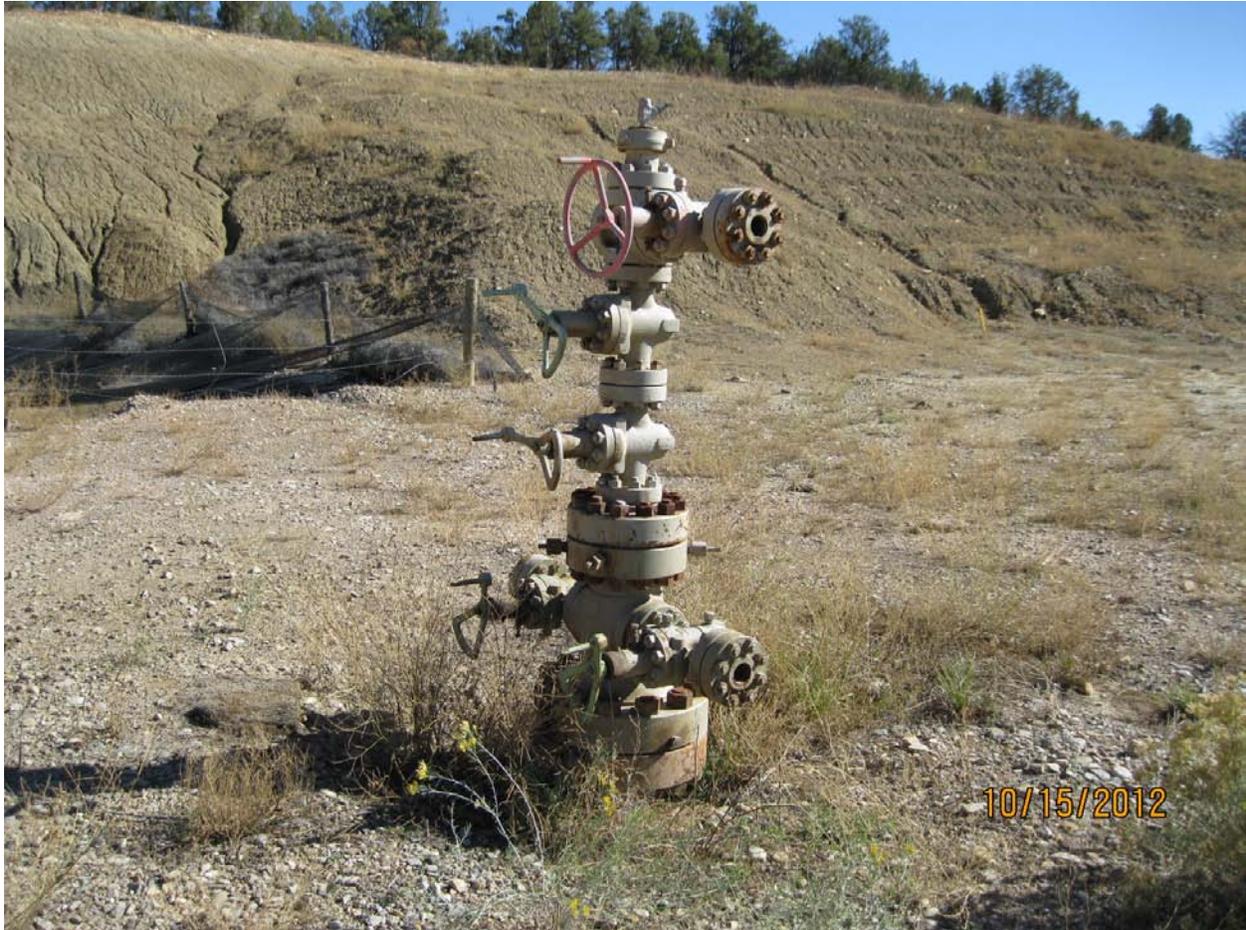
File Name: SNU1-32_dda_10-15-2012-23

Description: Wellhead surrounded by weeds in foreground; drilling pit, eroded cut slope, and marked well anchor in background.
