SITE INVESTIGATION AND REMEDIATION WORKPLAN

OGCC Operator Number: 10335	Contact Name and Telephone:
Name of Operator: Axia Energy, LLC	Jess Peonio
Address: 1430 Larimer St - #400	No: (720) 746-5212
City: Denver State: CO Zip: 80202	Fax: (720) 746-5200
API Number: NA - Facility	County: Moffat
Facility Name: Bulldog #5-31H-790 Completion Pit	Facility Number: COGCC Pit #429725
Well Name: NA	Well Number: NA
Location: (QtrQtr, Sec, Twp, Rng, Meridian): NWNE, Sec 5, T7N/R90W Latitude: 40.600627 Longitude: -107.512497

ATTACHMENT (TO FORM 27) – 4/9/13
SITE INVESTIGATION & REMEDIATION WORKPLAN

AXIA ENERGY, LLC
BULLDOG #5-31H-790 PIT FACILITY
COGCC PIT #429725
SPILL #2231734

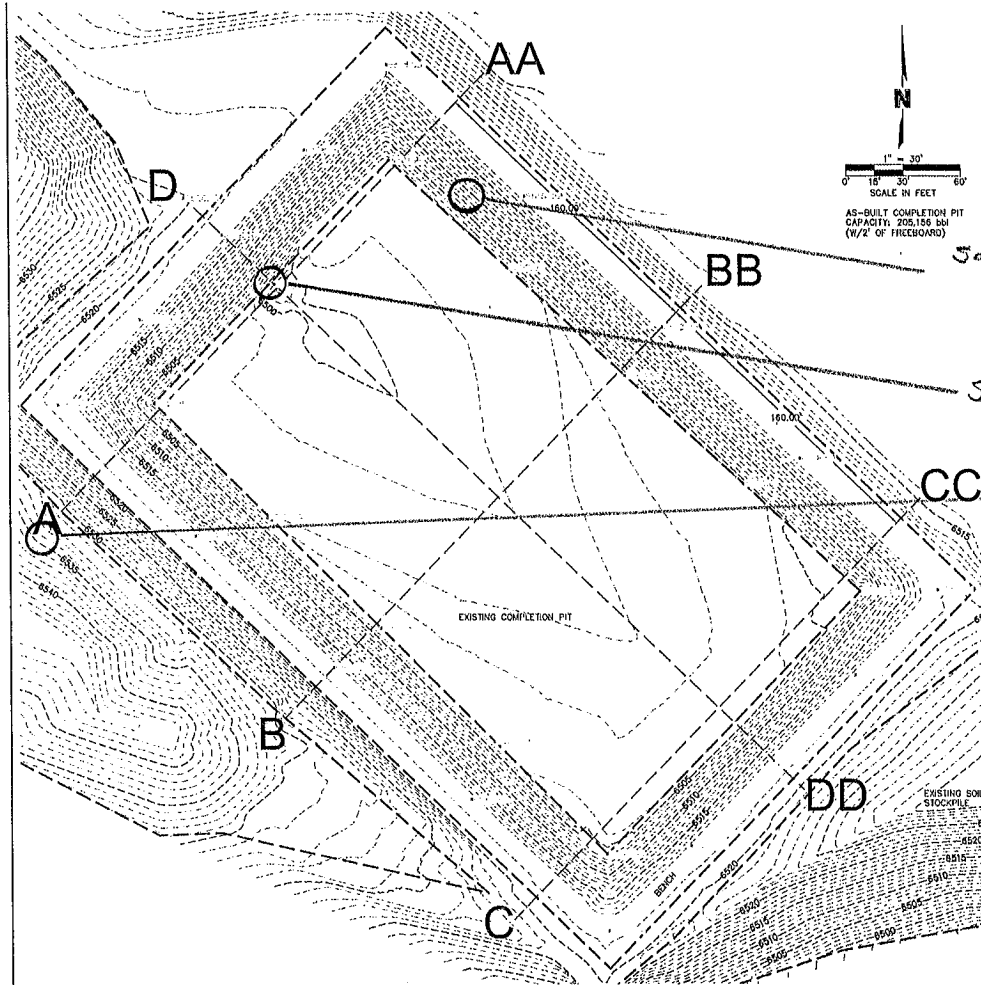
PIT SAMPLING LOCATIONS

Soil sampling has been conducted to investigate possible contamination or release to the surface at the pit facility. Axia Energy is currently awaiting the final analysis results and will submit the appropriate data to the COGCC when available. Attached please find the “as built” plat of the pit with the sampling locations with details below:

Sampling Site #1 – Three soil samples collected in the burnt pit liner area of the pit and submitted for analysis. The samples were combined for the full Table 910-1 analysis.

Sampling Site #2 – Three soil samples collected in the pit sump area and submitted for analysis. The samples were combined for the full Table 910-1 analysis.

Sampling Site #3 – Three soil samples collected as “baseline” soil samples for comparison and submitted for analysis. The samples were combined for the full Table 910-1 analysis.

Once the final soil sample analysis’ are completed, Axia Energy will provide the data to the COGCC. If no contamination of soils is detected, Axia Energy will request approval to schedule and initiate liner repair operations. Should the analysis show contamination exceeding table 910-1 criteria, a subsequent Form 27 will be submitted with remediation plans for the contaminated soil at the pit. Soils will be sampled for TPH-GRO, TPH-DRO, and COGCC Table 910-1 concentration levels.

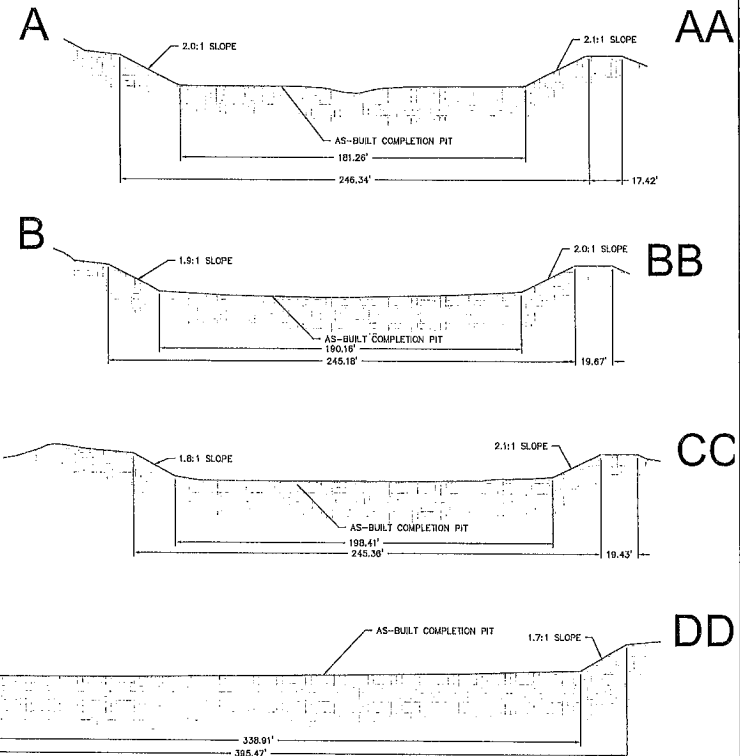
* = TANK / CONTAINMENT / MANIFOLD SAMPLING LOCATIONS

Five soil samples to be collected in the tank/manifold/containment area to adequately sample the area and have analysis completed. Sampling locations attached and shown on "as built" pit survey plat. Analysis' results to be provided to COGCC. If contamination present, a subsequent Form 27 will be submitted to the COGCC with remediation plan. Soils will be sampled for TPH-GRO, TPH-DRO, and COGCC Table 910-1 concentration levels. If contamination below table 910-1 standards, Axia Energy will request approval to reassemble tank/manifold and off-loading facility.

Remove any visible contaminated gravel and/or soil from the location and properly dispose.
