**RE: Elmer 8-31H & Disposal Facility**

**SPILL/RELEASE REPORT**

Date of Incident: <u>06/10/2013</u> Facility Name & No.: <u>Elmer 8-31H &amp; Disposal Facility</u>	County: <u>Weld</u>
Type of Facility (well, tank battery, flow line, pit): <u>Salt water disposal facility</u>	QtrQtr: <u>SW/SE</u> Section: <u>31</u>
Well Name and Number: <u>Elmer 8-31H SIMBA #1-06 SWD</u>	Township: <u>12N</u> Range: <u>62W</u>
API Number: <u>05-123-30584-00 123-3035</u>	Meridian: <u>6</u>
Specify volume spilled and recovered (in bbls) for the following materials: Oil spilled: _____ Oil recov'd: _____ Water spilled: <u>10BBL</u> Water recov'd: <u>0</u> Other spilled: <u>0</u> Other recov'd: <u>0</u>	
Ground Water impacted? <input type="checkbox"/> Yes <input checked="" type="checkbox"/> No	Surface Water impacted? <input type="checkbox"/> Yes <input checked="" type="checkbox"/> No
Contained within berm? <input type="checkbox"/> Yes <input checked="" type="checkbox"/> No	Area and vertical extent of spill: <u>200'</u> x <u>2'</u>

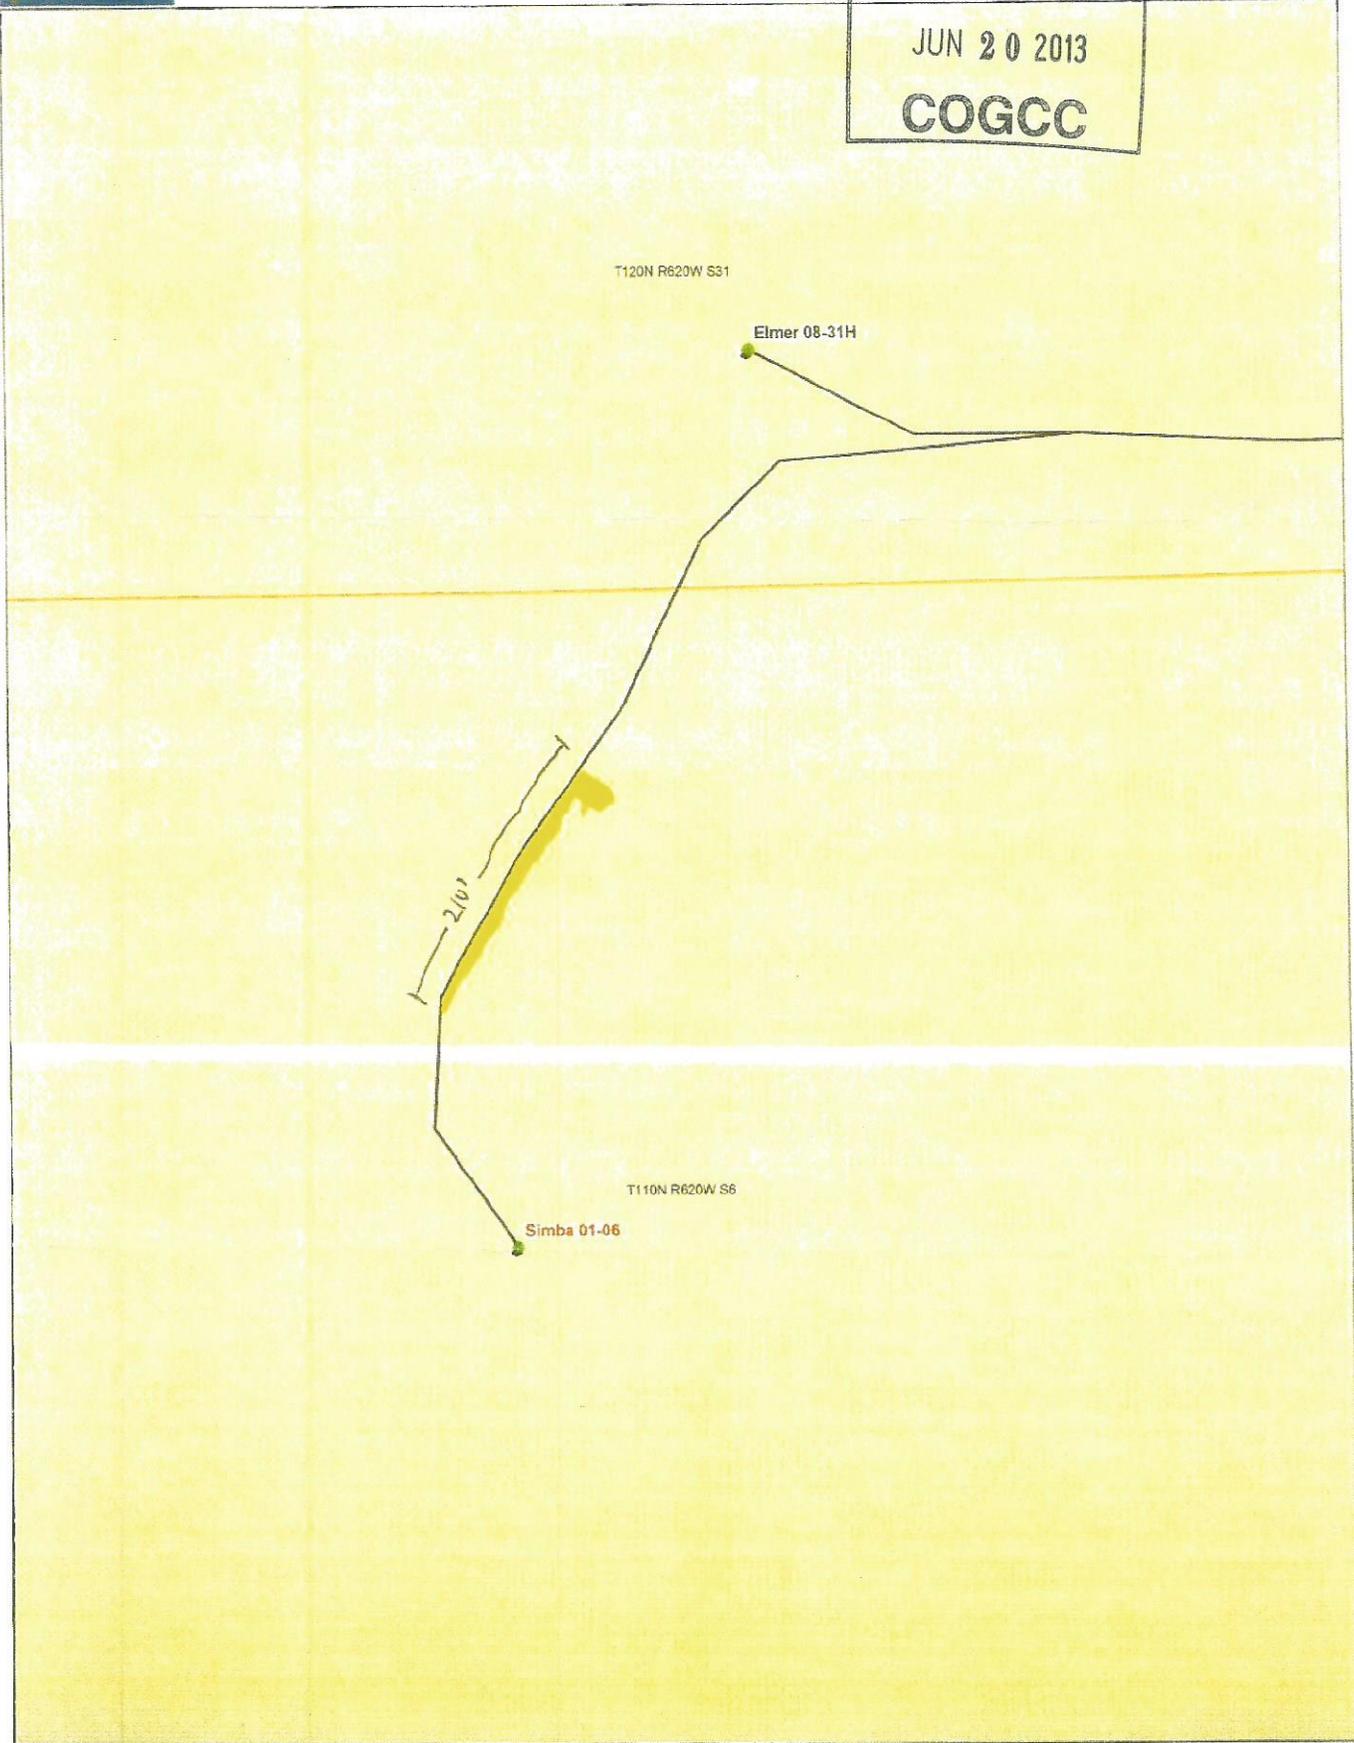
Leak from Elmer 70 Simba  
on 6-10-13
