State of Colorado
Oil and Gas Conservation Commission

SPILL/RELEASE REPORT

Date of Incident: <u>4/26/2013</u>	Facility Name & No: <u>GEISKE - 66S92W / 26SWNE</u>	County: <u>Garfield</u>
Type of Facility (well, tank battery, flow line, pit): <u>Tank Battery</u>		QtrQtr: <u>SWNE</u> Section: <u>26</u>
Well Name and Number: <u>Geiske 42A-26-692</u>		Township: <u>6S</u> Range: <u>92W</u>
API Number: <u>05-045-14323</u>		Meridian: <u>6th</u>

**GEISKE 42A-26-692 FORM 19 PHOTOGRAPHS
GARFIELD COUNTY, COLORADO
BILL BARRETT CORPORATION**

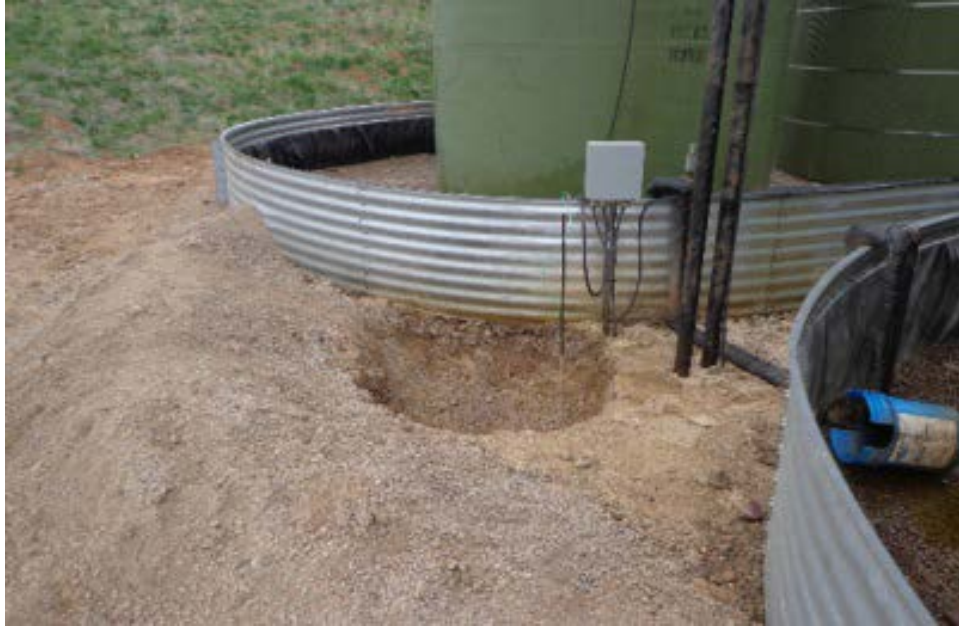
How was the extent of contamination determined?
The majority of the release was contained within the lined, steel containment. A limited amount of overspray (10-15 gallons) accumulated adjacent to the lined, secondary containment. As the overspray was only surficial, it was delineated visually during excavation and removal.

Photo 1 – Overspray excavation, approximate 5 foot radius by 2.5 feet deep.

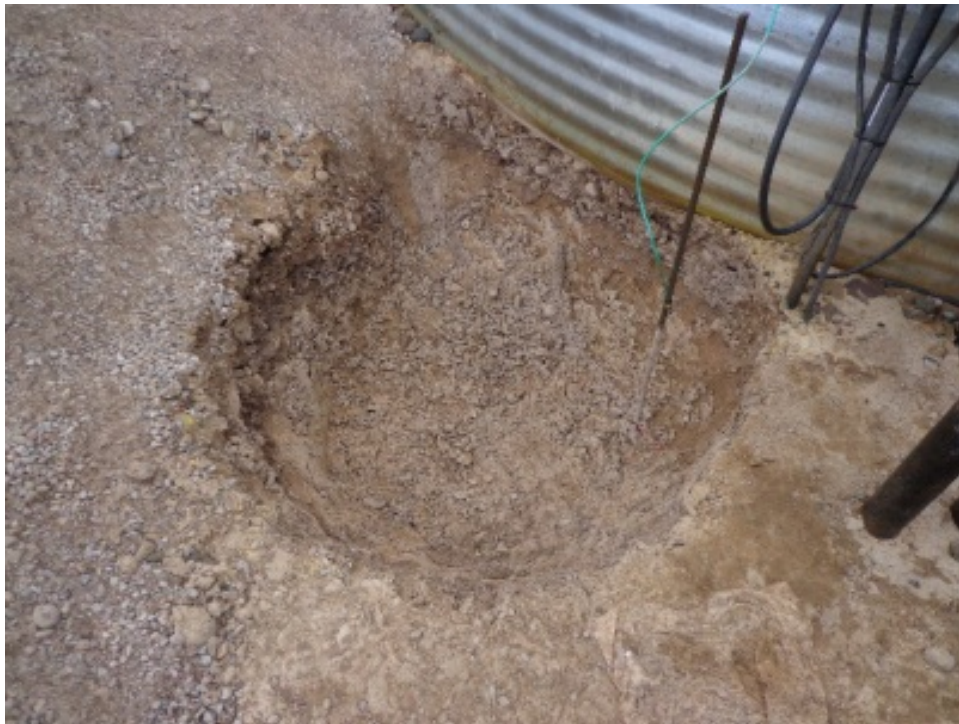
Photo 2 – Overspray excavation bottom.
