RE: Huggard 2-13API #05-045-07170, COGCC Facility # 211410, Location ID # 323984
NENW Section 2: TWP: 7s Range: 94w Garfield County Colorado

The Colorado Oil and Gas Conservation Commission (COGCC) are referring Notice of Alleged Violation (NOAV) Doc#200361992 for further enforcement. COGCC staff conducted follow up inspections on 11/13/12 and 8/21/13 Field Inspection Document numbers 668100129,668100225.

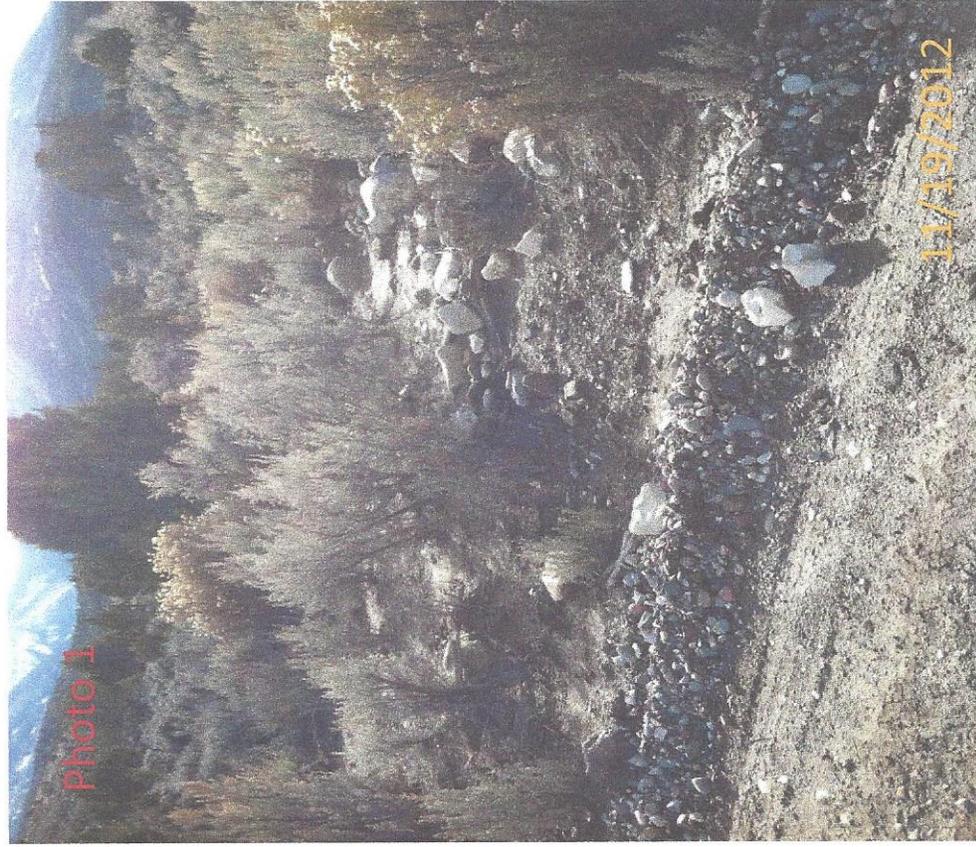
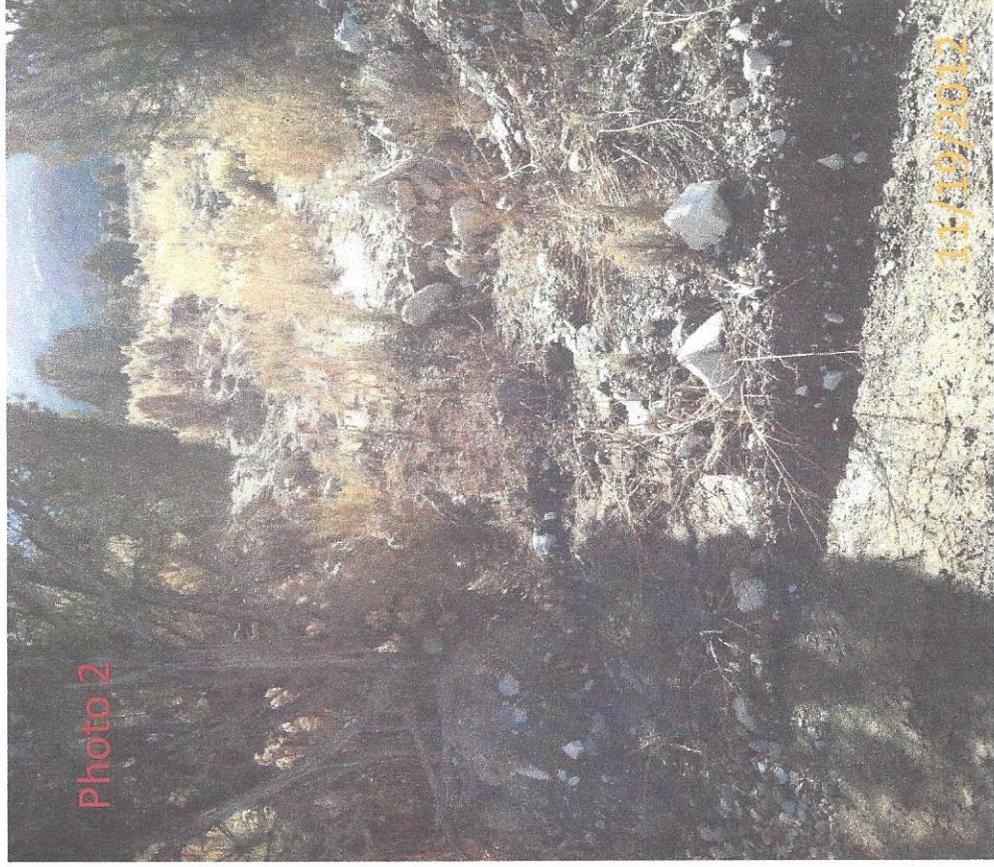
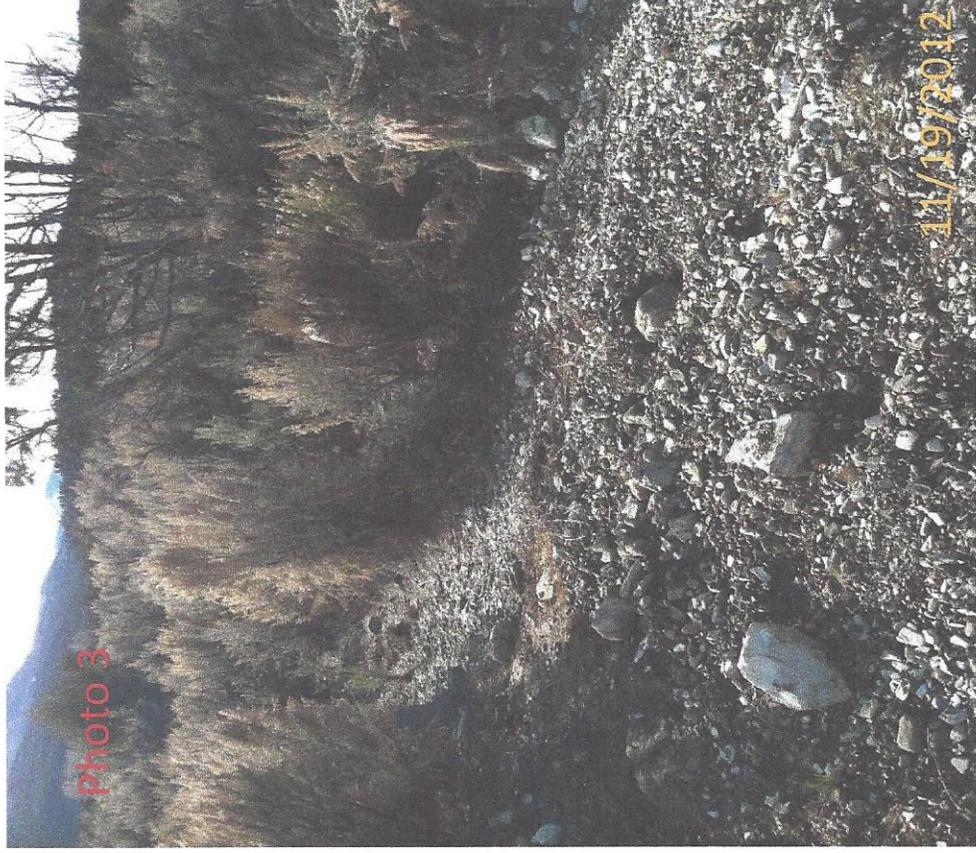
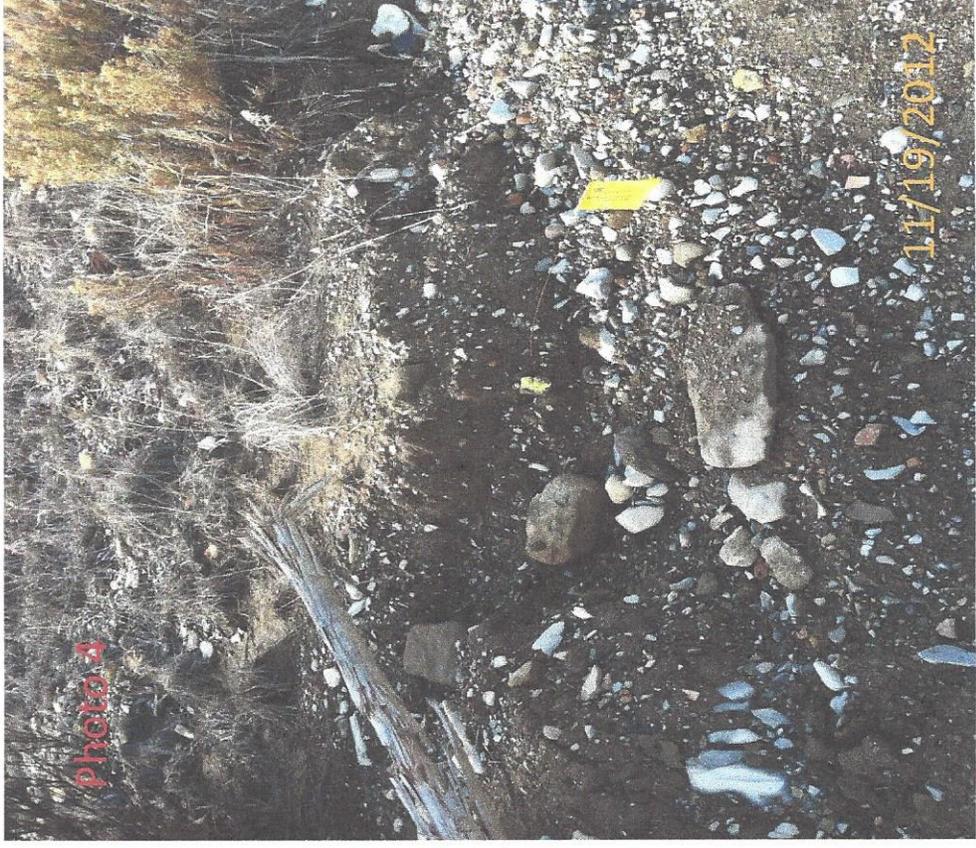
November 19, 2012 Lease Road

On 11/19/12 COGCC staff conducted a follow up inspection Doc# 668100143. COGCC staff observed that evidence of erosion was still evident along the lease road used to access Location # 323984, see attached photographs 1, 2, 3, &4. A corrective action date of 12/14/12 was given to provide a detailed time line of all planned work with completion dates. On 11/30/12 North West Inspection Unit Supervisor Shaun Kellerby, met with Encana staff at the parachute office of Encana, to discuss NOAV # 200361992. On 12/14/12 Encana provided a work plan to meet corrective actions required on COGCC NOAV Doc# 200361992 see attached work plan. Approval was given to Encana to implement all corrective actions listed on the Encana work plan. Completion date for all work was agreed upon as 7/31/2013.

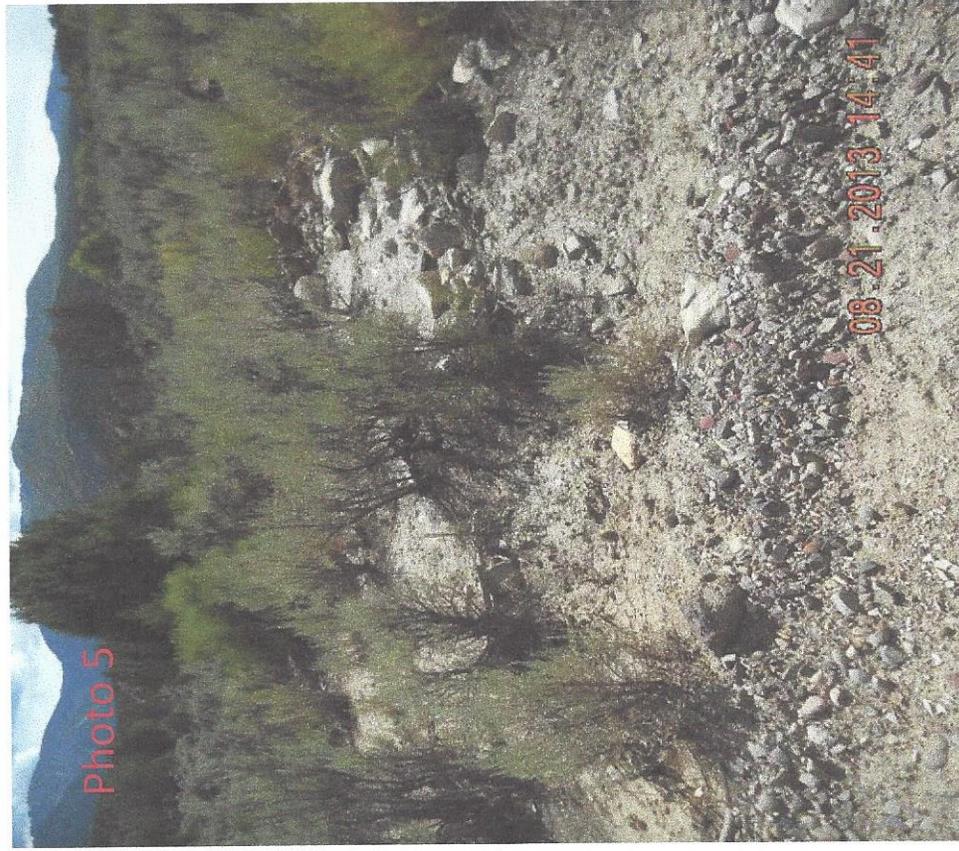
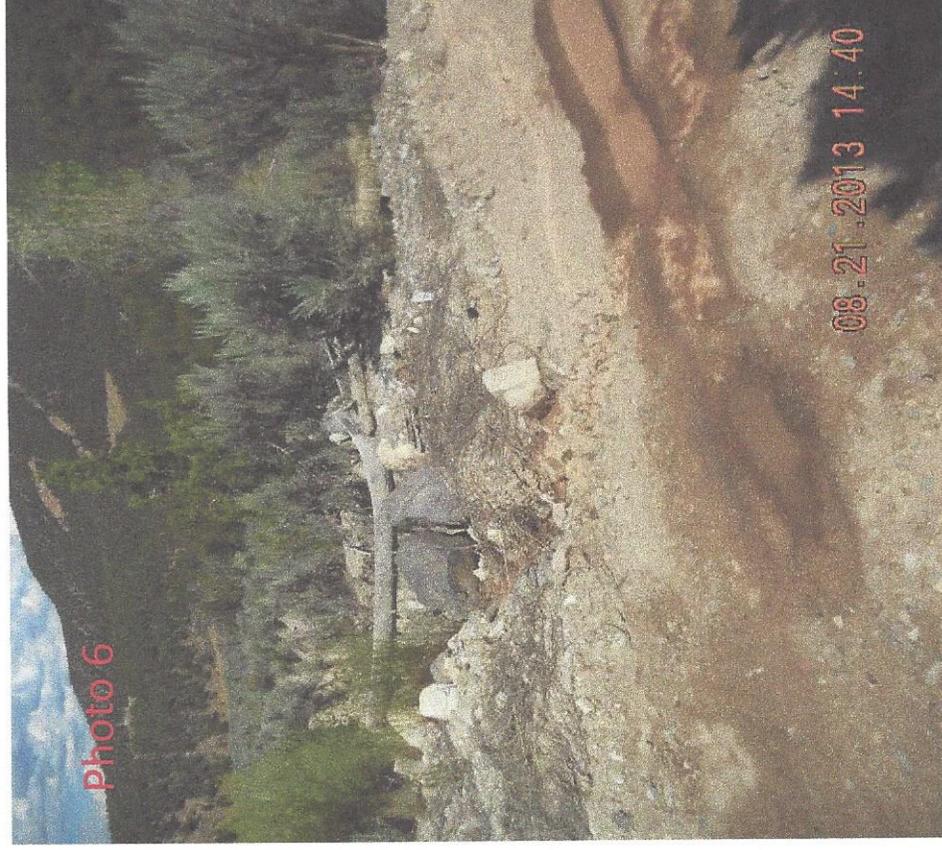
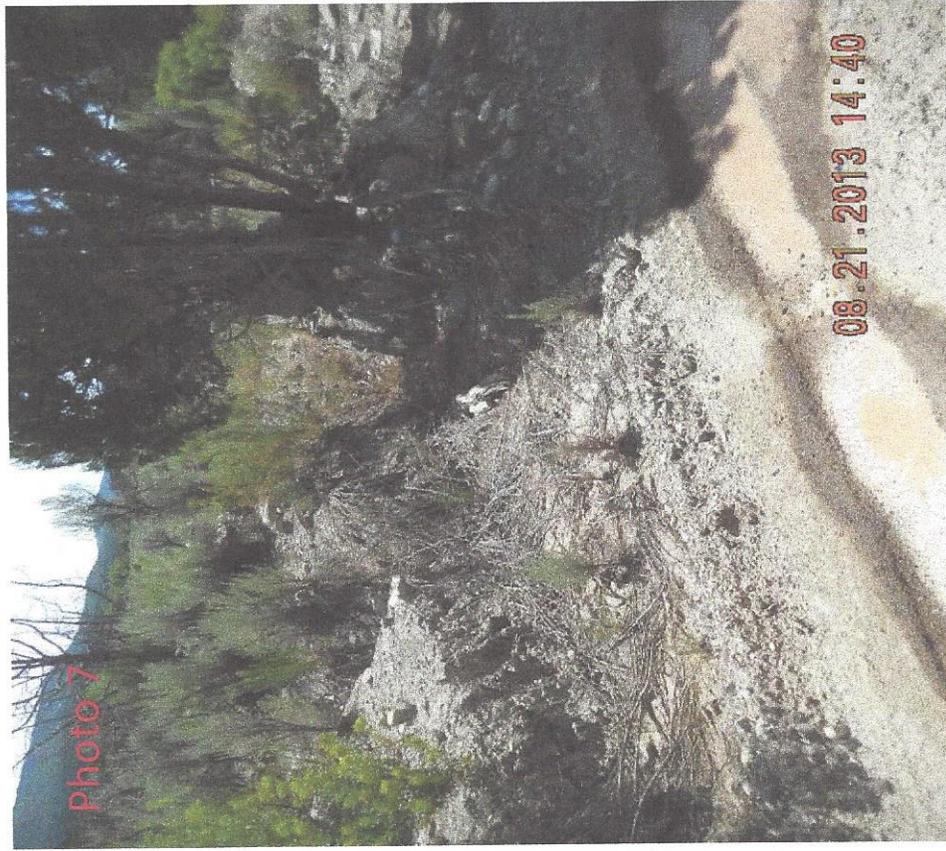
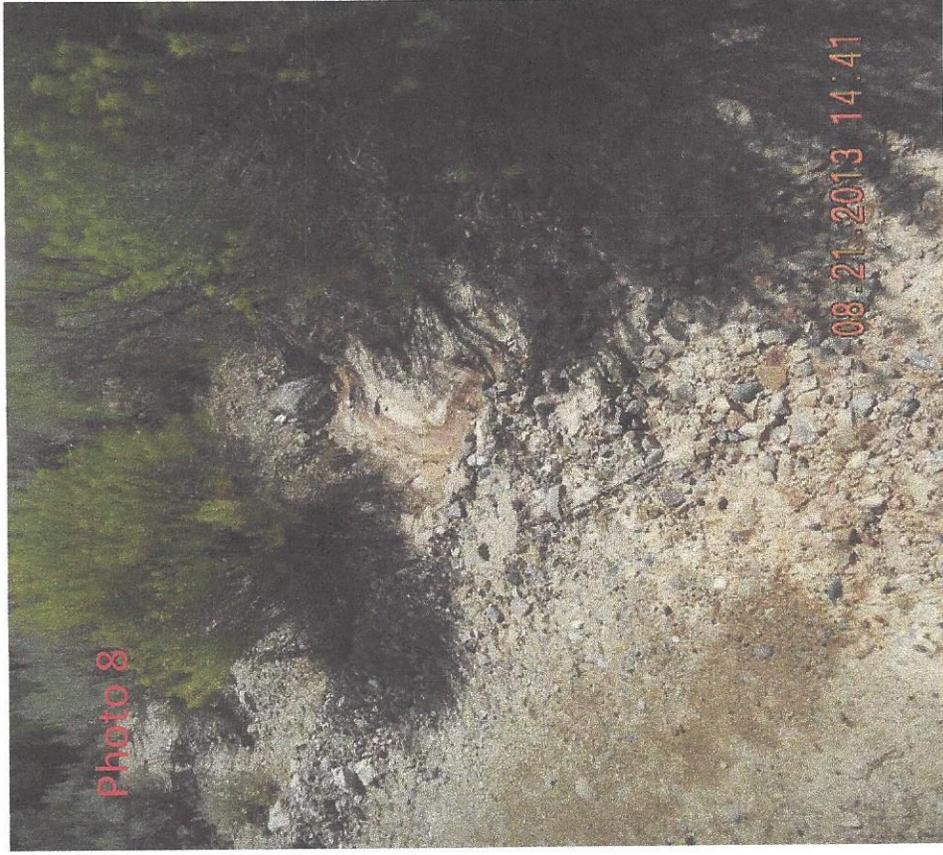
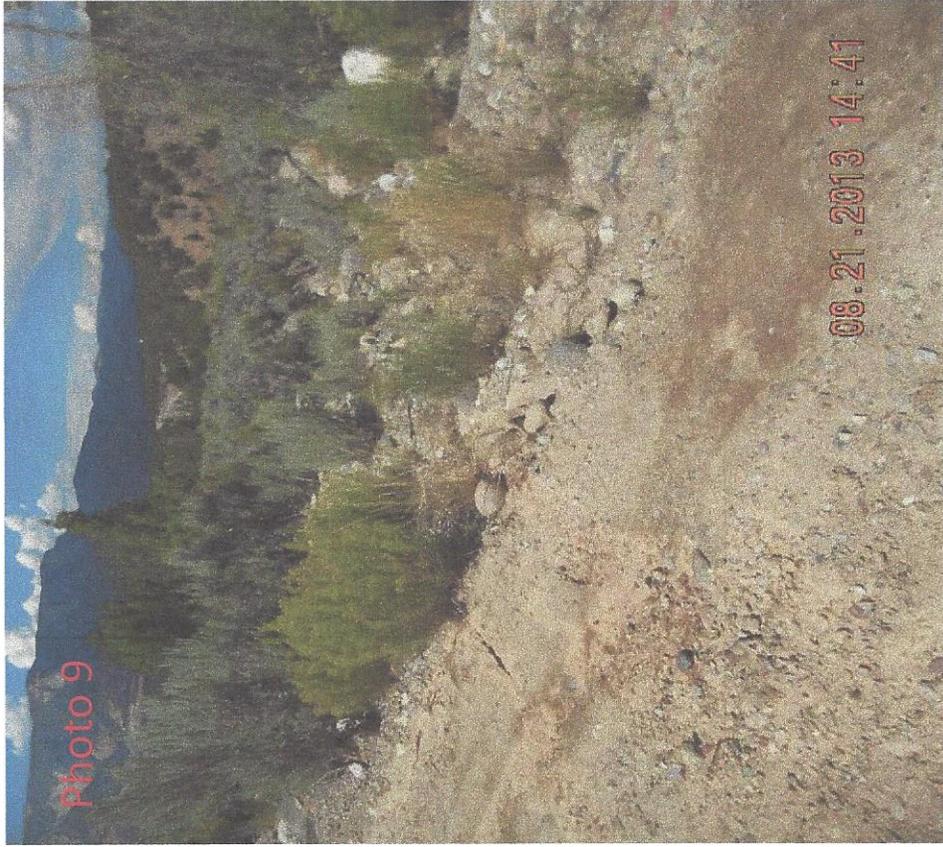
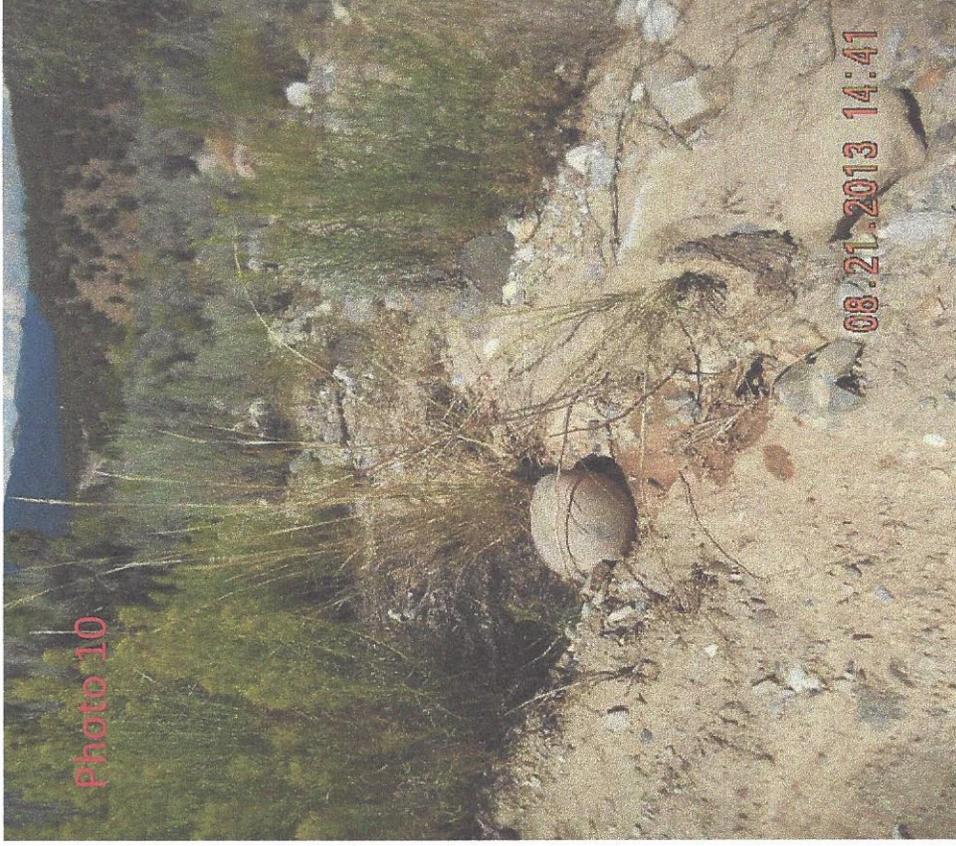
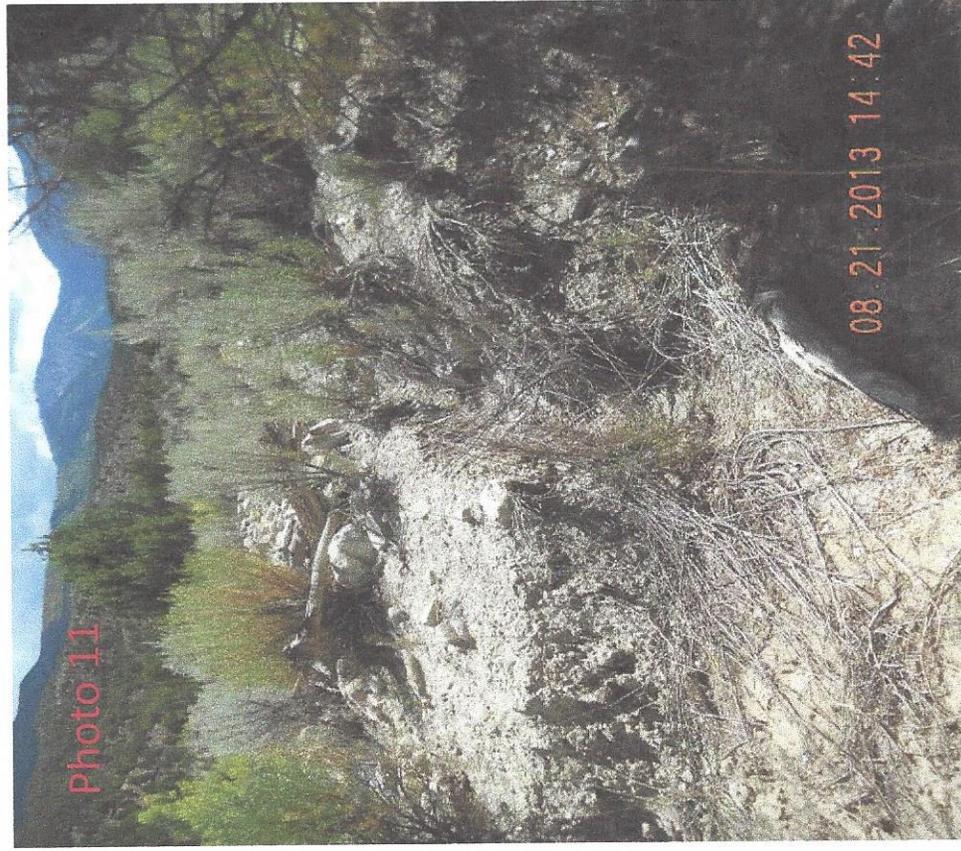
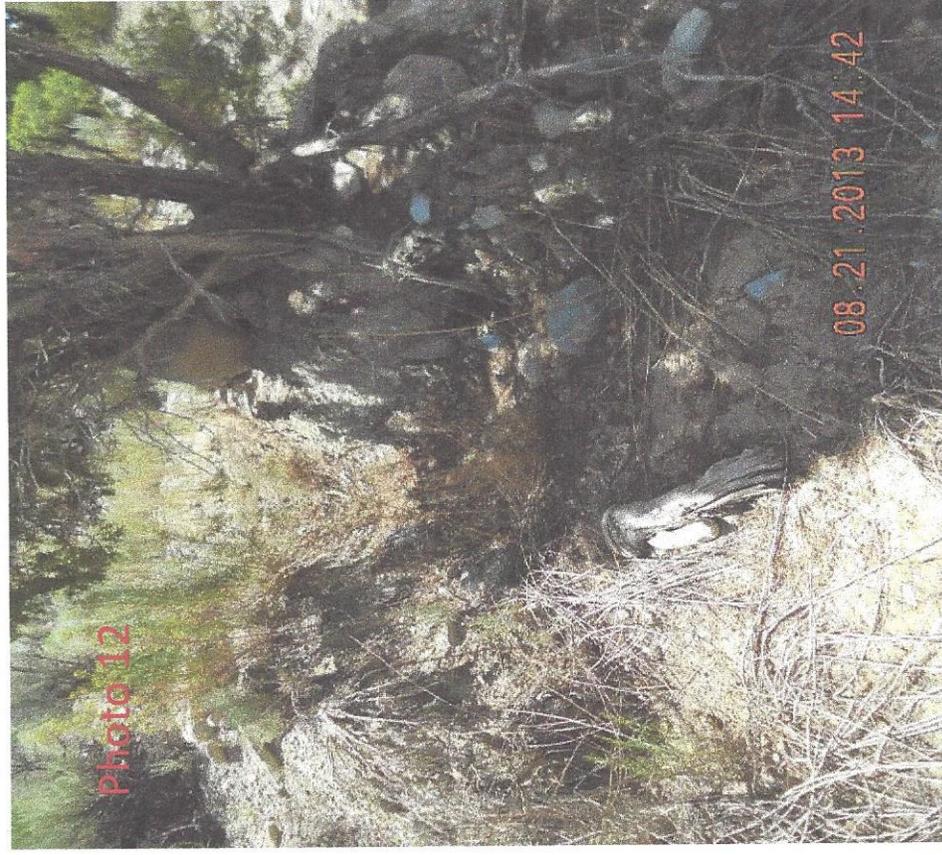
Lease Road Location 323984

On 9/3/13 COGCC staff conducted a follow up inspection Doc# 668100225. COGCC staff observed that all corrective actions listed on the Encana work plan were not complete; see attached photographs 5-12. Staff observed evidence of erosion during inspection of the lease road used to access Location # 323984. NOAV Doc # 668100129 has been referred for hearing.
