Subject: **Produced Water Pit Replacement Closure Report**
Hop 13-11B
API # 05-123-17457
Kersey, Colorado
Fremont Project No. C013-028

PRODUCED WATER PIT REPLACEMENT

HOP 13-11B

KERSEY, COLORADO

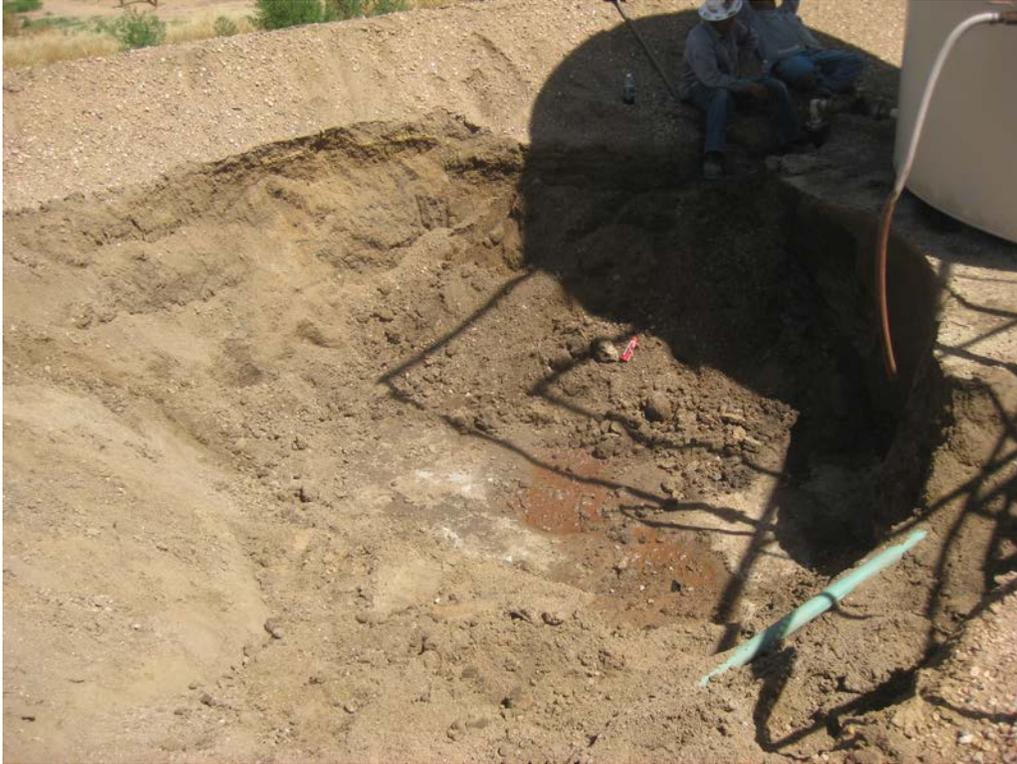
Looking northwest at pit excavation after most of the impacted soil was removed.

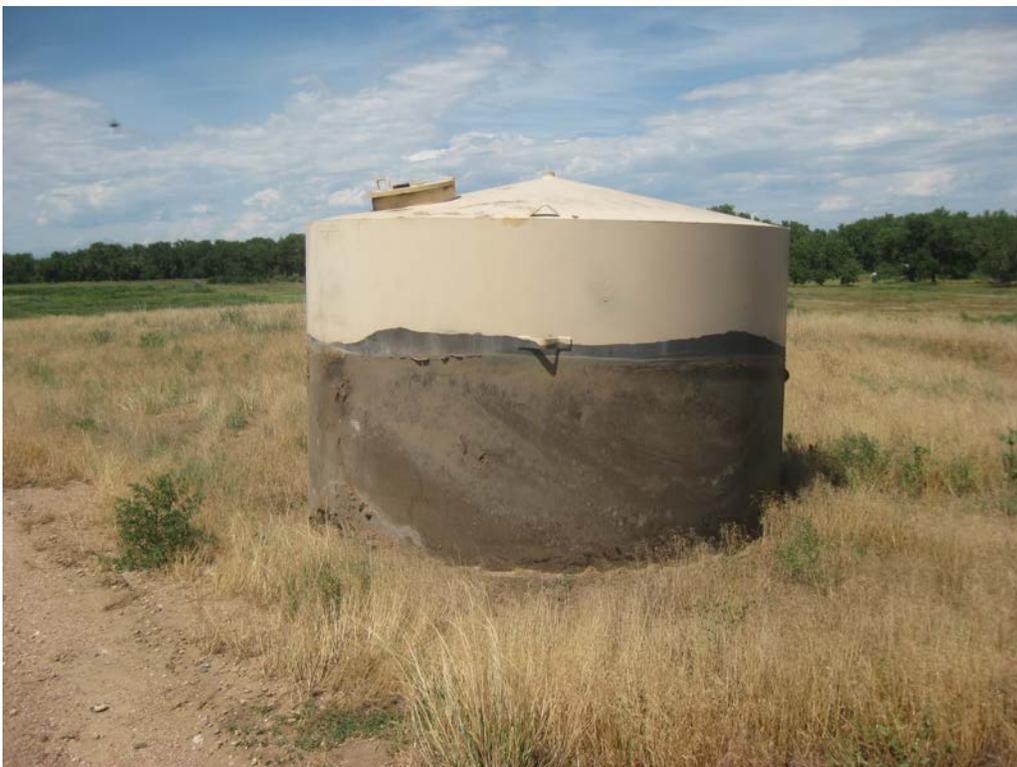
and inspected for damage. No obvious indication of failure was observed. Regardless, the steel pit was replaced with a new, concrete water pit. Photos of the pit excavation and former steel pit are provided.

Steel water pit after removal. No indication of failure was observed.

The steel pit was replaced by a new concrete pit at this same location and the facility was placed back in operation. Fremont personnel did not oversee that portion of the project.
