DEPARTMENT OF NATURAL RESOURCES

September 6, 2013

RE: Response to Complaint Report – Water Well Damage Due To Seismic Survey
Complaint No. 200381764
Division of Water Resources Well Permit No. 36205
SESW Section 14– Township 2 North – Range 66 West
Weld County, Colorado

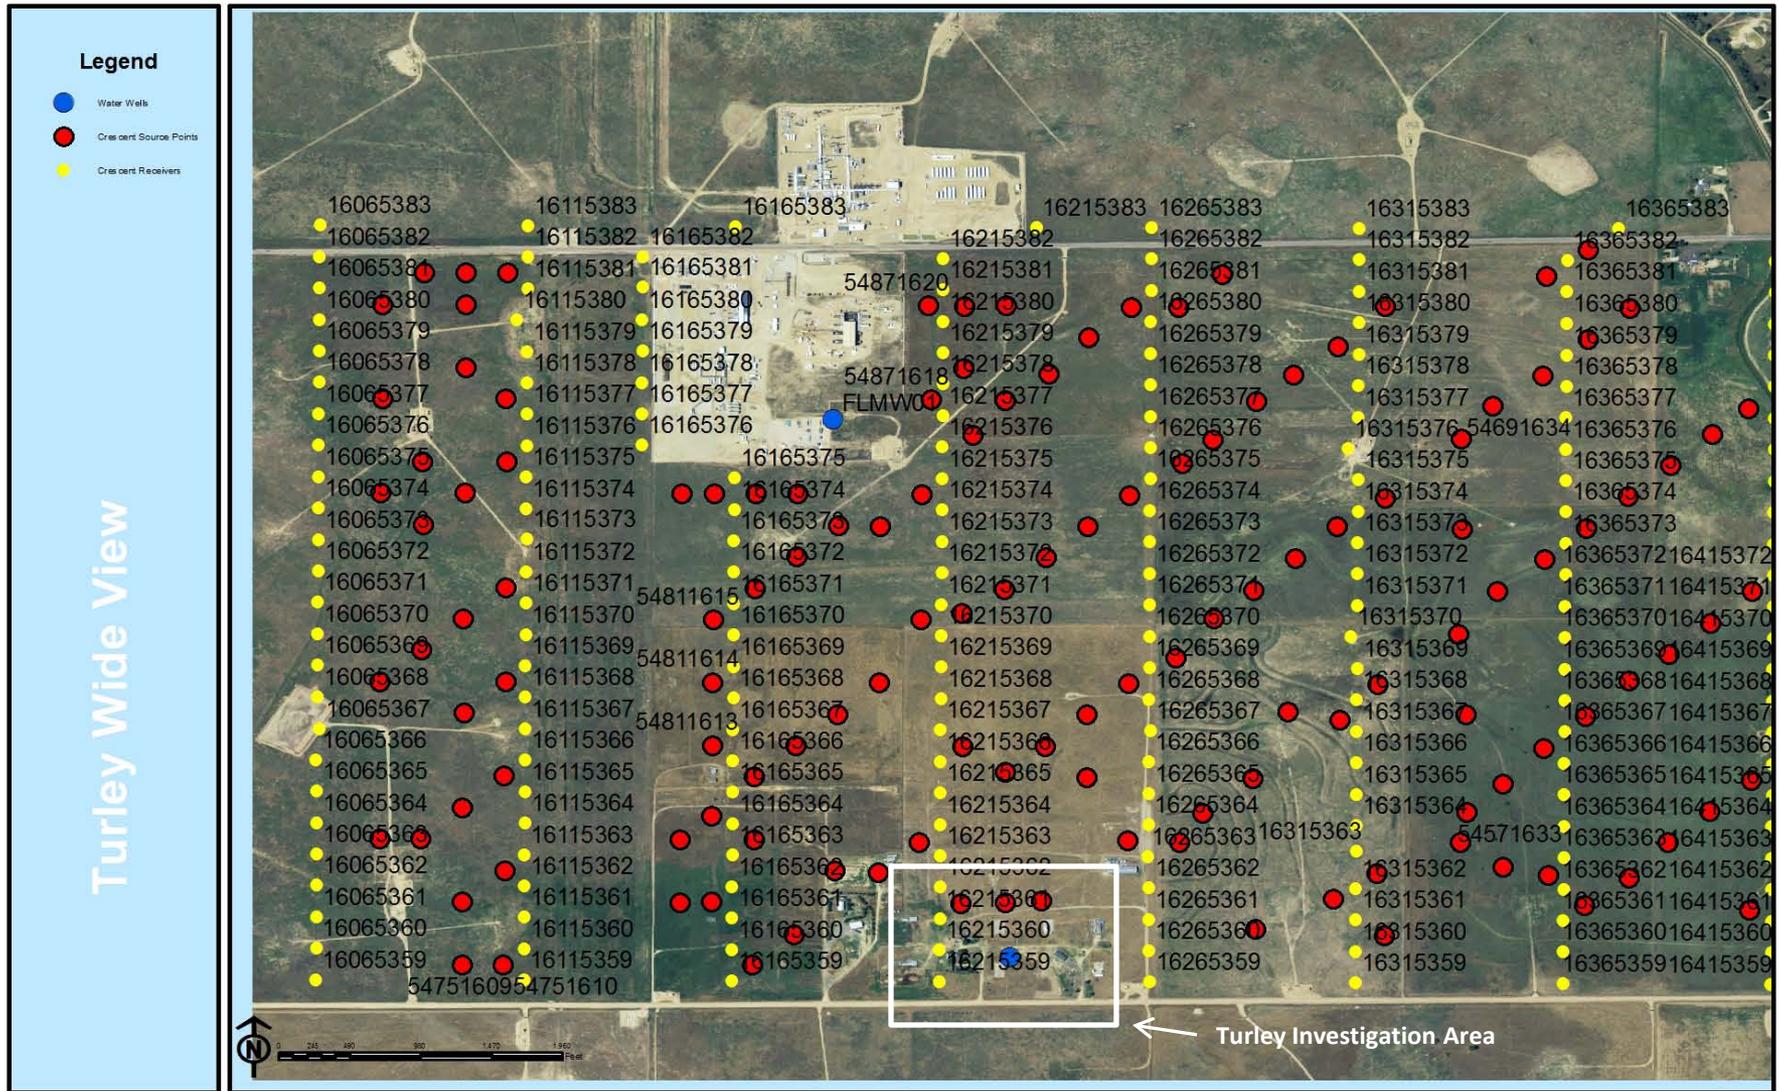
Figure 1

Southern Portion of the Crescent 3D Seismic Survey

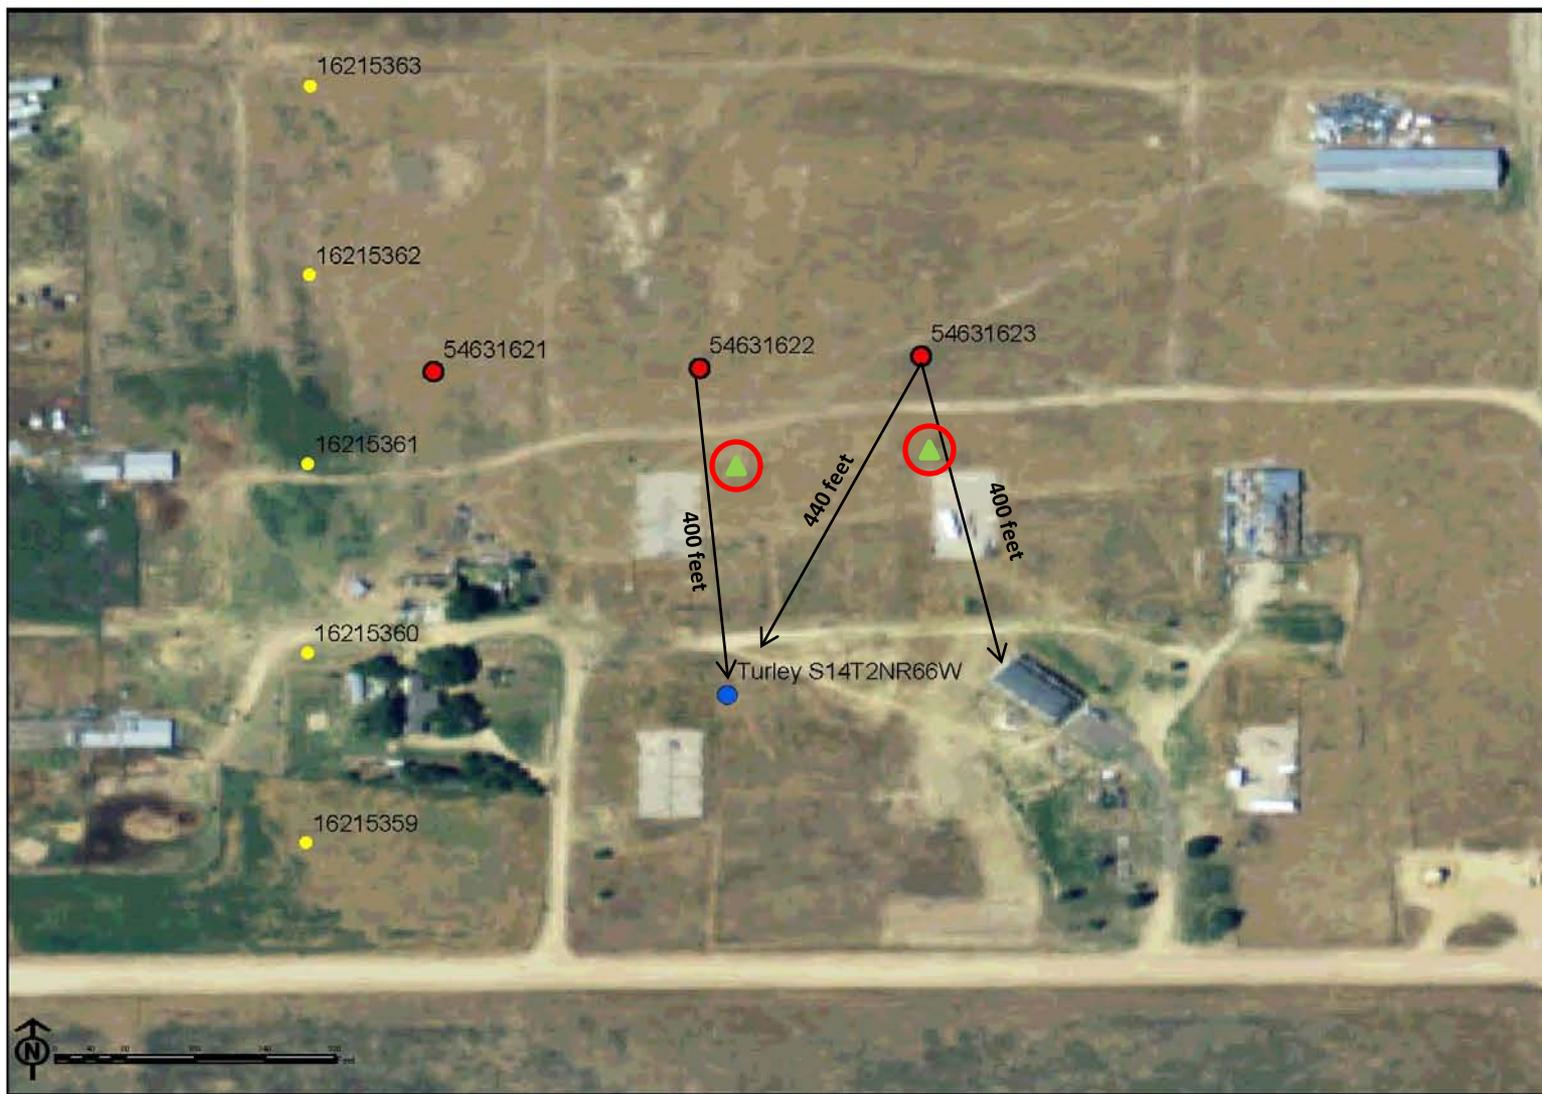
Figure 2
Crescent 3D Seismic Survey Detail – Turley Residence Area

December 30, 2011 – Urban Seismic Services, Inc. (USS), a third party observer, was present during the vibrosis operations conducted as part of the Crescent 3D survey, including the Turley property. Real-time monitoring data was collected by USS at locations shown on Figure 2 to record vibration or ground motion results from the Geokenitics vibrosis source points.

The COGCC received the latitude and longitude coordinates for all of the seismic vibrosis source points along with a map of the survey. The mapped locations of the seismic source points are shown on Crescent 3D survey (Figure 2) The data show the closest vibrosis source point to the water well was source point 54631622, approximately 400 feet north of the water well. The closest vibrosis source point to the Turley residence was point 54631623, approximately 400 feet north of the residence.

Statements by Ms. Turley and Mr. Dale Turley identify seismic vehicles between the water well and the Turley residence on December 30, 2011. The staff does not dispute this allegation, but can find no documentation that any seismic operations were actually conducted adjacent to the water well or between the water well and the Turley residence. Damage to the water well from seismic ground vibration is unlikely due to the distances between the seismic vibrosis source point and the water well (approximately 400- and 440-feet). Additionally, ground motion measurements by USS real-time monitoring show no recorded structure or water well damaging vibration equaling or exceeding the peak particle velocity of 2 inches per second (in/sec) damage threshold established by the US Bureau of Mines (1971 and 1980) for safe seismic operations around structure and water wells. Peak particle velocity reading provided by USS for the two monitoring locations on the Turley properties were 0.060 in/sec and 0.225 in/sec (USS, 2013).
