INSPECTION #675200004 [Please scroll down to view pictures](#)

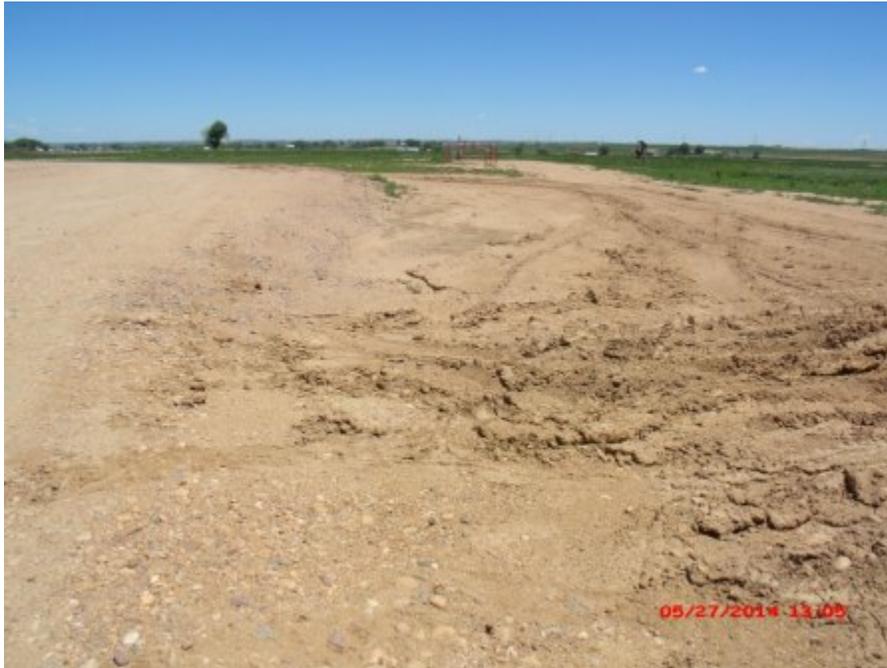
Rilling on South side of Battery location should be addressed through BMPs.

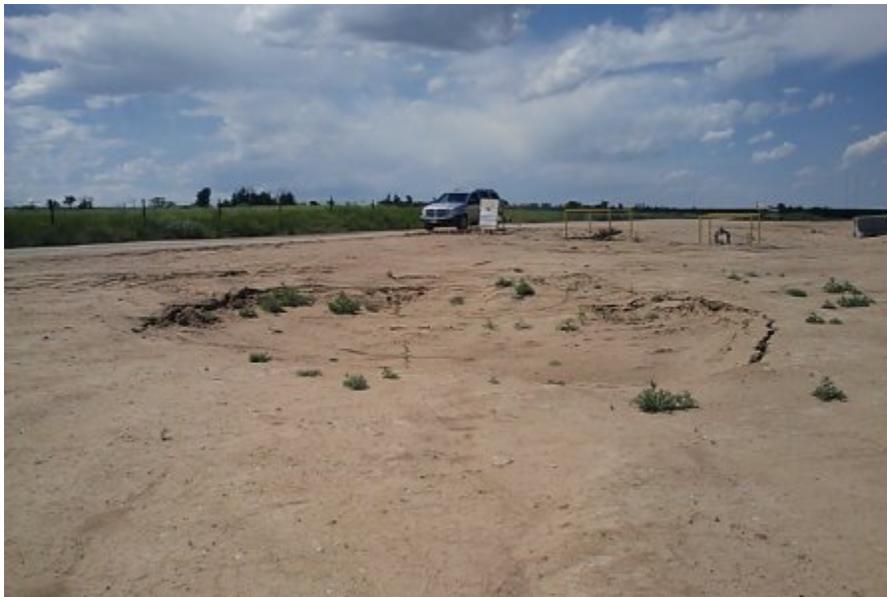
Subsidence observed on south end of battery tank location to be corrected.

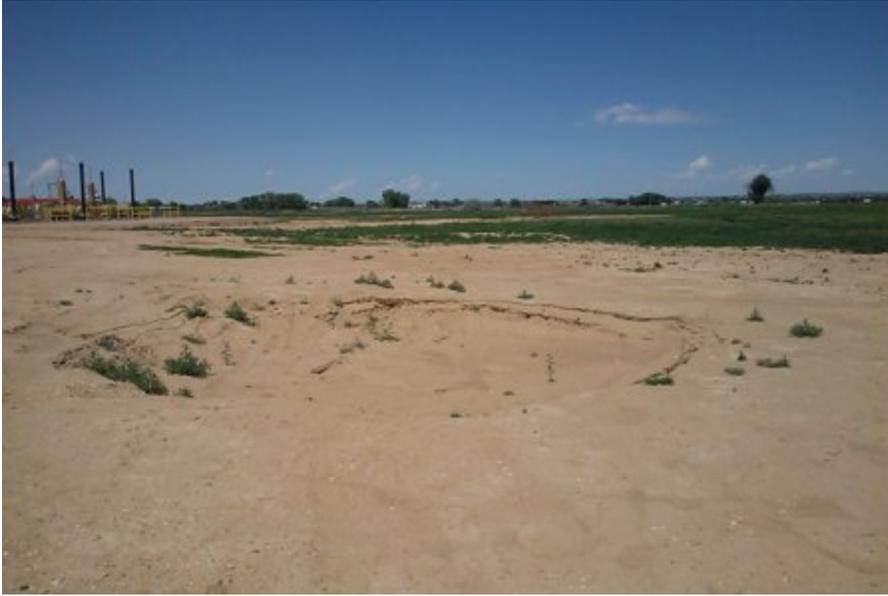
Subsidence observed on south end of battery tank location to be corrected.
