VEGA UNIT-610S93W9NWNE

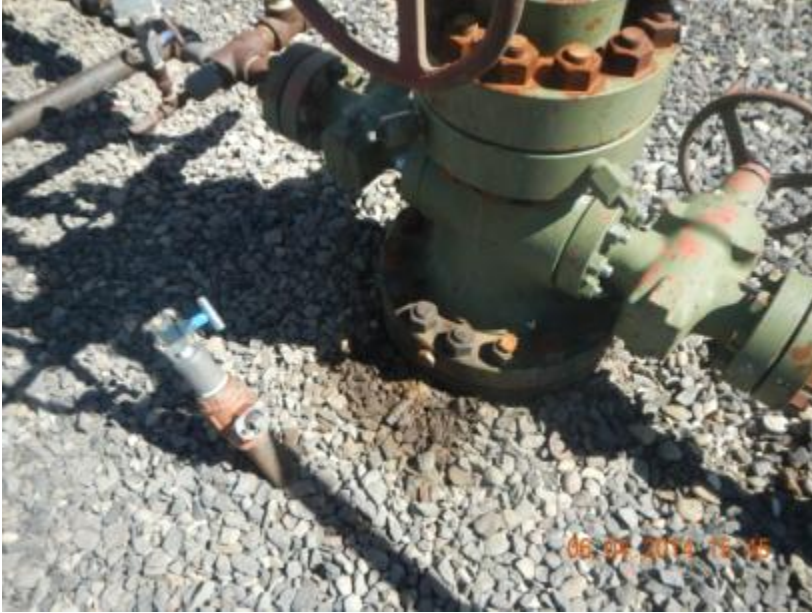
Staining from leaking around valve stem.

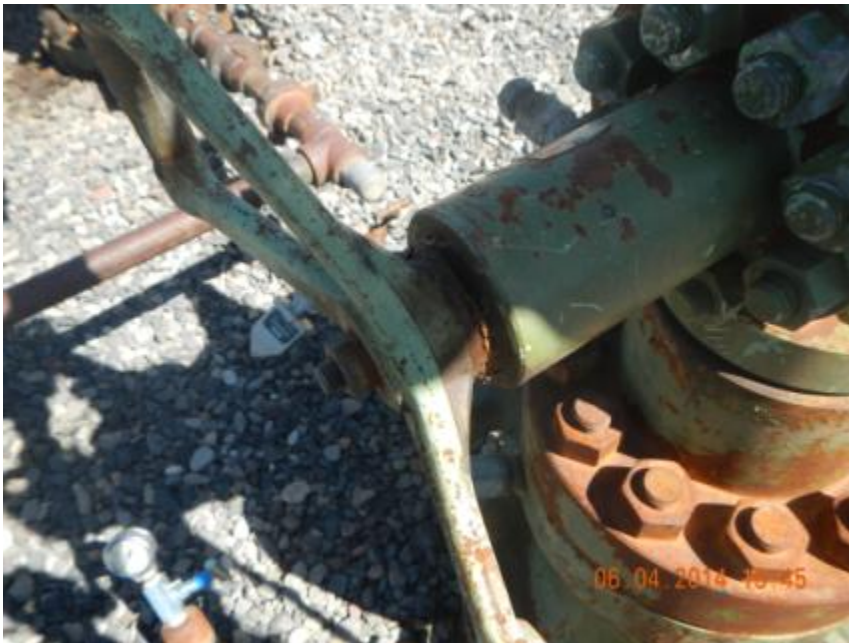
Leaking around valve stem
