API :077-08260

06/11/2014 Site Inspection Photos (4 total)

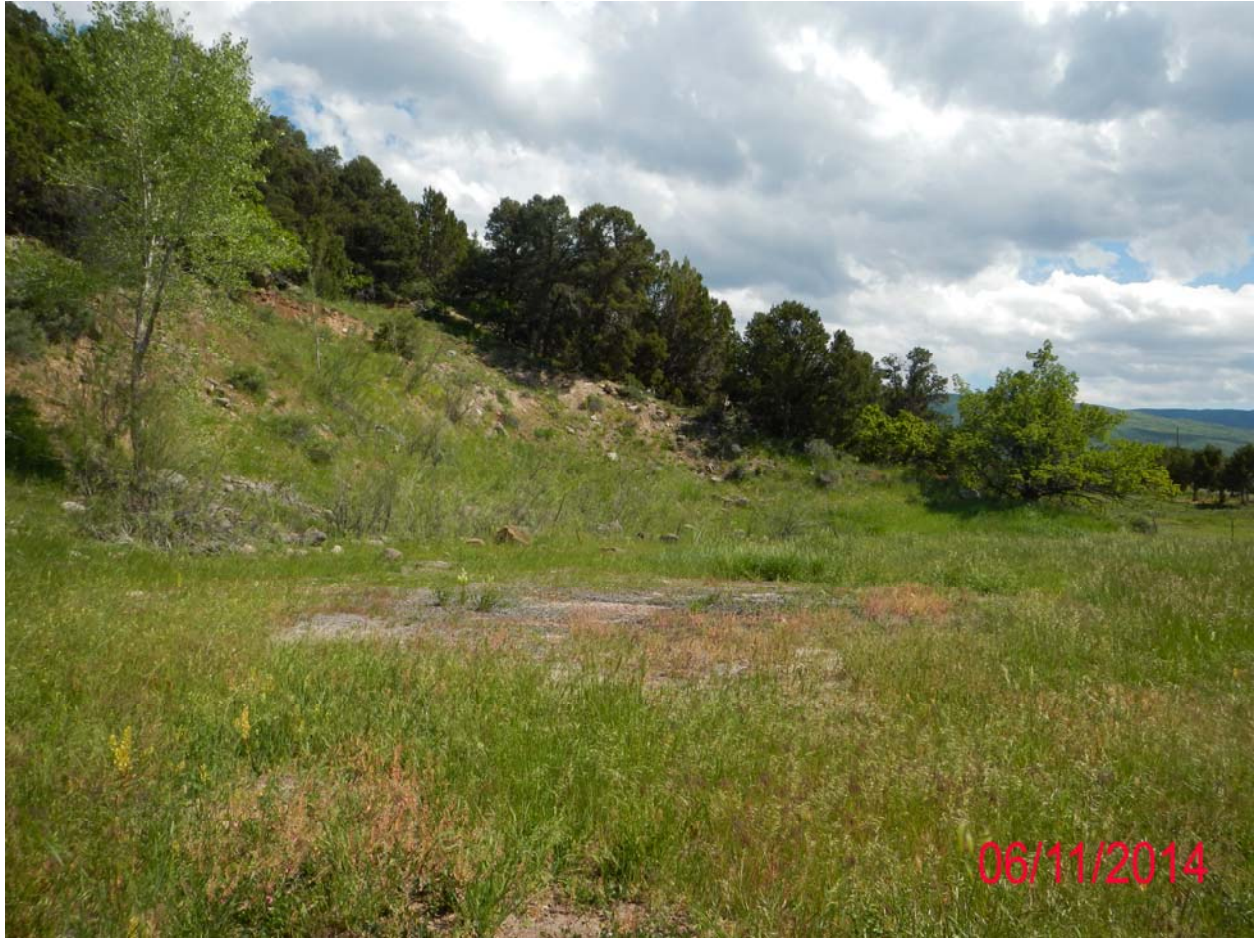
Gravel and Compaction present

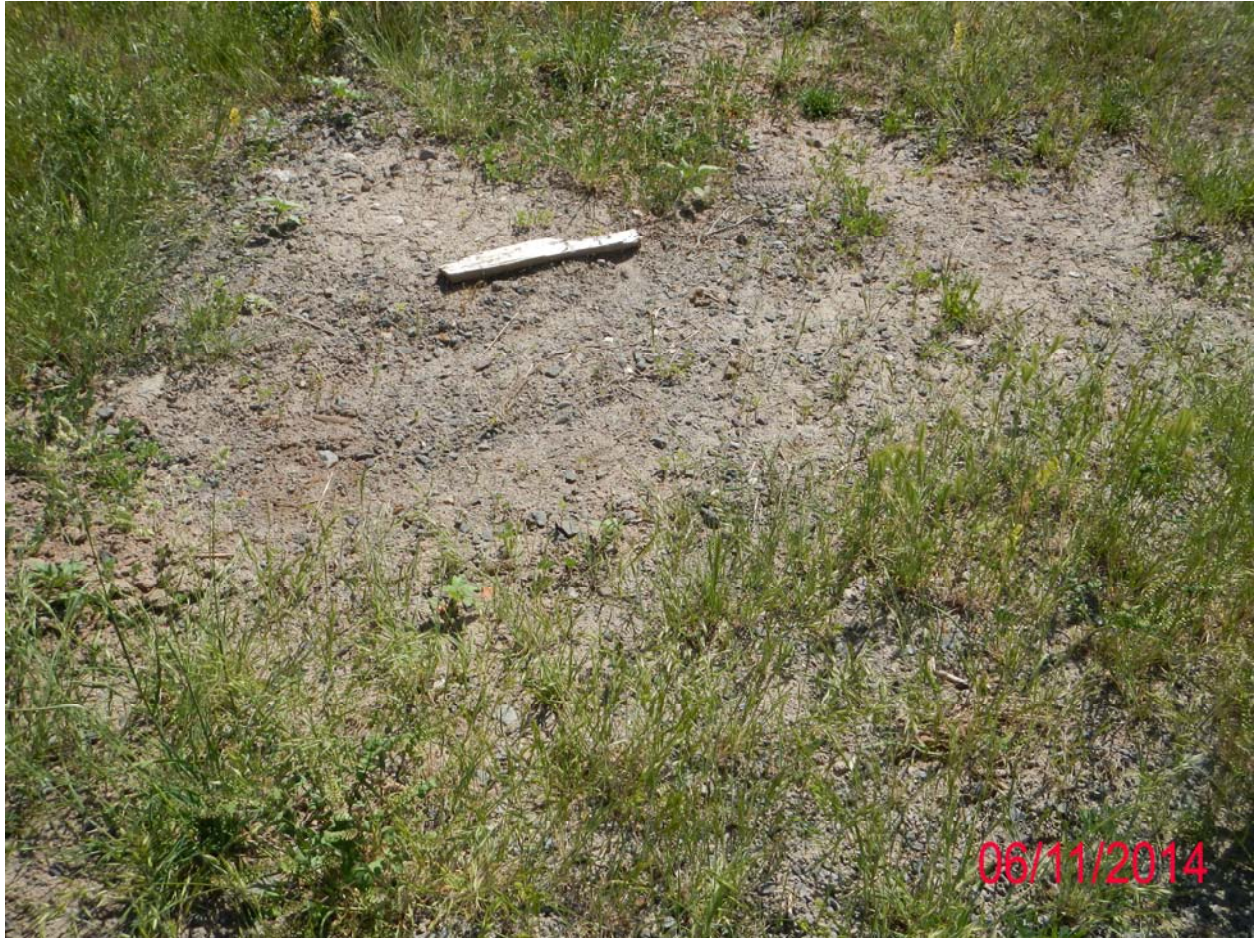
Debris present

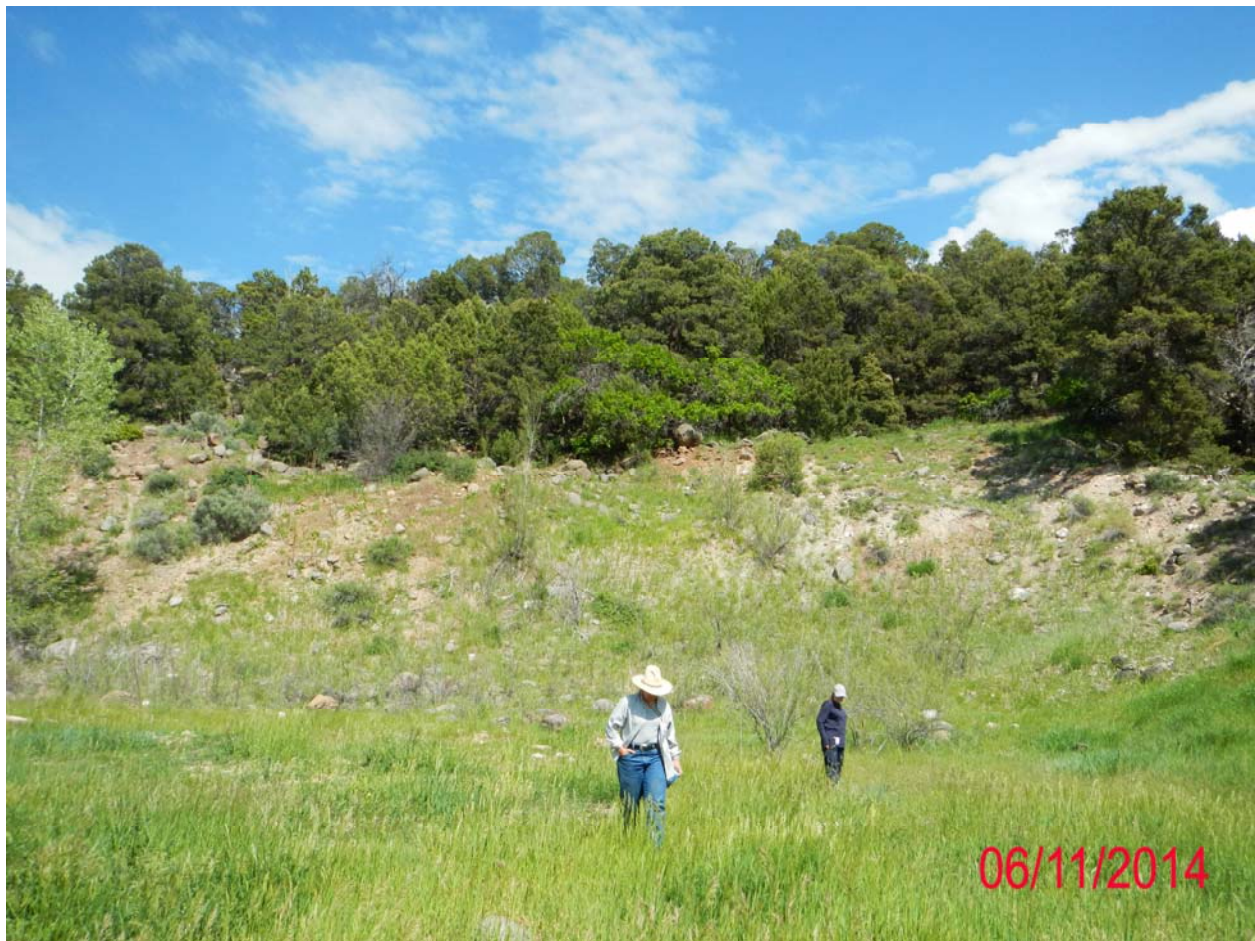
Pad Cut left uncontoured
