KNAUS 66S93W 19SWSW

Inspection DOC# 675200187

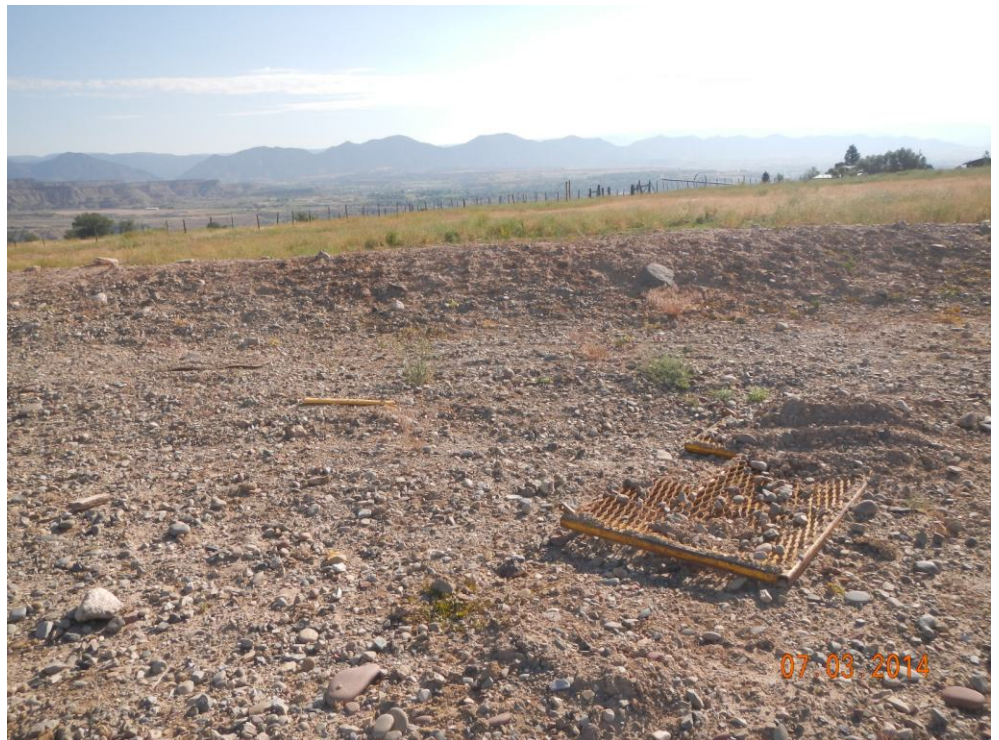
Trash on location

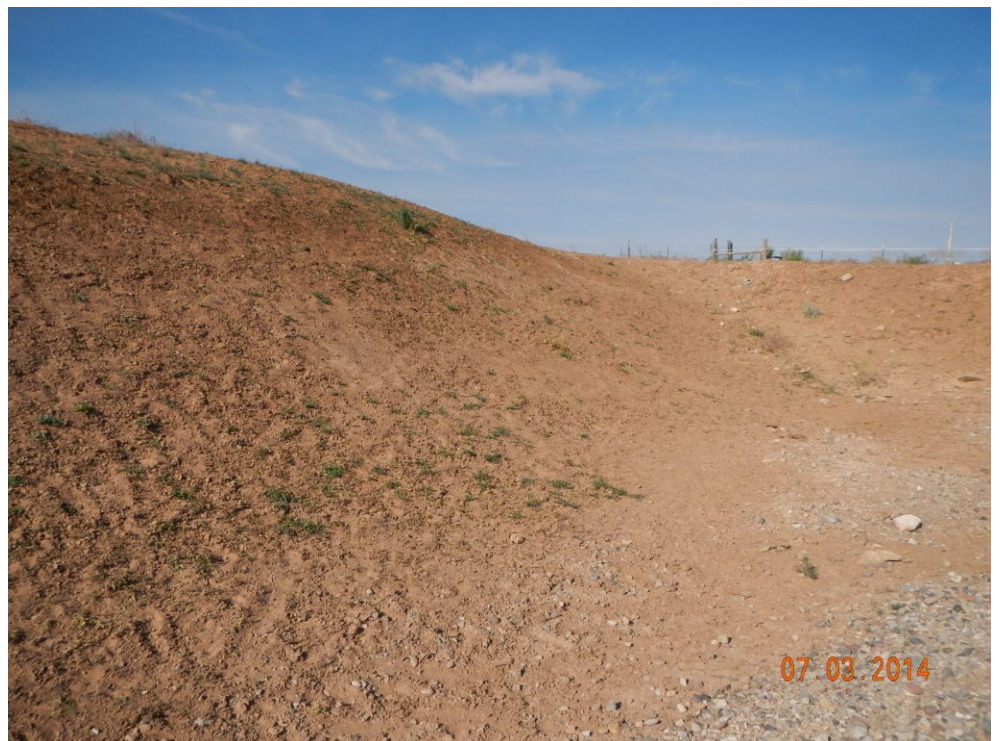
Some erosion and  
rilling on cut slope.
