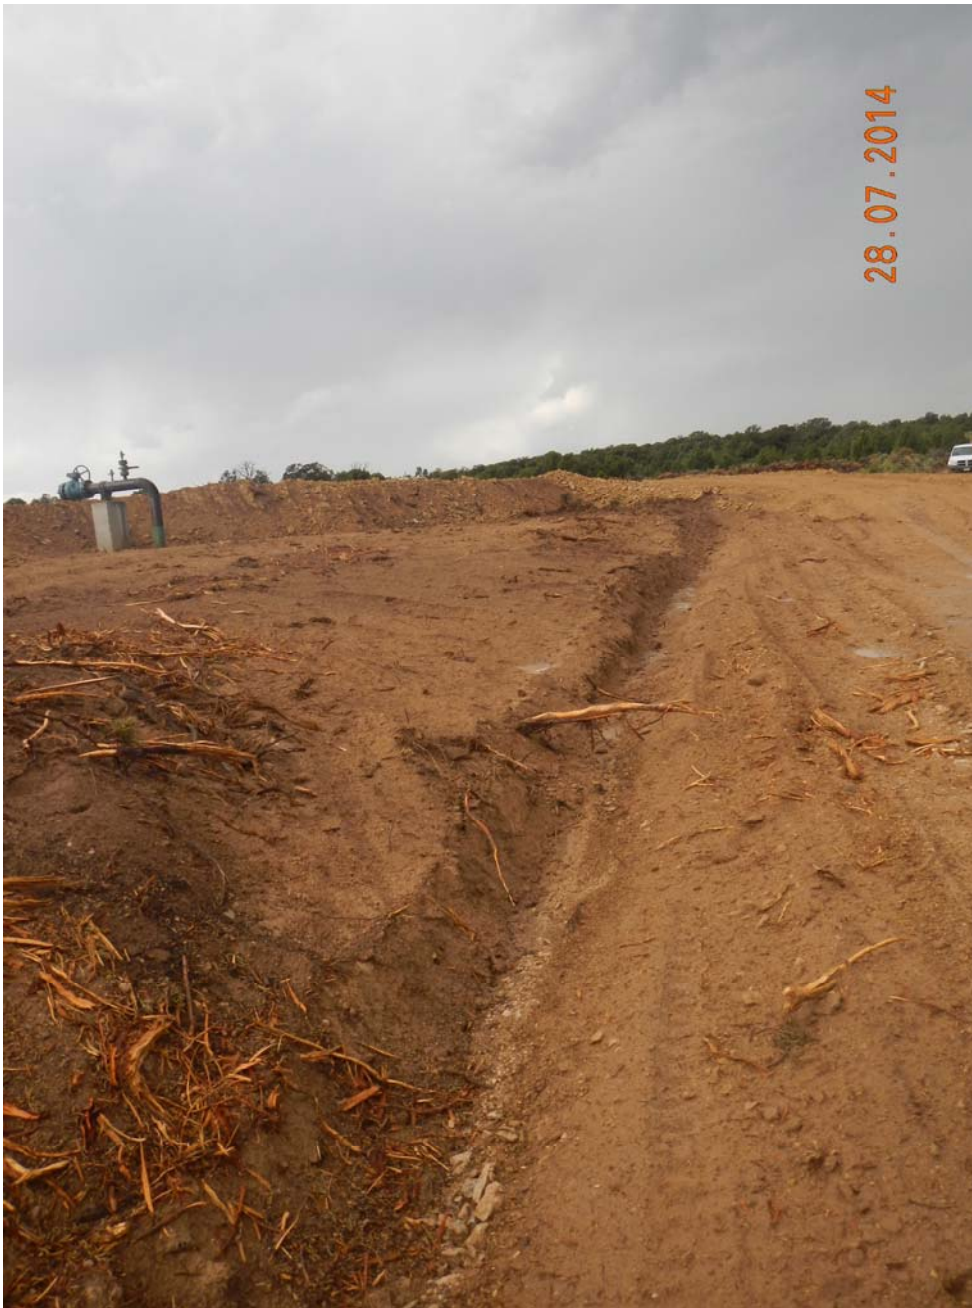
1.) Location entrance. Undercutting and sediment runoff observed.

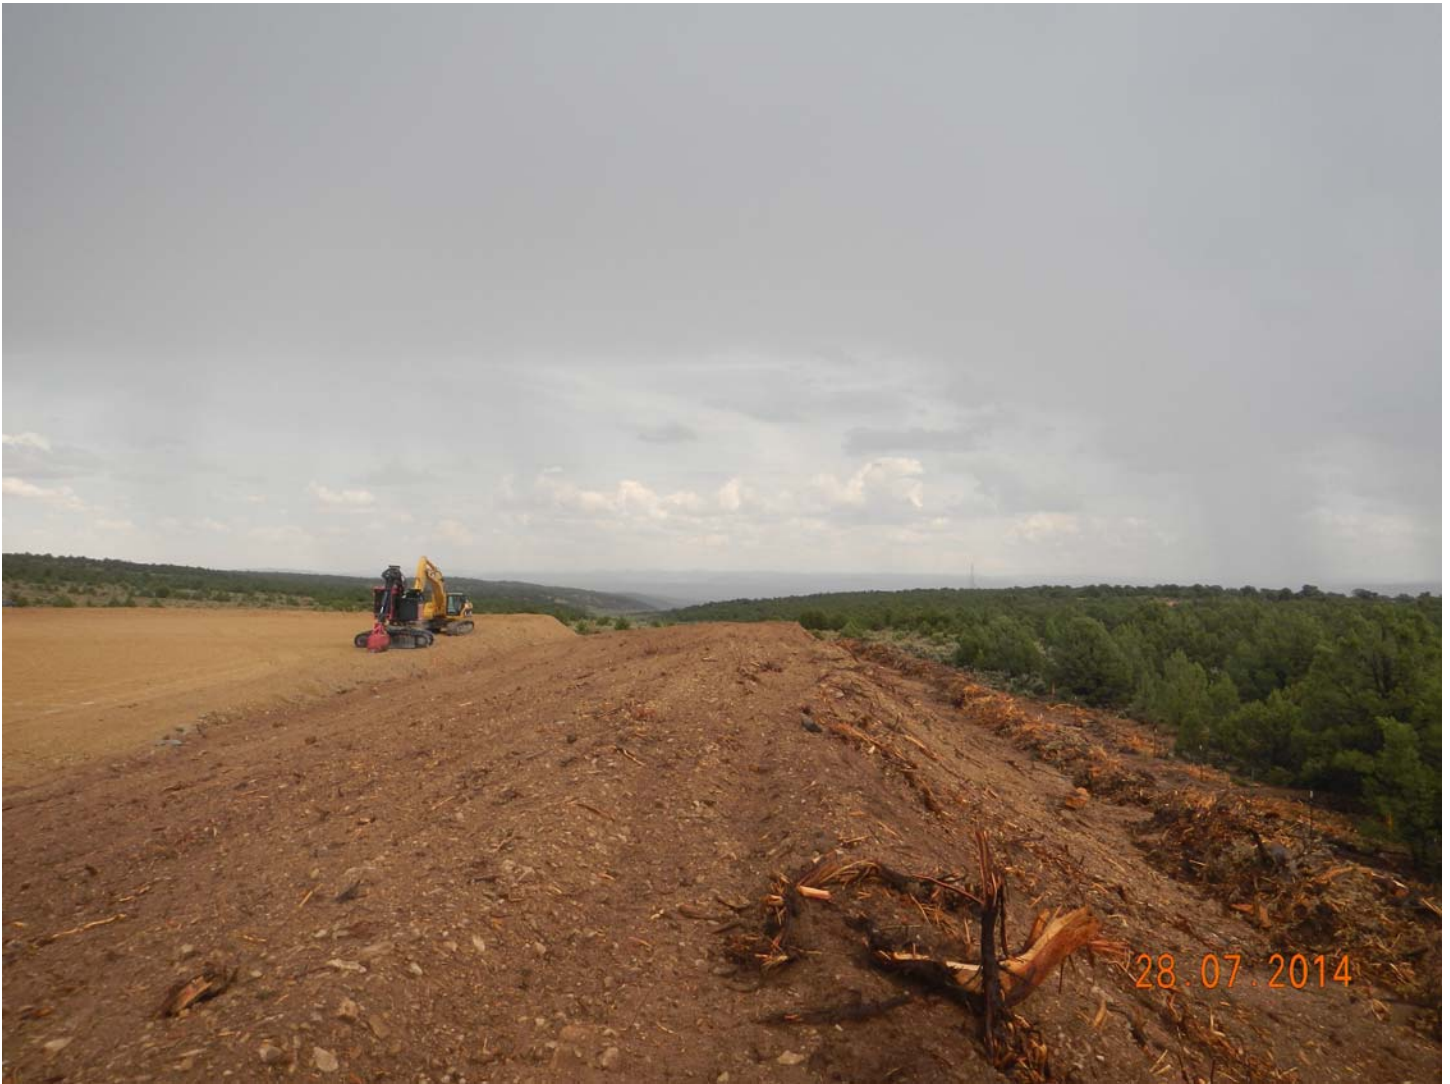
2.) Location stockpile being tracked. Slash utilized as BMP but contains a lot of topsoil without additional runoff BMPs.

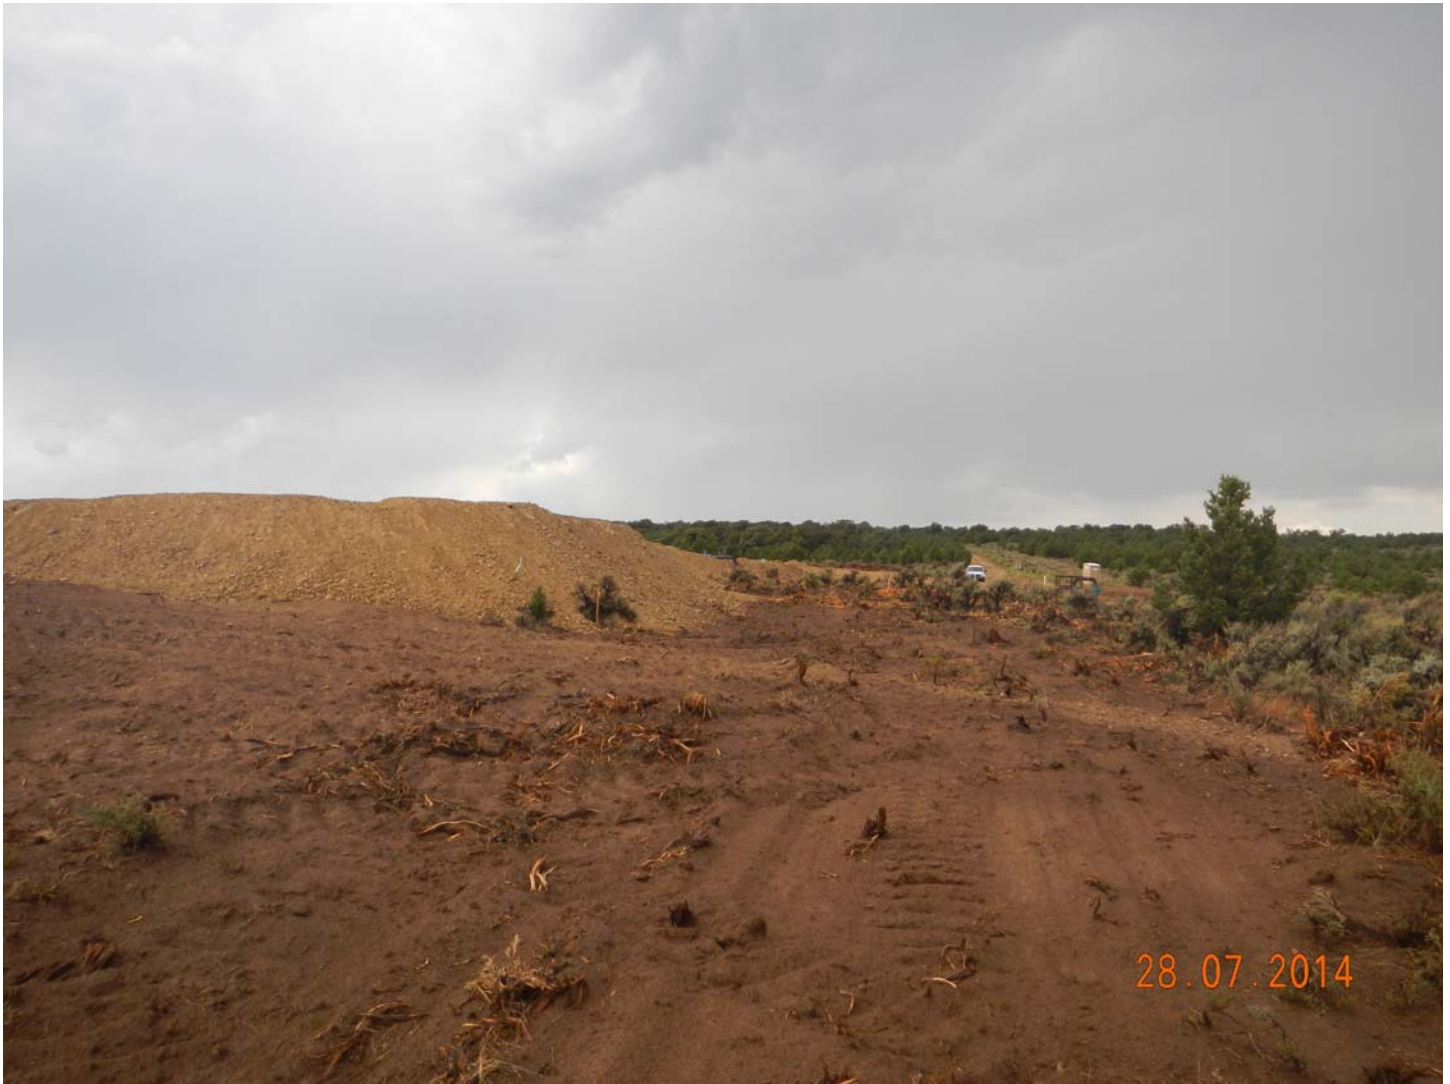
3.) Fill untracked/ vulnerable to erosion.

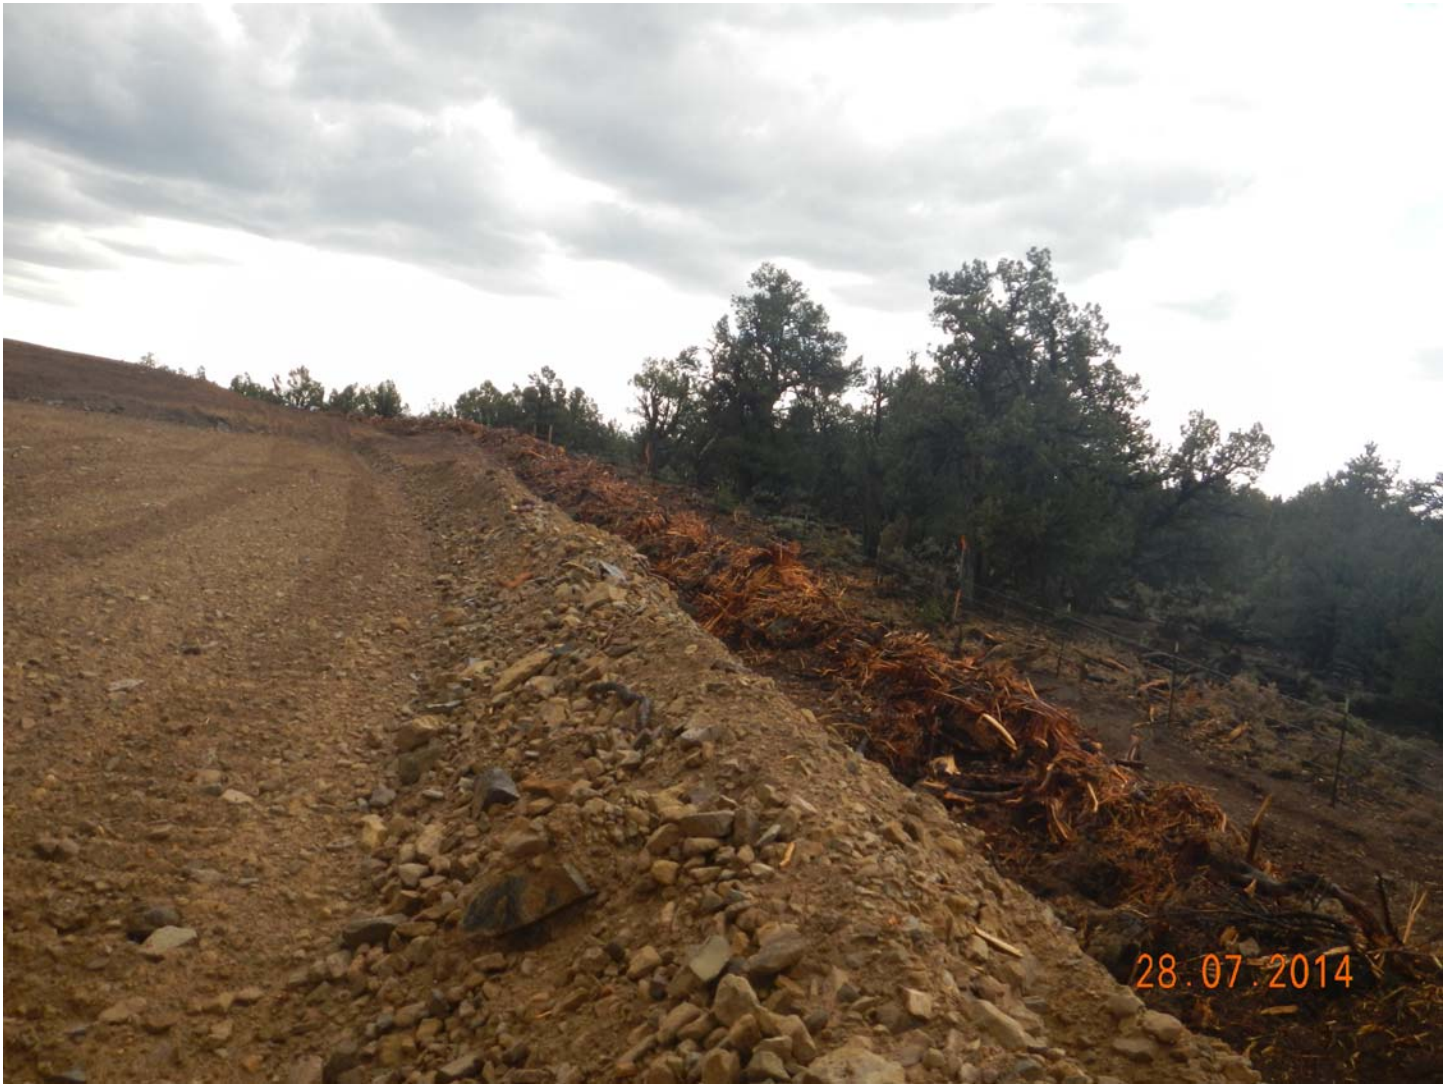
4.) Primary perimeter berm being constructed.
