## Lewis USA 36-1

Inspection DOC# 675200368

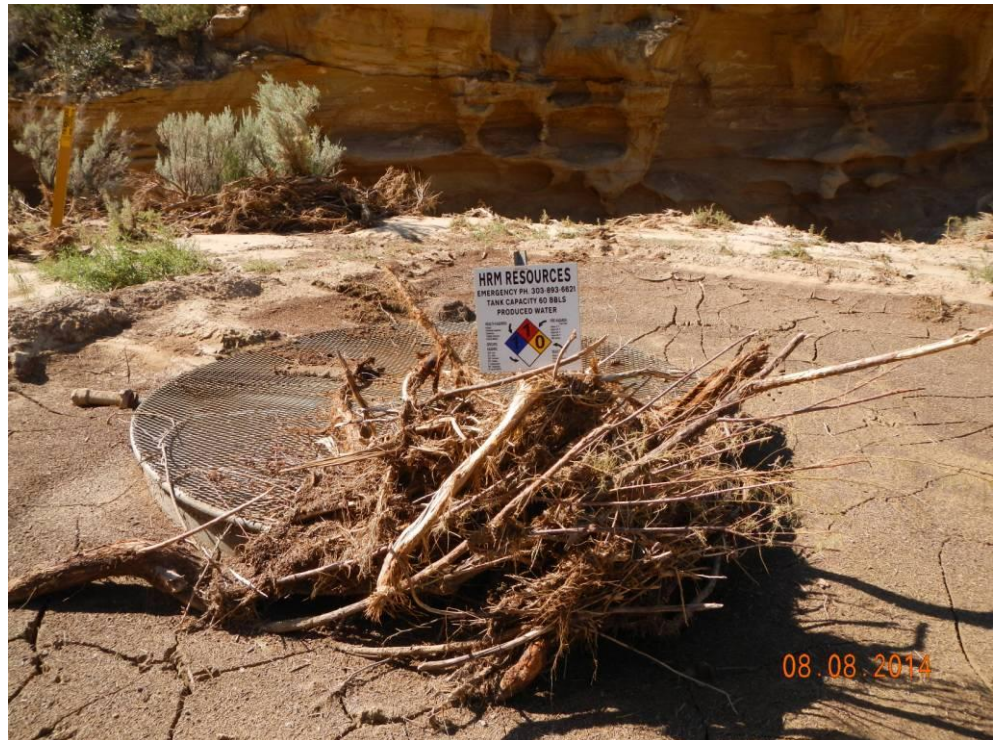
Sediment and debris on  
location from flood.  
Containment is at  
capacity.

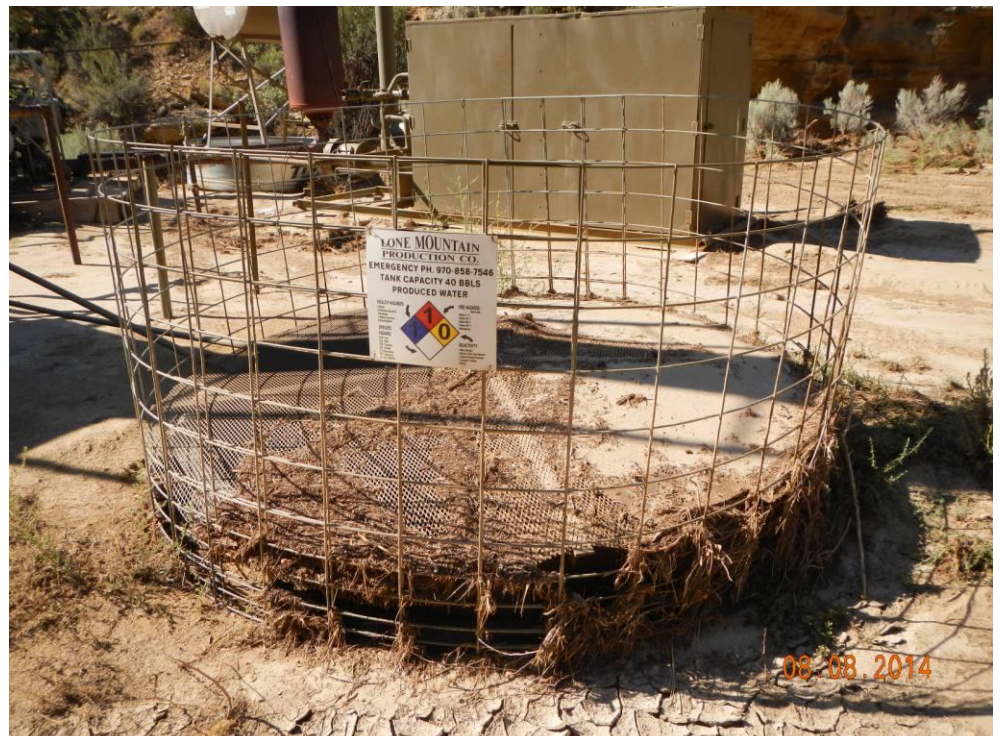
No containment around  
produced water tank.

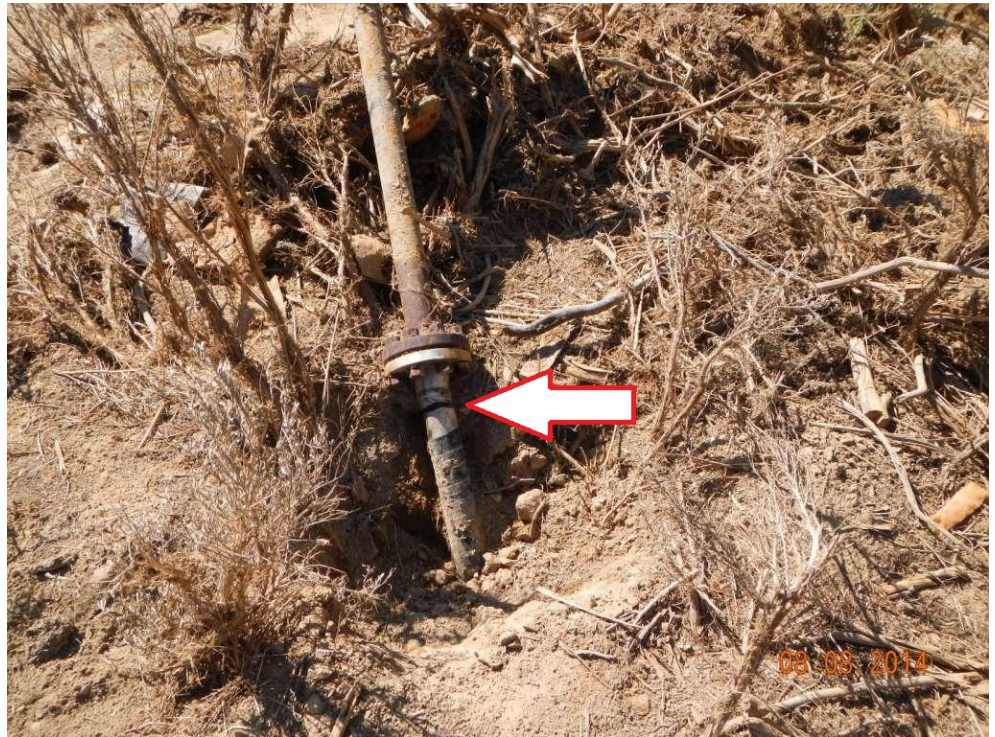
Damaged riser. Venting  
at time of inspection.

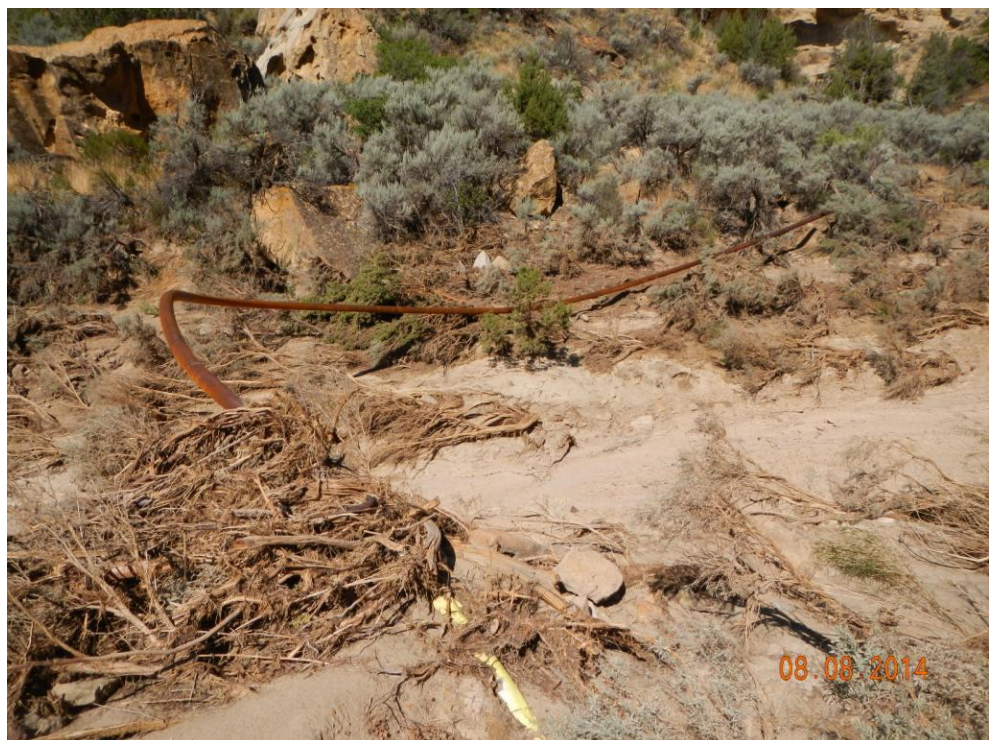
Damaged gathering line.

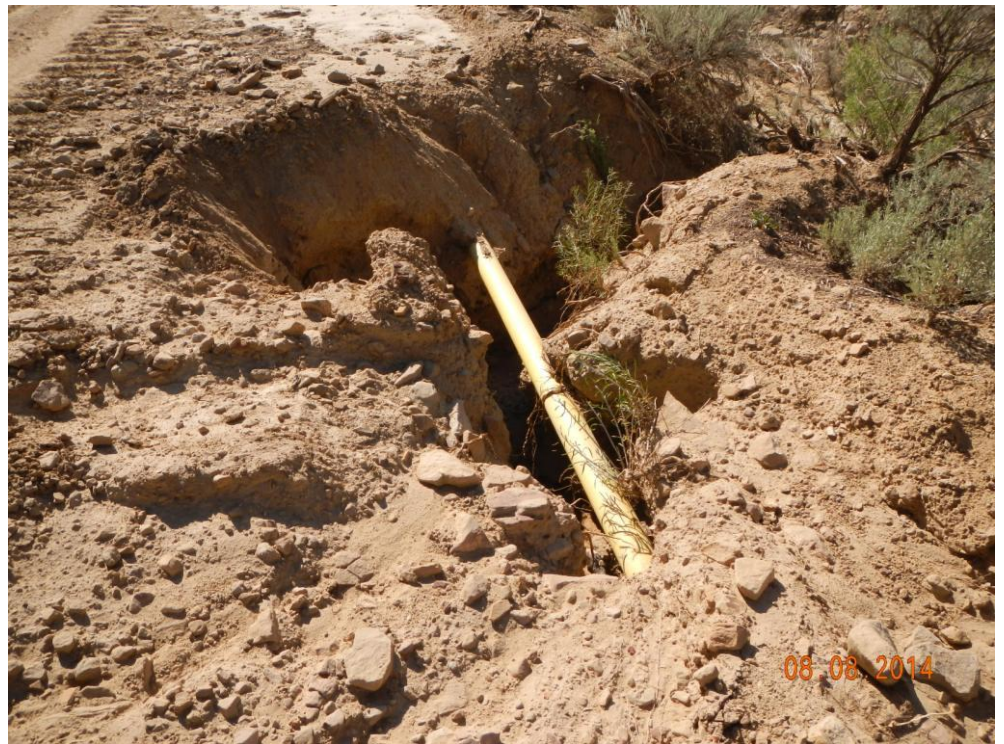
Exposed pipeline in  
roadway. (exposed in  
multiple location along  
road)

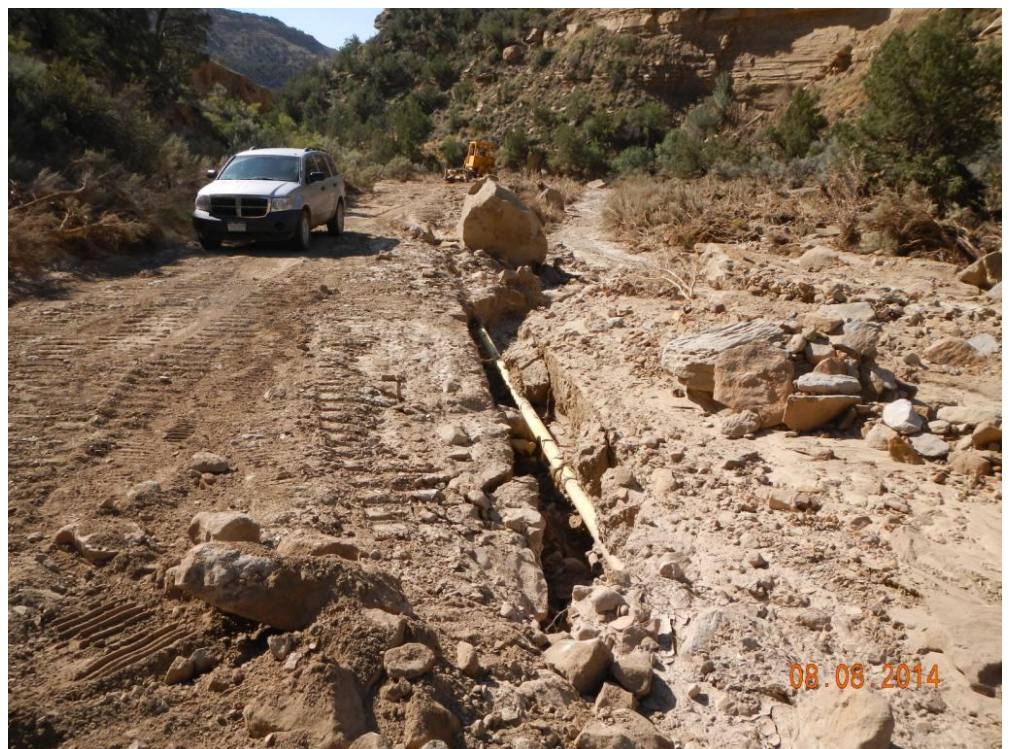
Exposed pipeline in  
roadway.
