Federal 31-3

Inspection DOC# 675200380

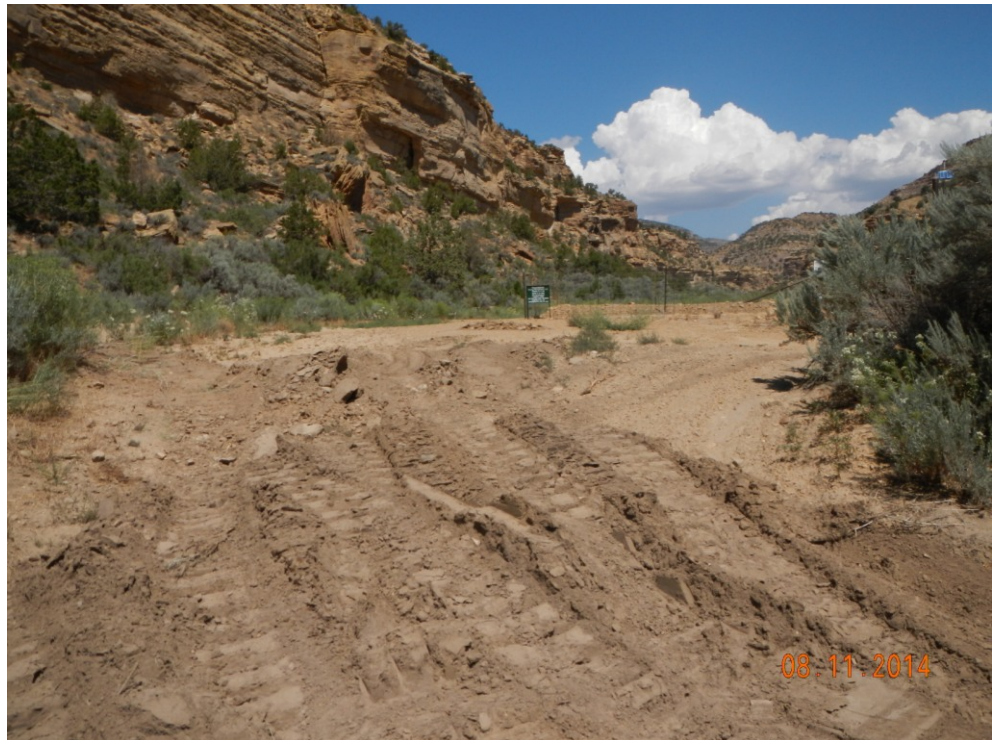
Location entrance is
blocked by pile of
material. Location is
being accessed by ATV.

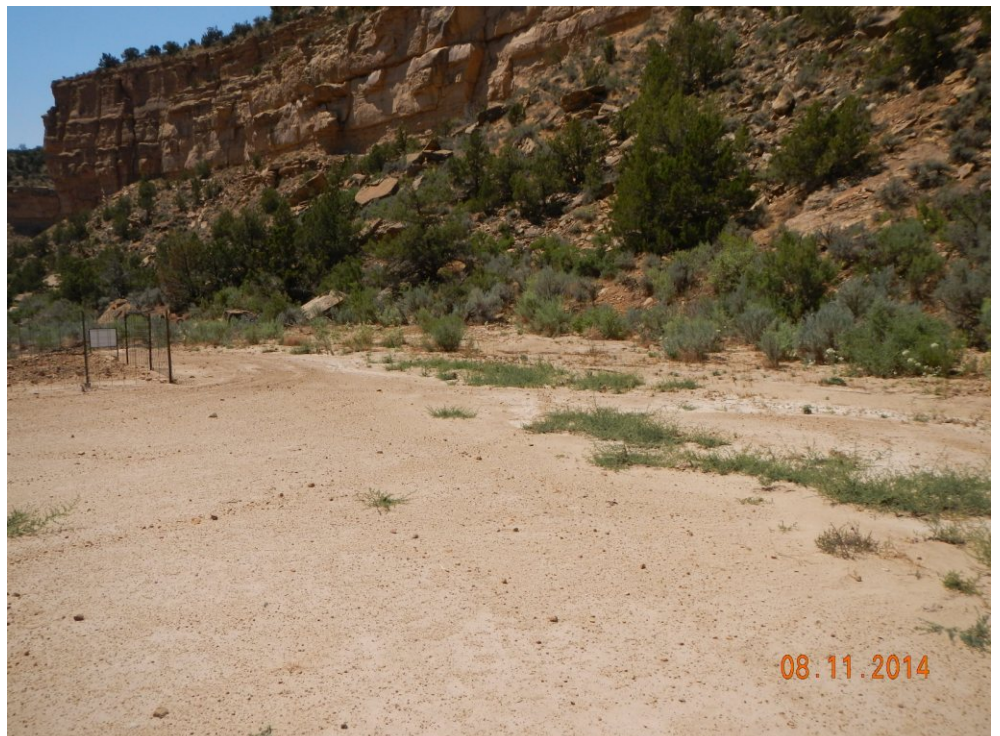
Sediment run-on from
recent flooding.
