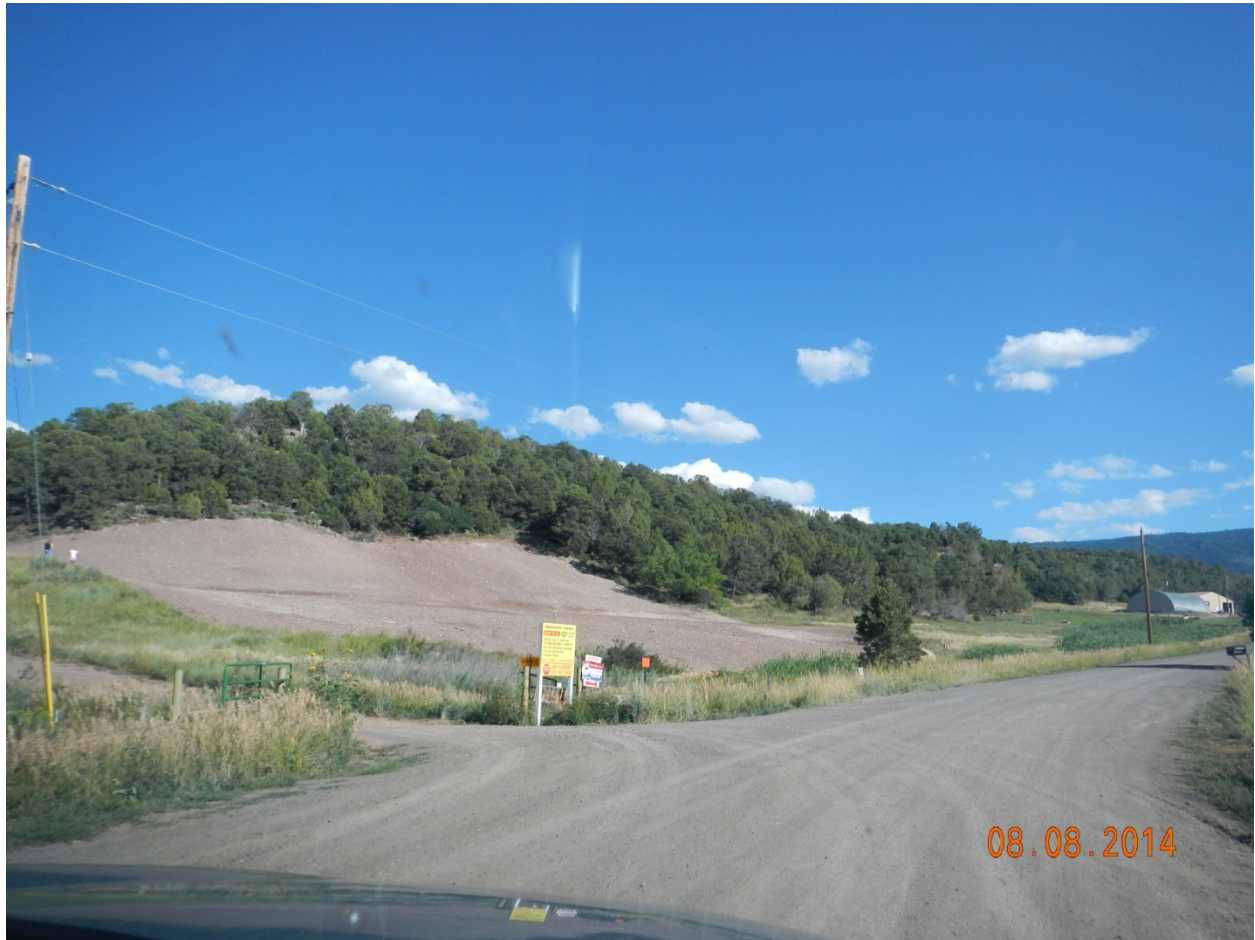
1.) Location recontouring as seen from main road.

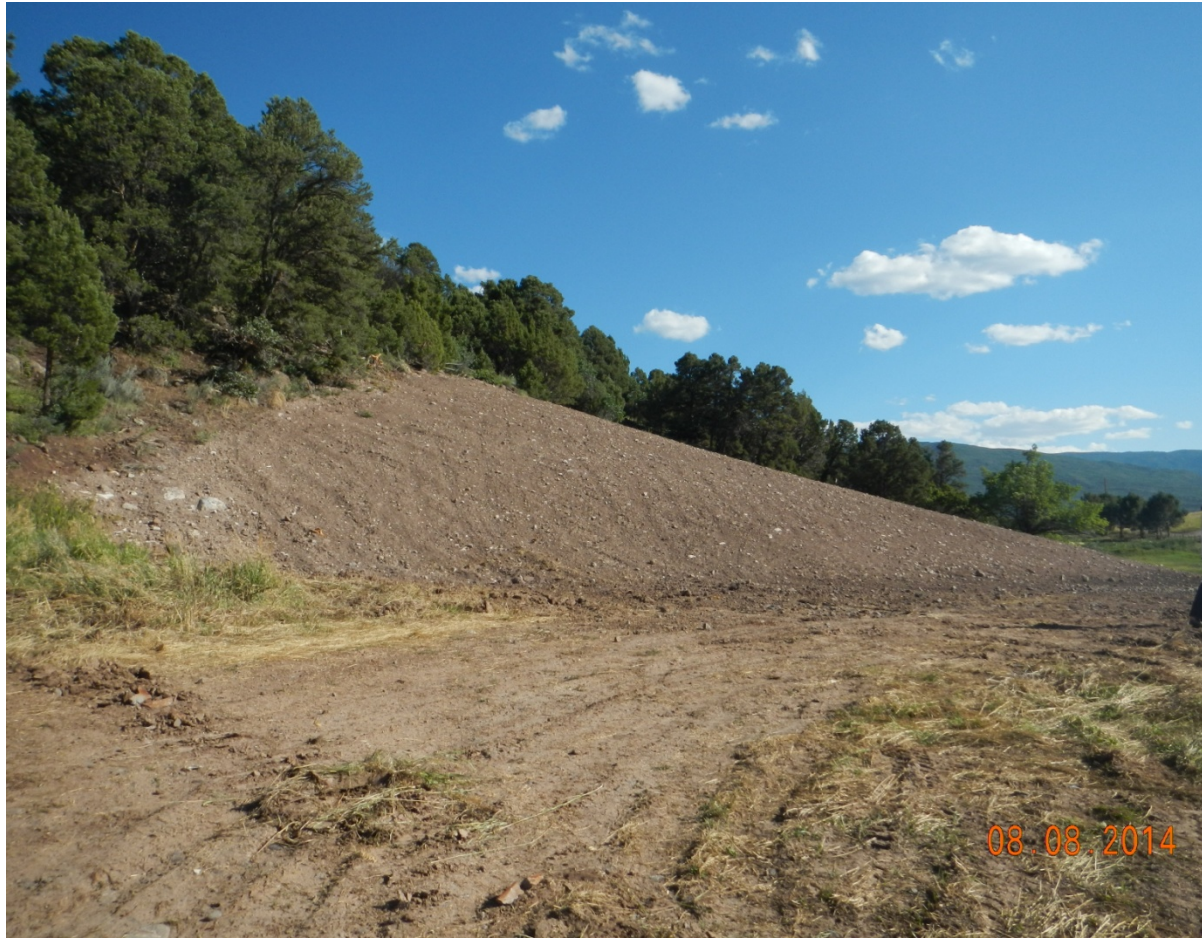
2.) Location recontouring looking at Southeast corner.

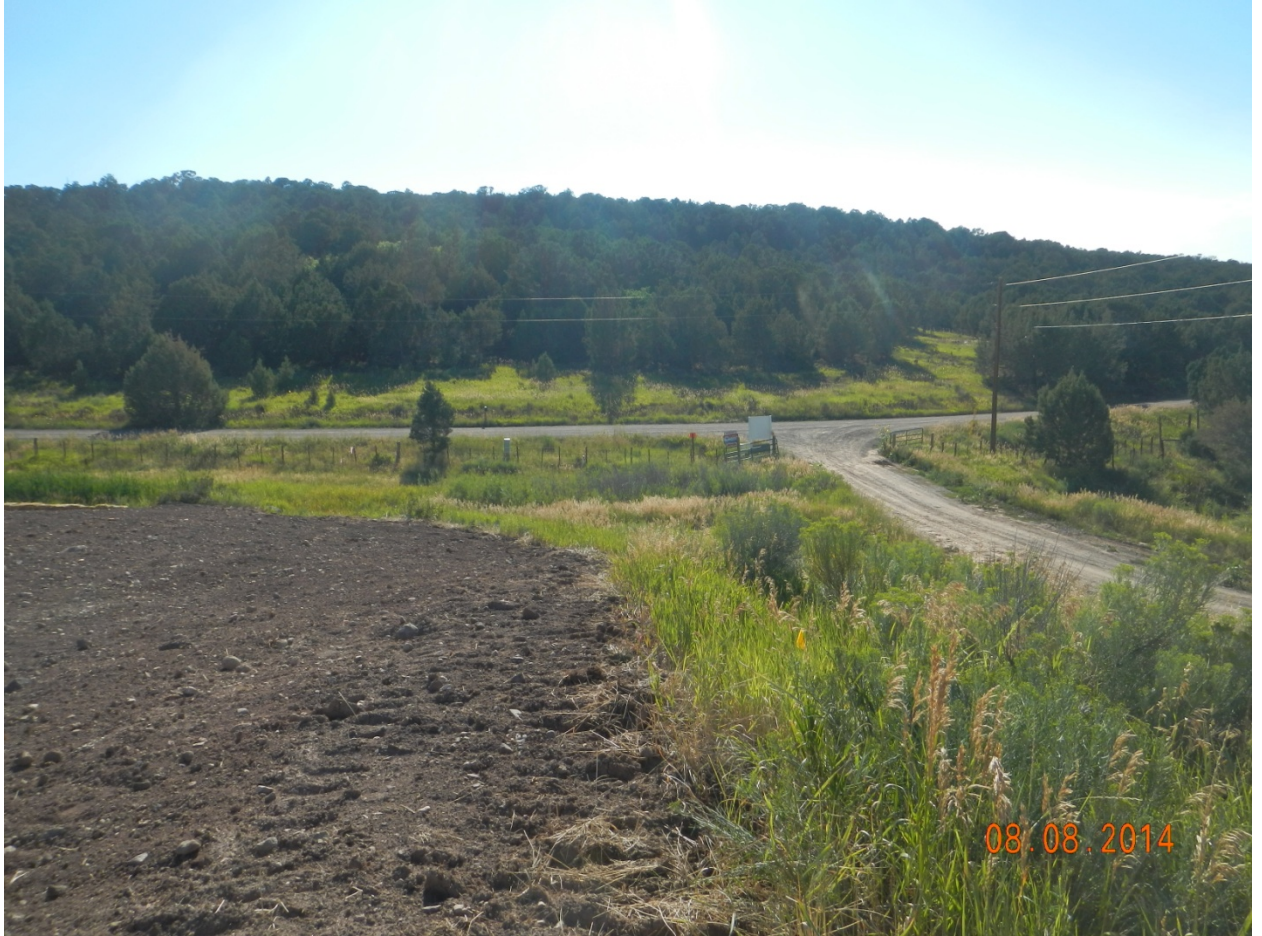
- 3.) Location recontouring looking due West from Northwest midpoint. (Surface owner requests reclamation be extended to access road along the North in order to tie-in elevations but existing East/West pipeline running through has yet to be surveyed for buried depth).

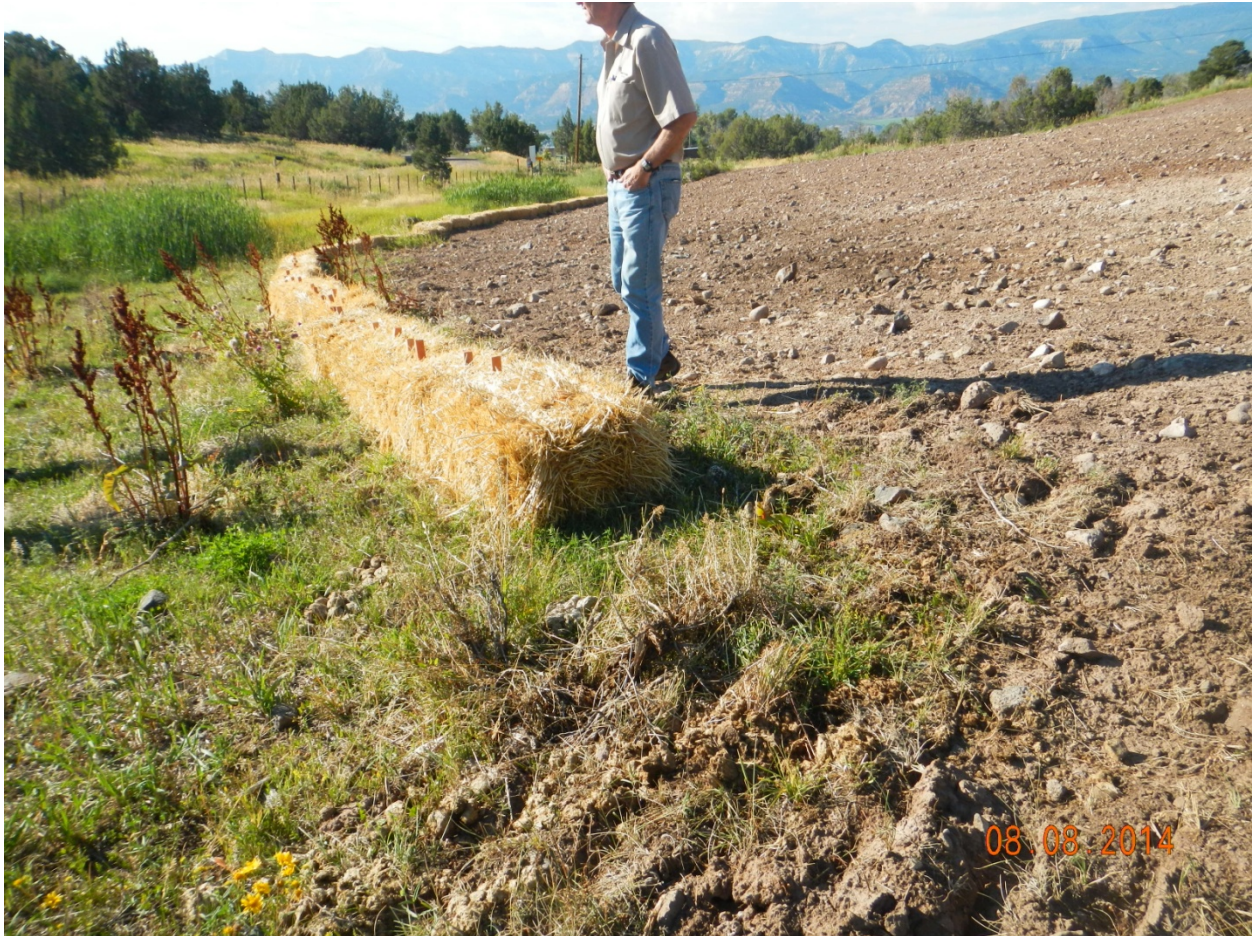
- 4.) Straw bales along Western perimeter installed improperly, (twine should not be in contact with soil).

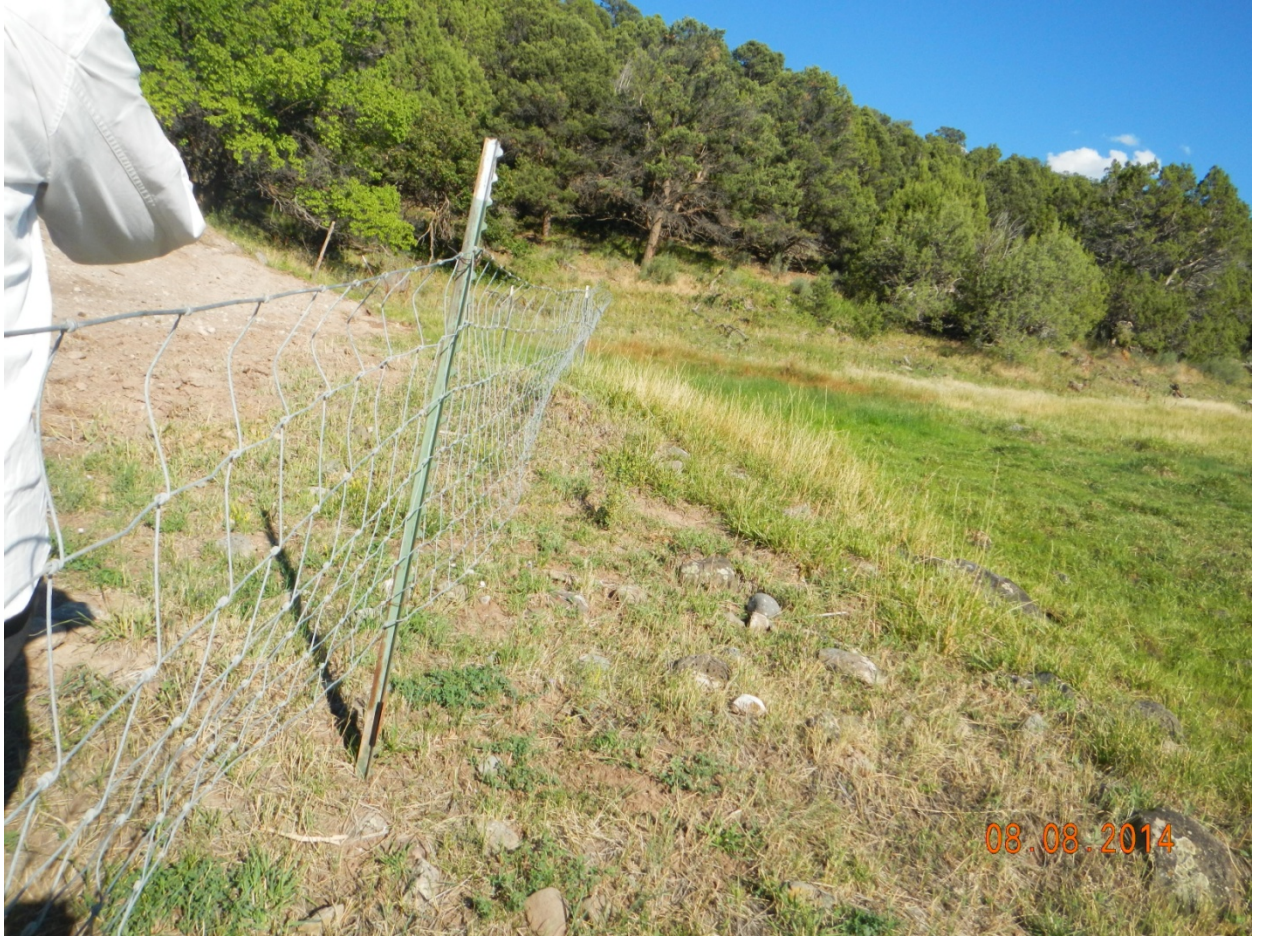
5.) Reclamation along Southern edge. Pad fill still visible. (Surface owner requests reclamation be extended past fencing.)
