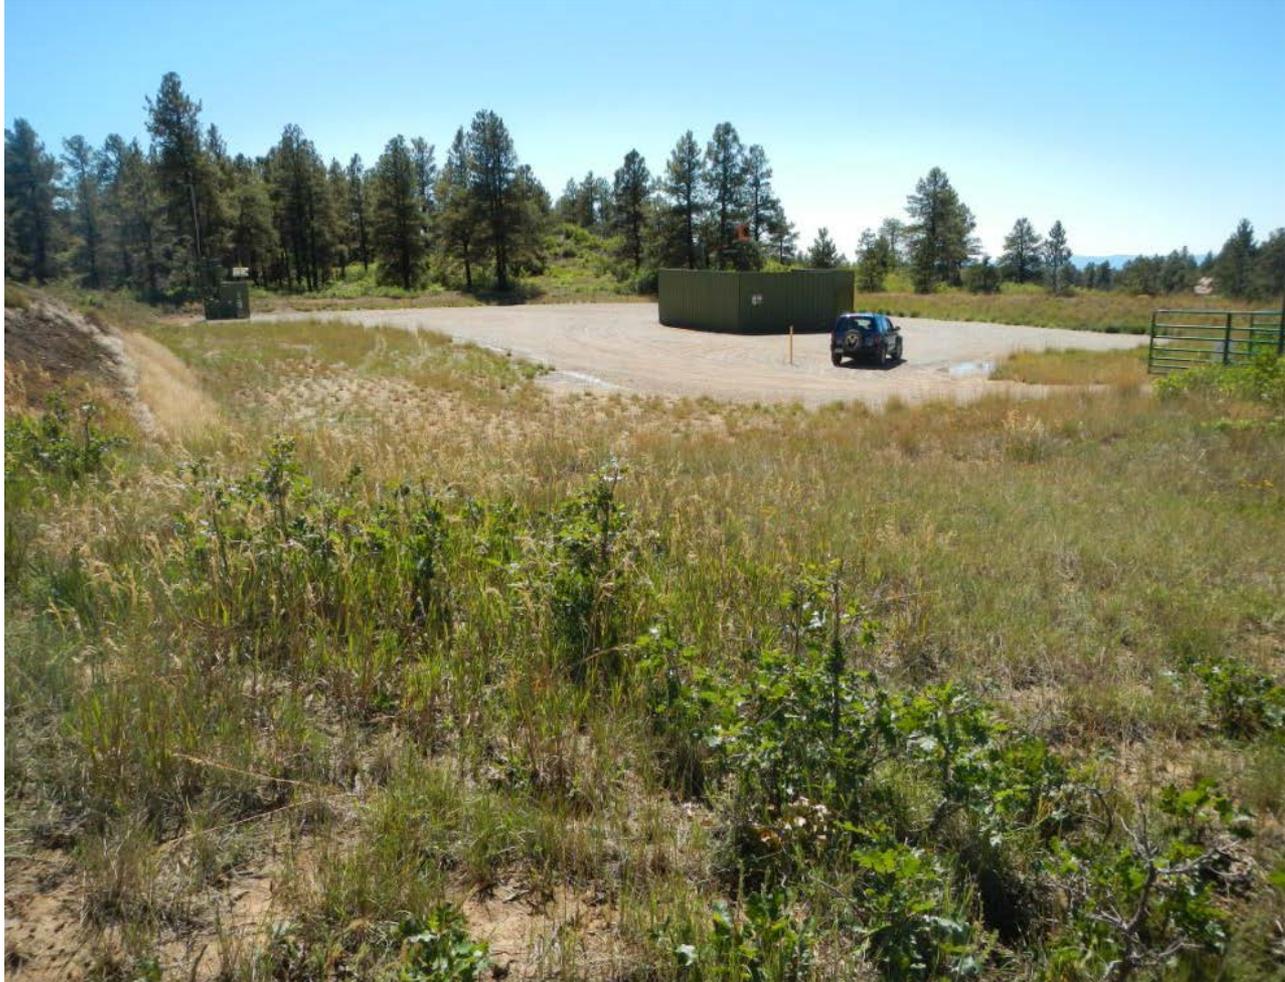
Photo 1. View from northeastern corner of project area facing center.

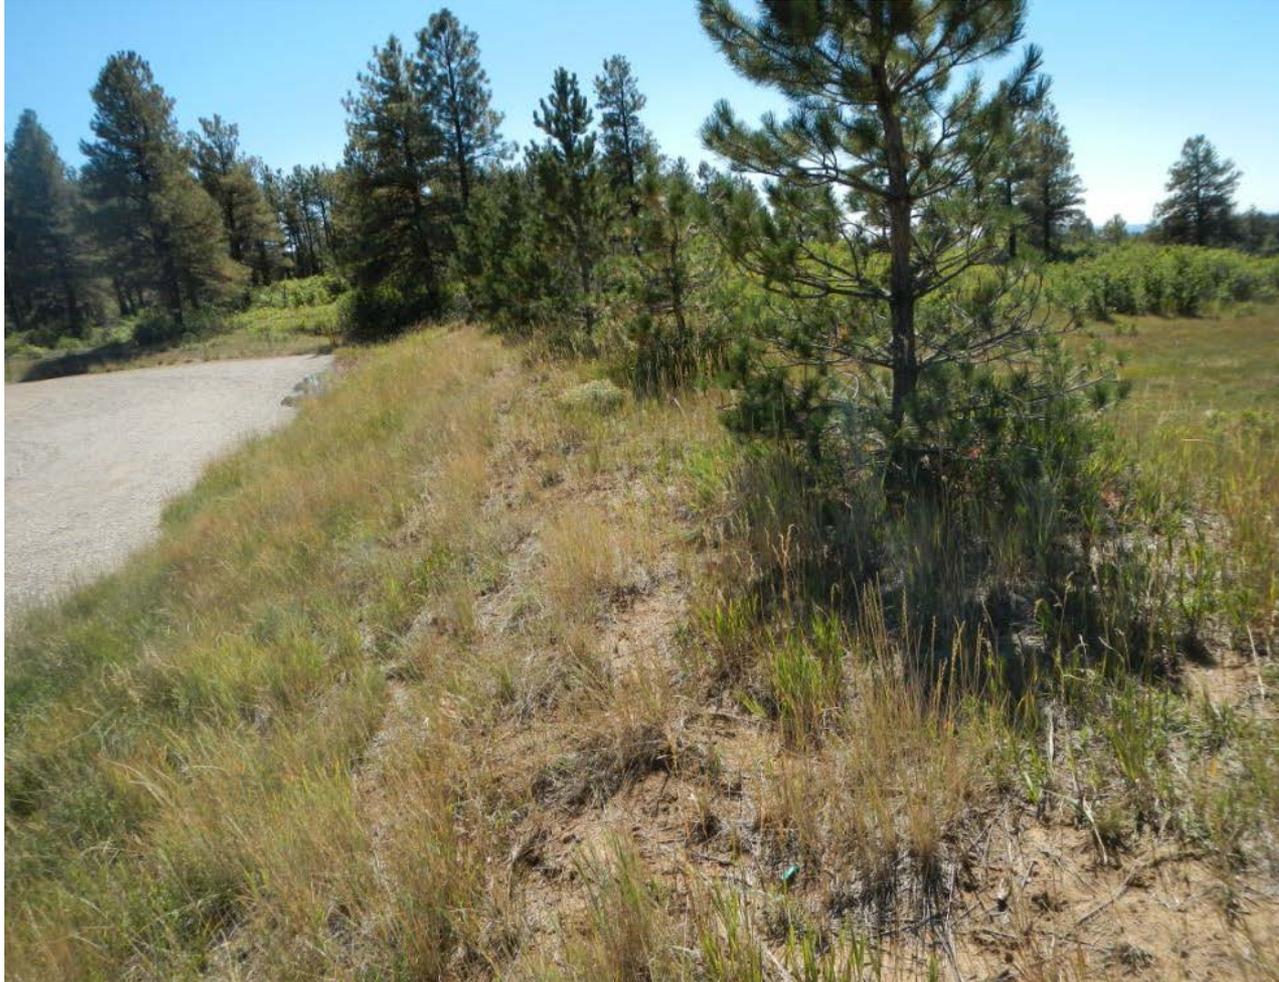
Photo 2. View of planted trees in good condition along the southern edge of the well pad working area.

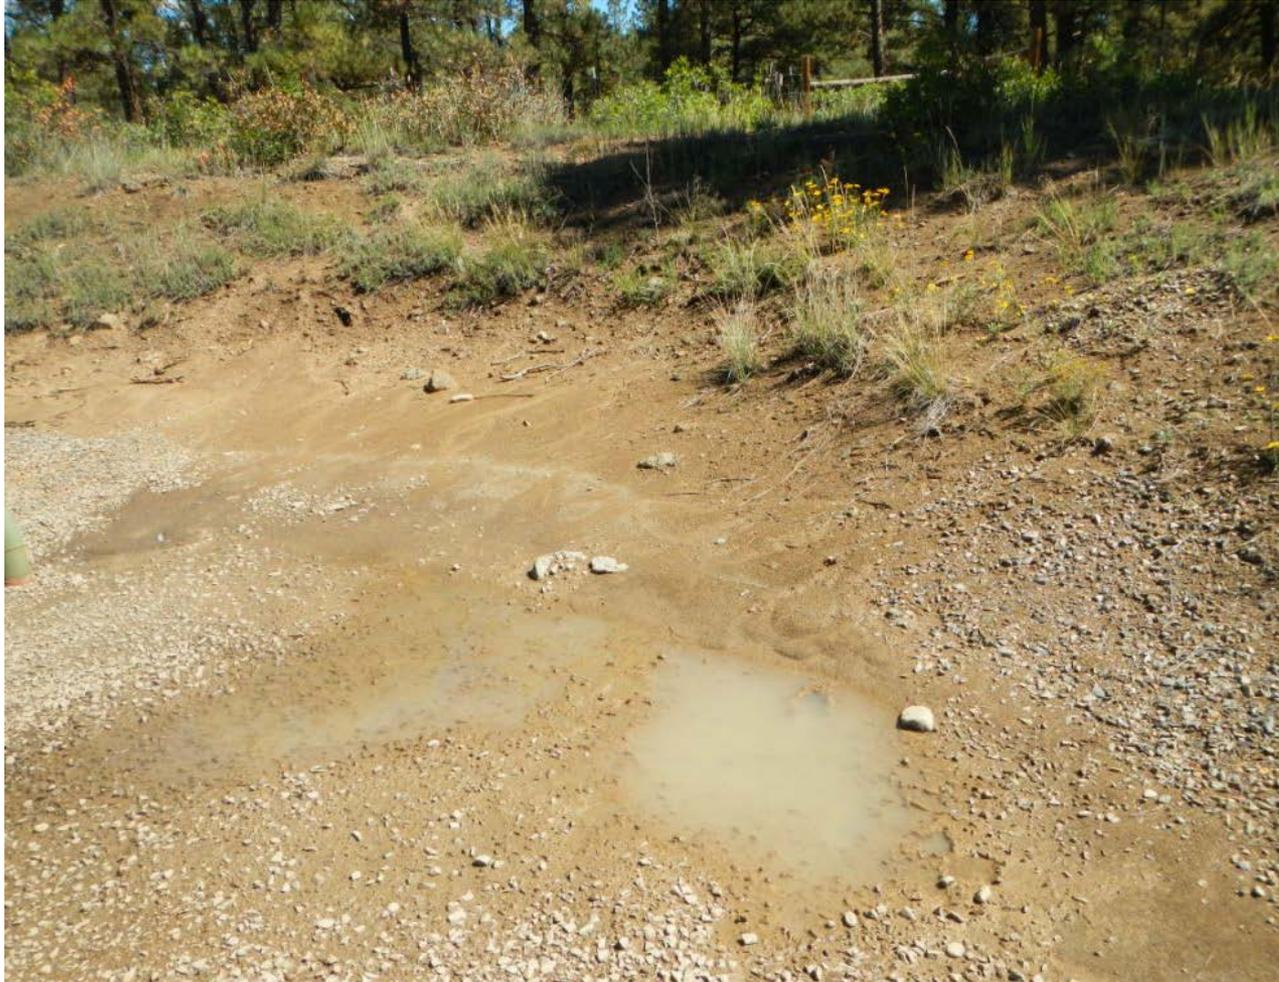
Photo 3. Minor erosion in the southeastern corner of the project area needs to be monitored.
