STATE OF
COLORADO

DOC 2141772

Remediation Project 3439 (Energy O&G) - Bayswater Moody 1-30 location (05-123-12702)1 message

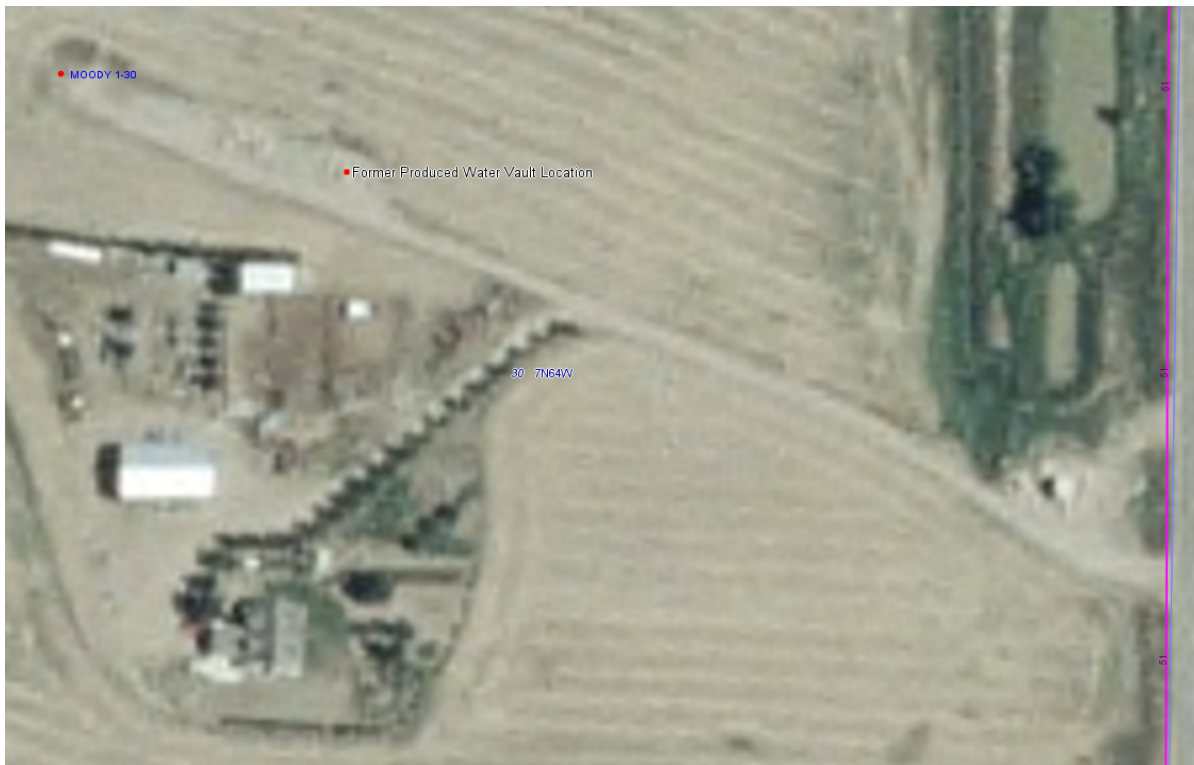
2005 Aerial Image:

COGCC records do not include any documentation that the conditionally approved workplan was executed. In addition, it appears that the subject buried produced water vessel was located near the separator, between the current production facilities and the wellhead. The produced water vessel has since been removed and relocated to the current production facility location. See the 2005 and 2013 aerial images below. However, no assessment of the subsurface at the former produced water vessel location has been provided to COGCC.

Therefore, COGCC requests Bayswater Exploration and Production to conduct an investigation to resolve Remediation Project Number 3439 and to perform a subsurface assessment at the former produced water vessel location. Please submit a Form 27 Site Investigation and Remediation Workplan within 60 days with a proposal to perform the requested work. The assessment should focus on the former produced water vault location as seen in historical aerial imagery.
