Island Ranch 13-796

Inspection# 675200644

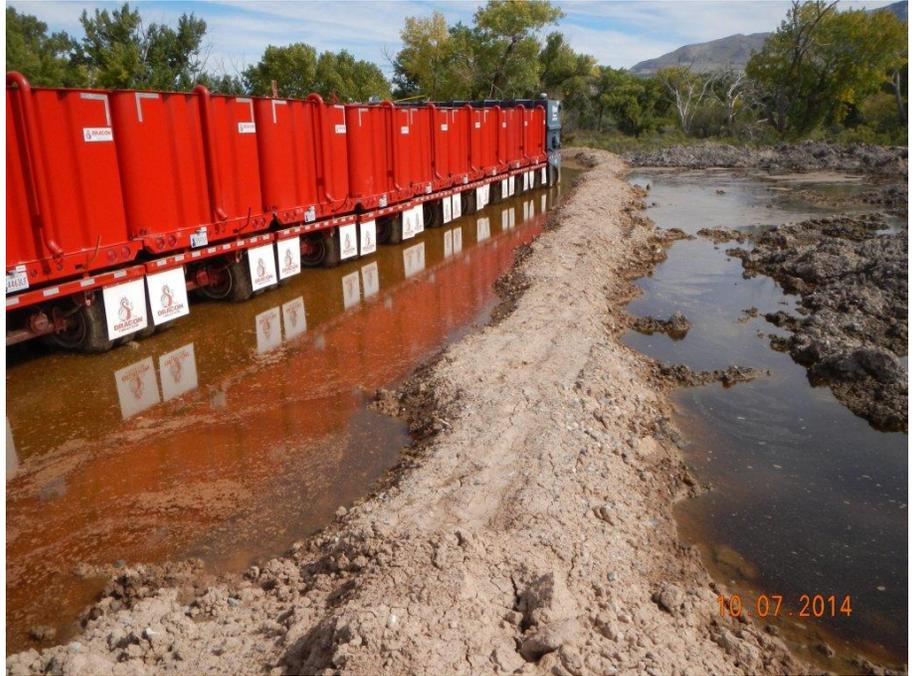
Pooling of stormwater behind frac tanks and at base of cuttings.

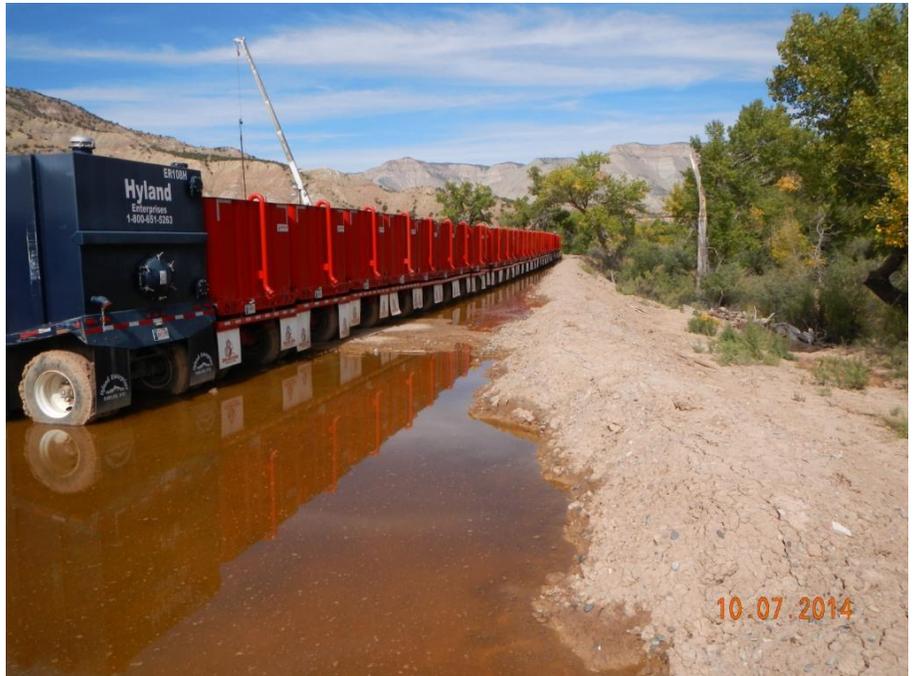
Pooling of stormwater behind frac tanks.

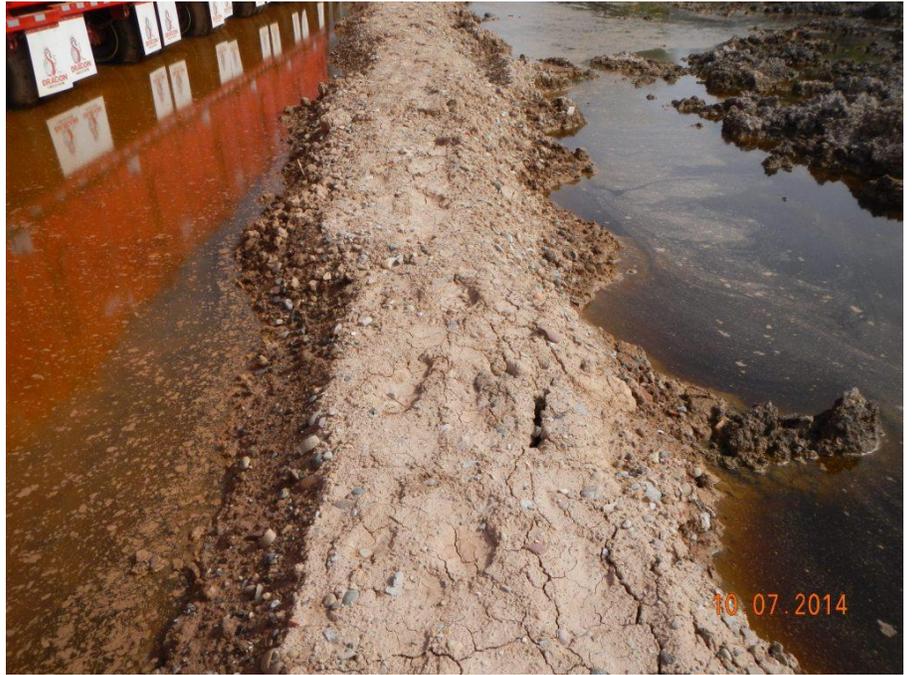
Pooling water. Berm is soft and beginning to subside.

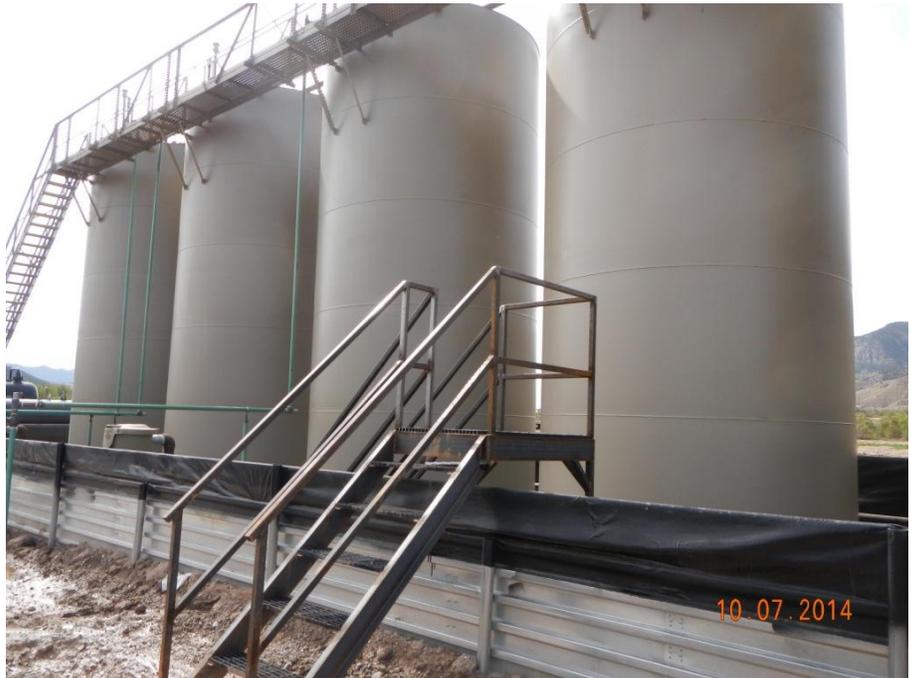
Tanks with no signage on them.

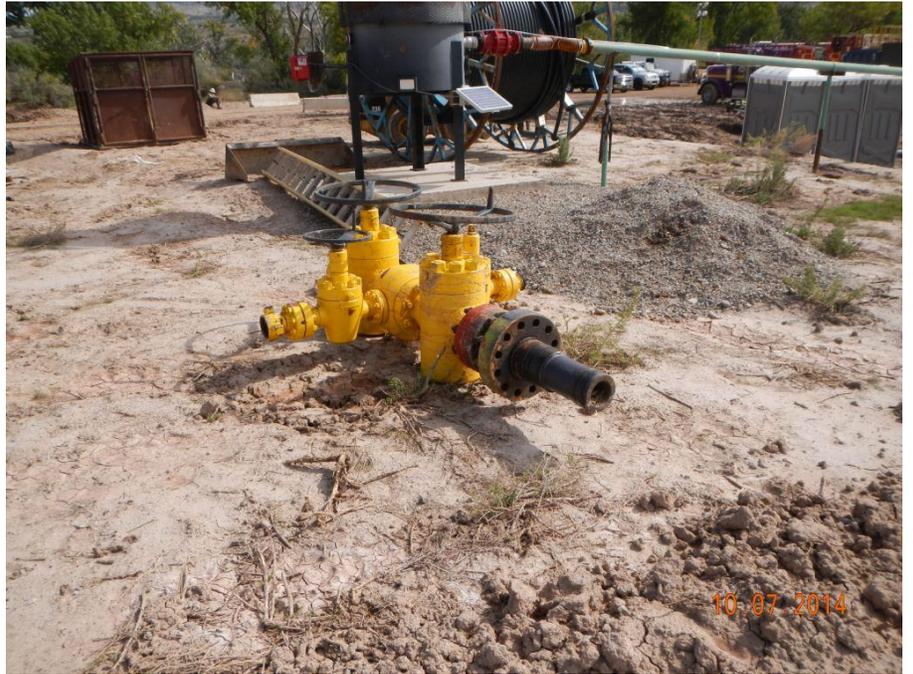
Frac tree with mandrel stored off location.

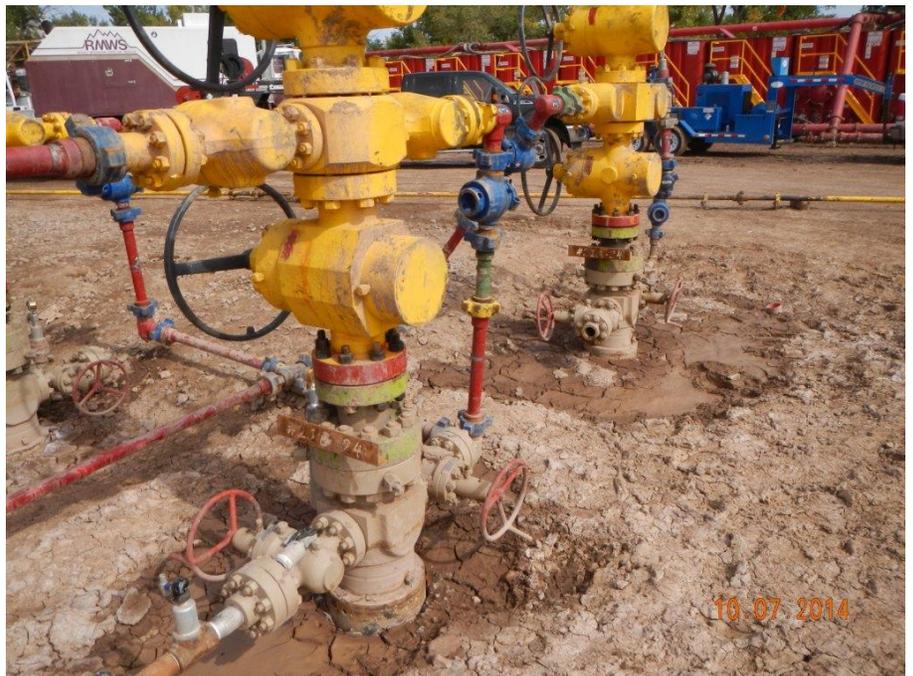
Insufficient signage at wellheads.
