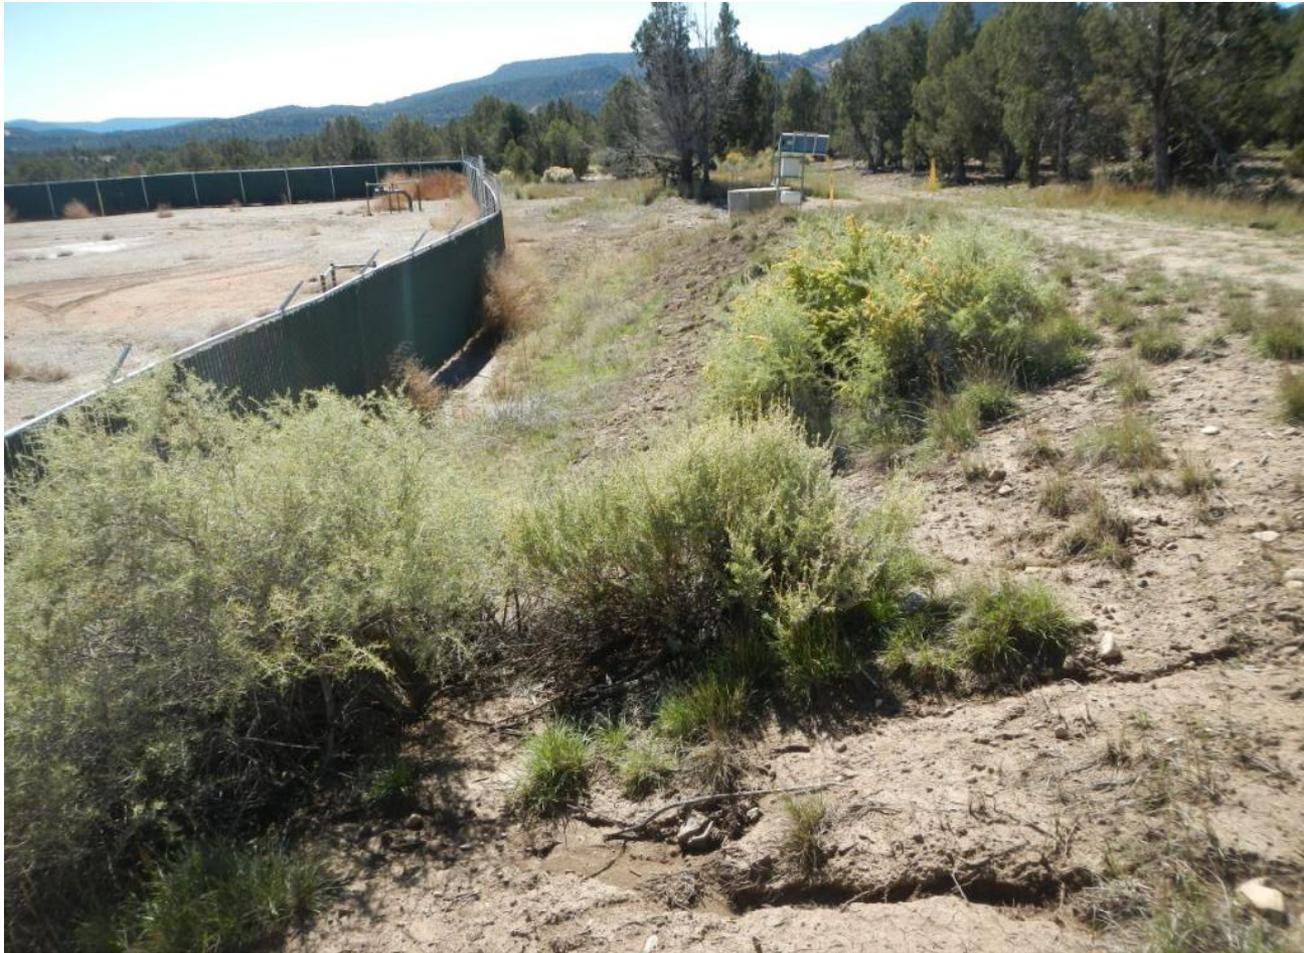
Photo 1. View of western edge of project area from northwestern corner facing southward.

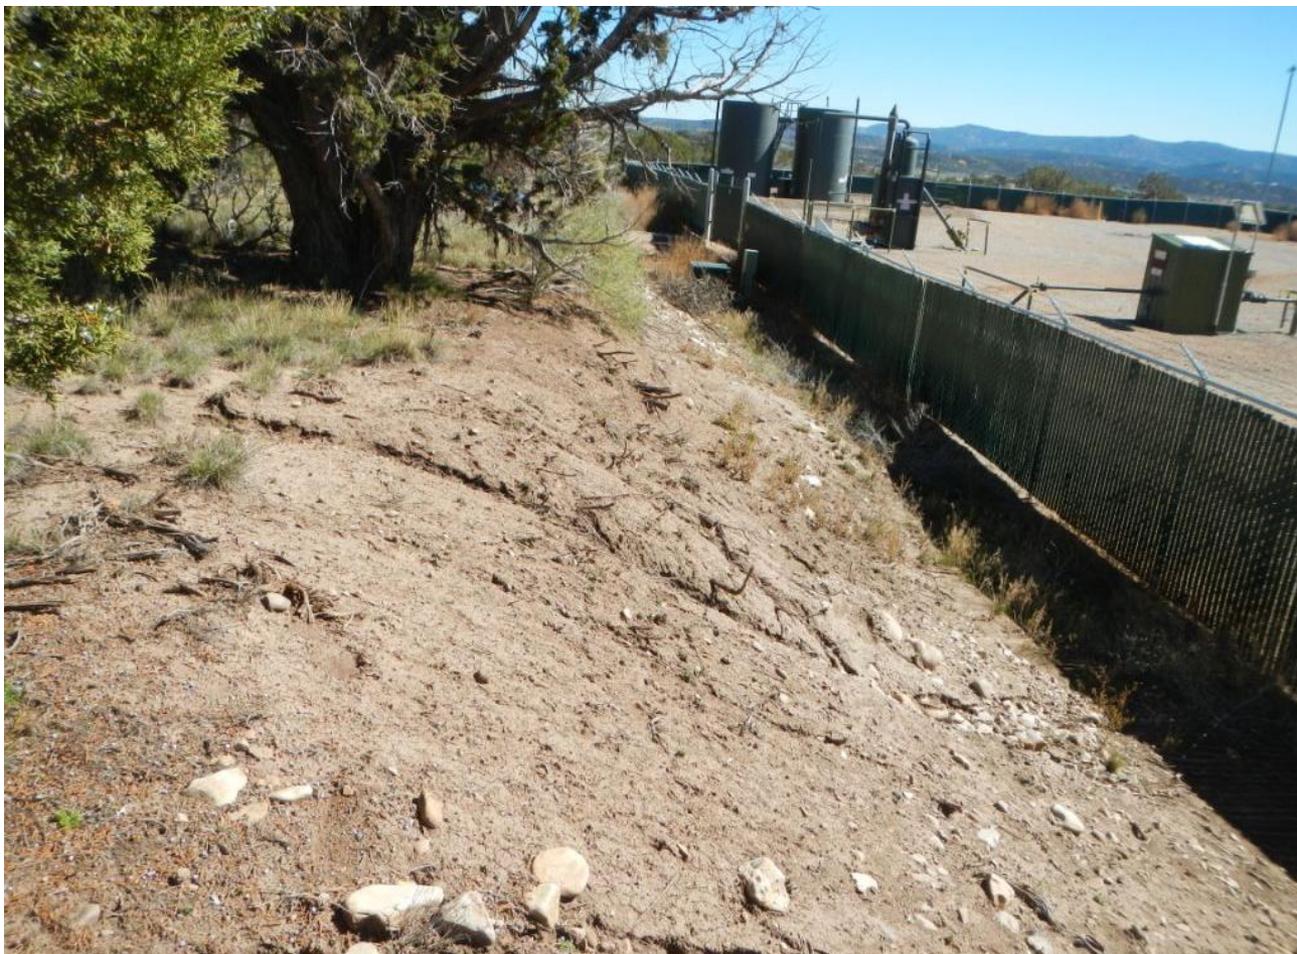
Photo 2. View of northern edge of project area from northwestern corner facing eastward.

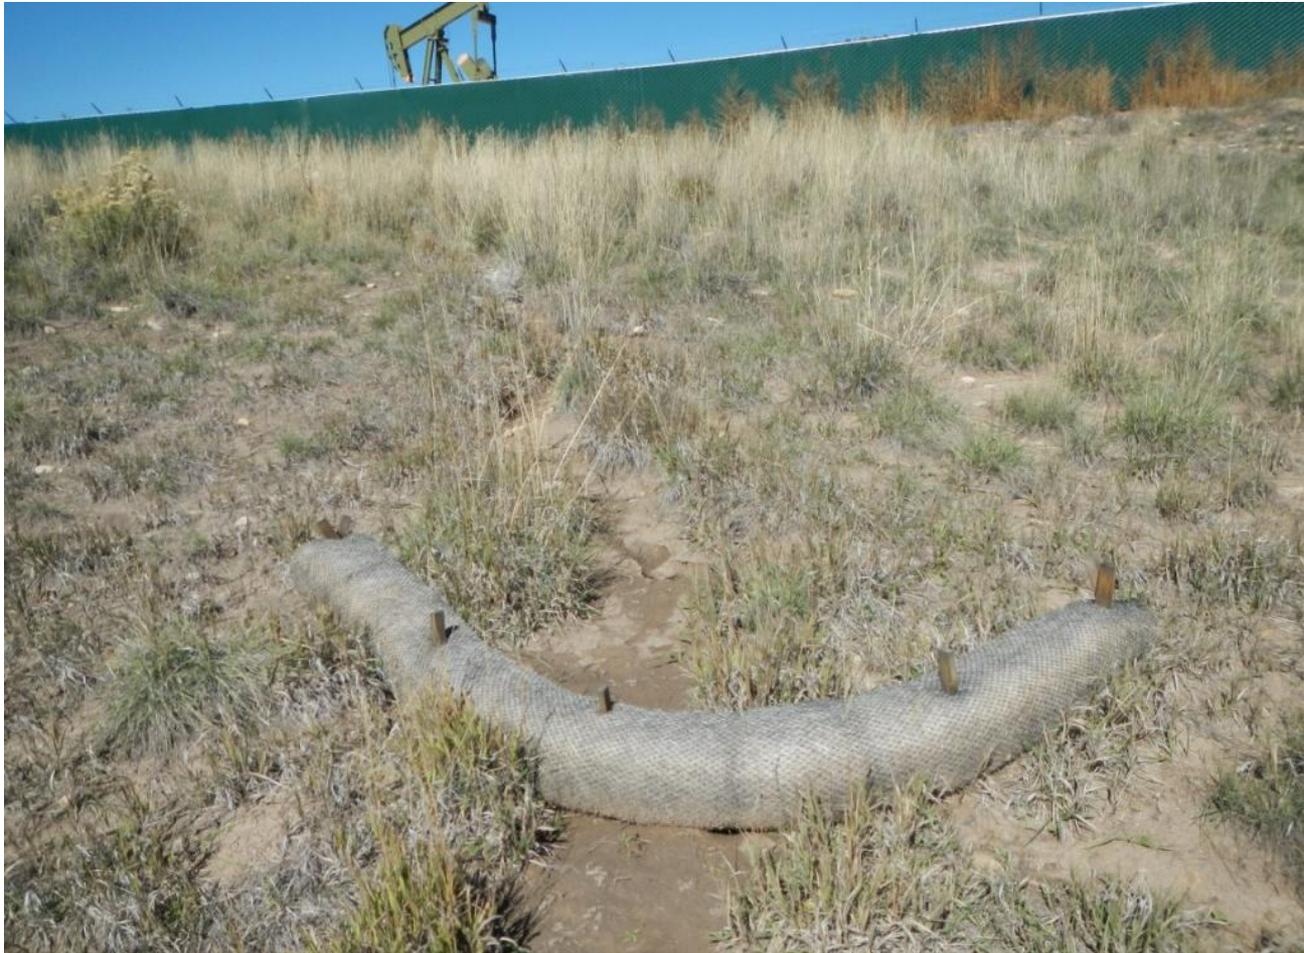
Photo 3. View of straw wattle that appears to be functioning within southern portion of project area.

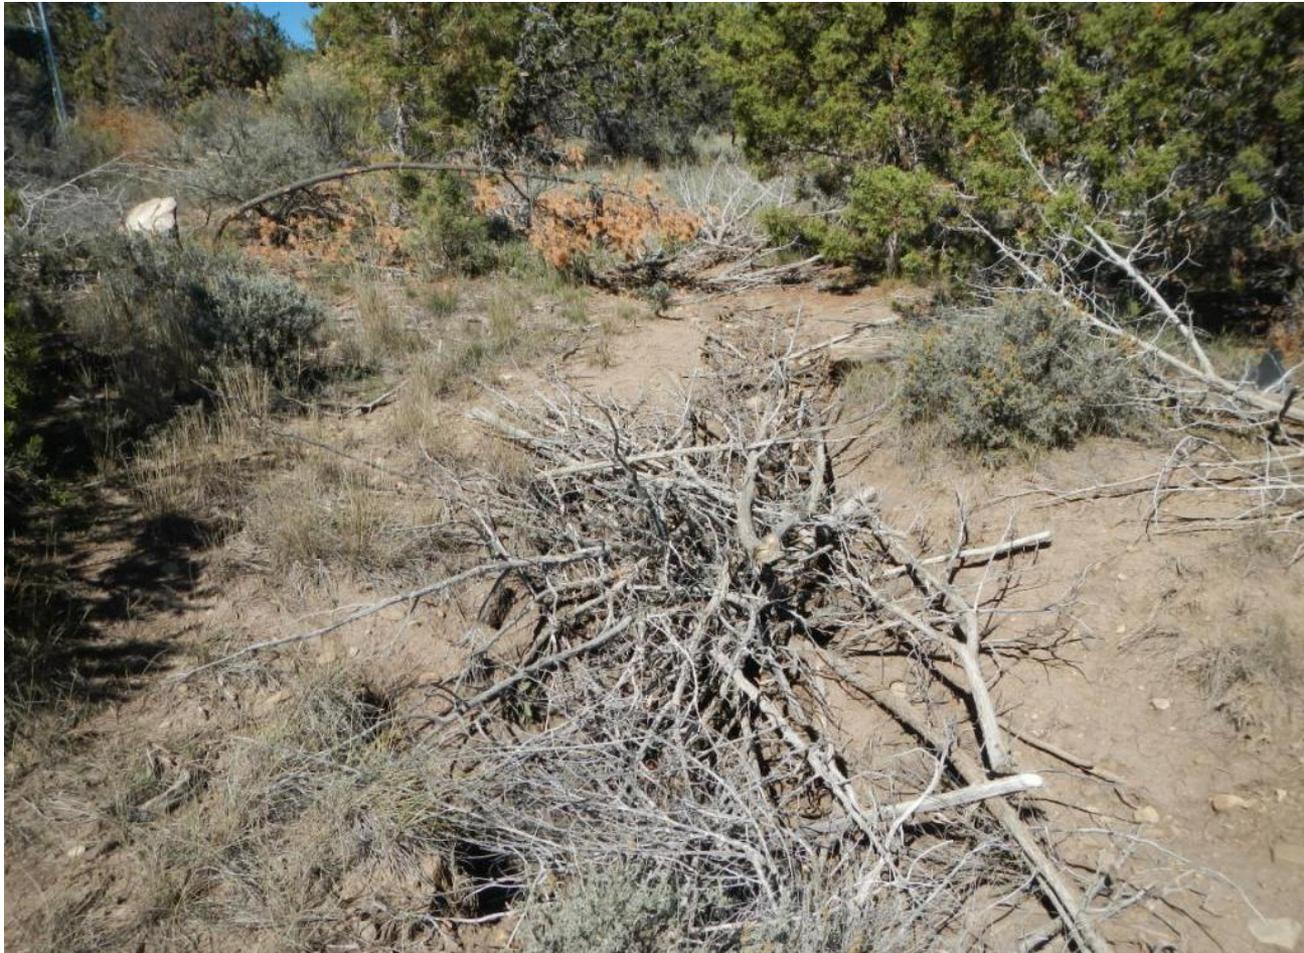
Photo 4. View of woody debris placed in erosional channel which will not likely be sufficient for stormwater control.
