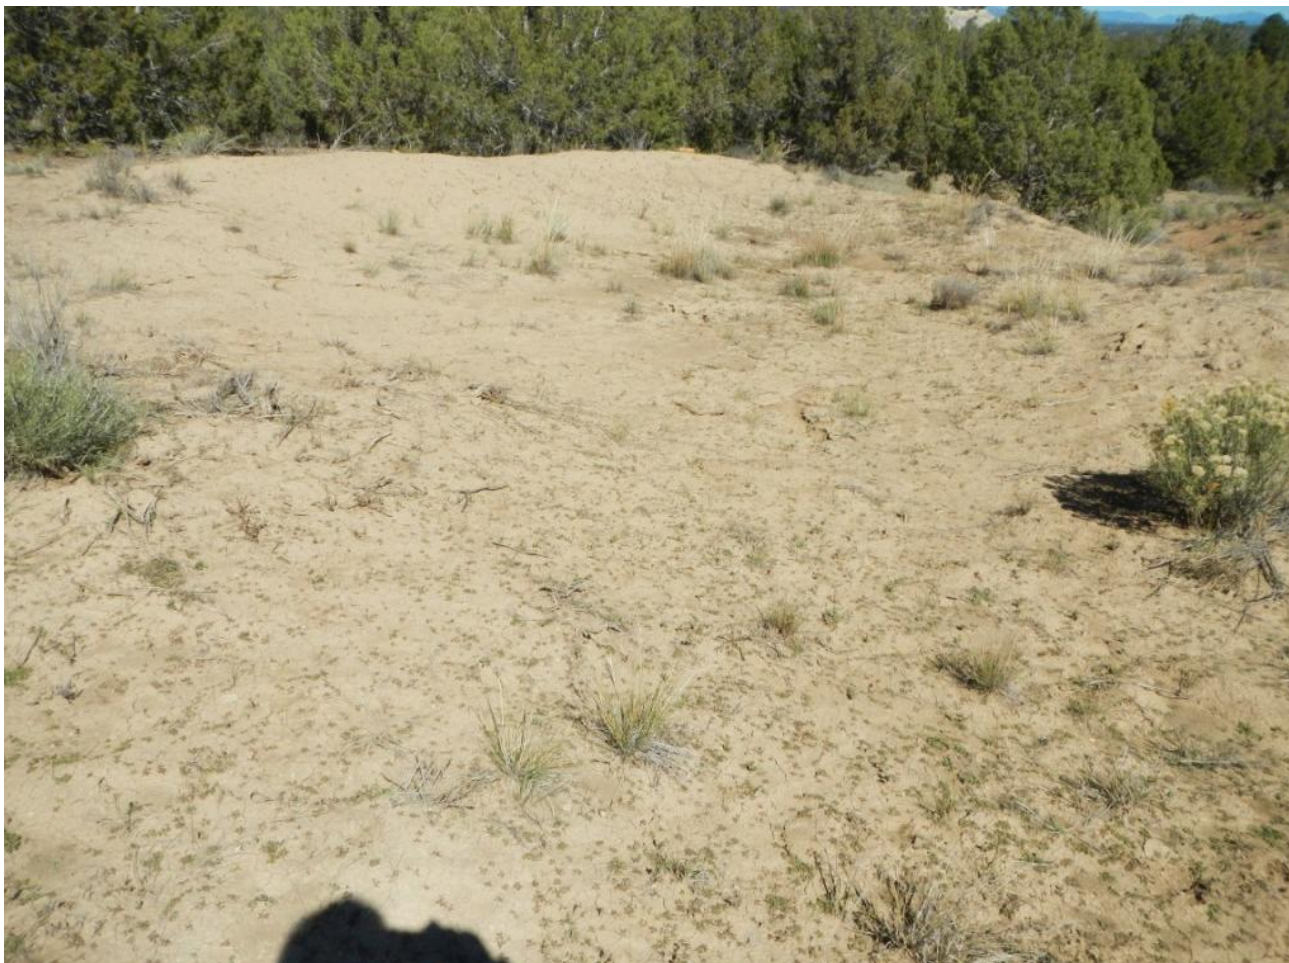
Photo 1. View of silt trap in good condition in northeastern corner of project area.

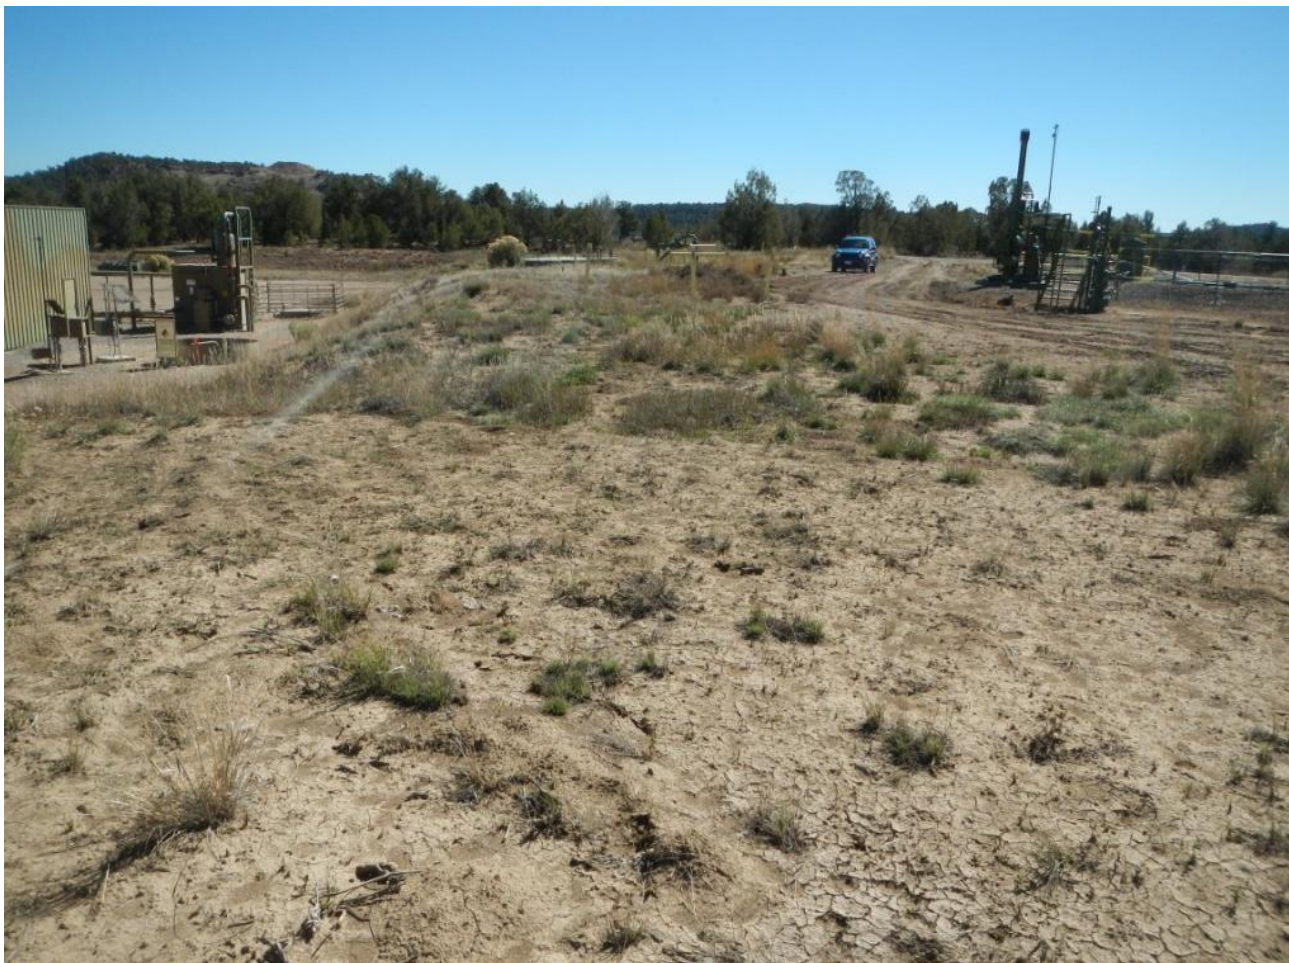
Photo 2. View of revegetation in eastern portion of project area.

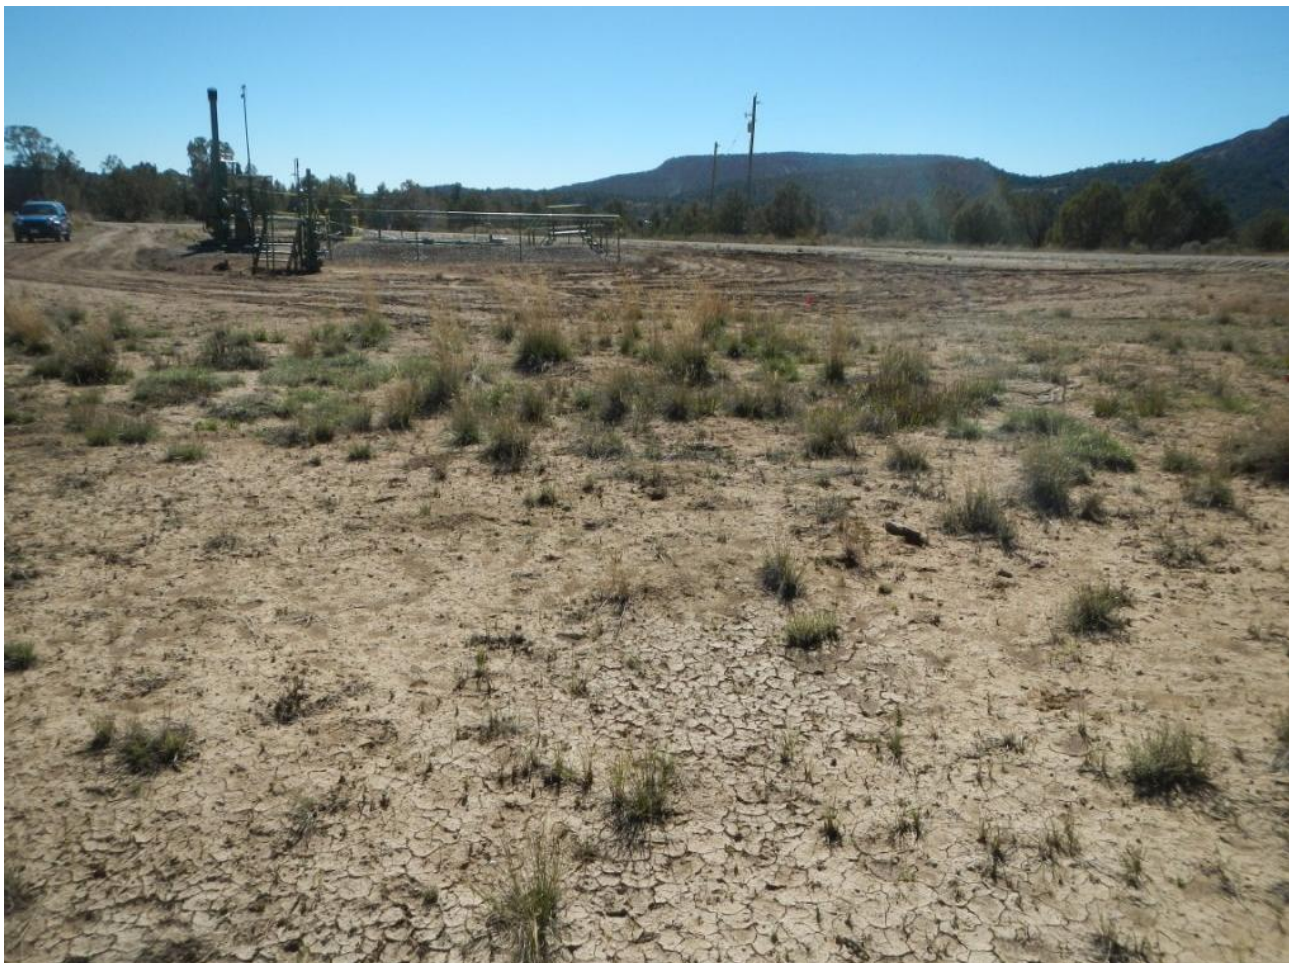
Photo 3. View of project area from northeastern corner toward center.

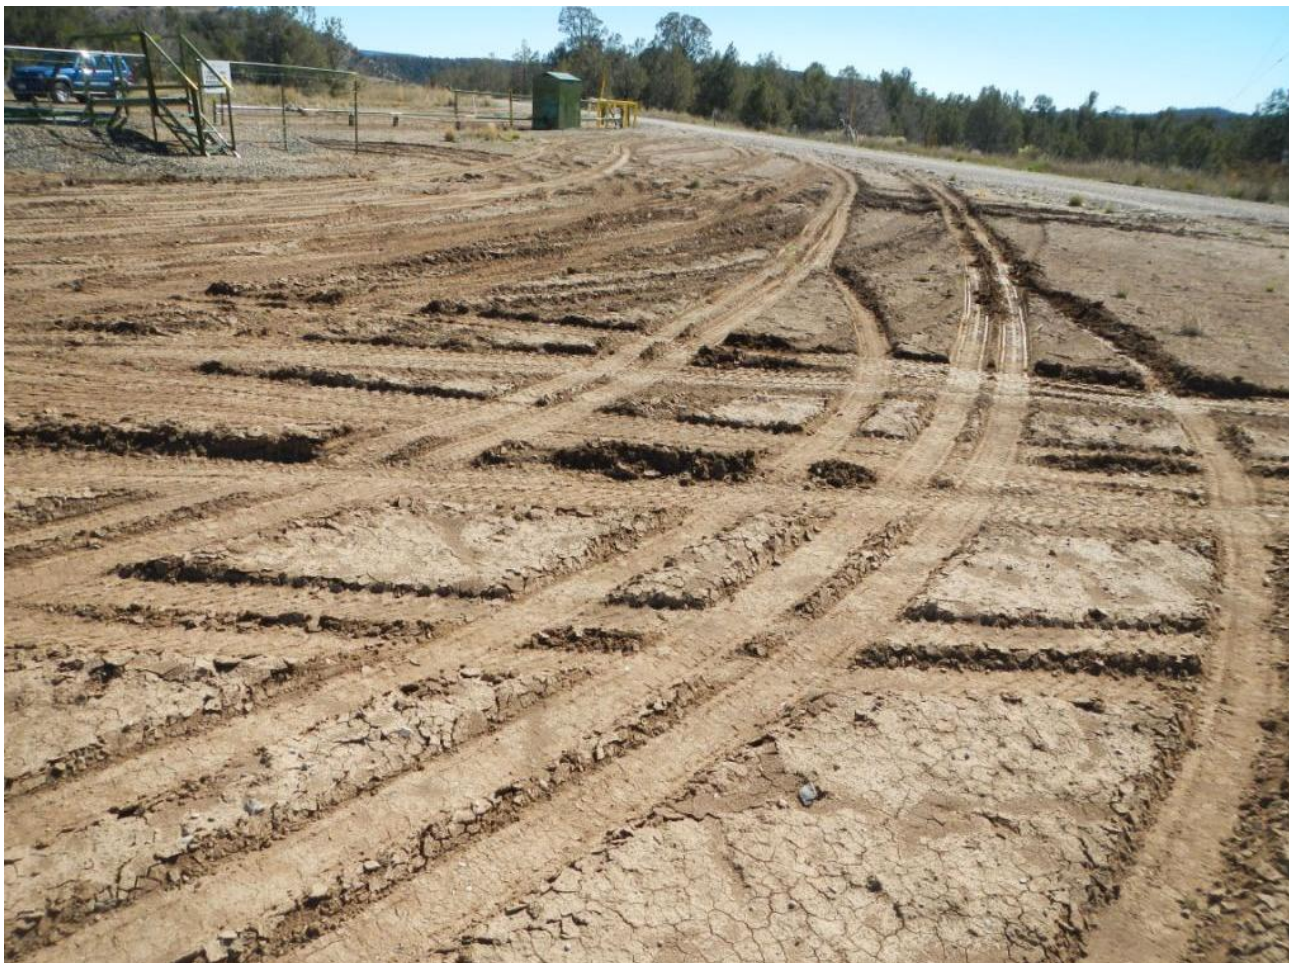
Photo 4. View of deep ruts in western portion of project area.

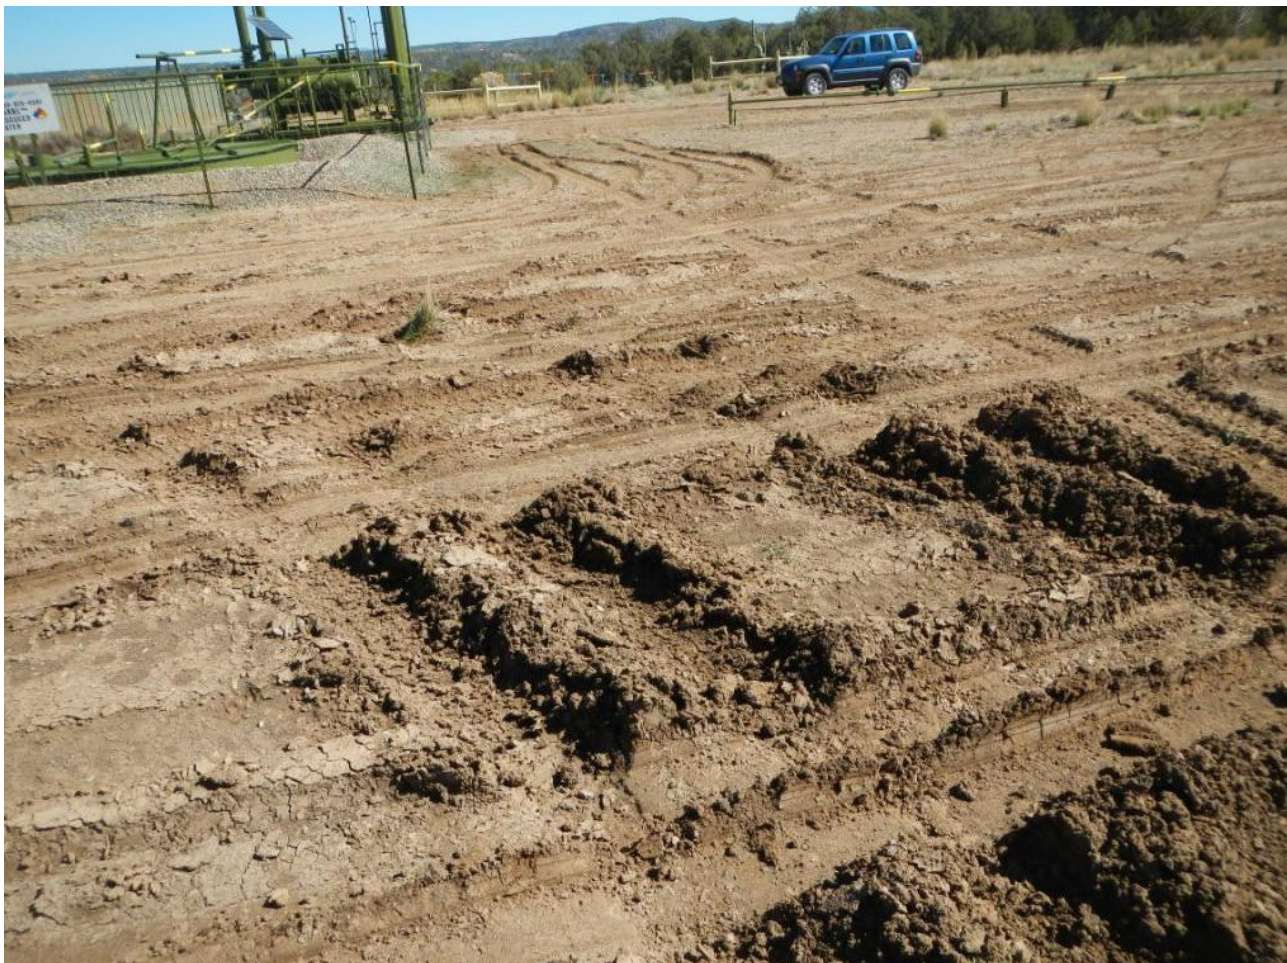
Photo 5. View of deep ruts in western and central portion of project area.
