## **Reference Area Photographs**

**Inspection Conducted on October 18, 2014**

**Buzzard Creek 11-13**

**Location ID #312614**

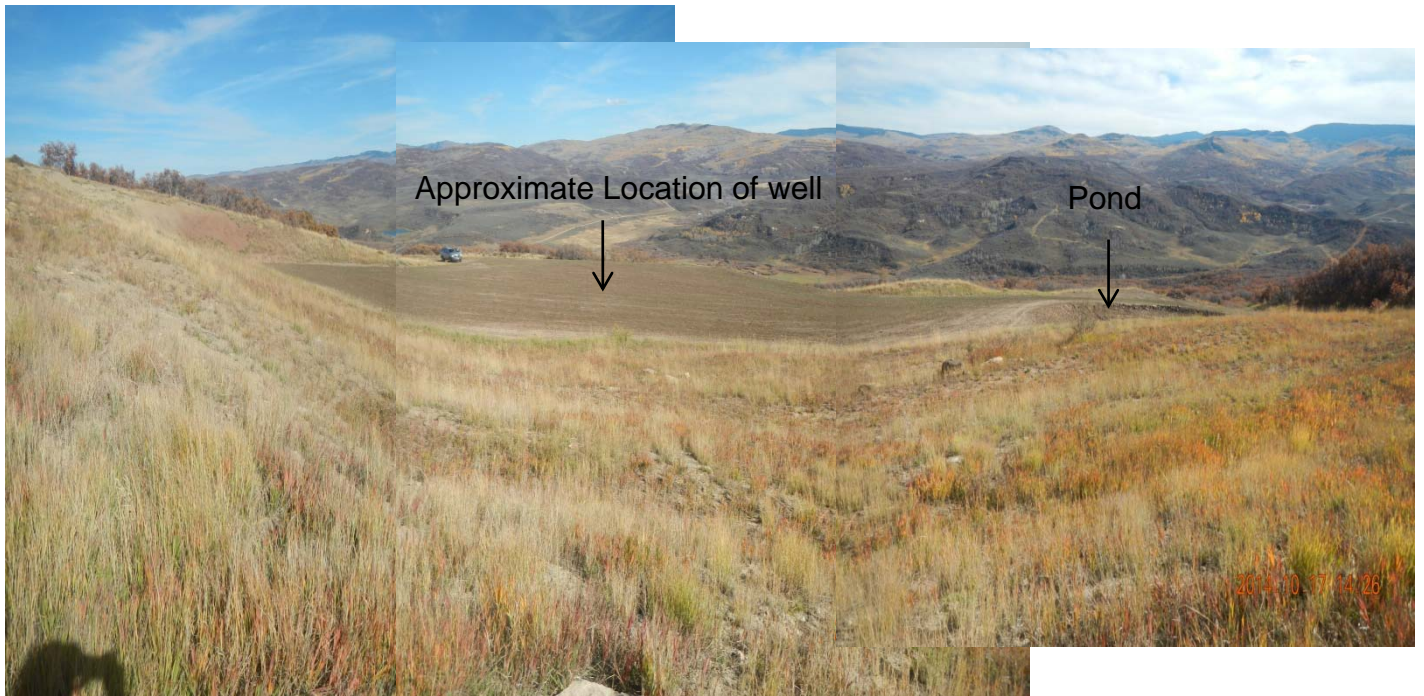
Approximately 90 feet between well location (as built coordinates) and pond.  
Pond is lower by about 9 feet than the well ground surface .

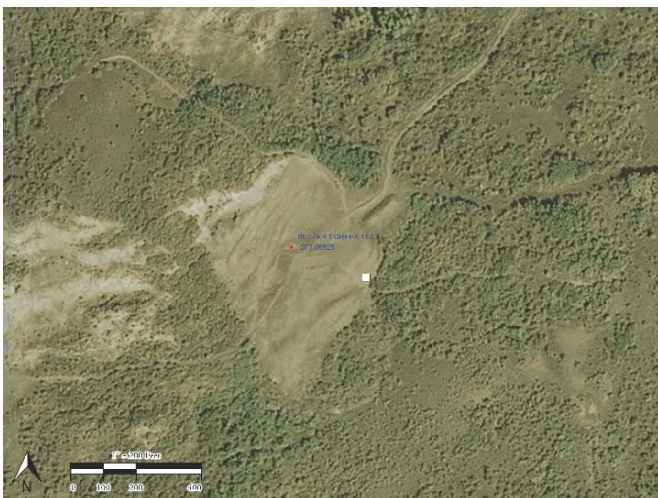
Aerial view. Well location as built.

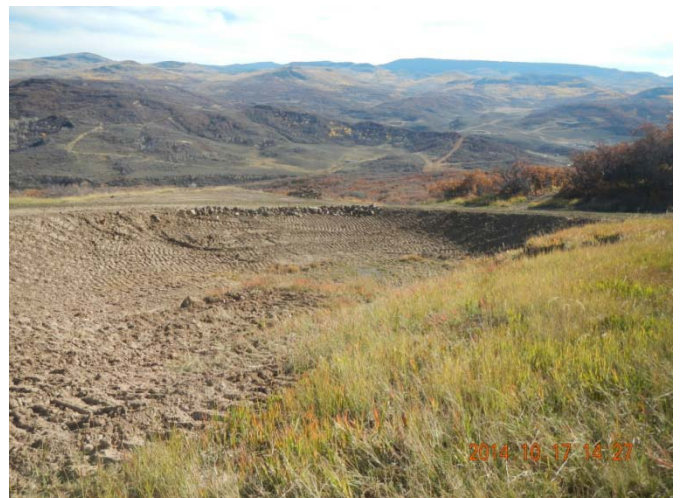
View of the pond, on the western side of the pad.

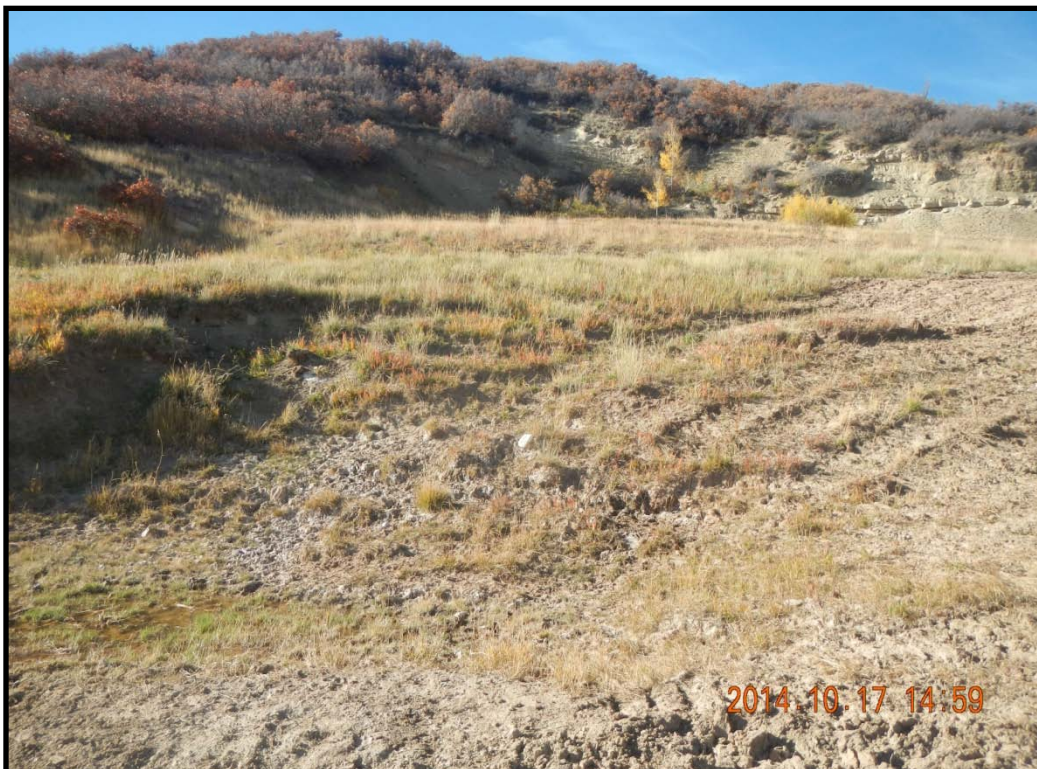
Moist soil and green vegetation on the northwest corner of the pad, up-gradient of the pond. Seeps on the north and northwest sides of the pond. Very little water. No flow.

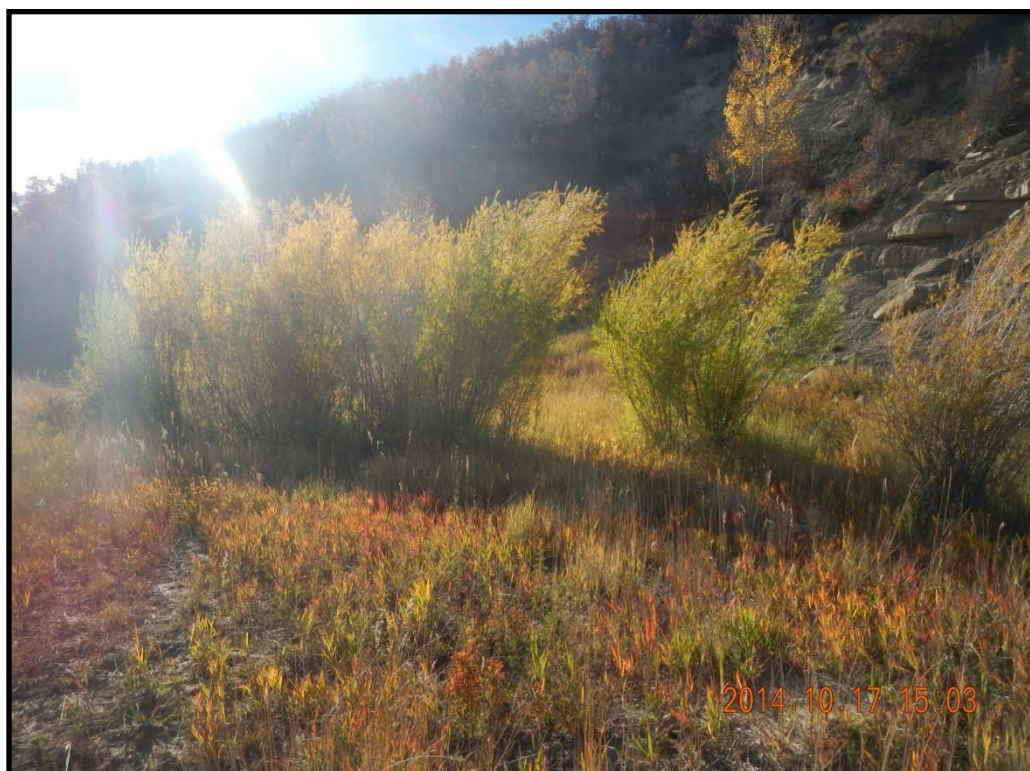
Moist soil and green vegetation on the northwest corner of the pad, up-gradient of the pond.

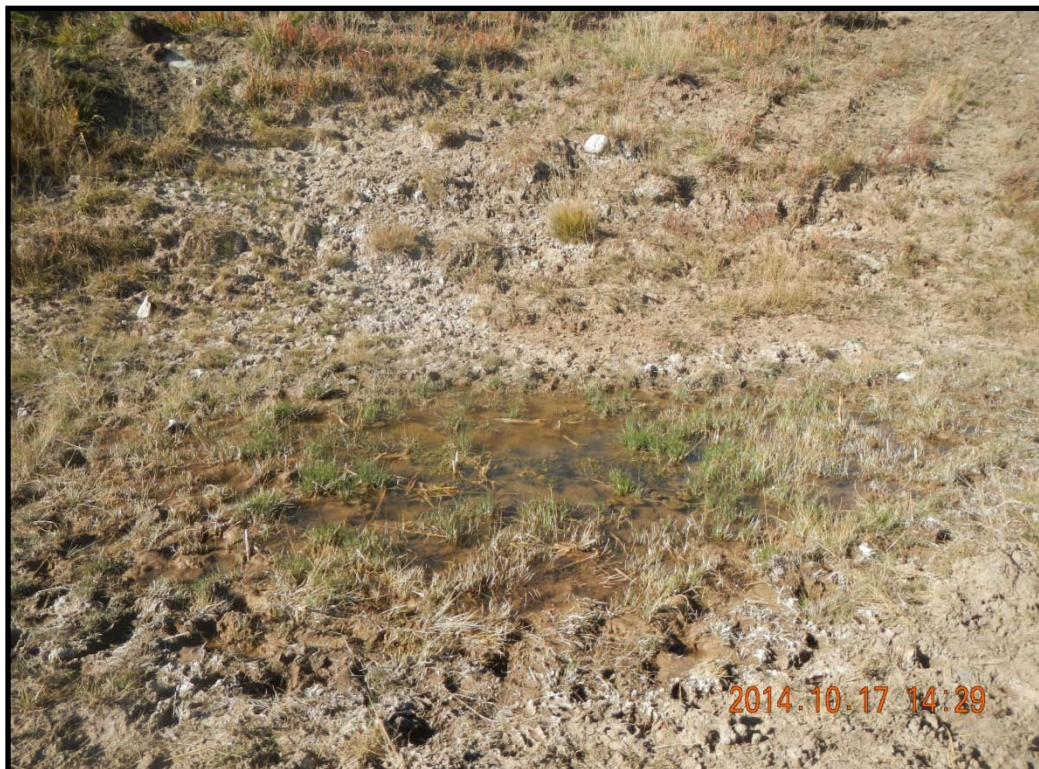
Little water at the bottom of the pond. No hydrocarbon odor or sheen.

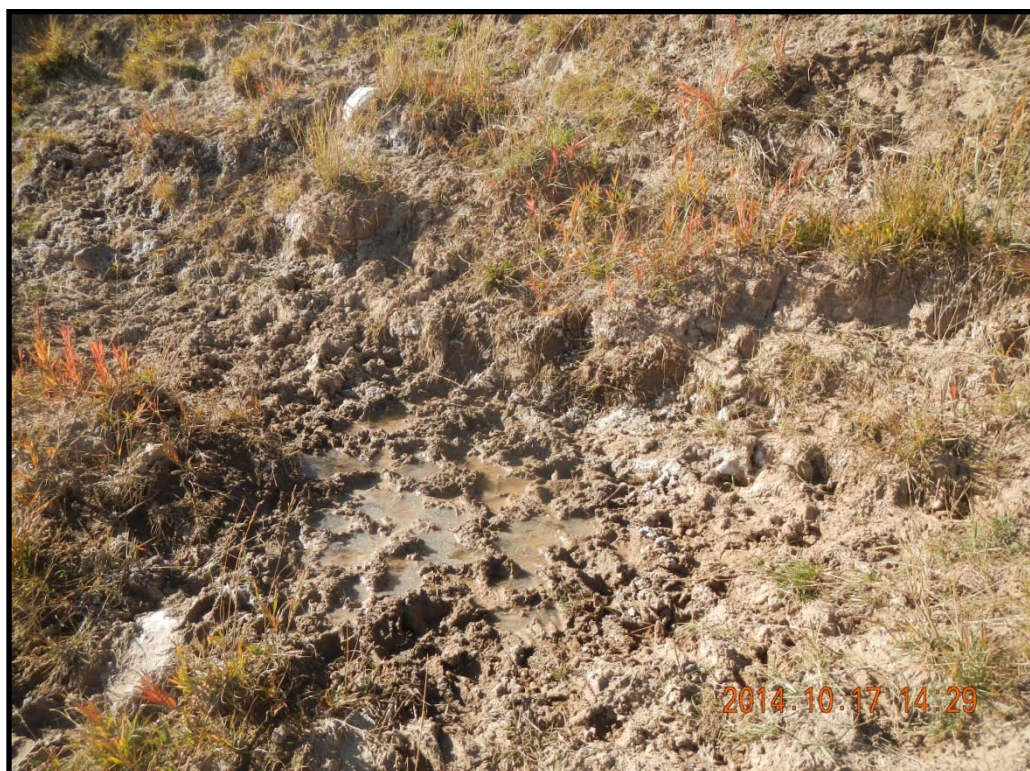
Seeps on the northwest side of the pond.  
Some white mineral deposition.
