**Site Photos (05-055-06066) 10/30/2014**

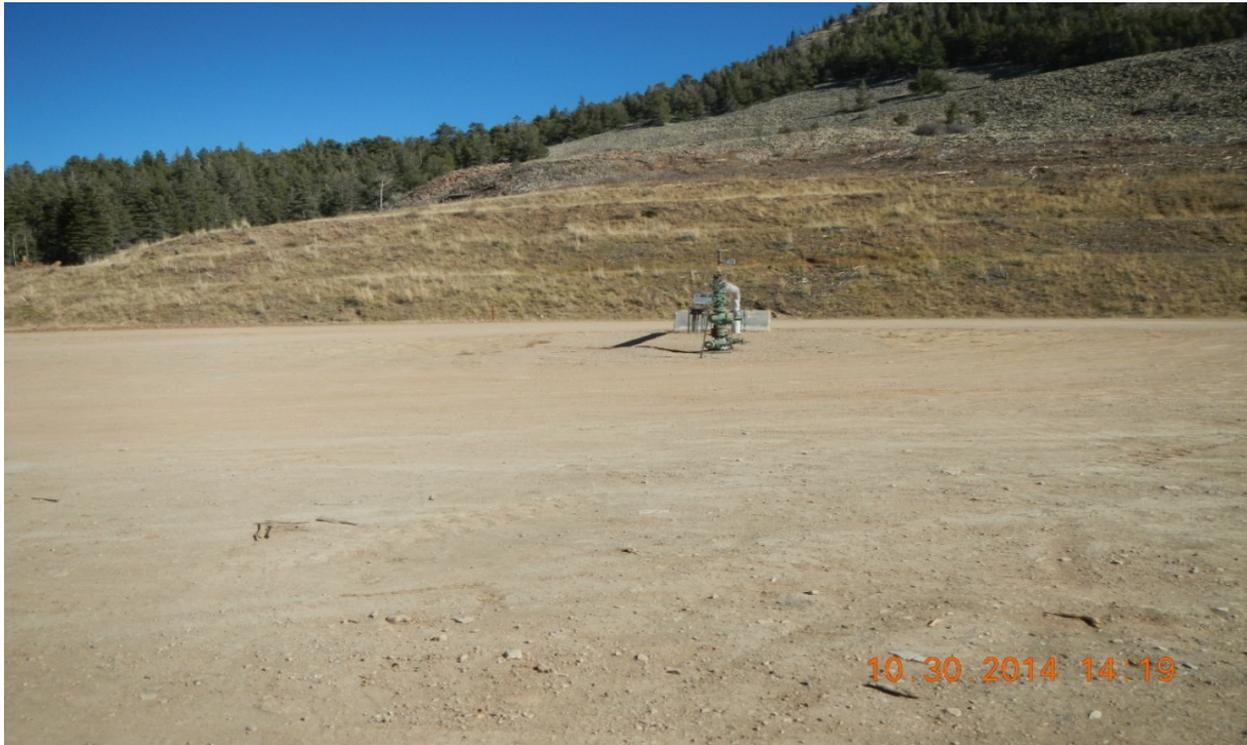
photo #1

Looking towards the East, SMU 6-15-I

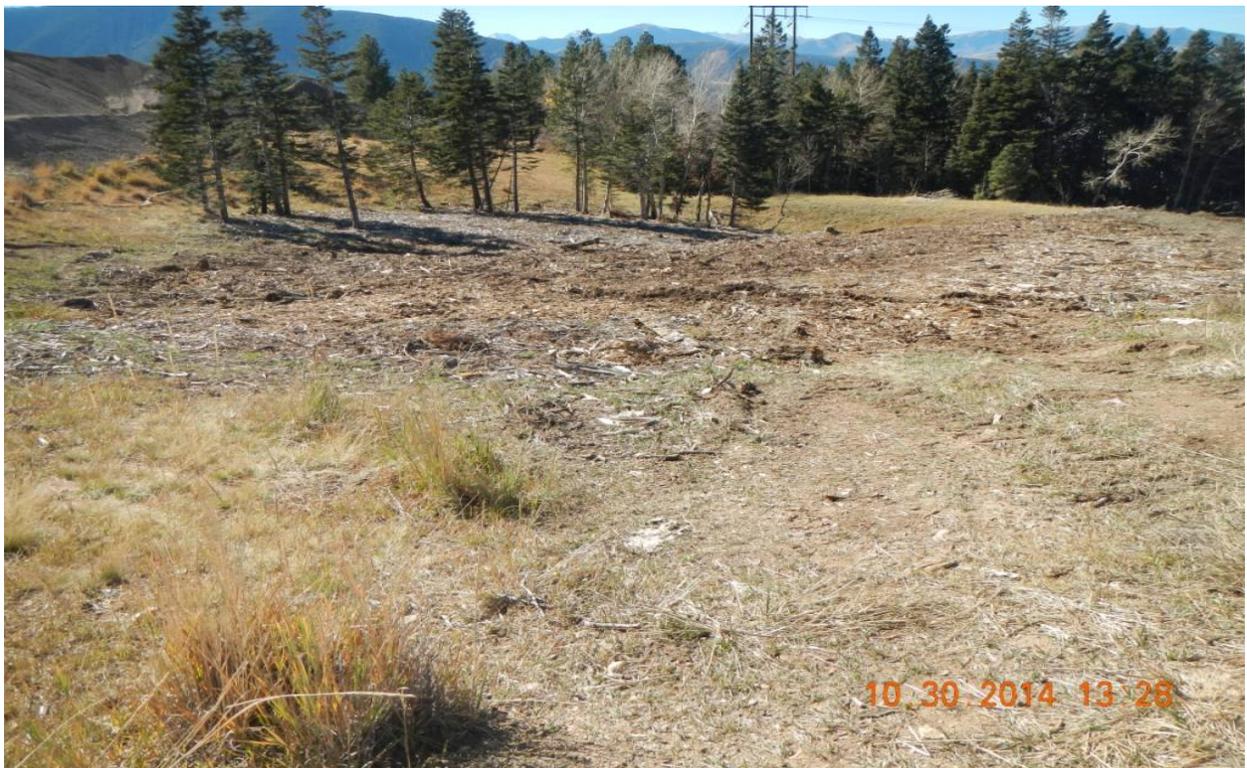
photo #2

Looking Southwest where timber was cut

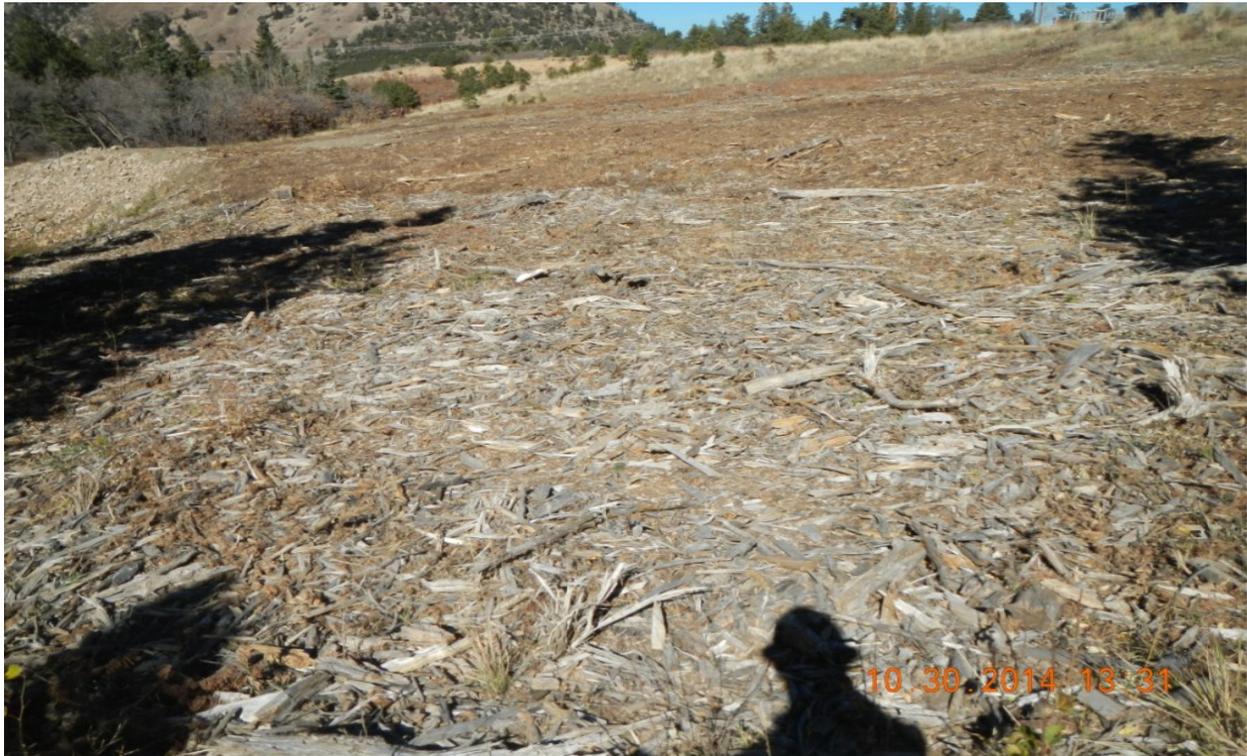
photo #3

Looking North, wood debris remains where trees were cut

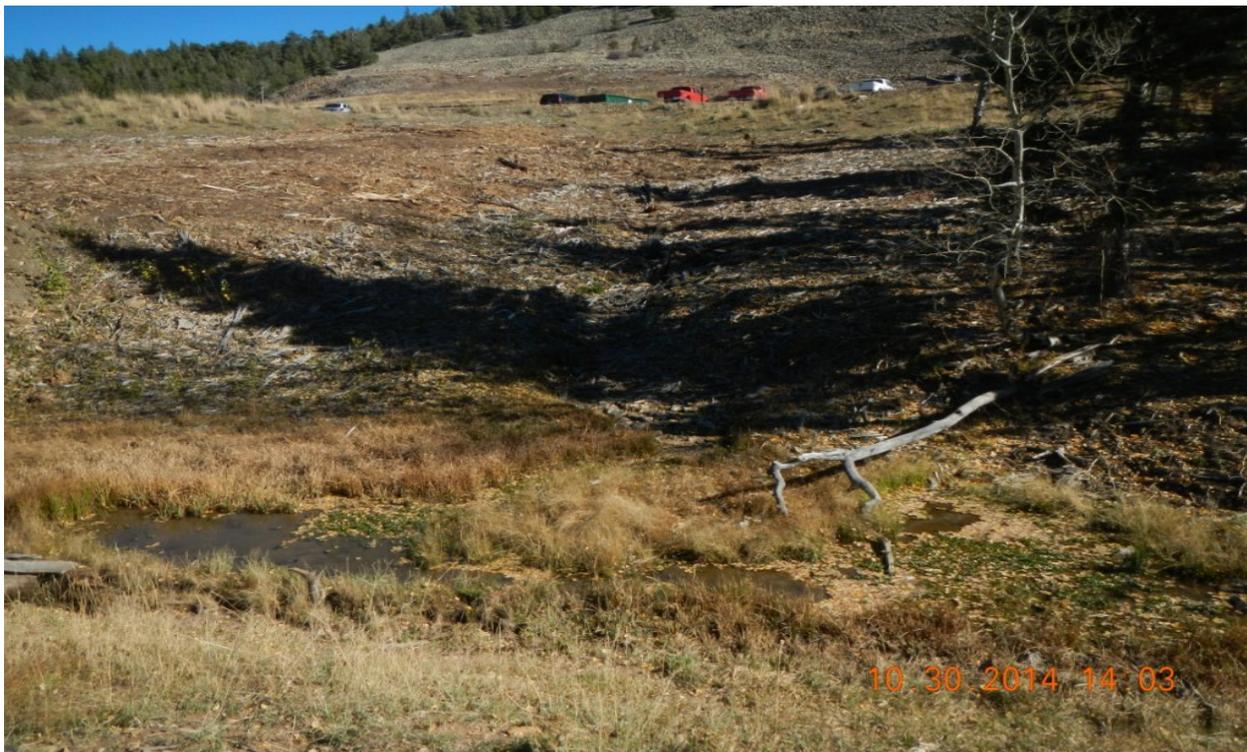
photo #4

Looking East at the West side of location near a water spring where trees were cut

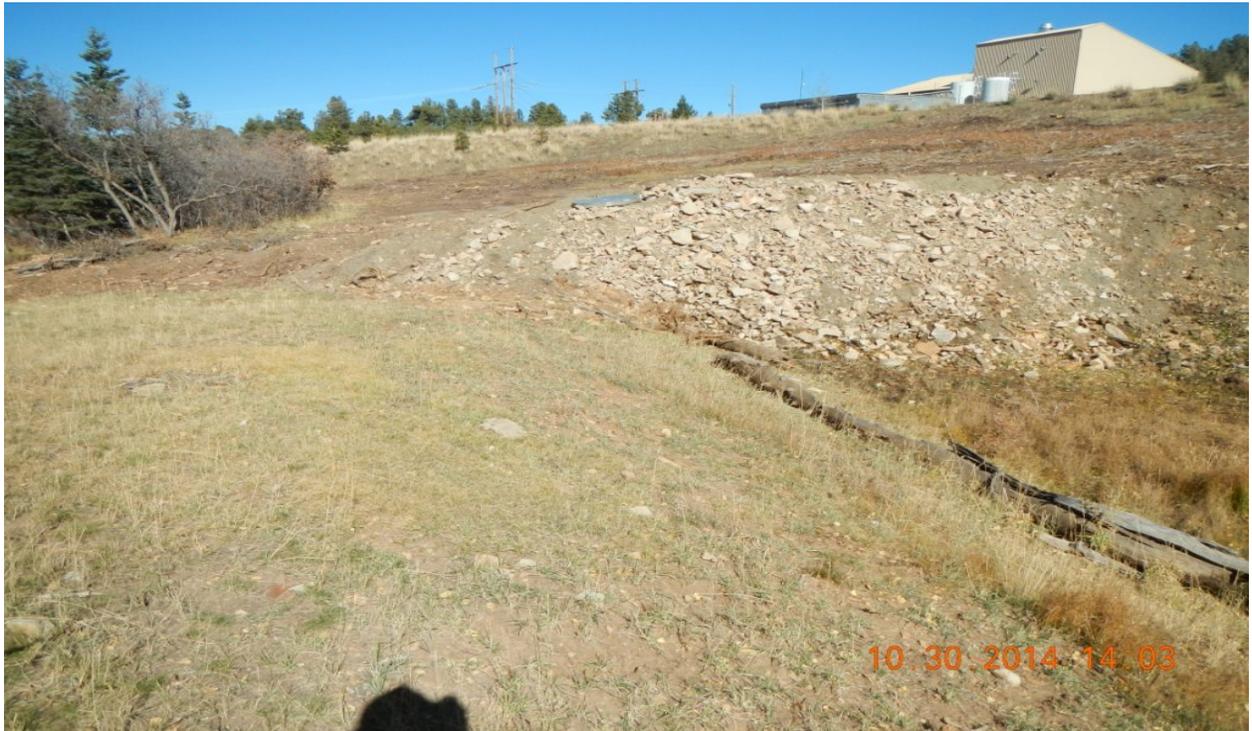
photo #5

West side of location looking towards the Northwest

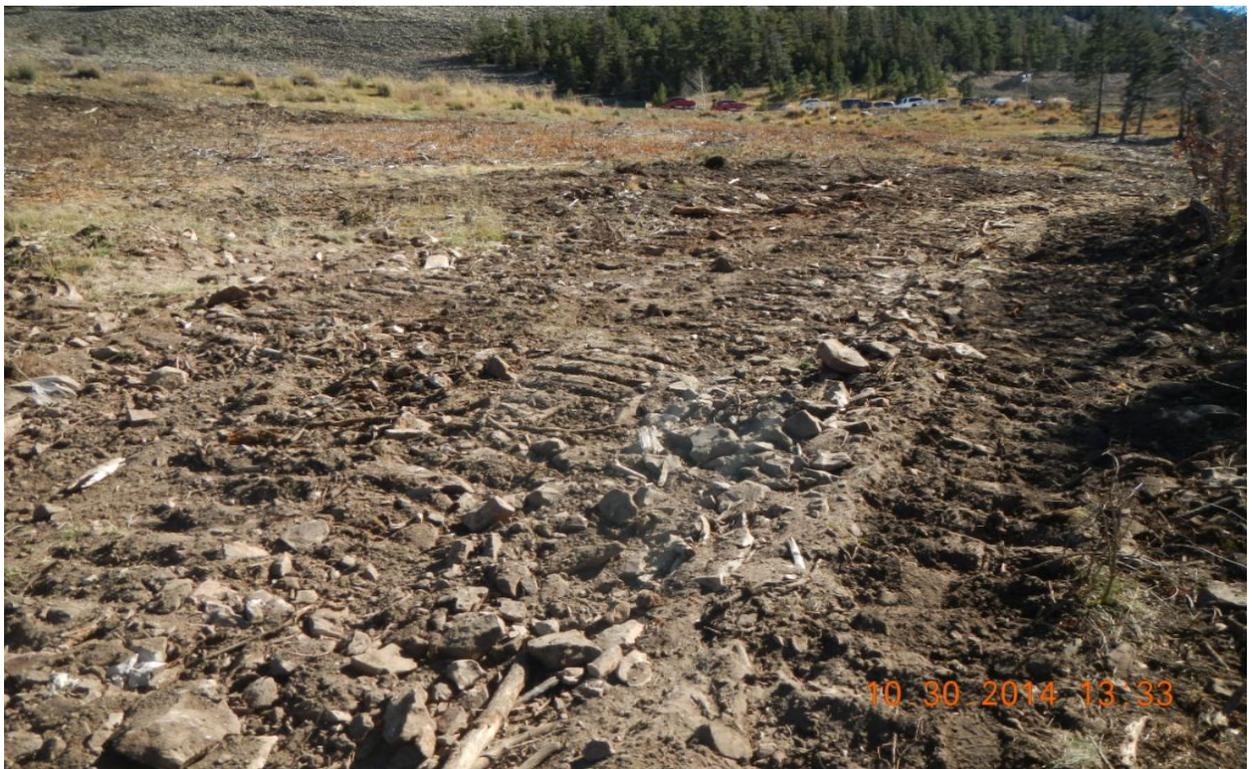
photo #6

Ground disturbance on West side of location creates erosion potential

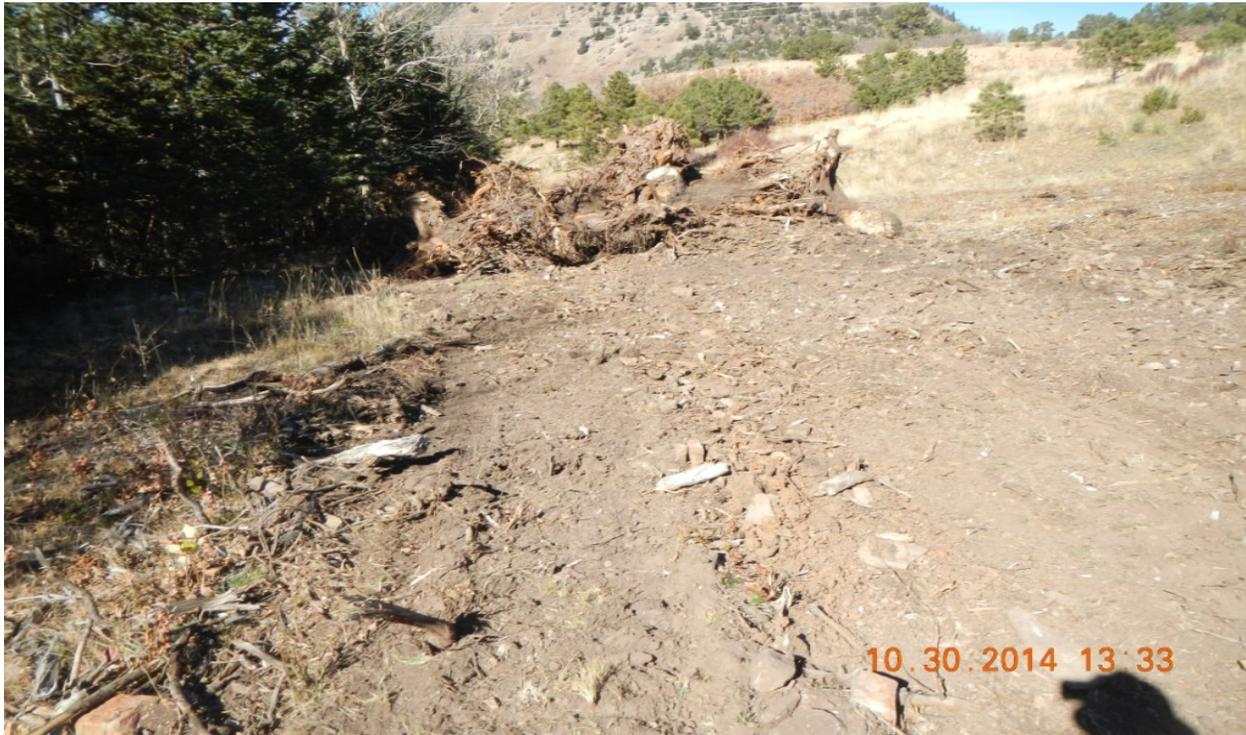
photo #7

Tree stumps pushed into a pile on the Northwest side of the location

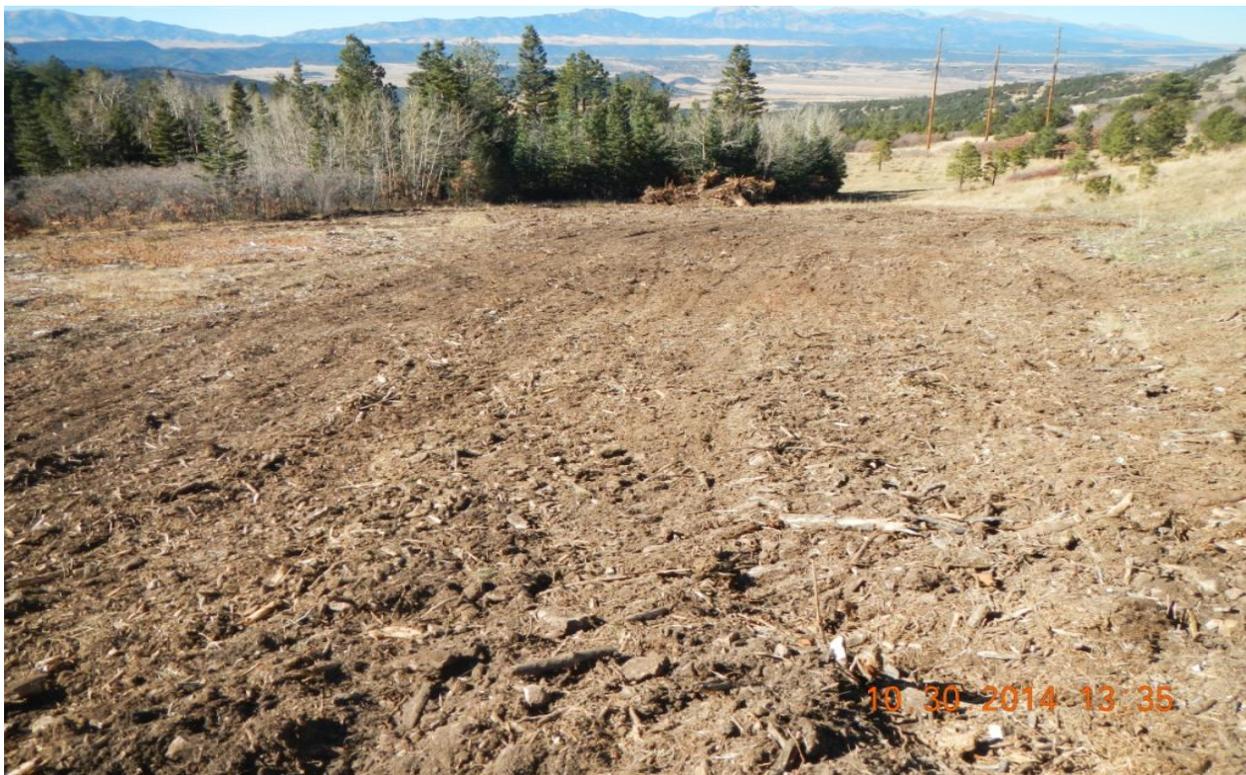
photo #8

Ground disturbance on West side of location creates erosion potential

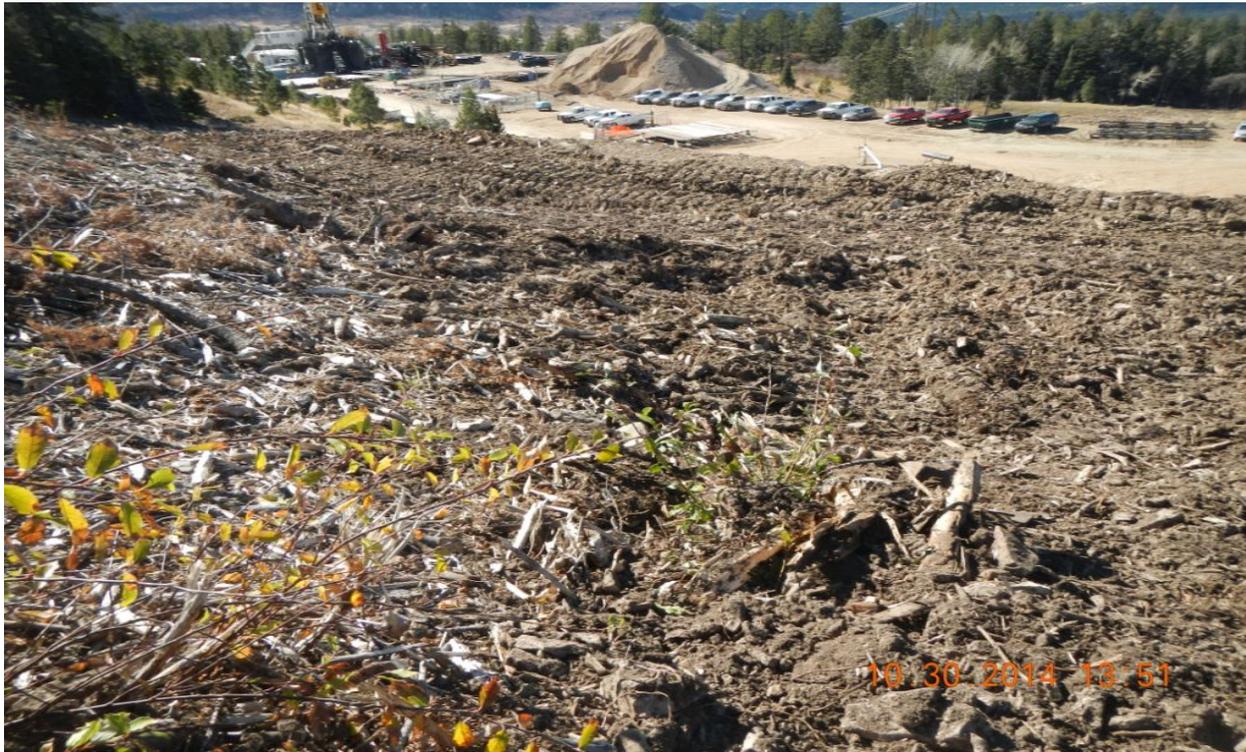
photo #9

East side of location where timber was cut

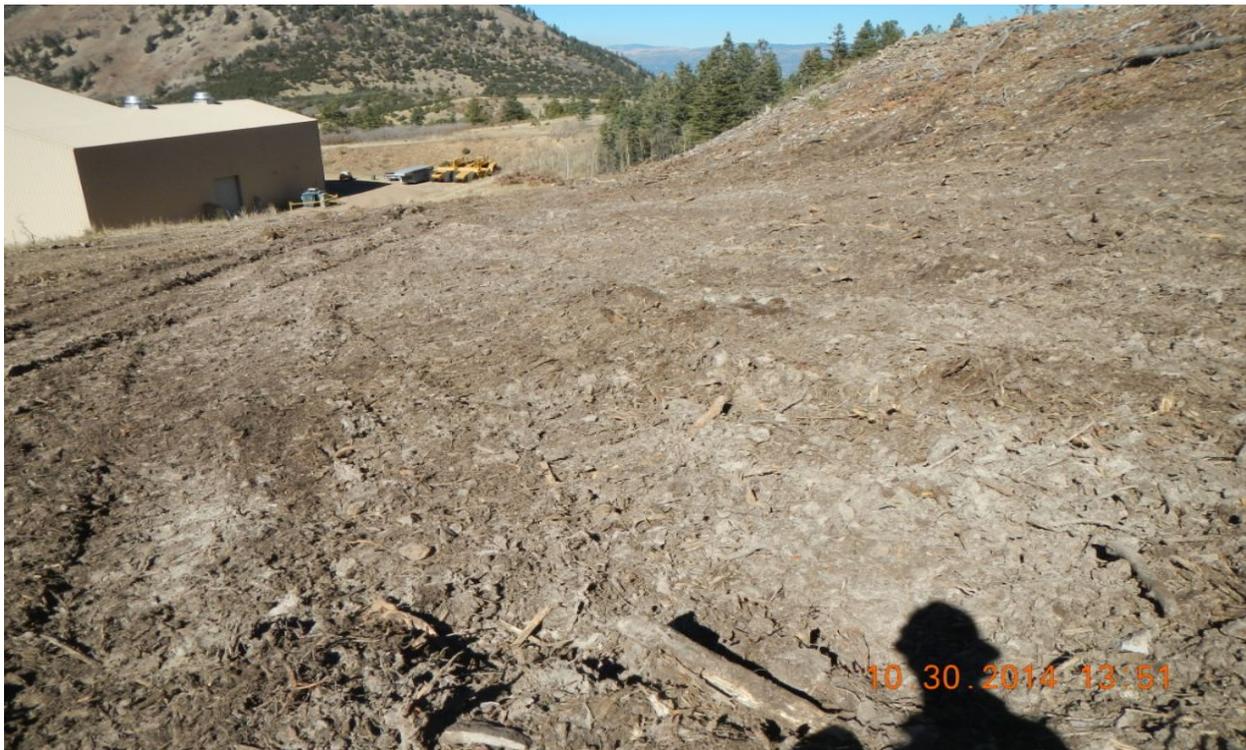
photo #10

Ground disturbance on East side of location creates erosion potential

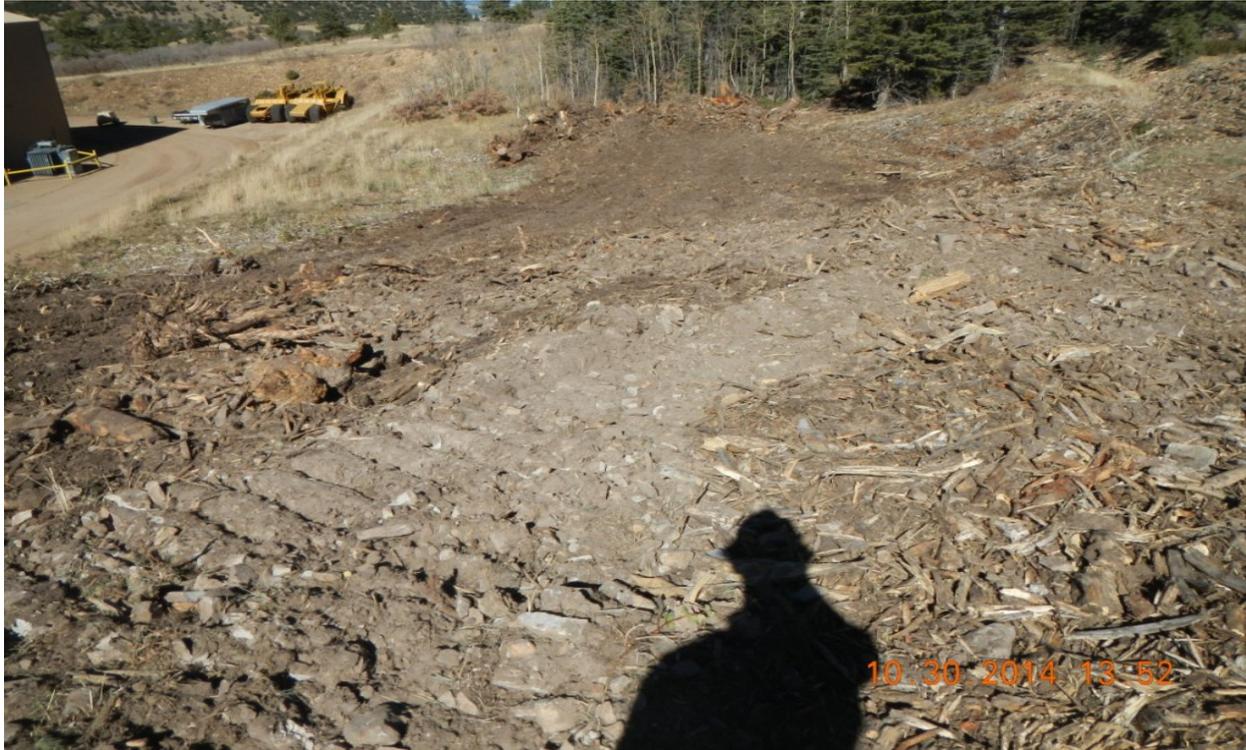
photo #11

Ground disturbance on East side of location creates erosion potential

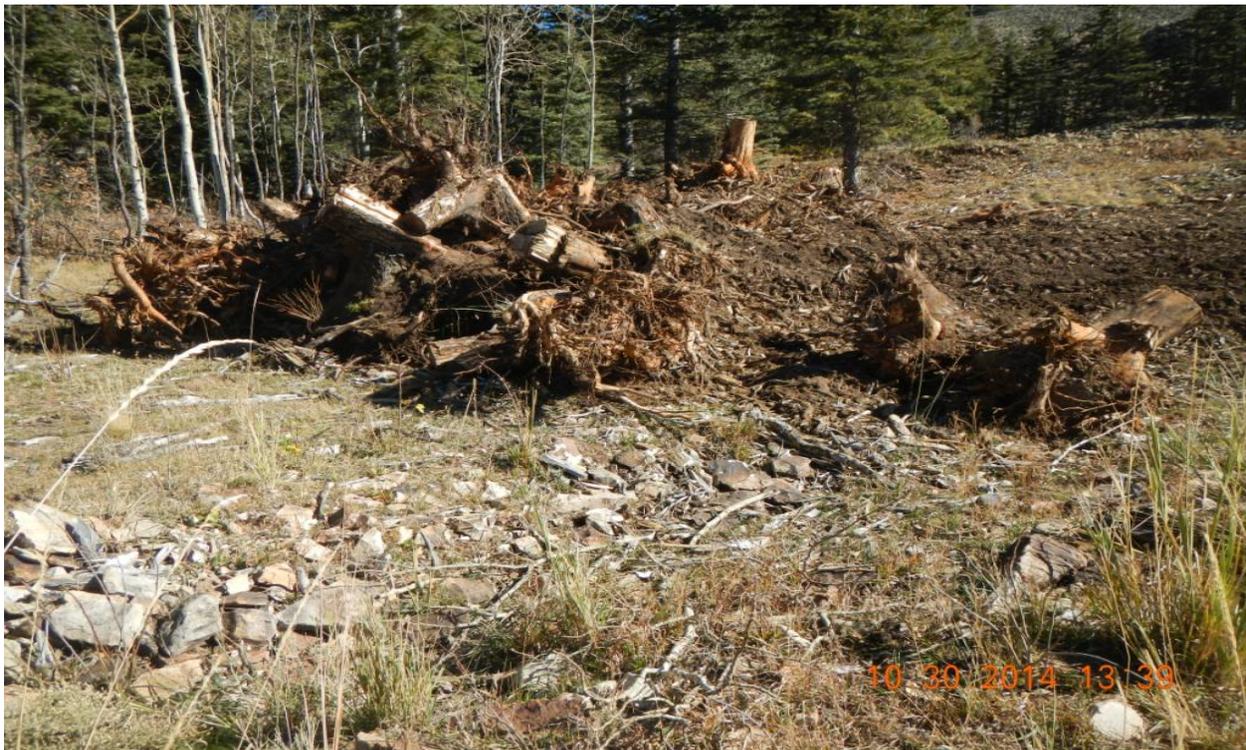
photo #12

Stumps pushed into a pile on the Northeast side of location

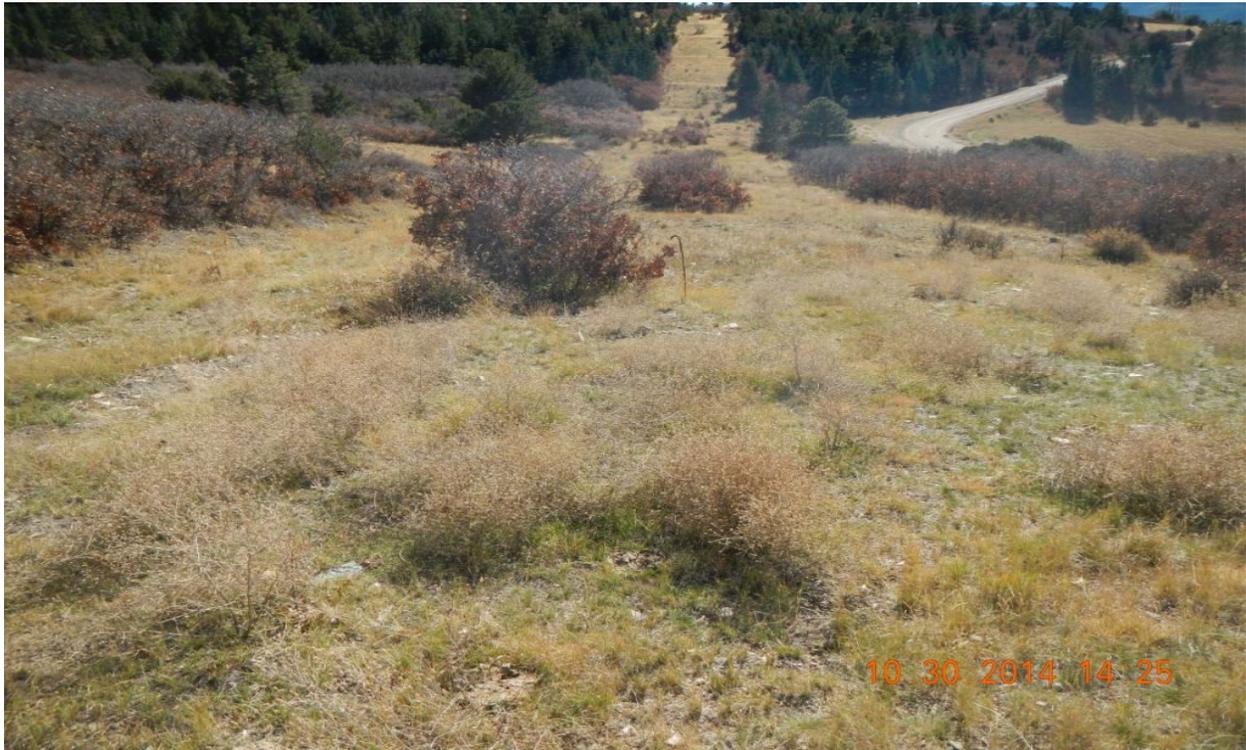
photo #13

Pipeline to the Meter station has Diffuse Knapweed growth

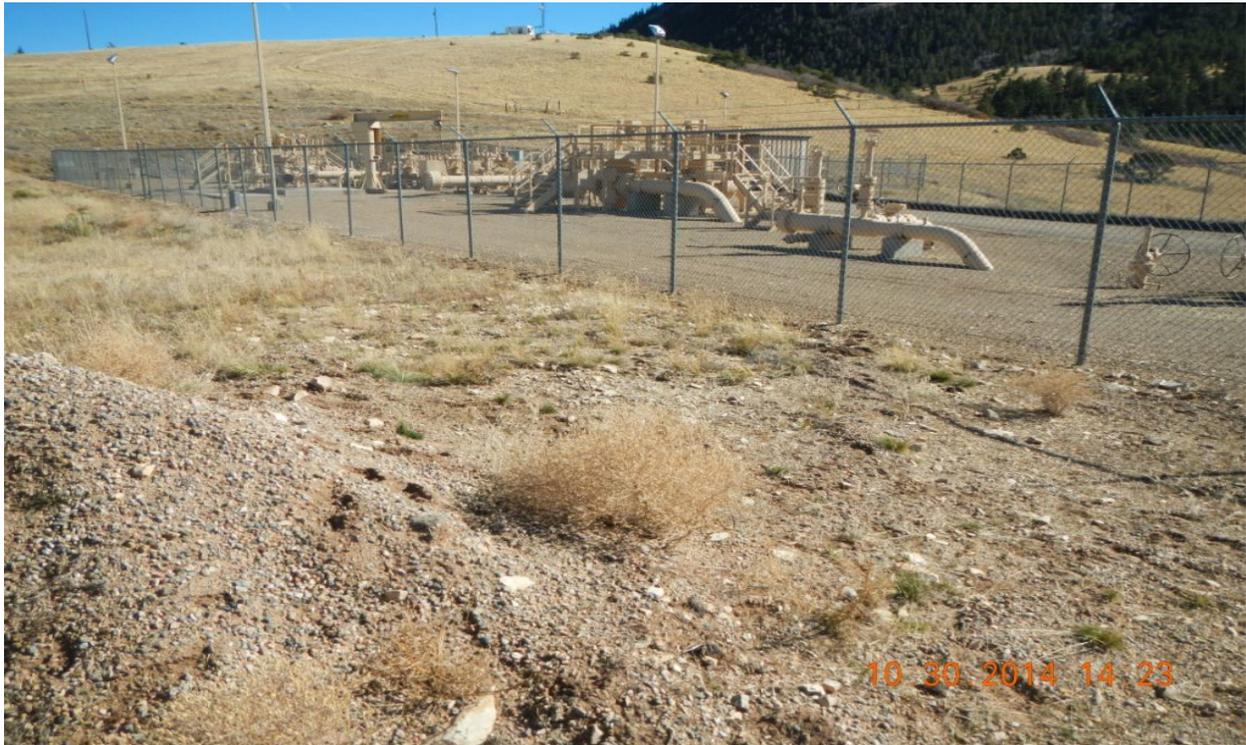
photo #14

Knapweed is present around the Meter station

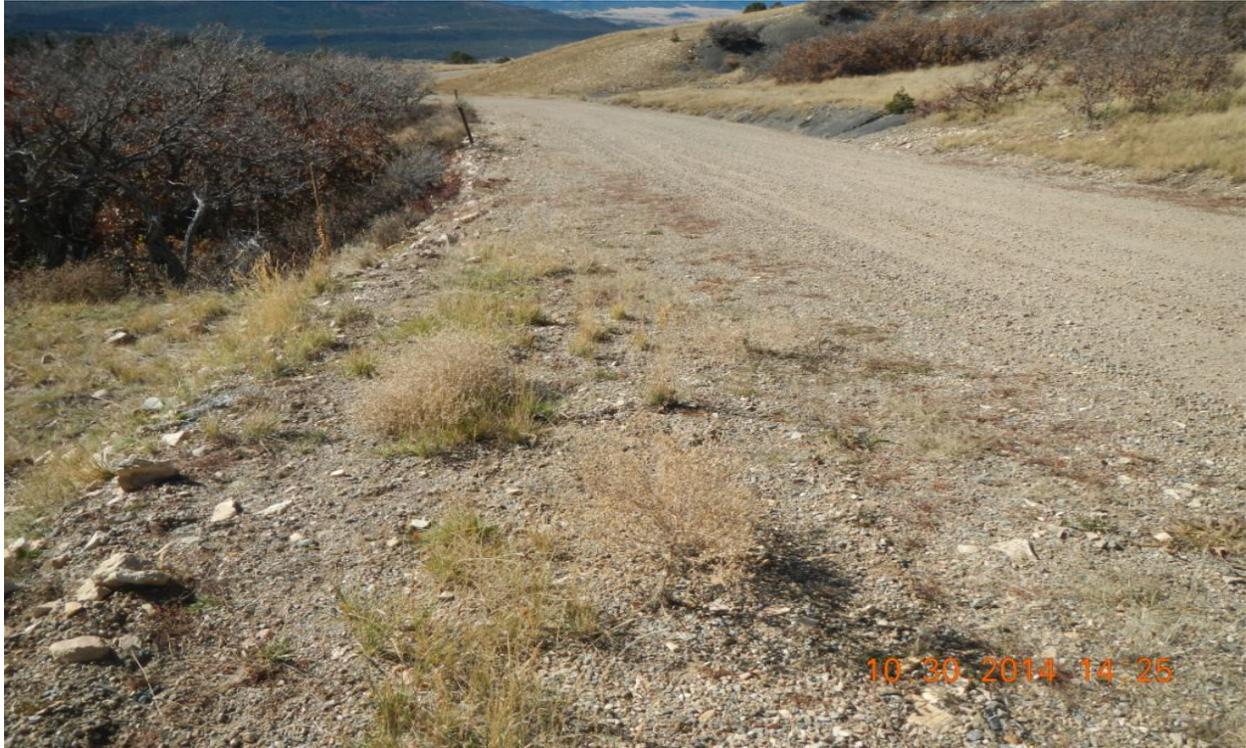
photo #15

Diffuse Knapweed present along roadsides

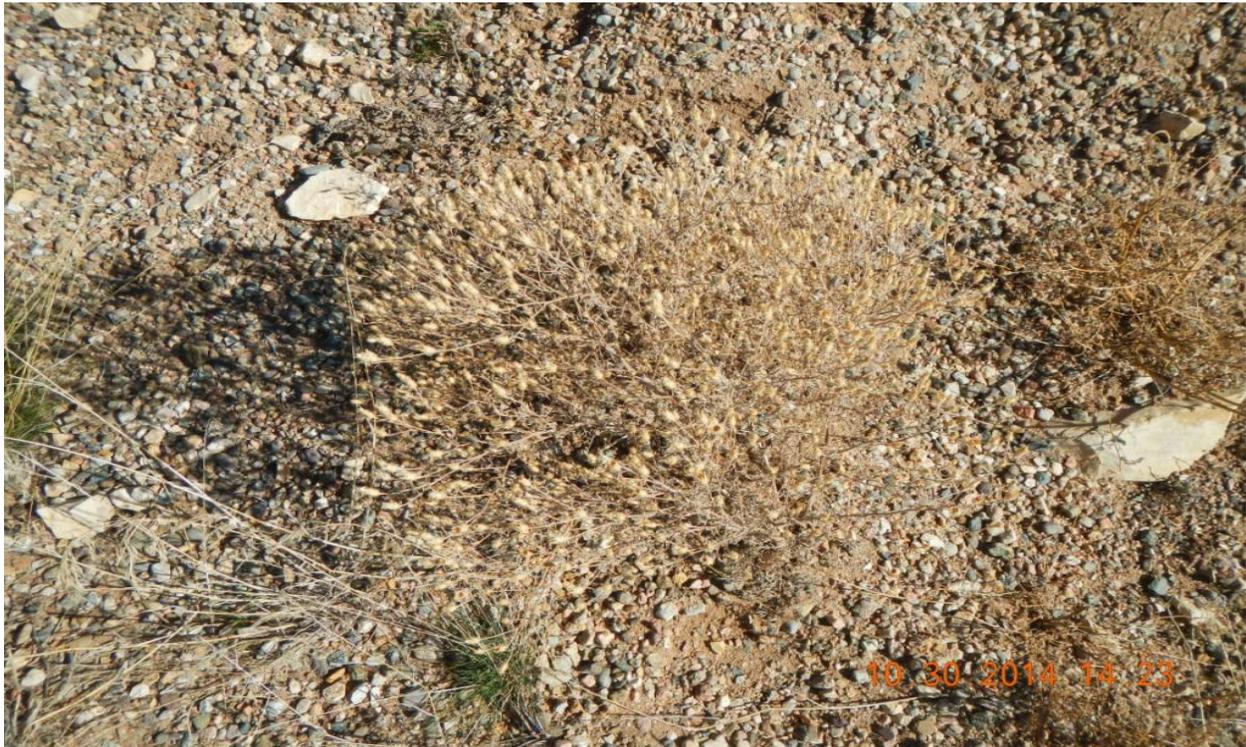
photo #16

Noxious weed growth: Diffuse Knapweed
