**Site Photos: API# 05-017-06399**

**Date: November 19, 2014**

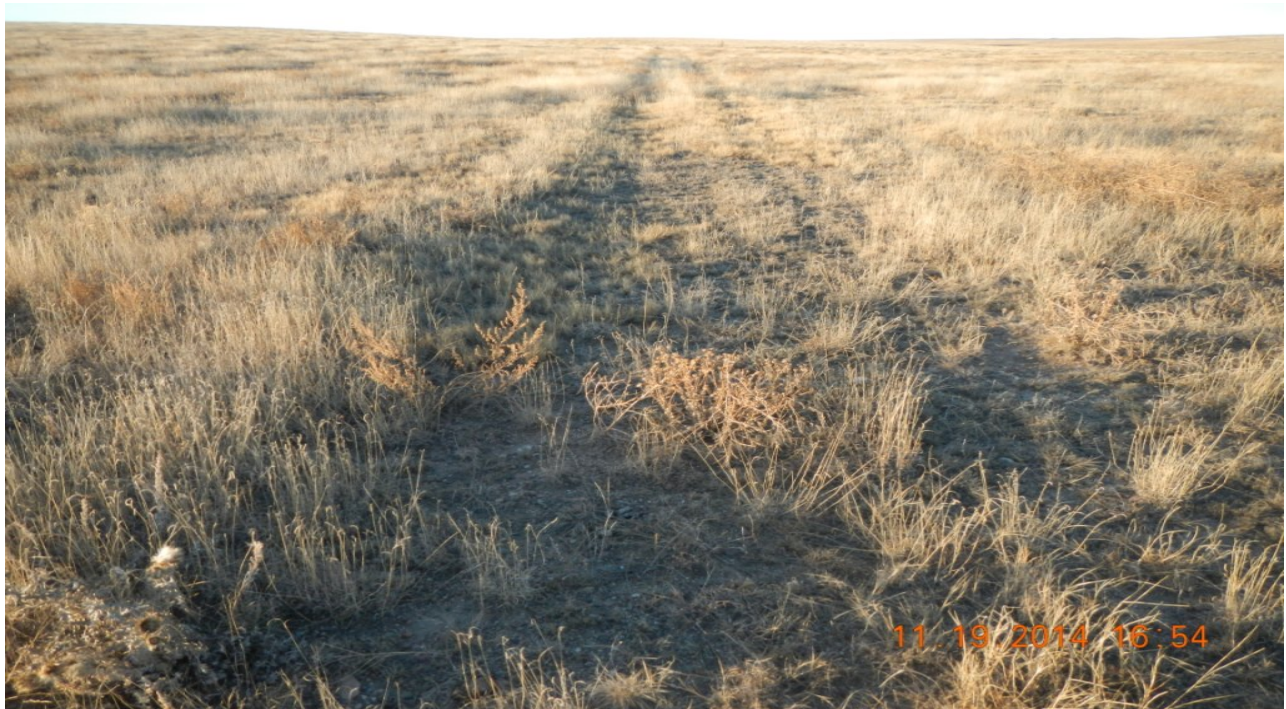
**photo 1:** Access Road to the location, facing North.

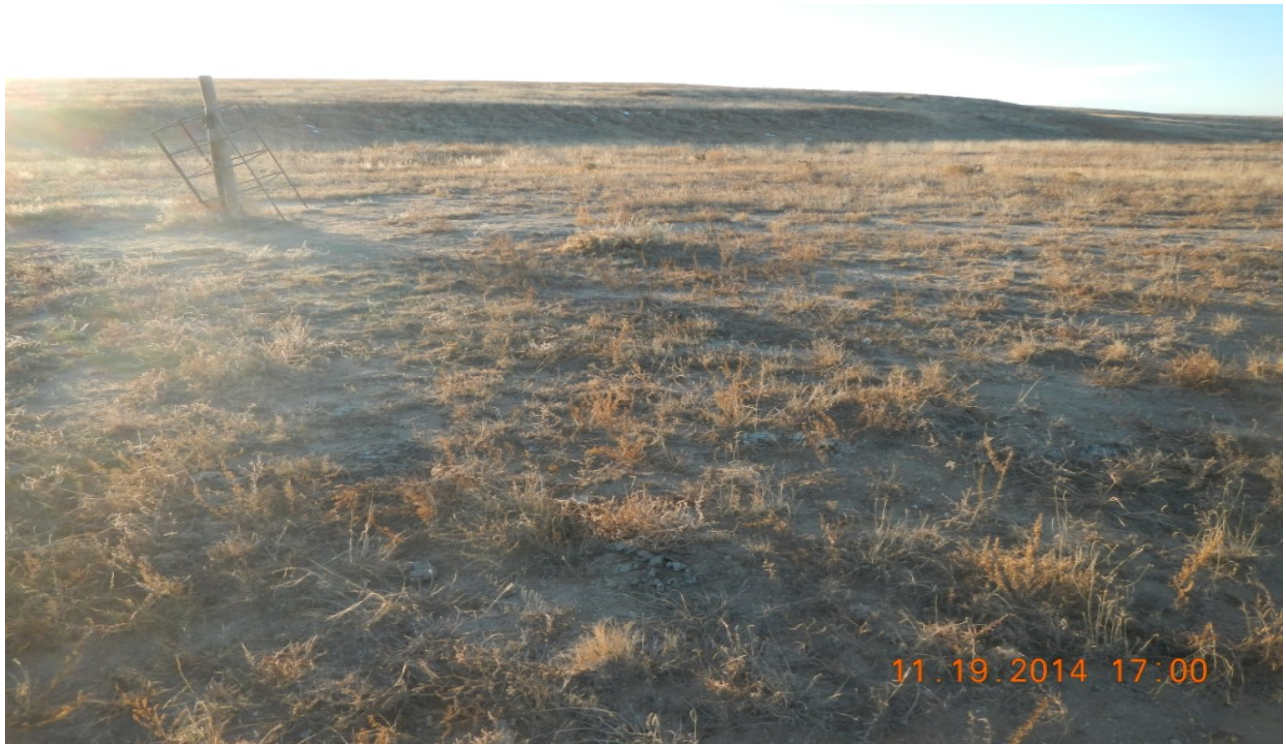
**photo 2:** Facing Northwest at the Southeast corner of the location.

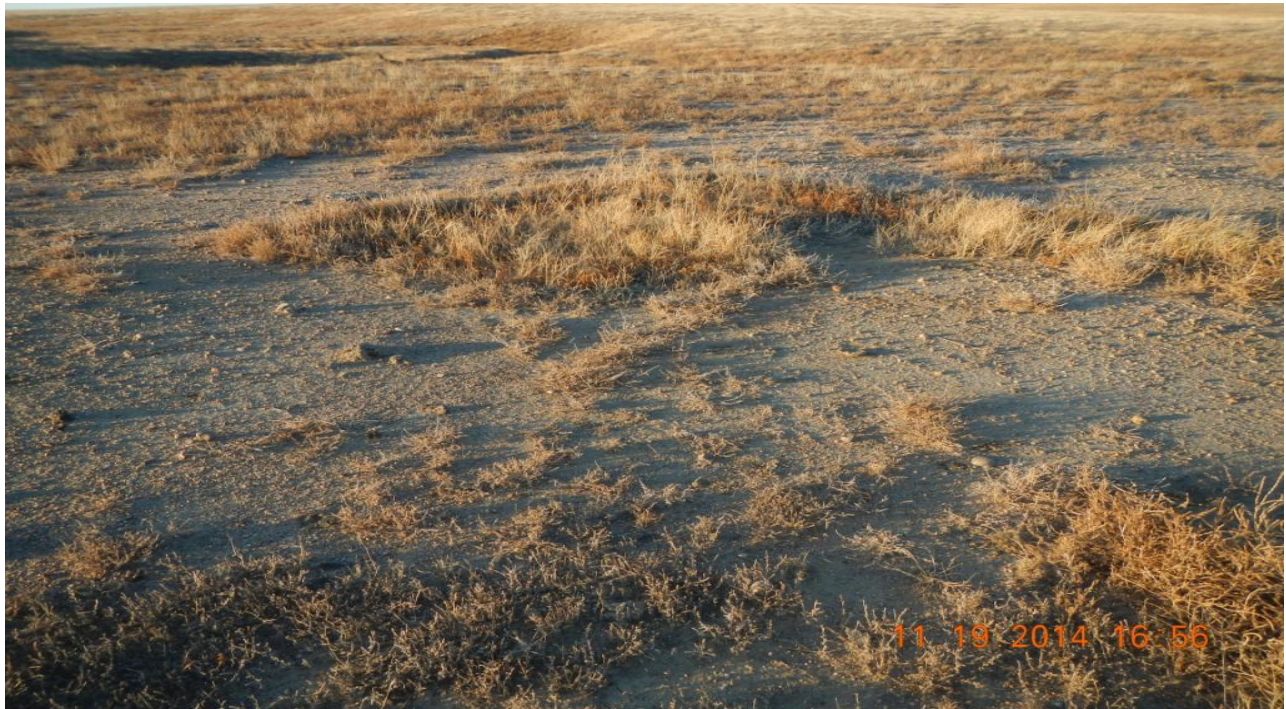
**photo 3:** Center of the location facing North.

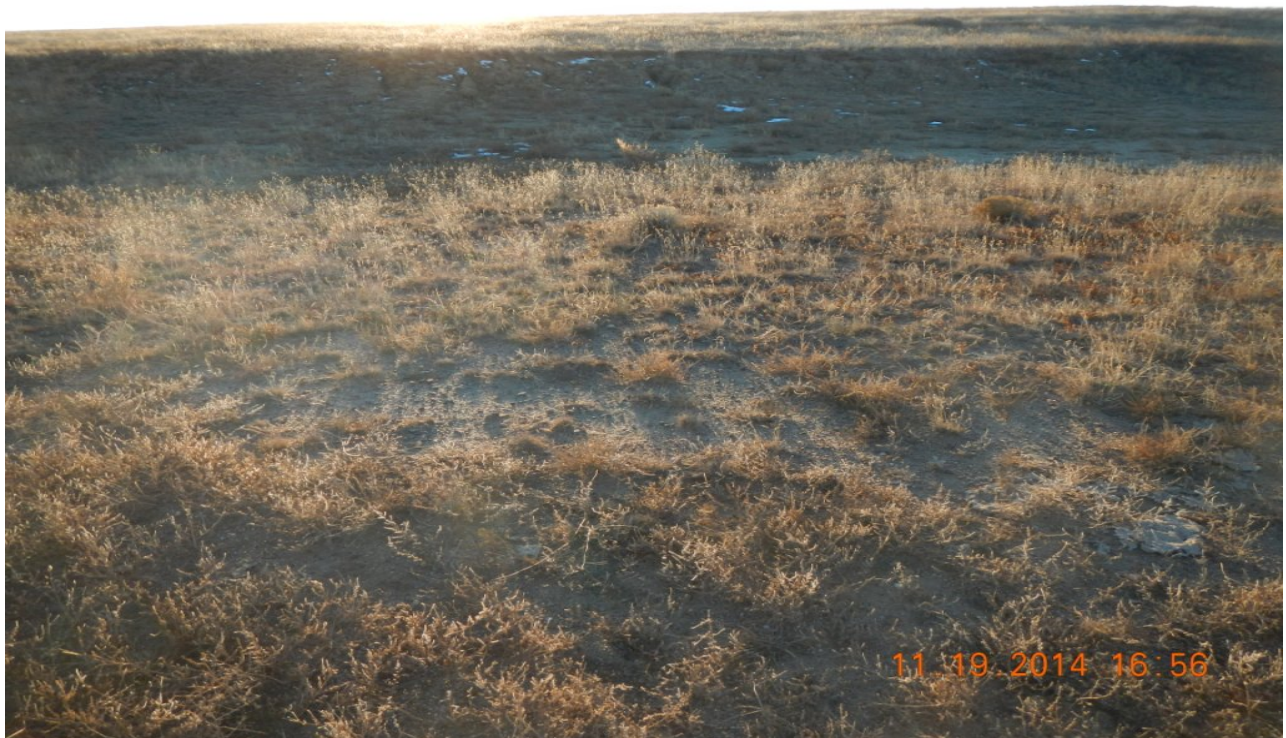
**photo 4:** Center of the location facing West.

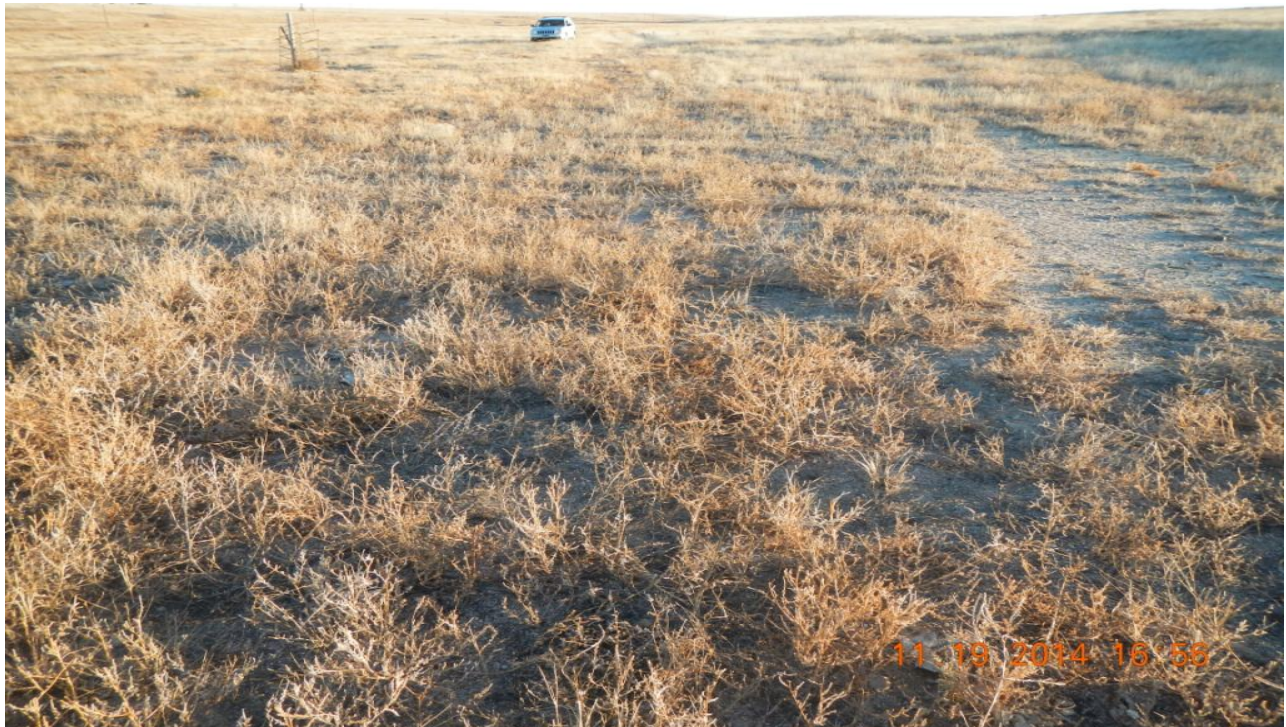
**photo 5:** Center of the location facing South.

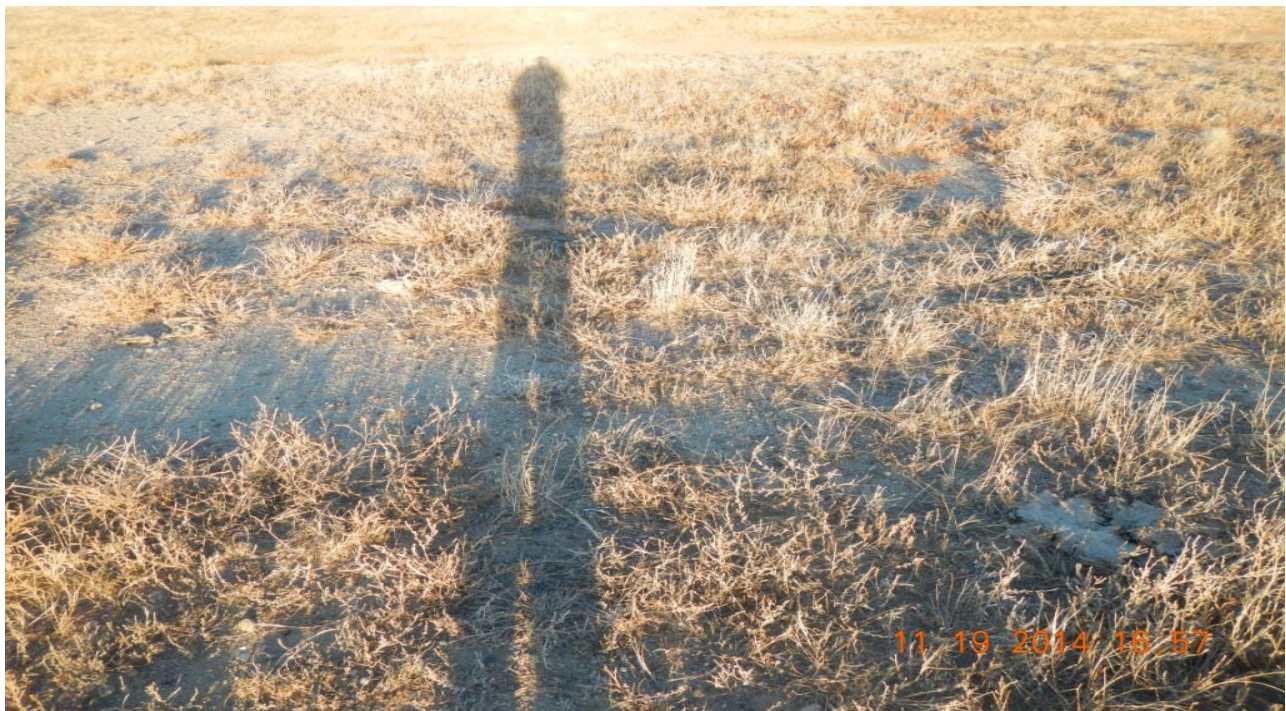
**photo 6:** Center of the location facing East.

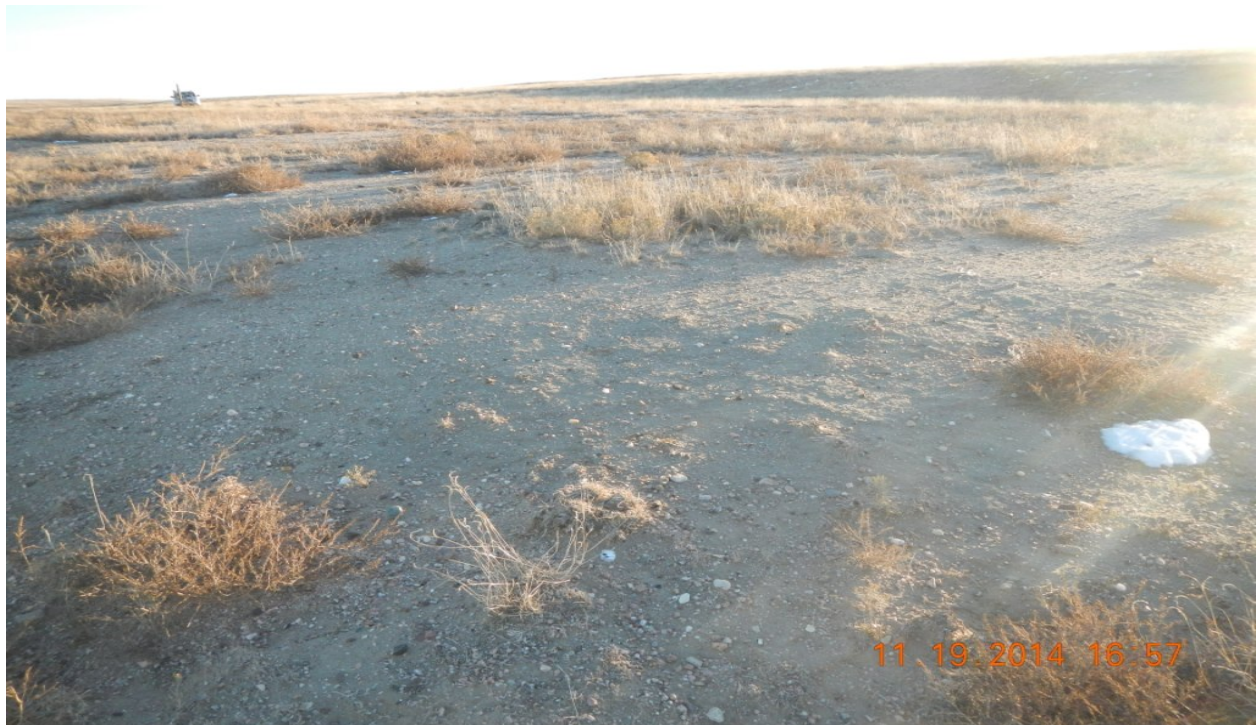
**photo 7:** Area bare of vegetation at the Northeast corner of the location.

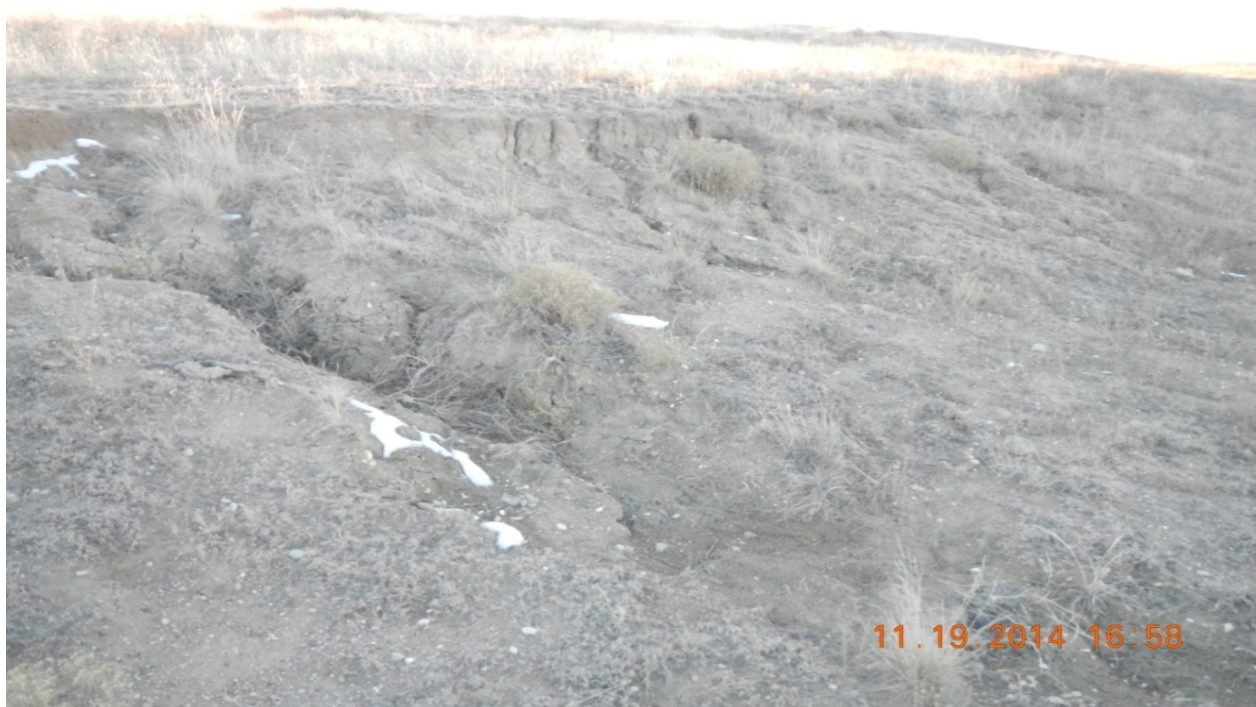
**photo 8:** Erosion occurring at the West side of the location.

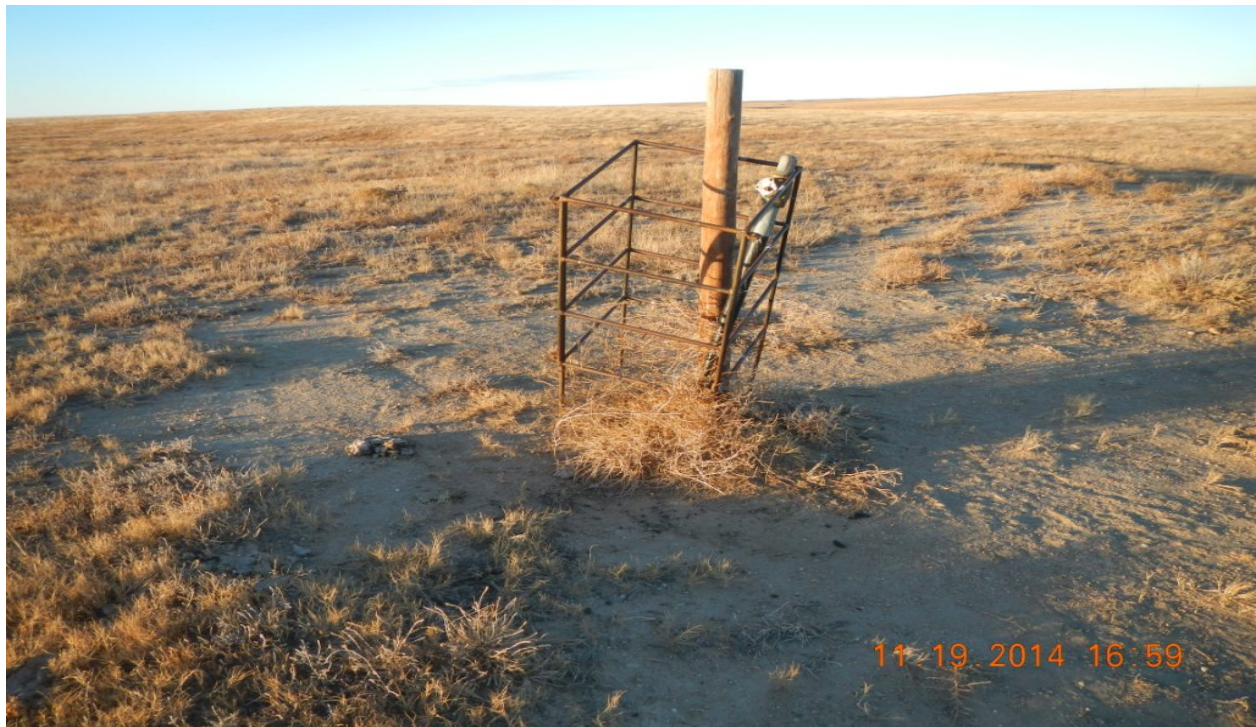
**photo 9:** Wood pole and pipe with metal cage remains on location (38.97165/-103.05369).

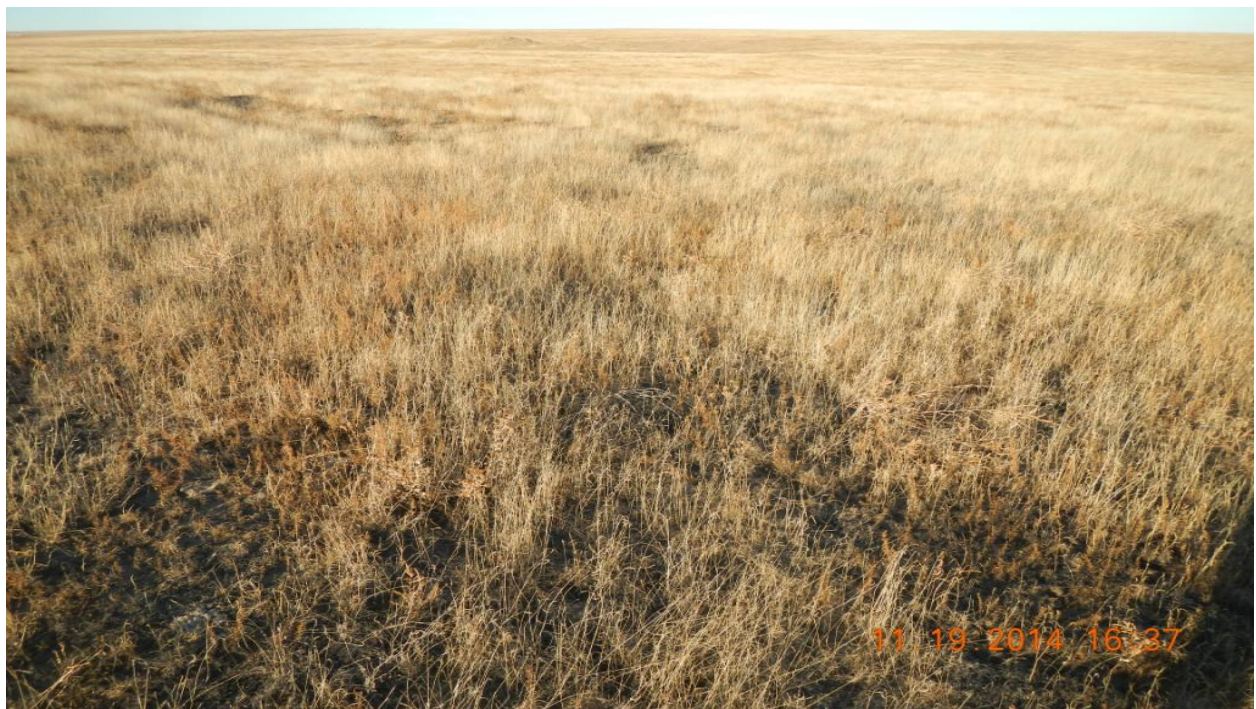
**photo 10:** Surrounding vegetation, reference area.
