Furr22-07 (F1) Pad

Inspection# 675200928

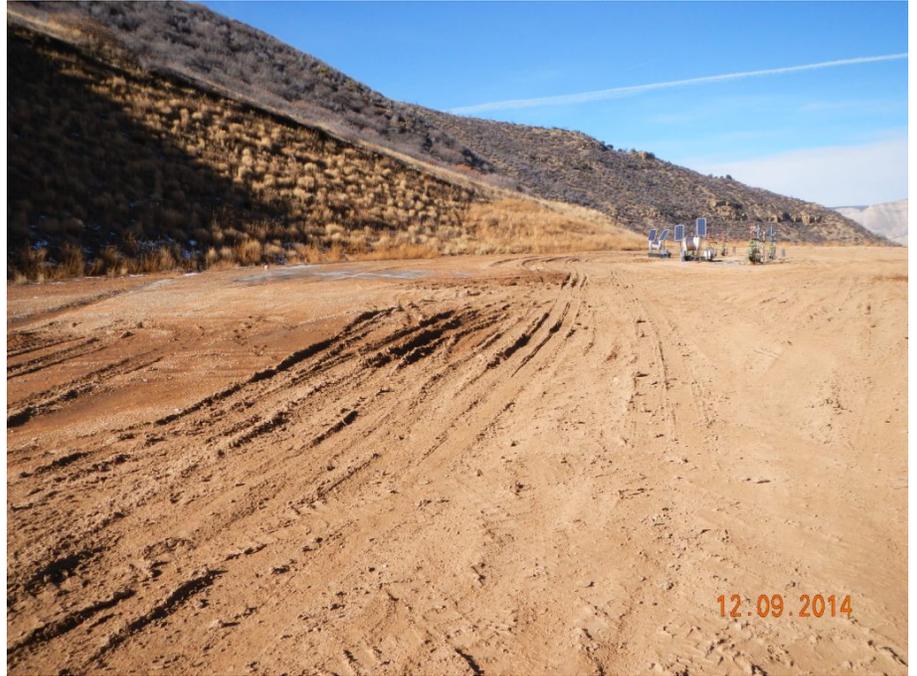
Rutting on location.

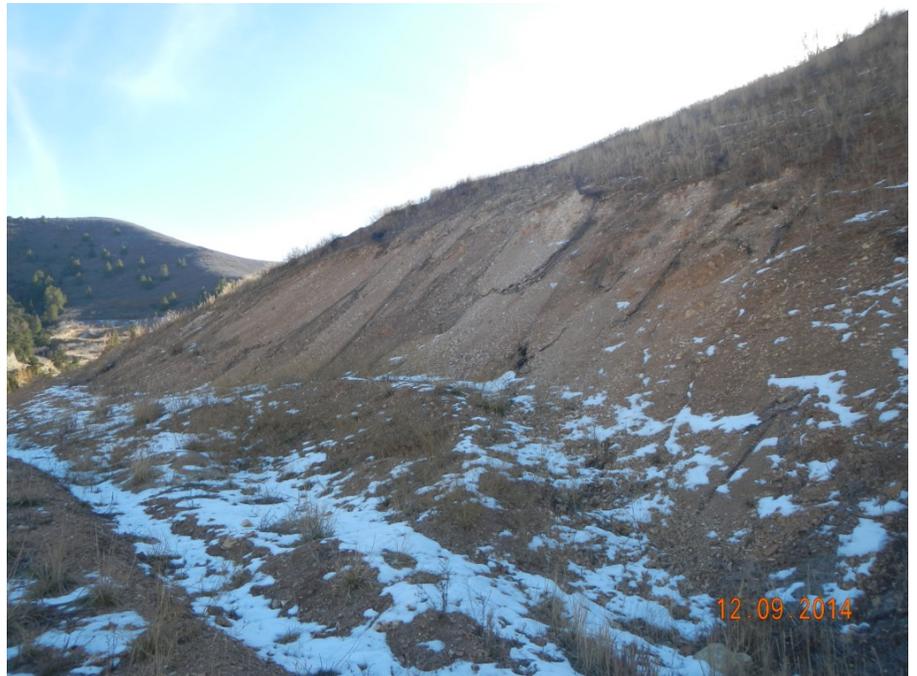
Erosion of cut slope on south end
of location.

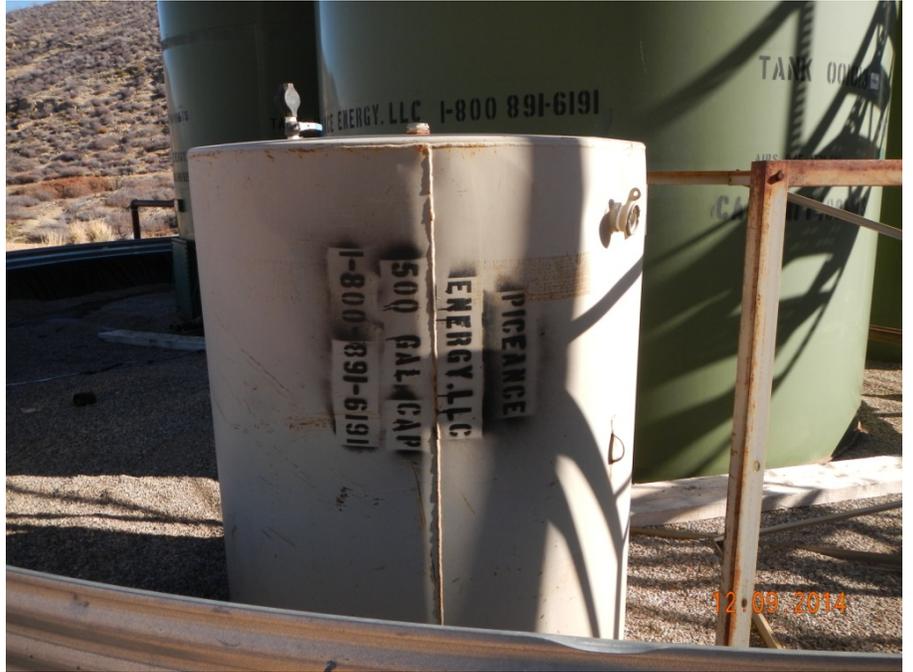
Unused tank to be removed.

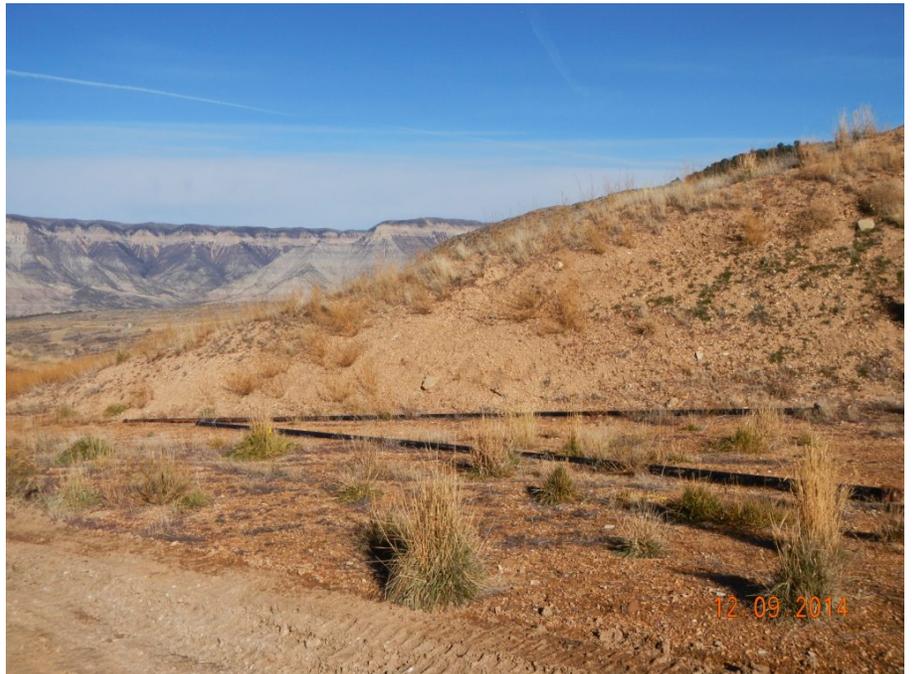
Pipe at entrance of location to be removed.

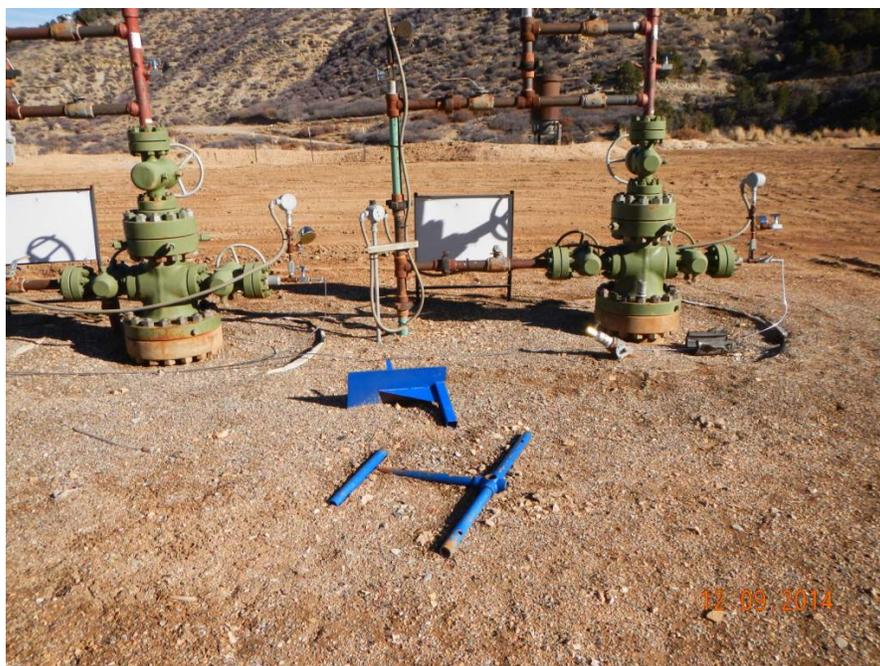
Solar panel stand to be removed at wellheads.
