Bosely SG 21-27

Inspection# 675200974

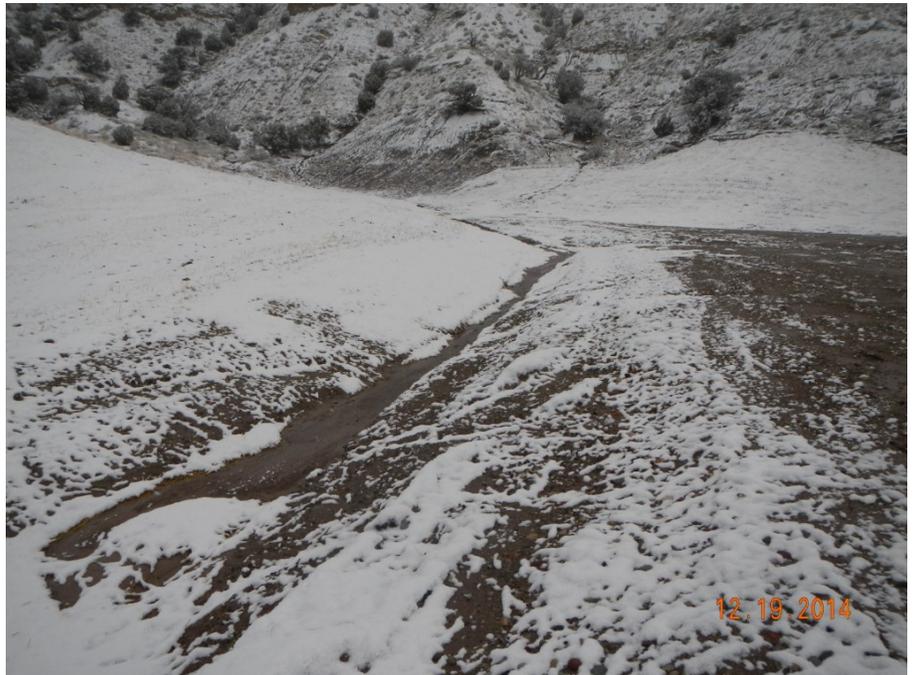
Stormwater drain from wellheads.

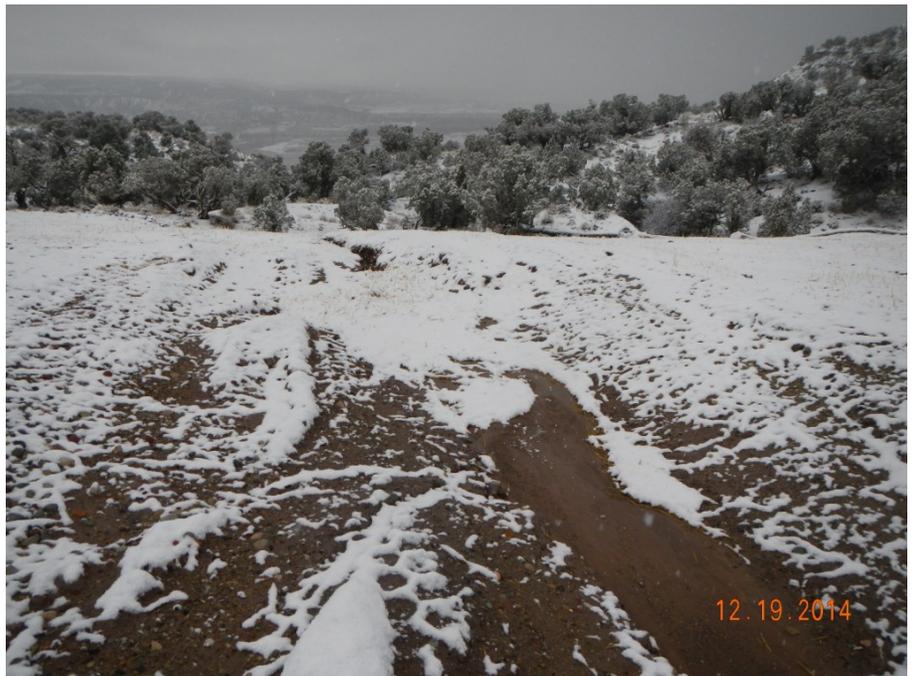
No retention pond or check at end of drain.

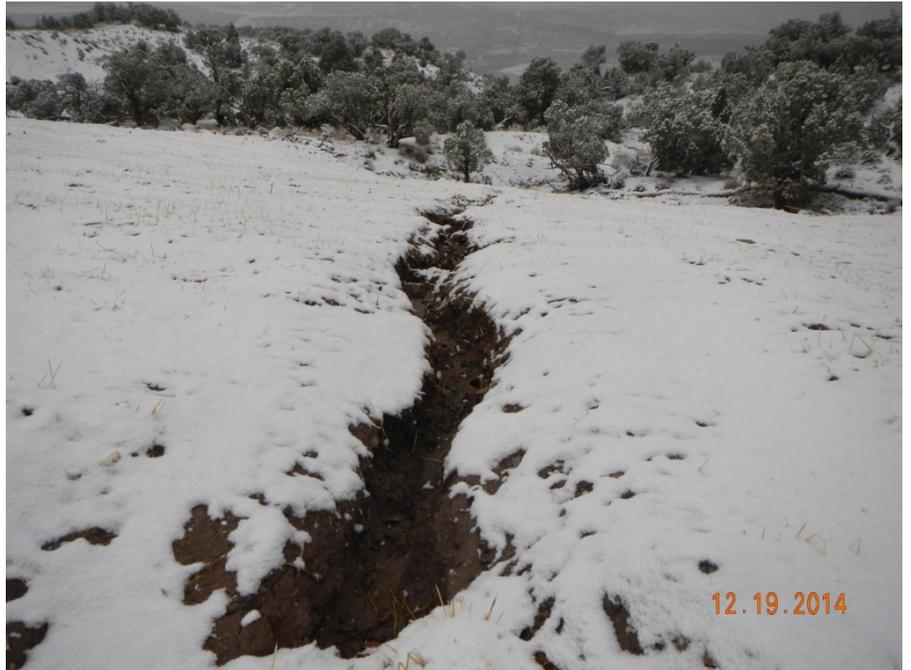
Erosion from drain outlet on reclaimed area.

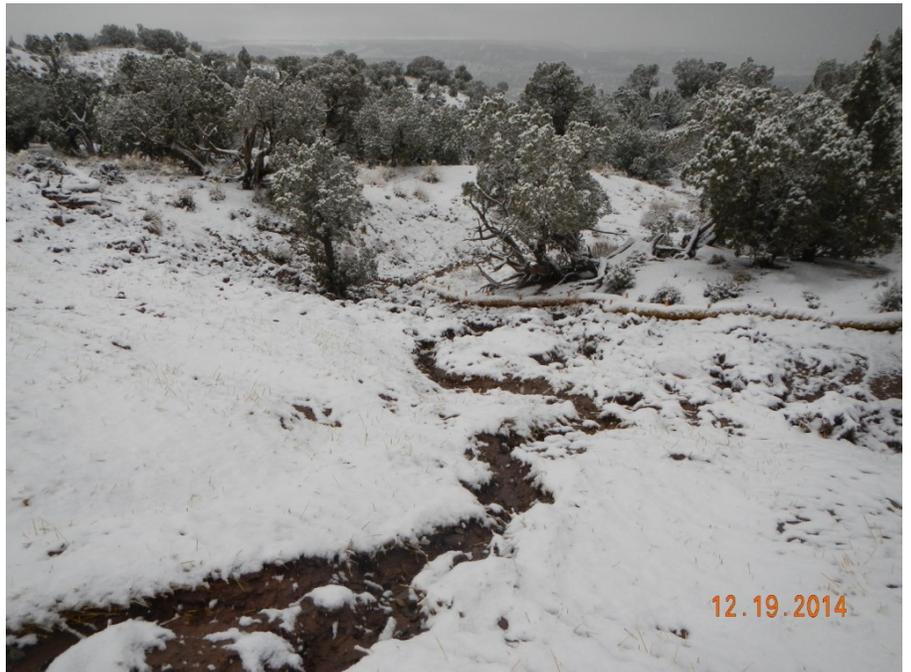
Erosion from drain outlet on reclaimed area.

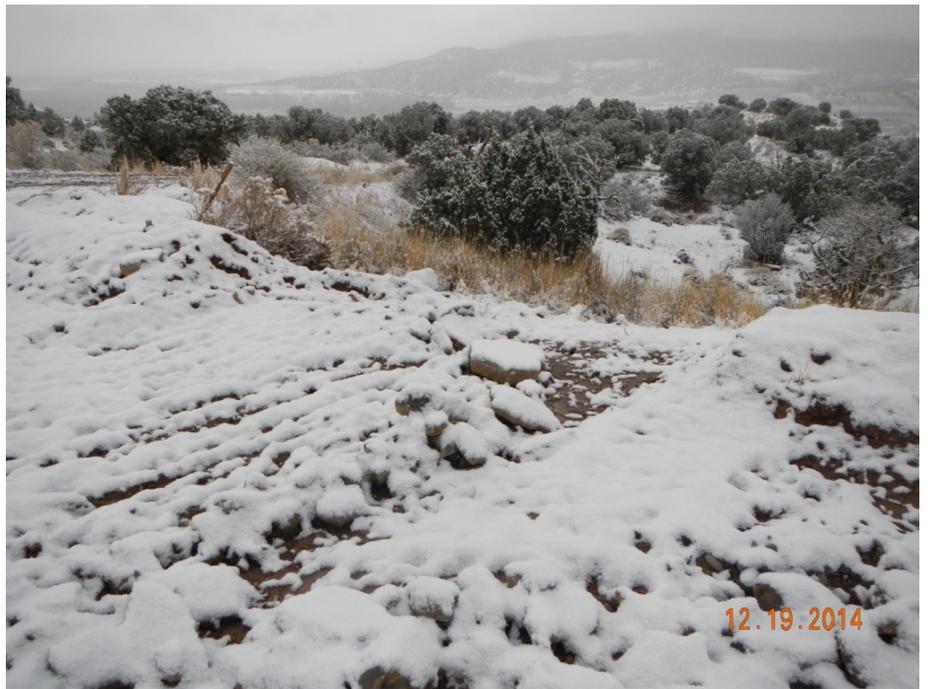
Breached area on berm on south end of location.

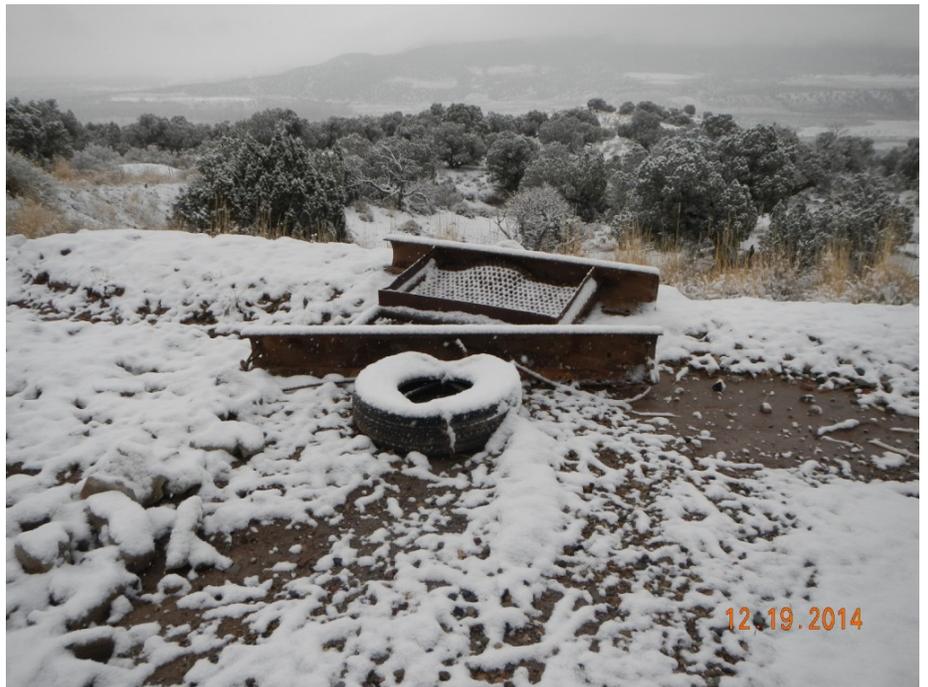
Debris/ Unused equipment near tank containment.
