**SG 34-28**

Inspection# 675200993

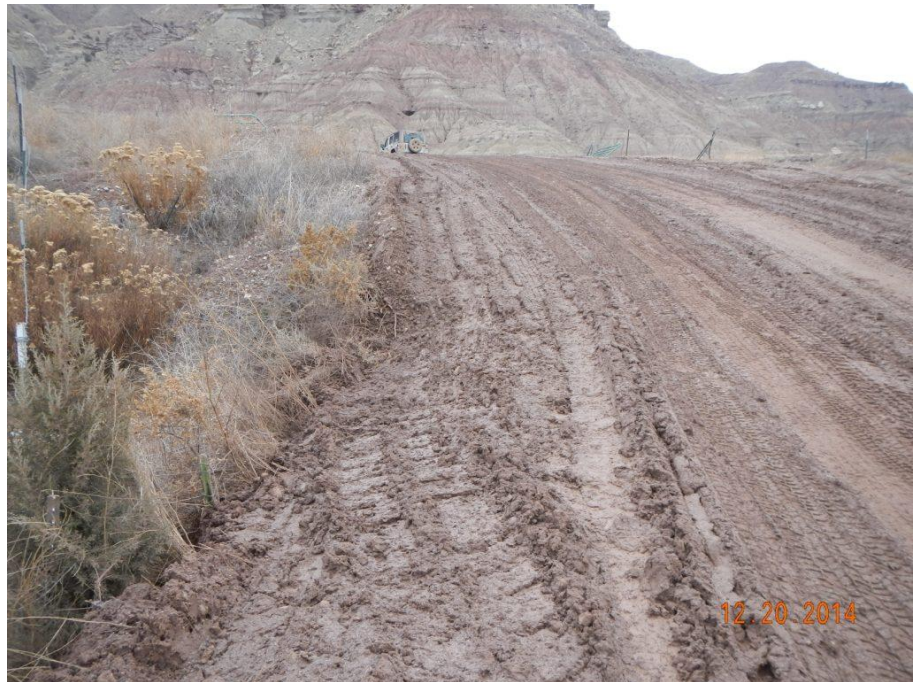
Access road: Shoulders have been damaged from truck traffic and sediment pushed into vegetation.

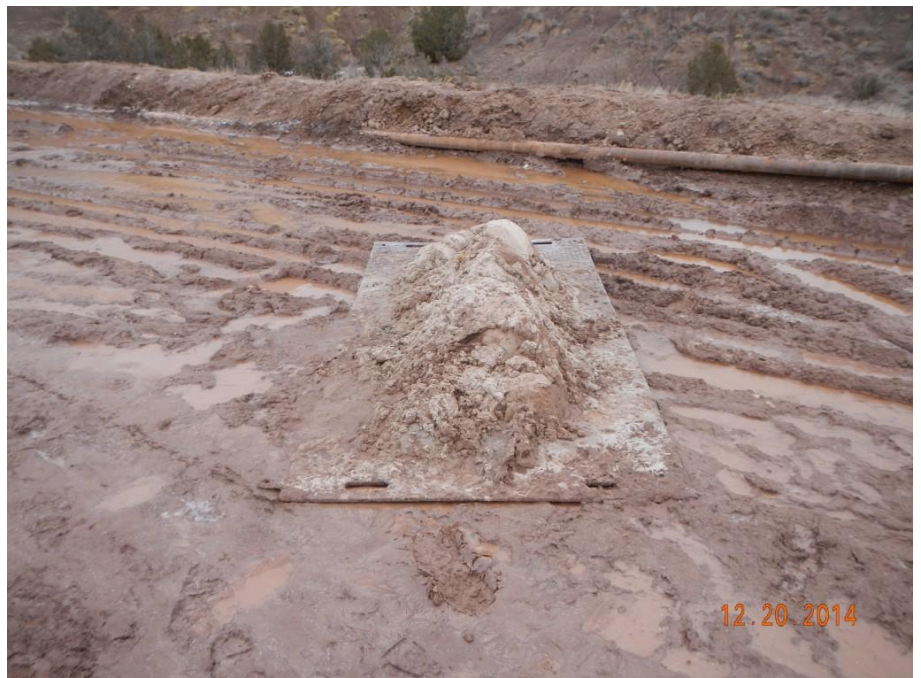
Debris on location

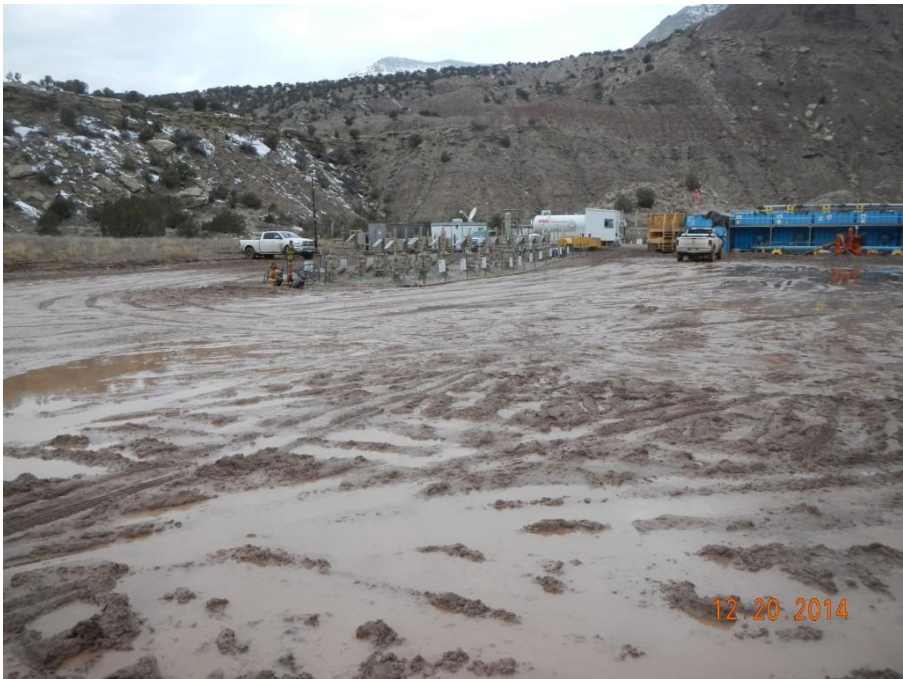
Location the day of inspection.
