WPX Energy

GM 44-1 Pad

Location # 324080

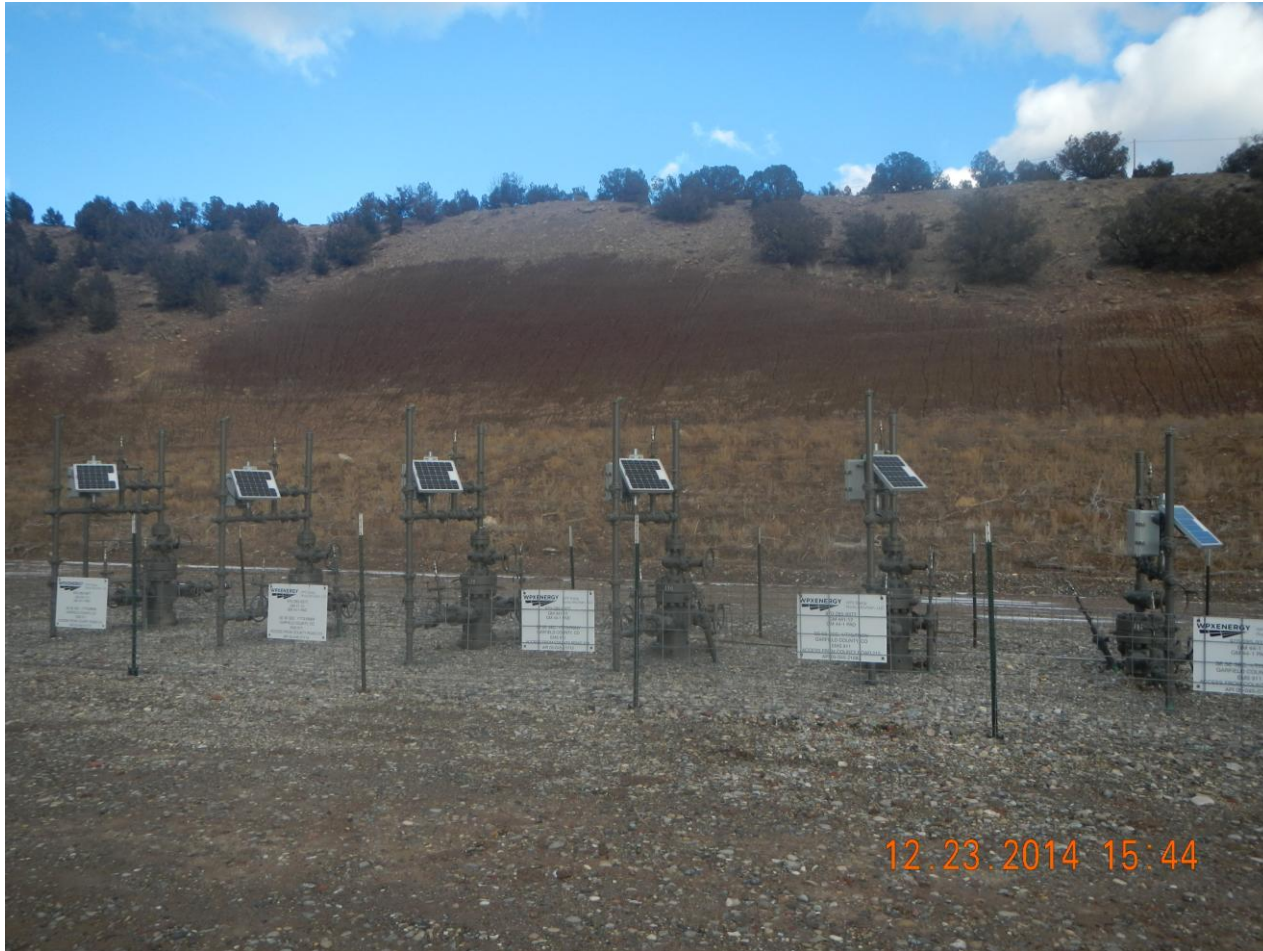
Unstabilized cut wall behind wells

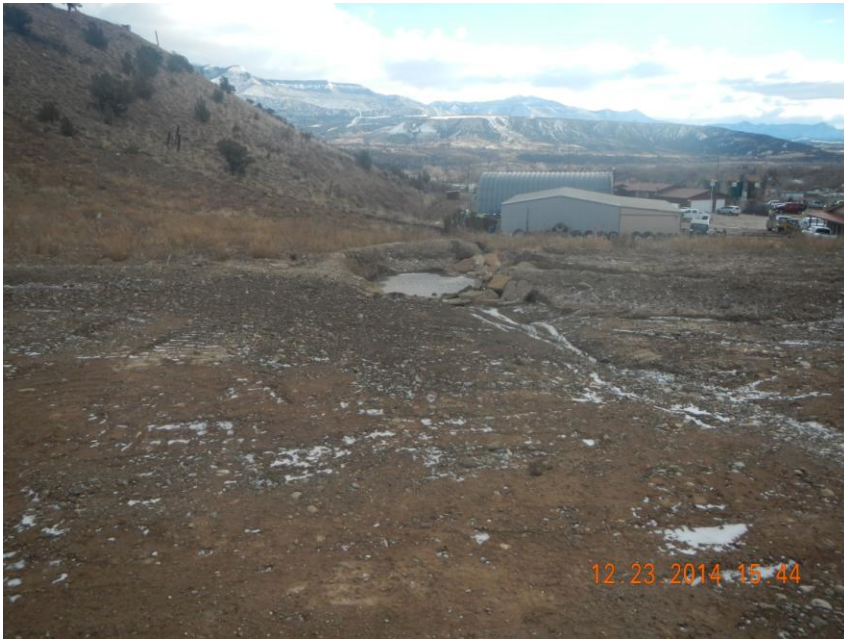
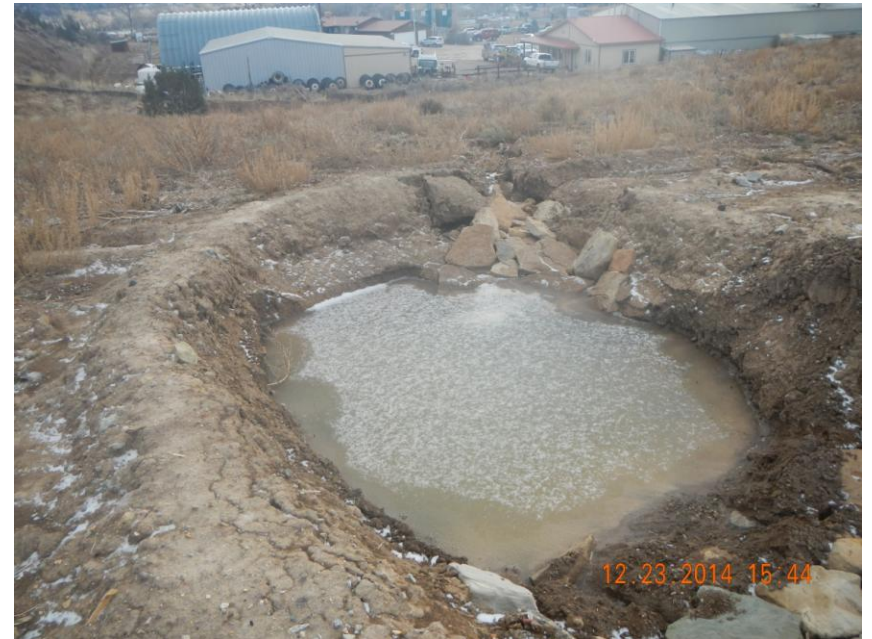
Erosion of check dam

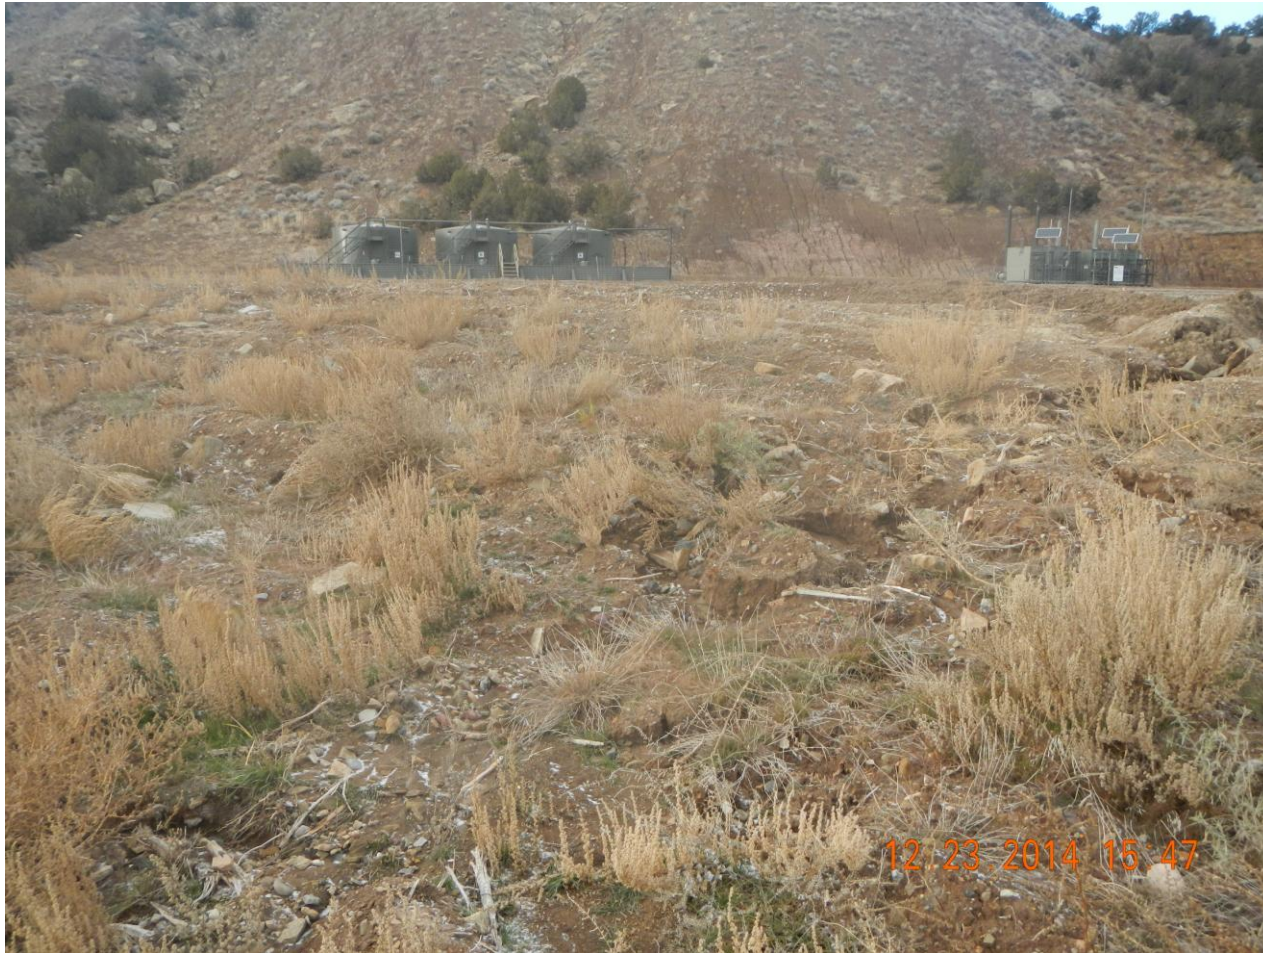
Erosion from discharge of check dam

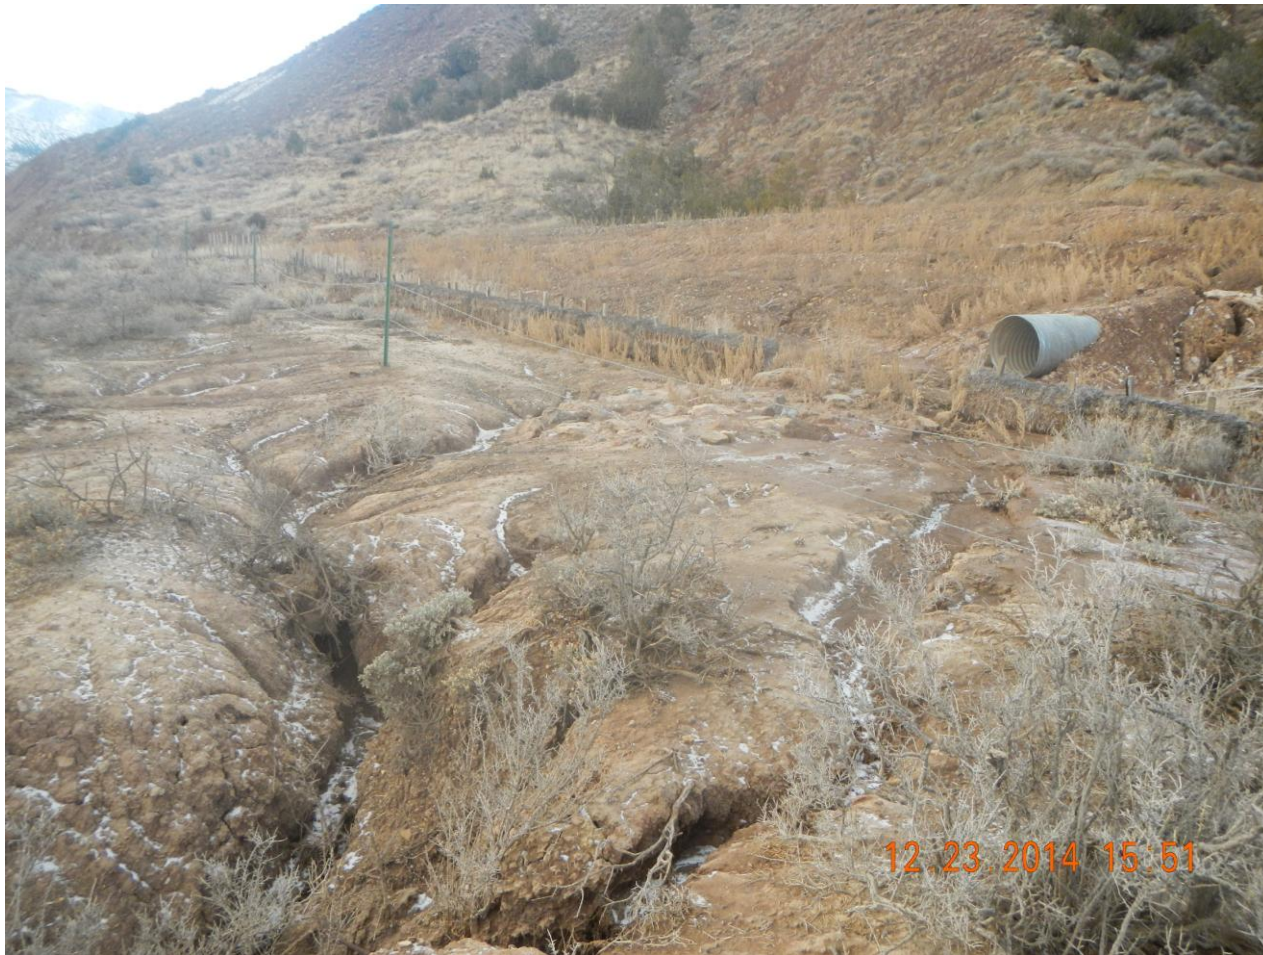
Erosion at culvert

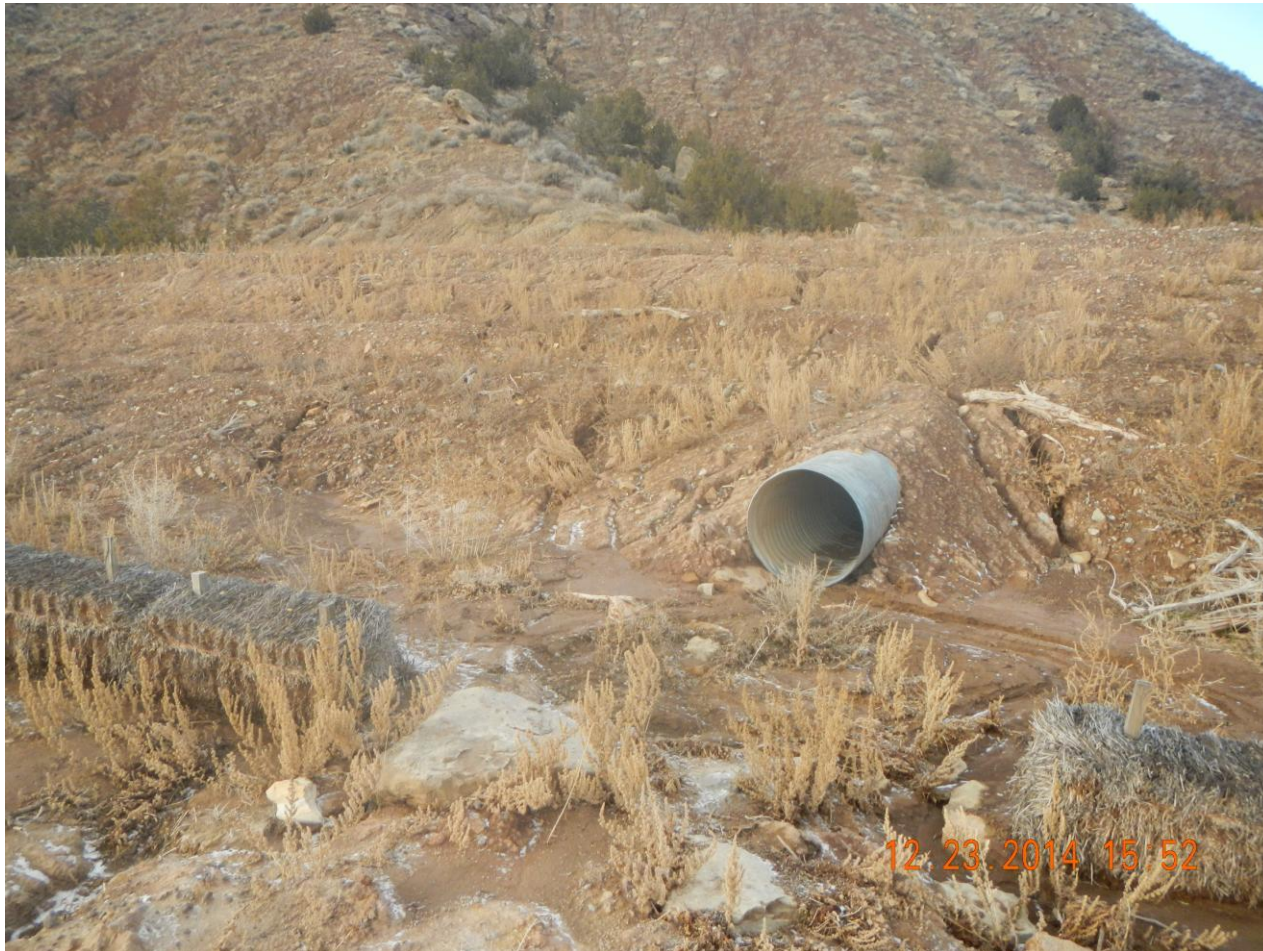
Bales have been washed away

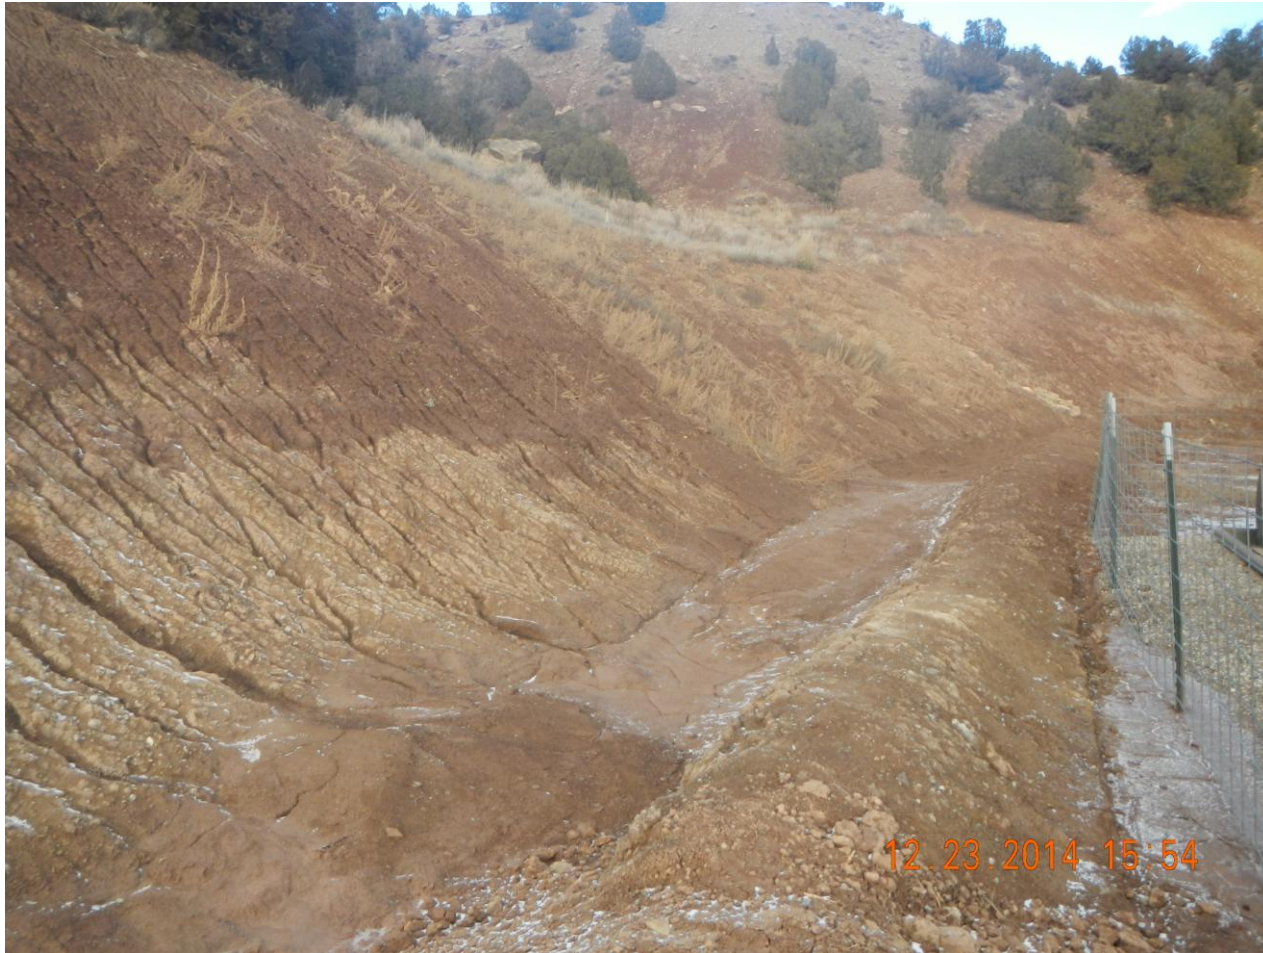
Unstable wall behind separators
