## F 8 OU Pad

Inspection# 675201056

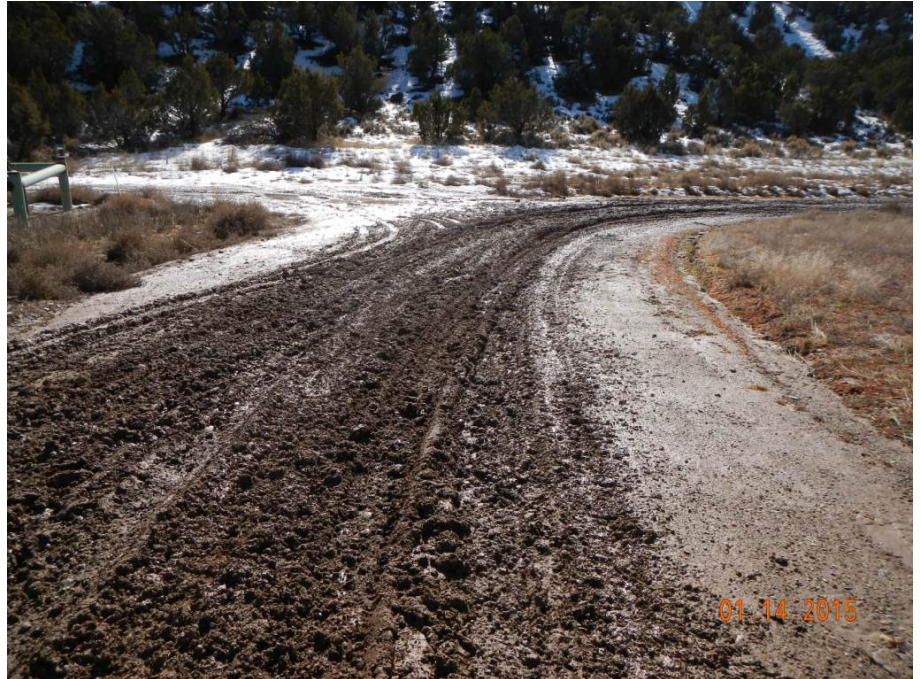
Access road to location was rutted  
and travel was difficult at time of  
inspection.

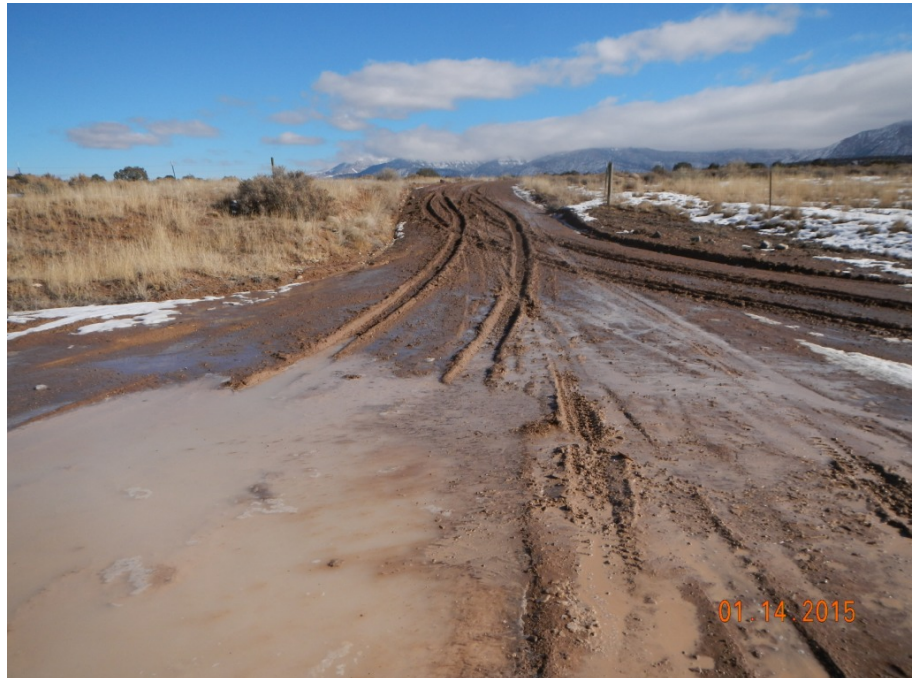
Entrance of location.

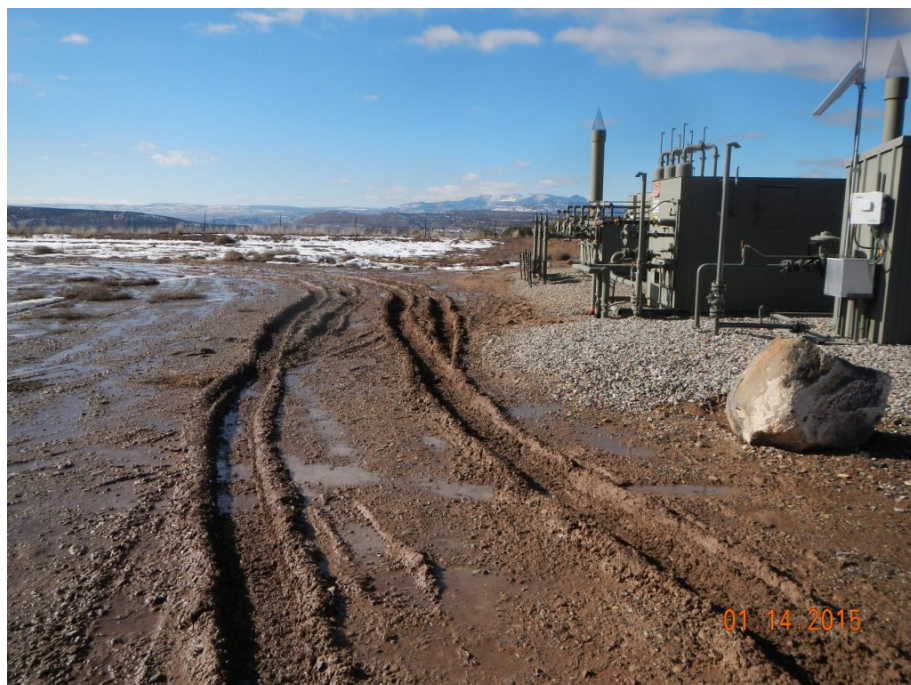
Rutting on location.
